# **GENERAL ASSESSMENT REPORT**

## **EXISTING STRUCTURAL SYSTEMS**

**803 2<sup>ND</sup> STREET  
MIAMI BEACH, FLORIDA**

**APRIL 5, 2021**

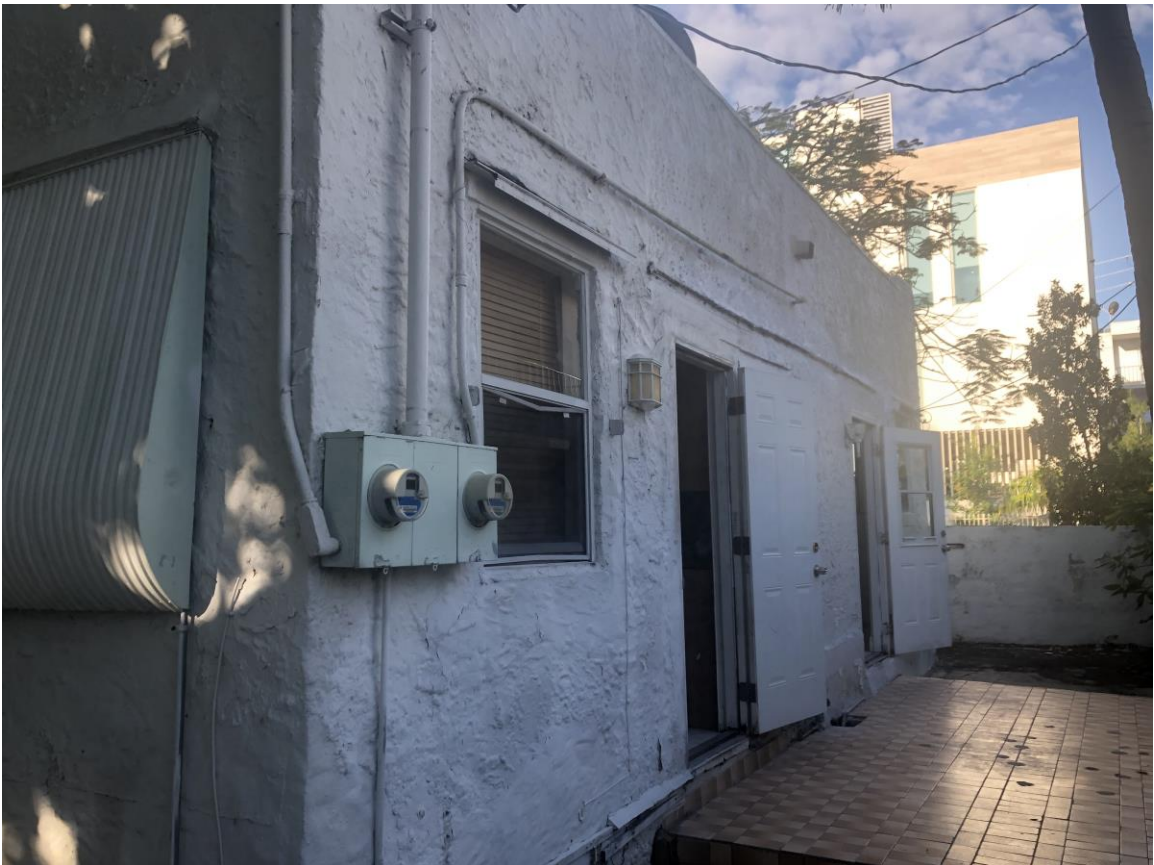
**PHOTOGRAPH NO. 4**

8. None of the existing windows are original to the building. Most of the windows are single-hung aluminum (some painted white, others exposed aluminum), but one window is a slider, and the windows in the southwest room are jalousie. Most of the windows and their seals and caulking are in poor condition. None of the windows have an impact resistance rating. Refer to Photographs Nos. 4, 25, 31, 32, 34, 35, 38, 42, 68, 76, 78, 83 and 93.

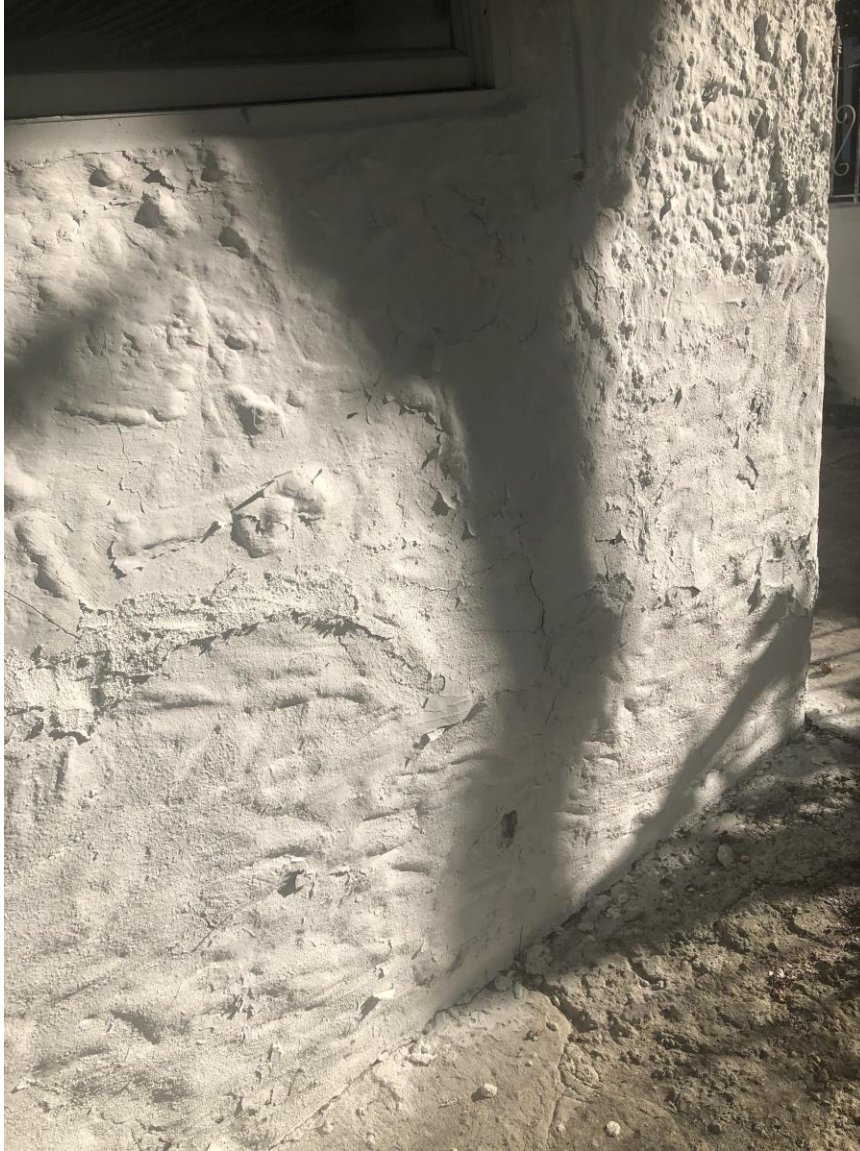
**PHOTOGRAPH NO. 13**

1. Most of the exterior stucco has been replaced, with almost all of the stucco below the window-sill level having been replaced. The replacements have apparently occurred at a number of different times. The replacement areas are of obviously different textures (some very crudely applied). Some of the patches appear to have been extended over adjacent areas of stucco without proper surface preparation, resulting in areas of delamination. Refer to Photographs Nos. 6, 10 through 14, 17, 19 through 22, 26, 30, 31, 33, 34, 36, 39, 58, 59, 60, 64, 75 and 77.

2. There are numerous exterior stucco cracks and numerous holes in the exterior stucco. With the stucco on wood lath and no vapor or moisture barrier, each of these cracks and holes is a source of water intrusion to the structural wood framing behind. Refer to Photographs Nos. 7, 8, 9, 12, 13, 14, 16, 18, 22, 23, 24, 26 through 30, 35, 36, 37, 45, 46, 49, 59, 65 and 68.

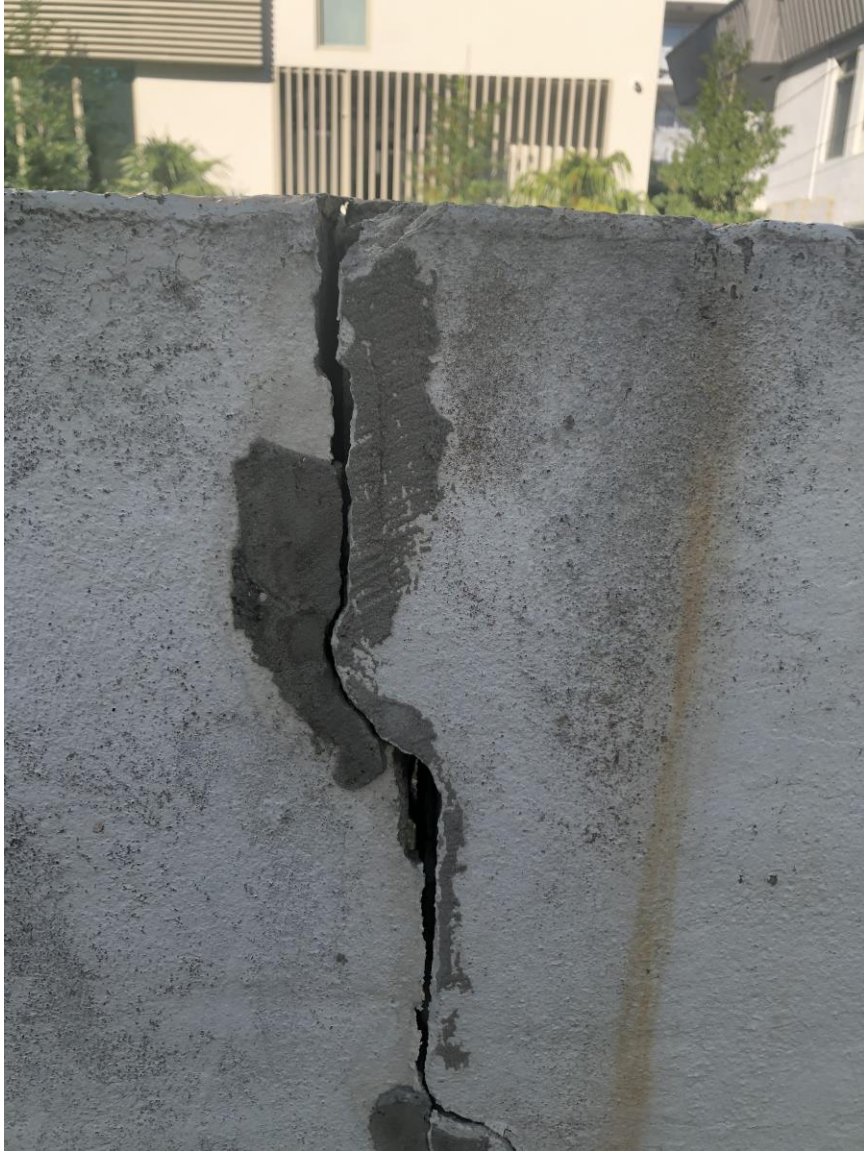
**PHOTOGRAPH NO. 51**

There are several cracks in this fence. There is one particularly wide crack near the middle of its length. No reinforcement was visible in the crack. Refer to Photographs Nos. 50 through 54. The narrower cracks are likely primarily due to material shrinkage, and the wider crack is likely due to some soil settlement as well as material shrinkage. This fence lacks appropriate strength for its height.

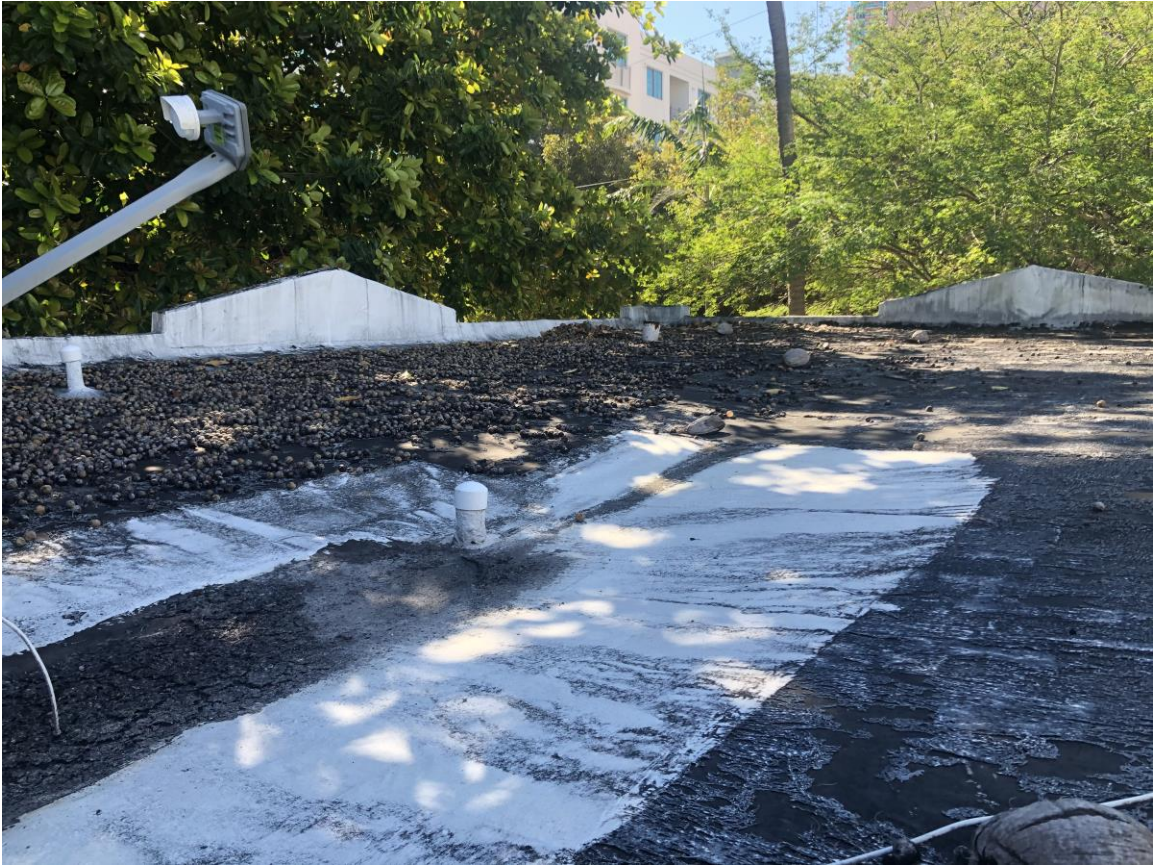
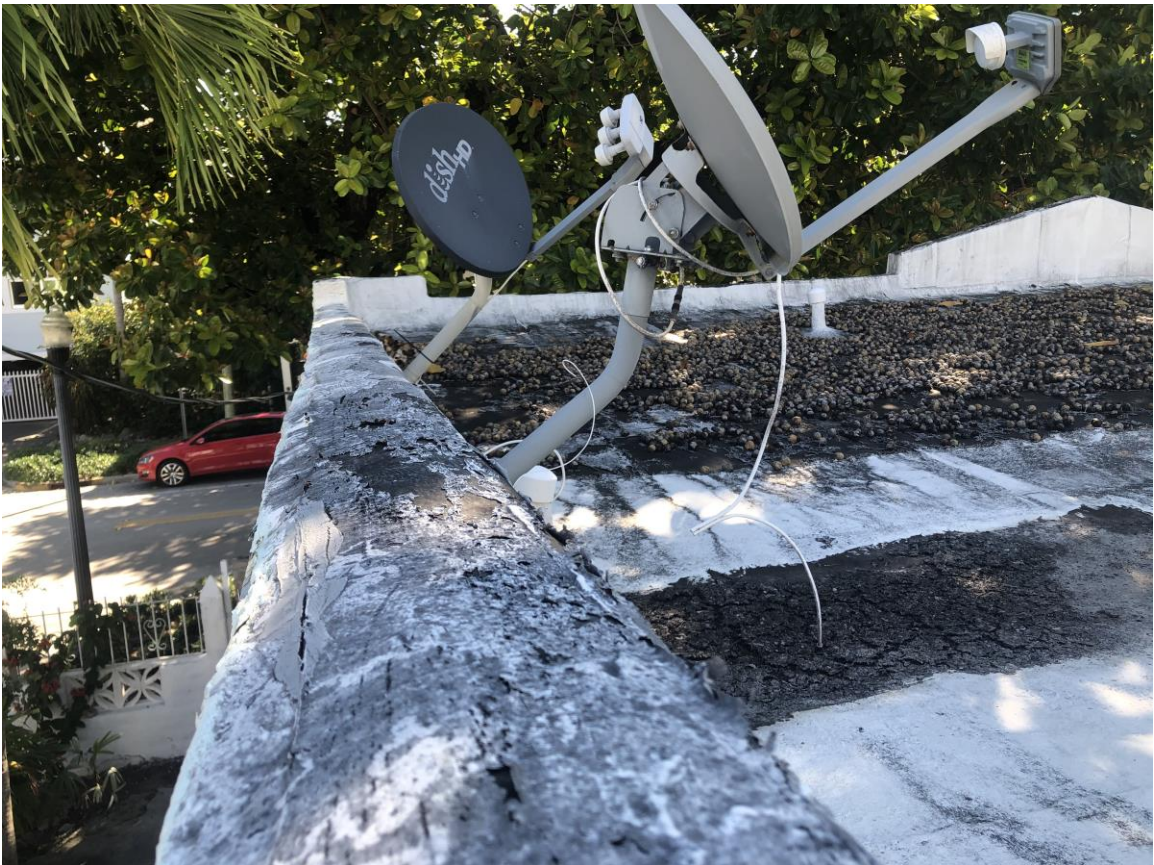
PHOTOGRAPH NO. 94

1. There is only one roof scupper (through the rear parapet) for the entire roof, and there is no overflow scupper/drain. Refer to Photographs Nos. 58, 94 and 95.

2. The adjacent tall trees have deposited, and will continue to deposit, a considerable amount of debris on the roof. Such debris could easily clog the one scupper, causing a back-up of water on the roof, which could overload portions of the roof structure. Refer to Photographs Nos. 58, 94 and 95.

4. There are signs of current or previous roof leaks on the interior of the southeast room. Refer to Photographs Nos. 84, 85, and 86.
5. The presently existing roofing is old, worn and cracked. Refer to Photographs Nos. 94 and 95.
