# Arborist Report

1901 Alton Road

Miami Beach

9/13/2023

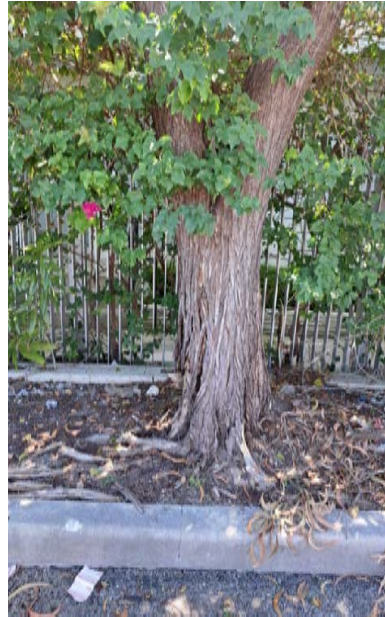
## Tree #5

| NUMBER | COMMON NAME | SCIENTIFIC NAME | DBH (IN) | HT (FT) | SP (FT) | CONDITION | NATIVE? | NOTES |
|---|---|---|---|---|---|---|---|---|
| 5 | EARLEAF ACACIA | ACACIA AURICULIFORMIS | 17 | 33 | 20 | POOR | INVASIVE | LARGE DEADWOOD; PRUNE TO REMOVE DEADWOOD ASAP |

Tree #5 is an Earleaf Acacia located on the east side of the property. It is in poor condition. There is limited rooting space and many large surface roots. The tree is thinning with extensive dieback. Large dead limbs are present.

Prune to remove the deadwood as soon as possible since it is over the parking lot. This species is highly invasive in South Florida and this tree will therefore need to be removed.

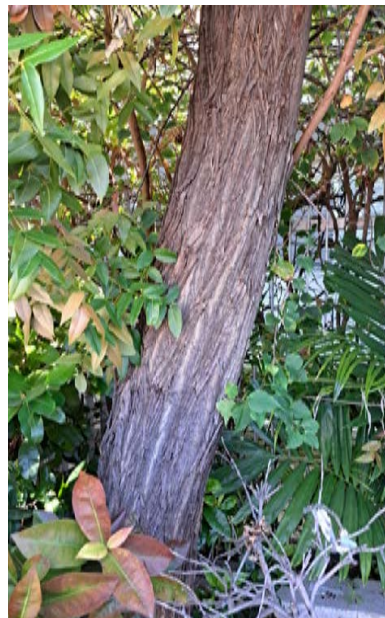
## Tree #6

Tree #6 is an Earleaf Acacia located on the east side of the property. The tree is in fair condition. It has a poor, spreading form. There is limited rooting space and many large surface roots.

Continue to prune to remove deadwood. This species is highly invasive in South Florida and this tree will therefore need to be removed.

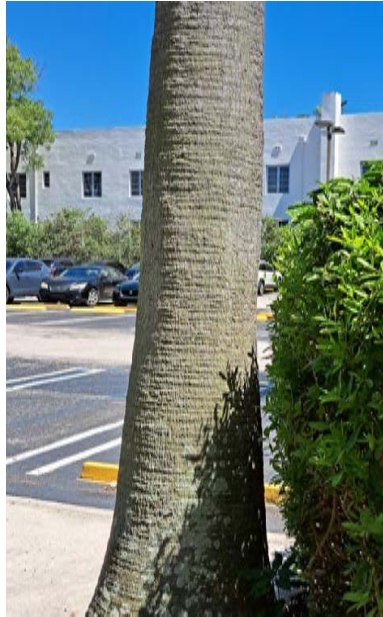
## Tree #31

Tree #31 is a Mexican Fan Palm located in the existing parking lot. It is in good condition. Prune to remove the lower dead fronds.

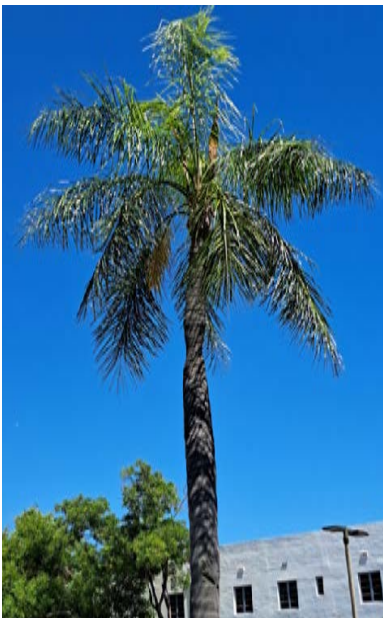
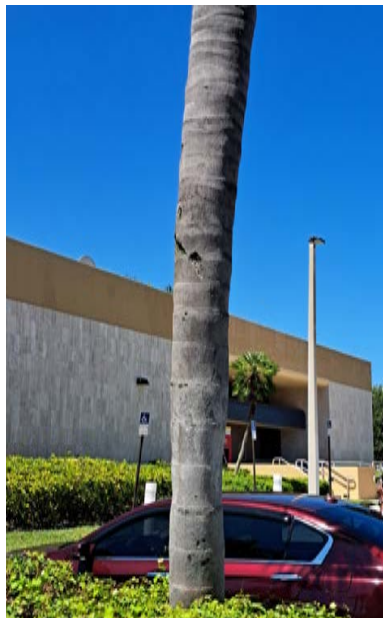
## Tree #32

Tree #32 is a Queen Palm located in the existing parking lot. It is in poor condition with a trunk constriction and a thin, chlorotic canopy.
