# Arborist Report

1901 Alton Road

Miami Beach

9/13/2023

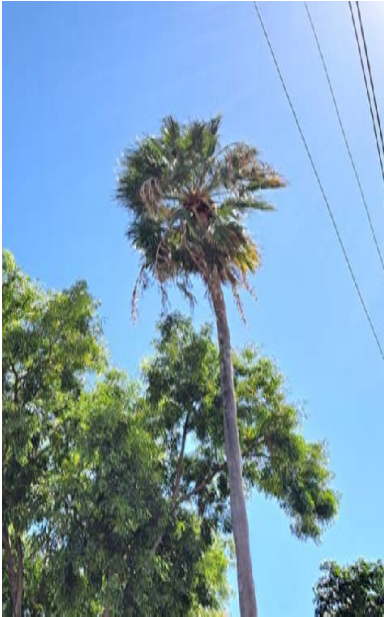
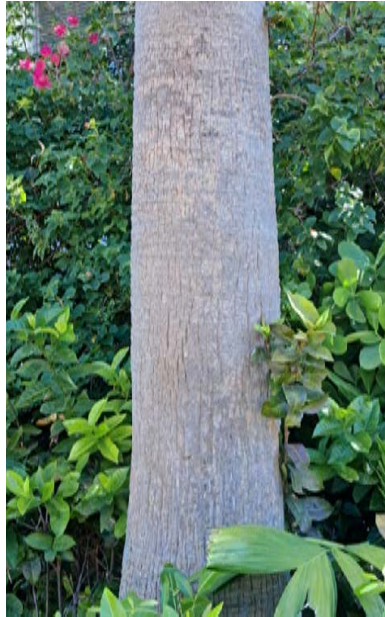
## Tree #1

Tree #1 is a Mexican Fan Palm located in the southeast corner of the property. It is in good condition. Overhead wires are nearby.

Prune to remove the lower dead fronds.

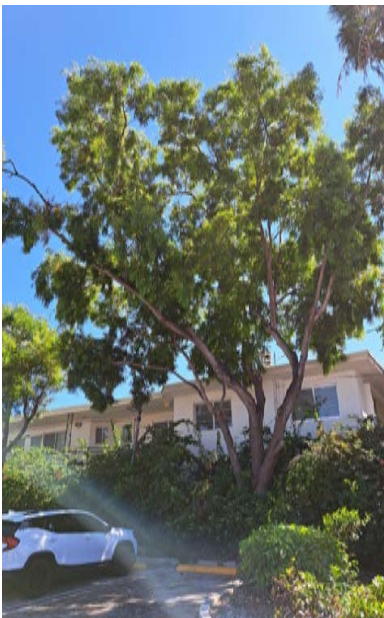
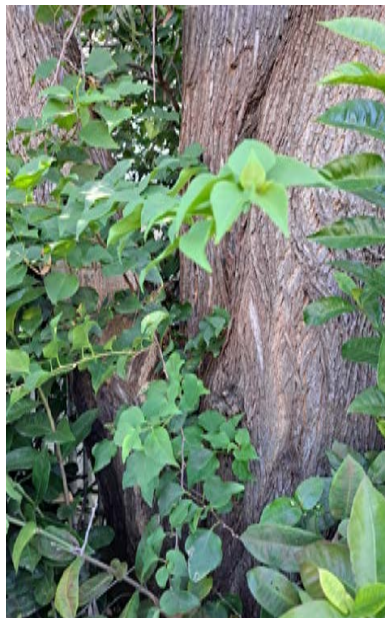
## Tree #2

Tree #2 is an Earleaf Acacia located on the eastern side of the property. It is in fair condition. There is included bark between the leaders. Long, over-extended limbs are present. Little deadwood is present.

Continue to prune to remove deadwood and to maintain clearance over the parking lot. This species is highly invasive in South Florida and this tree will therefore need to be removed.

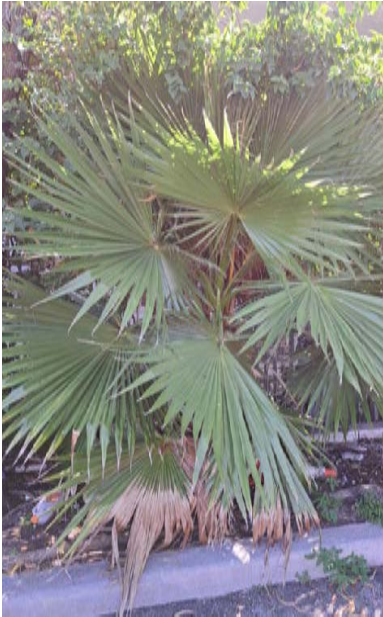
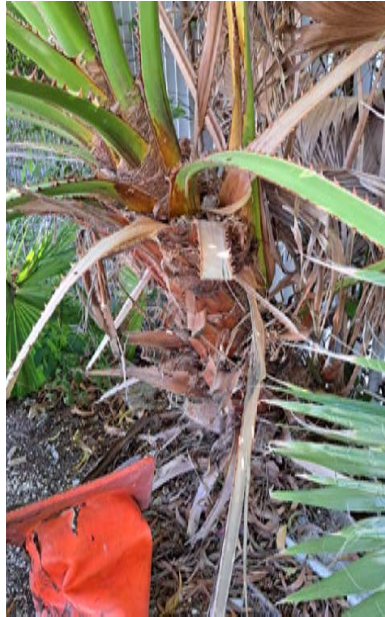
### Tree #3

Tree #3 is a small Mexican Fan Palm located on the eastern side of the property. It is in good condition.

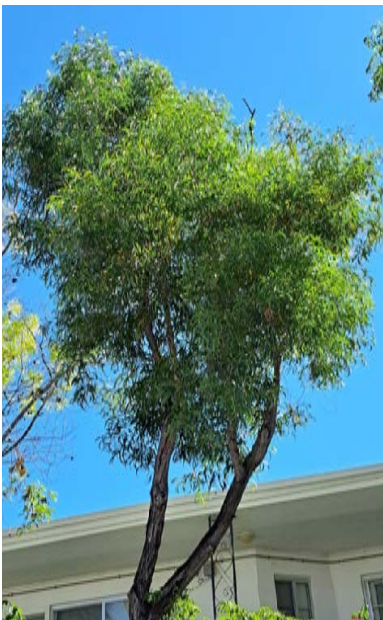
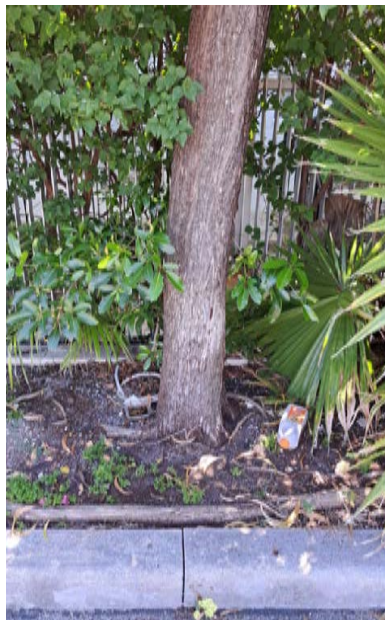
### Tree #4

Tree #4 is an Earleaf Acacia located on the eastern side of the property. It is in fair condition. There is limited rooting space. Large surface roots are present. The tree has a small, asymmetrical canopy with a low live crown ratio. Continue to prune to remove deadwood. This species is highly invasive in South Florida and this tree will therefore need to be removed.

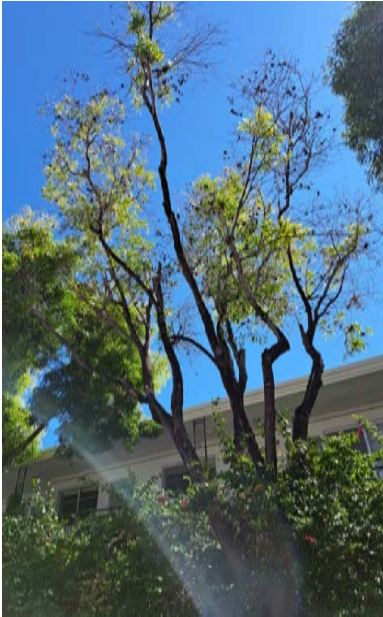
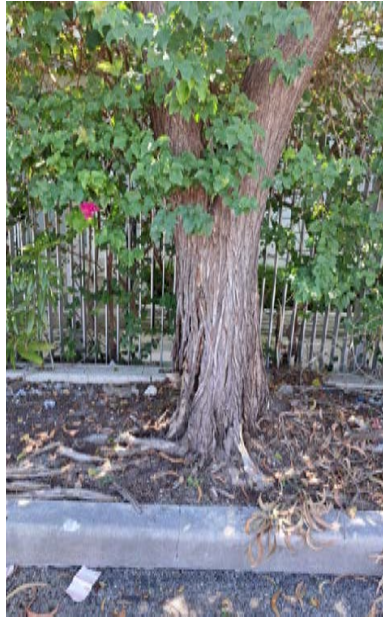
## Tree #5

| NUMBER | COMMON NAME | SCIENTIFIC NAME | DBH (IN) | HT (FT) | SP (FT) | CONDITION | NATIVE? | NOTES |
|---|---|---|---|---|---|---|---|---|
| 5 | EARLEAF ACACIA | ACACIA AURICULIFORMIS | 17 | 33 | 20 | POOR | INVASIVE | LARGE DEADWOOD; PRUNE TO REMOVE DEADWOOD ASAP |

Tree #5 is an Earleaf Acacia located on the east side of the property. It is in poor condition. There is limited rooting space and many large surface roots. The tree is thinning with extensive dieback. Large dead limbs are present.

Prune to remove the deadwood as soon as possible since it is over the parking lot. This species is highly invasive in South Florida and this tree will therefore need to be removed.

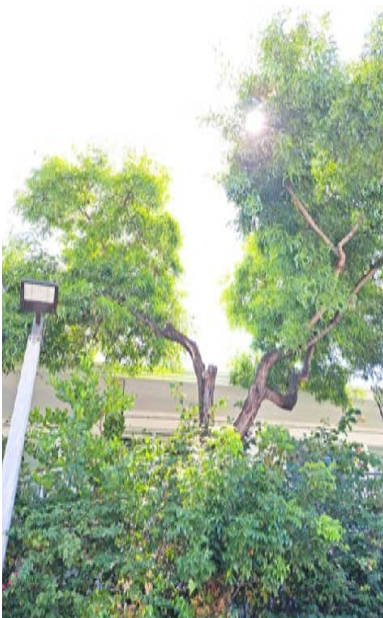
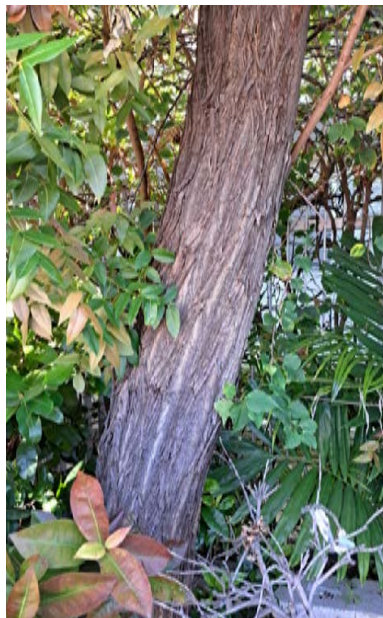
## Tree #6

Tree #6 is an Earleaf Acacia located on the east side of the property. The tree is in fair condition. It has a poor, spreading form. There is limited rooting space and many large surface roots.

Continue to prune to remove deadwood. This species is highly invasive in South Florida and this tree will therefore need to be removed.

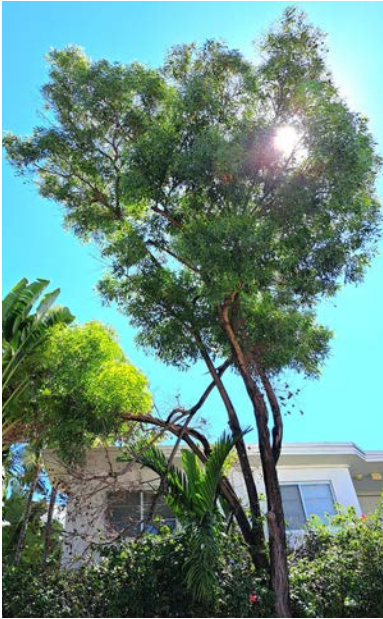
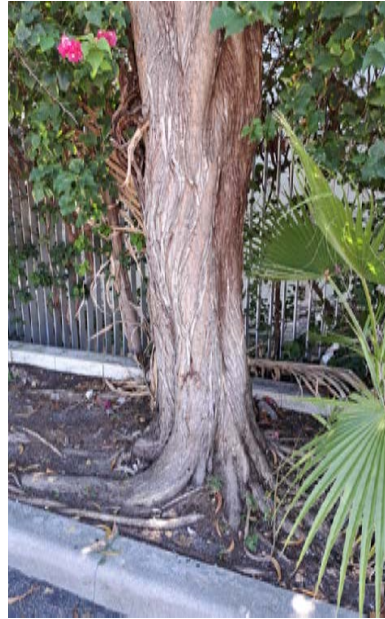
## Tree #7

| NUMBER | COMMON NAME | SCIENTIFIC NAME | DBH (IN) | HT (FT) | SP (FT) | CONDITION | NATIVE? | NOTES |
|---|---|---|---|---|---|---|---|---|
| 7 | EARLEAF ACACIA | ACACIA AURICULIFORMIS | 18.5 | 40 | 20 | POOR | INVASIVE | HANGING BROKEN LIMB; PRUNE TO REMOVE DEADWOOD ASAP |

Tree #7 is an Earleaf Acacia located on the east side of the property. The tree is in poor condition. There are large, hanging dead limbs in the canopy. There is limited rooting space and many large surface roots. Prune to remove the deadwood as soon as possible since it is over the parking lot. This species is highly invasive in South Florida and this tree will therefore need to be removed.

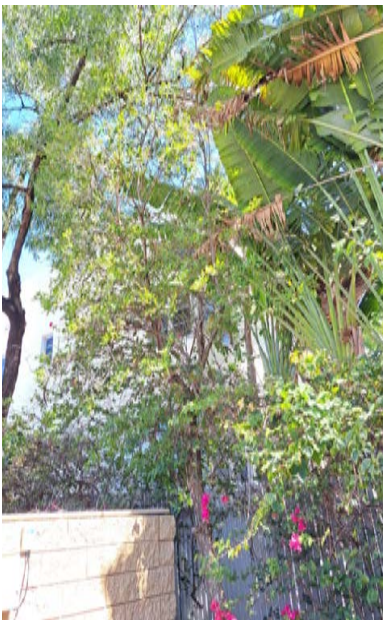
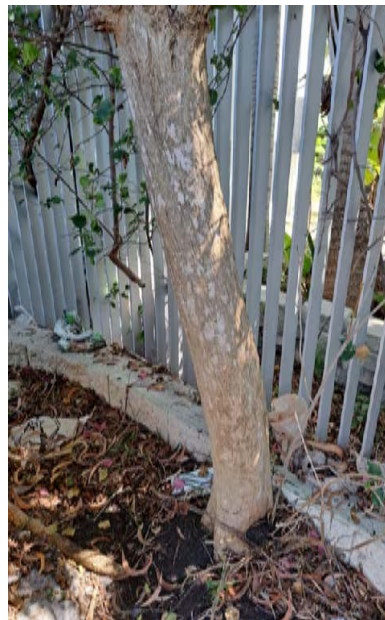
## Tree #8

Tree #8 is a Pink Trumpet Tree located on the northeast side of the property. It is in poor condition. There is limited rooting space. There are pest issues affecting the foliage. The canopy is thin.

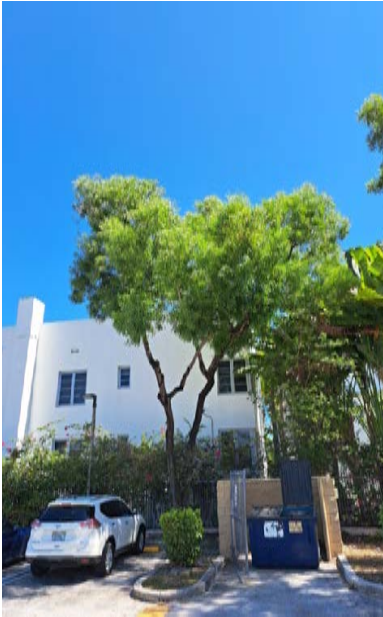
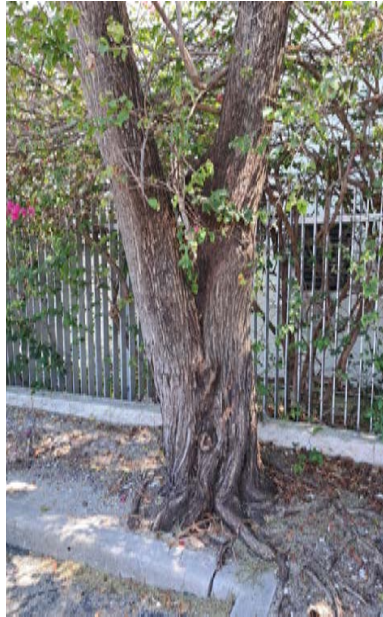
## Tree #9

Tree #9 is an Earleaf Acacia located on the northeast side of the property. It is in fair condition. There is limited rooting space and there are many large surface roots. The trunk divides into two with included bark. The tree has a low live crown ratio. Continue to prune to remove deadwood. This species is highly invasive in South Florida and this tree will therefore need to be removed.

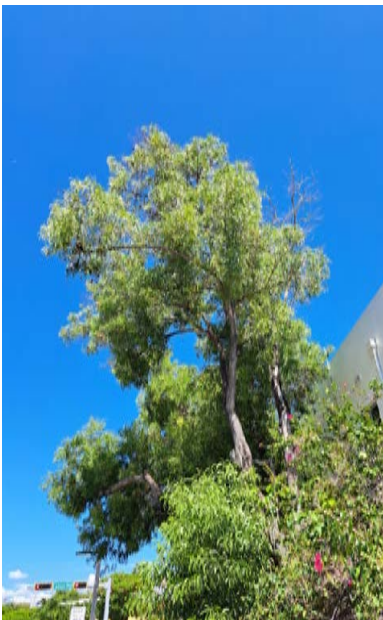
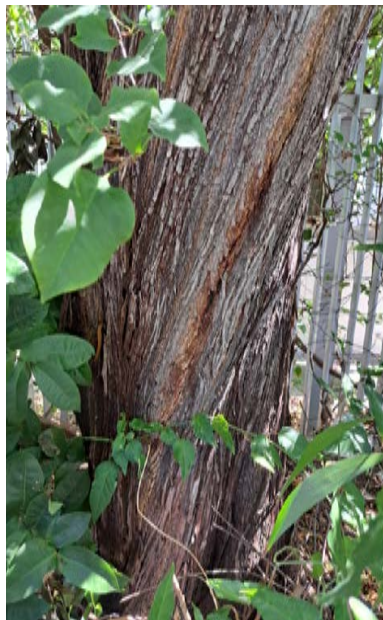
## Tree #10

| NUMBER | COMMON NAME | SCIENTIFIC NAME | DBH (IN) | HT (FT) | SP (FT) | CONDITION | NATIVE? | NOTES |
|---|---|---|---|---|---|---|---|---|
| 10 | EARLEAF ACACIA | ACACIA AURICULIFORMIS | 24 | 40 | 18 | POOR | INVASIVE | LARGE DEADWOOD; PRUNE TO REMOVE DEADWOOD ASAP |

Tree #10 is an Earleaf Acacia located on the northeast side of the property. It is in poor condition. There is limited rooting space. The secondary leader has died. The tree has low vigor and extensive dieback. Prune to remove the deadwood as soon as possible since it is over the parking lot. This species is highly invasive in South Florida and this tree will therefore need to be removed.

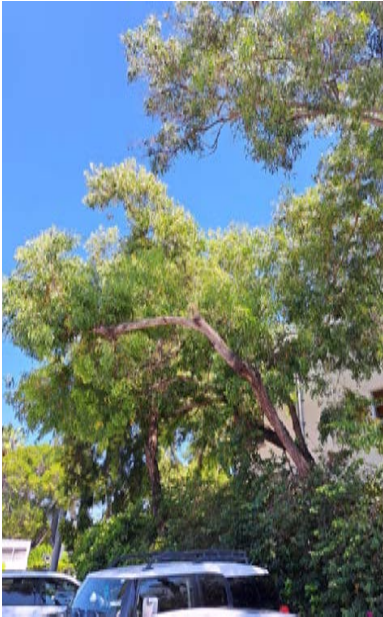
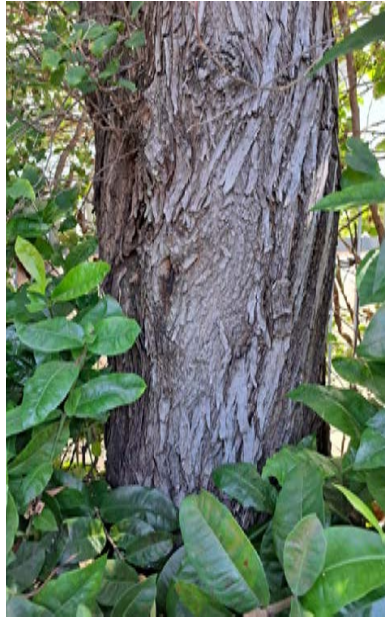
## Tree #11

Tree #11 is an Earleaf Acacia located on the northeast side of the property. It is in fair condition. There is limited rooting space. There are large, over-extended limbs. The tree has poor form. There is included bark between the limbs.

Continue to prune to remove deadwood and to maintain clearance over the parking lot. This species is highly invasive in South Florida and this tree will therefore need to be removed.

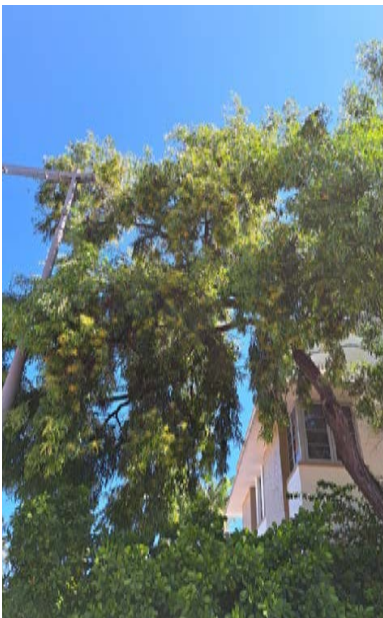
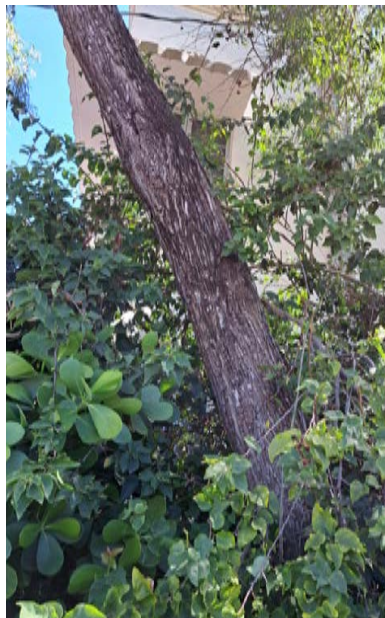
## Tree #12

Tree #12 is an Earleaf Acacia located on the northeast side of the property. It is in fair condition. There is limited rooting space. The tree has a corrected lean.

Continue to prune to remove deadwood and to maintain clearance over the parking lot. This species is highly invasive in South Florida and this tree will therefore need to be removed.

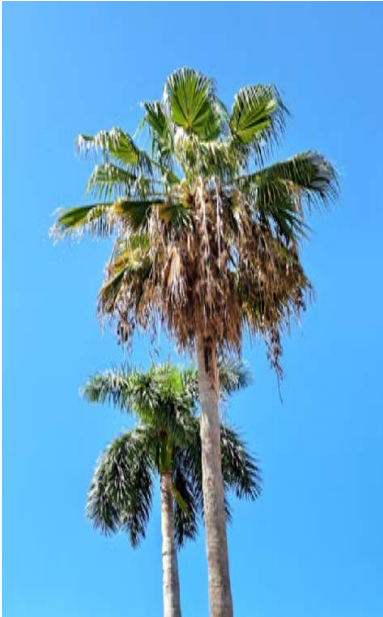
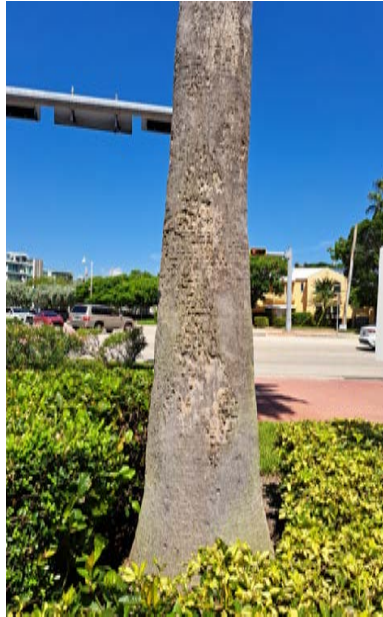
## Tree #13

Tree #13 is a Mexican Fan Palm located on the northwest side of the property. It is in fair condition. Prune to remove the lower dead fronds.

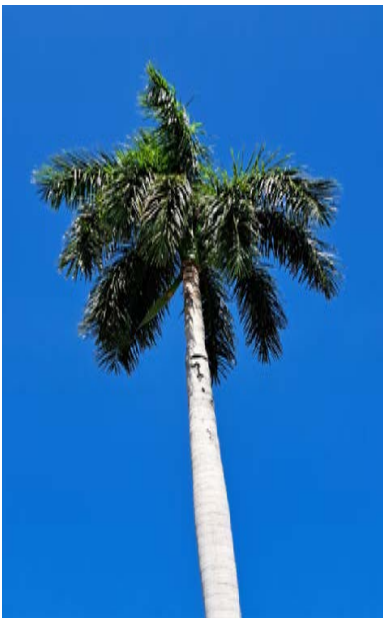
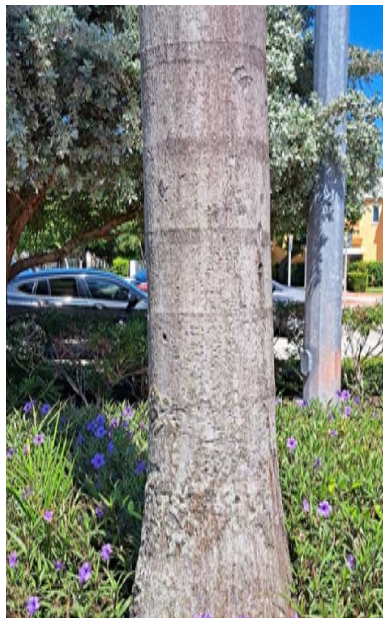
## Tree #14

Tree #14 is a Royal Palm located on the northwest side of the property. It is in fair condition with a pencilling trunk. There are a number of injuries on the trunk.

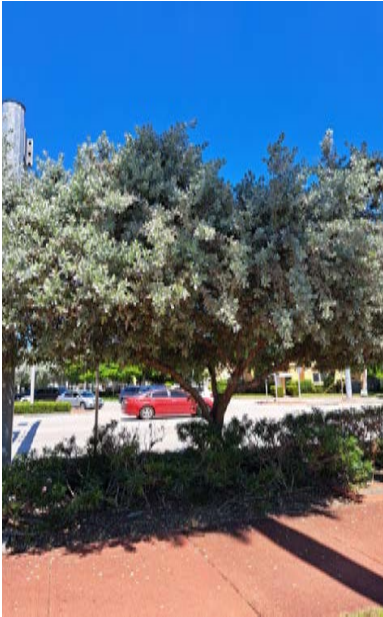
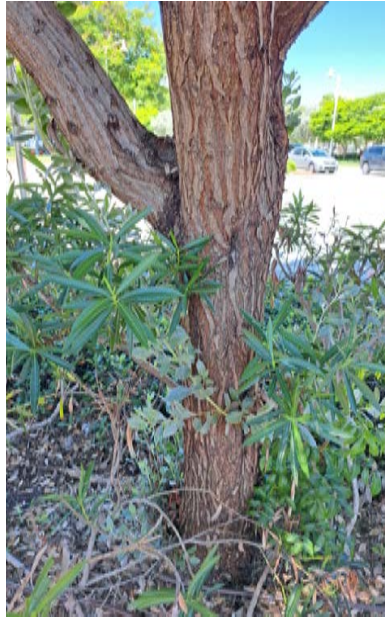
## Tree #15

Tree #15 is a Silver Buttonwood street tree located along Alton Road. It is growing in a 16ft wide planting strip. The tree is in good condition with good vigor. Prune to maintain clearance over the sidewalk.

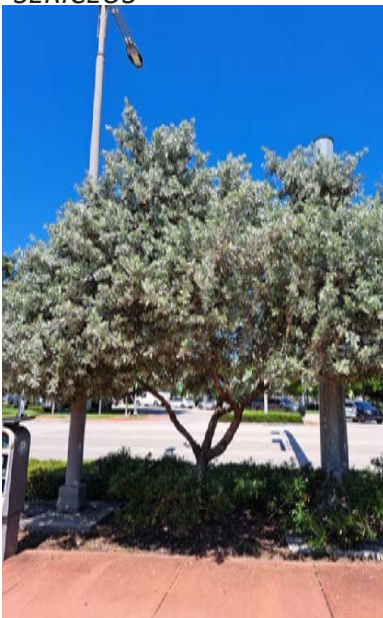
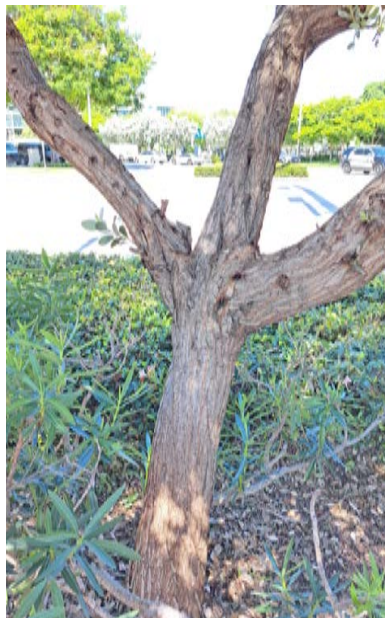
## Tree #16

Tree #16 is a Silver Buttonwood street tree located along Alton Road. It is growing in a 16ft wide planting strip. The tree is in good condition with good vigor. Prune to maintain clearance over the sidewalk.

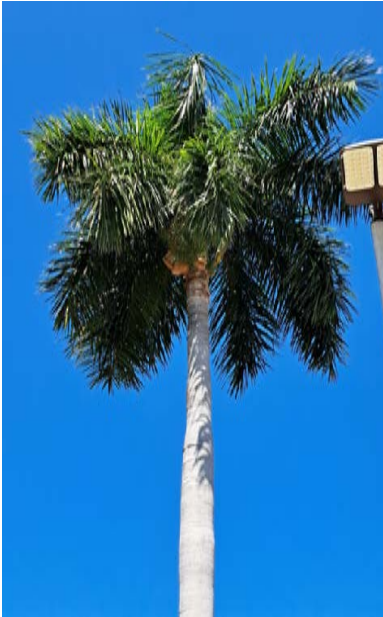
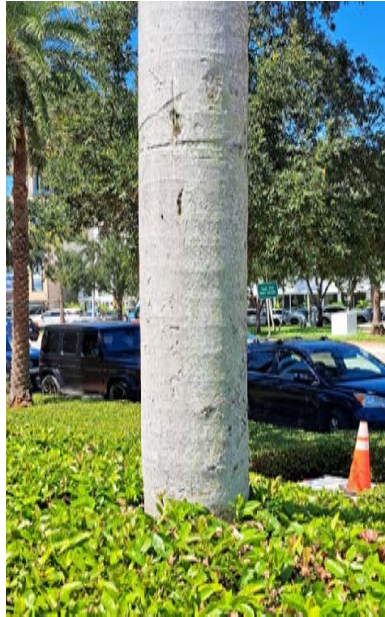
## Tree #17

Tree #17 is a Royal Palm located on the western side of the property. It is in fair condition with a narrowing trunk.

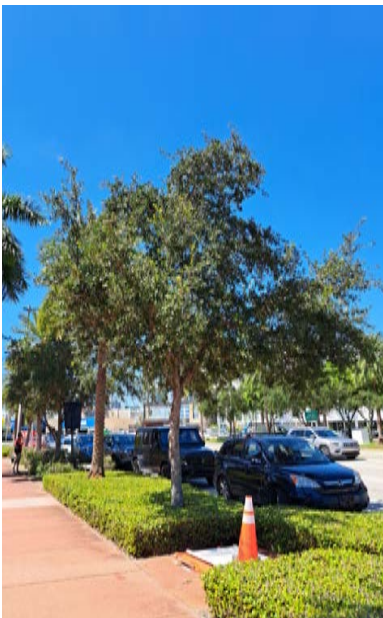
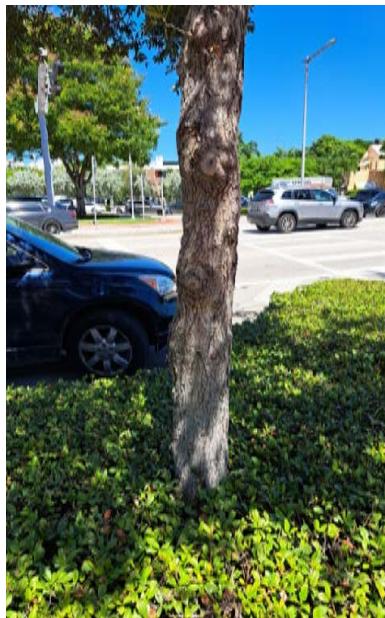
## Tree #18

Tree #18 is a Live Oak street tree located along Alton Road. It is in good condition and is growing in a 10ft wide planting swale. Prune to increase clearance over the sidewalk and the street.

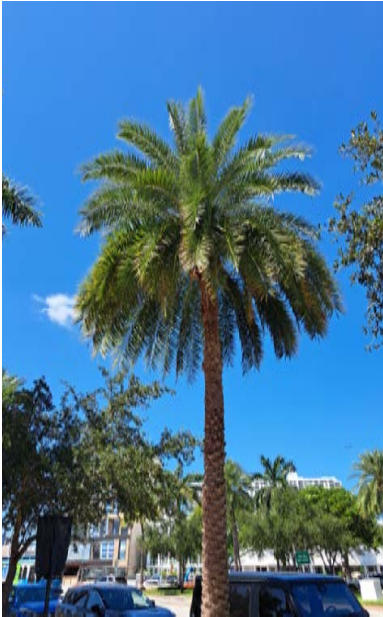
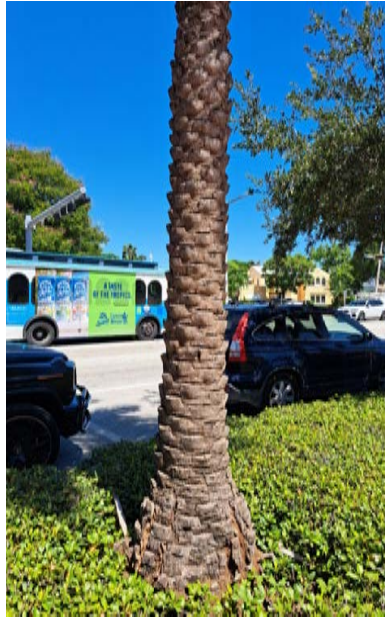
## Tree #19

Tree #19 is a Sylvester Palm street tree located along Alton Road. It is in good condition and is growing in a 10ft wide planting swale.

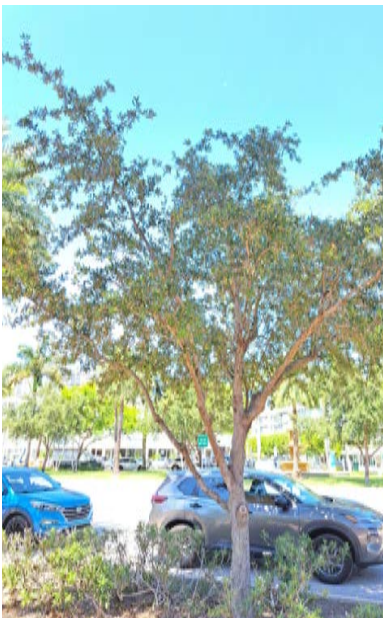
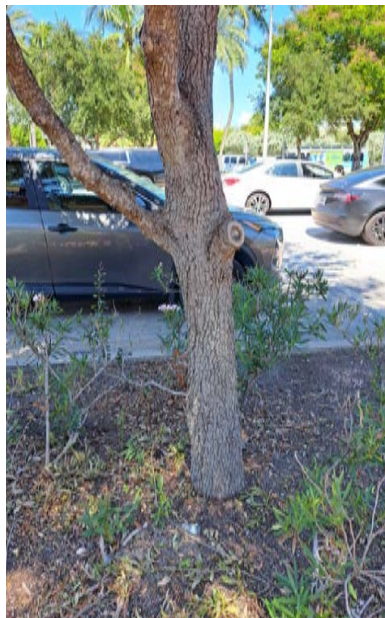
## Tree #20

Tree #20 is a Live Oak street tree located along Alton Road. It is in good condition and is growing in a 10ft wide planting swale. Prune to increase clearance over the sidewalk and the street.

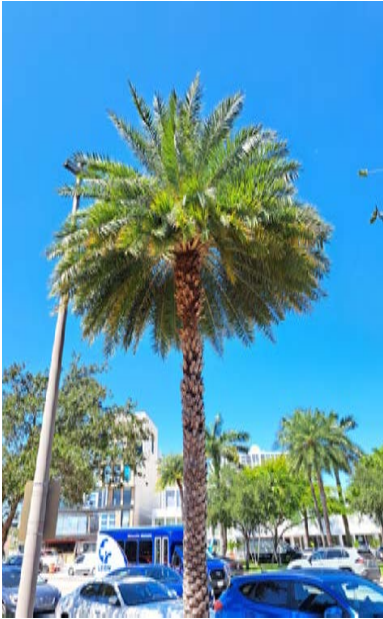
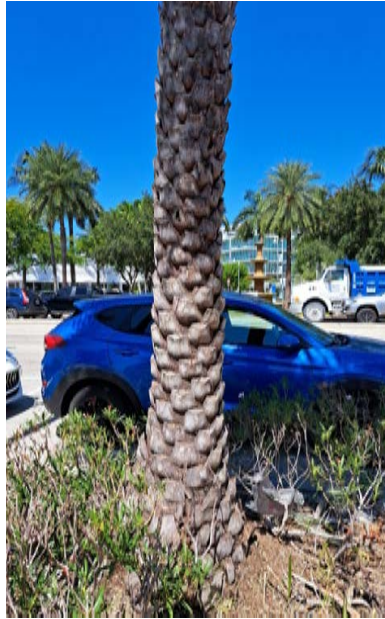
## Tree #21

Tree #21 is a Sylvester Palm street tree located along Alton Road. It is in good condition and is growing in a 10ft wide planting swale. There is some yellowing on the fronds.

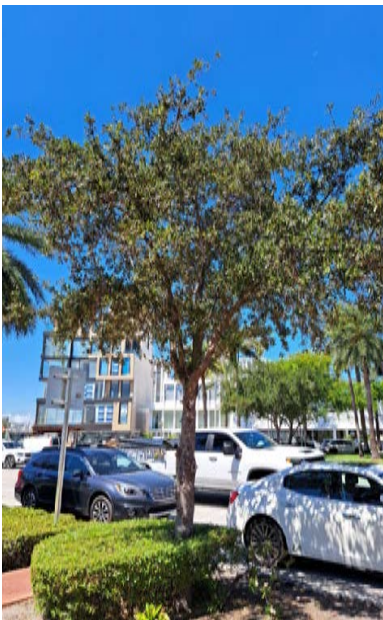
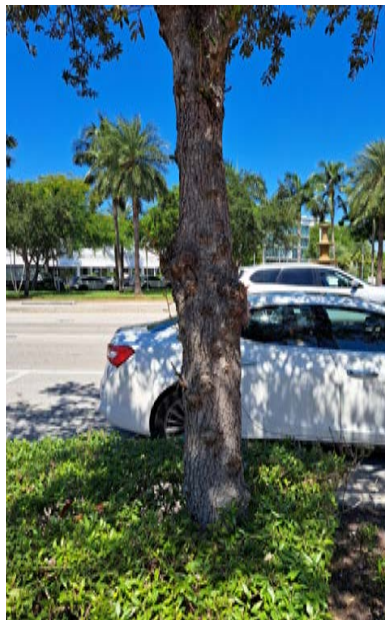
## Tree #22

Tree #22 is a Live Oak street tree located along Alton Road. It is in good condition and is growing in a 10ft wide planting swale. Prune to increase clearance over the sidewalk and the street.

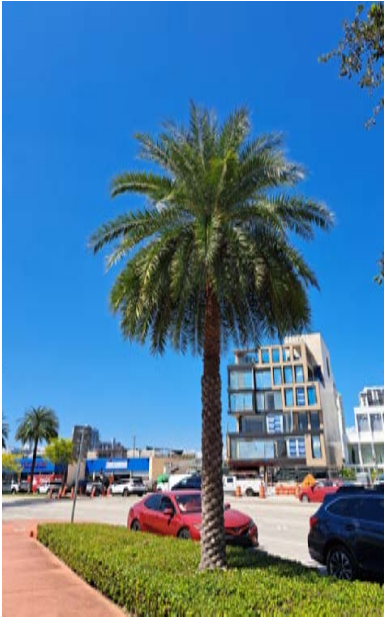
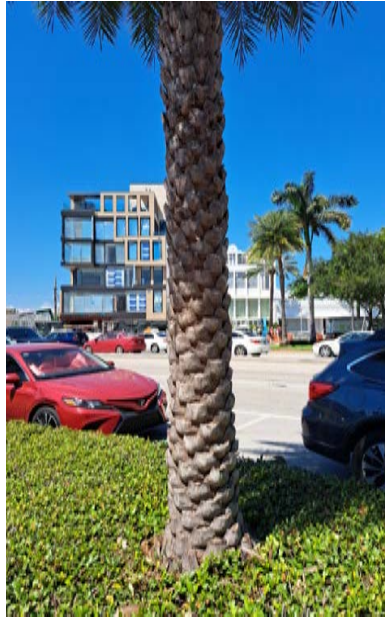
## Tree #23

Tree #23 is a Sylvester Palm street tree located along Alton Road. It is in good condition and is growing in a 10ft wide planting swale.

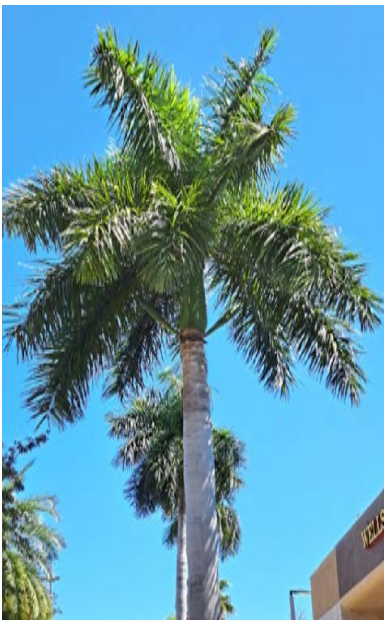
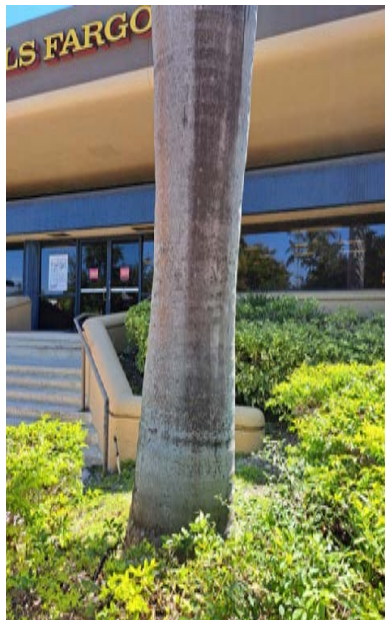
## Tree #24

Tree #24 is a Royal Palm located on the western side of the property. It is in good condition with healthy green fronds.

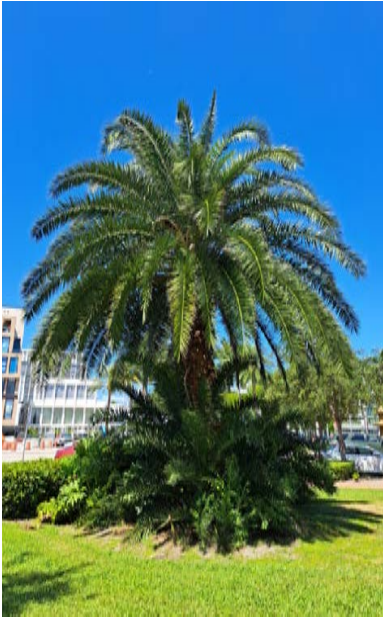
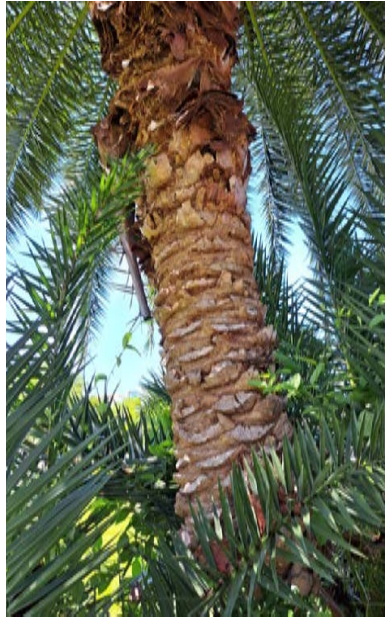
## Tree #25

Tree #25 is a Date Palm located in the right-of-way area between Alton Road and 19th Street. It is in good condition. There is some growth at the base of the trunk. This tree is a good candidate for relocation.

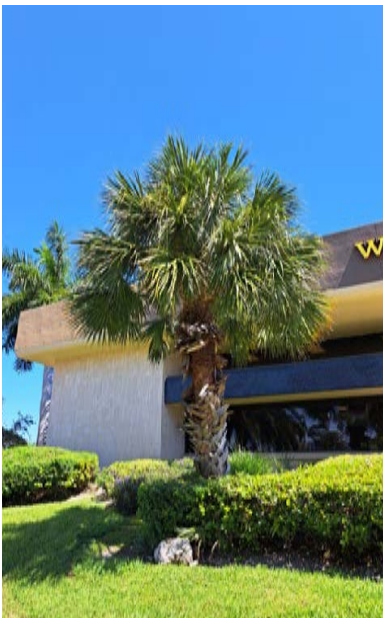
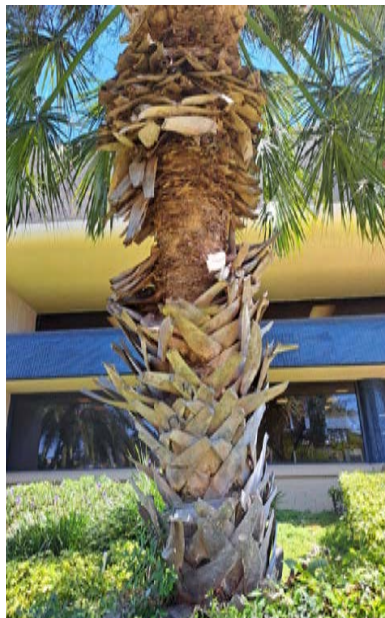
## Tree #26

Tree #26 is a Sabal Palm located in the southwest corner of the property. It is in good condition.

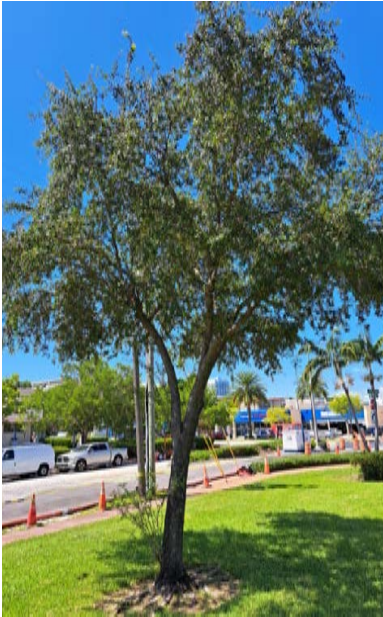
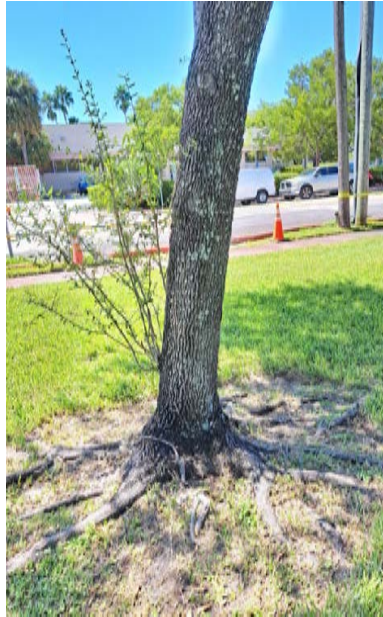
## Tree #27

Tree #27 is a Live Oak located in the right-of-way area between Alton Road and 19th Street. It is in good condition. The tree has a nice, symmetrical form. There are many large surface roots. There is some sprout growth from the base of the trunk. Overhead wires are along 19th Street. This tree is a good candidate for relocation.

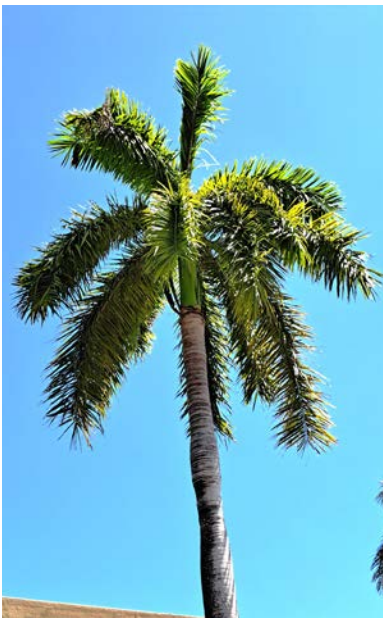
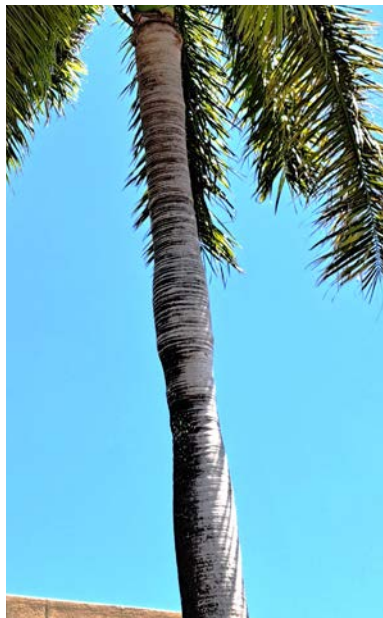
## Tree #28

Tree #28 is a Royal Palm located on the south side of the property. The tree is in poor condition with a trunk constriction and chlorotic fronds. Overhead wires are nearby.

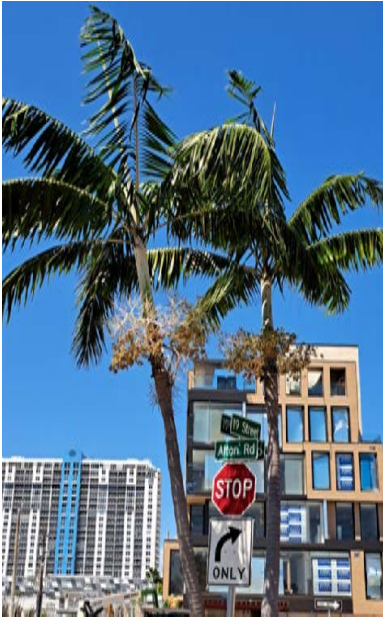
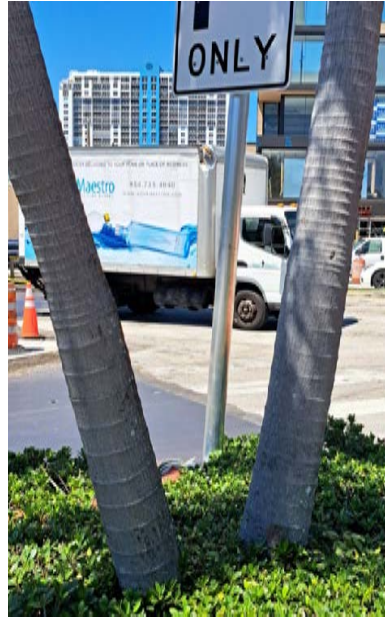
## Tree #29

Tree #29 is a double Montgomery Palm street tree located at the corner of Alton Road and 19th Street. It is in good condition. There are some trunk constrictions.

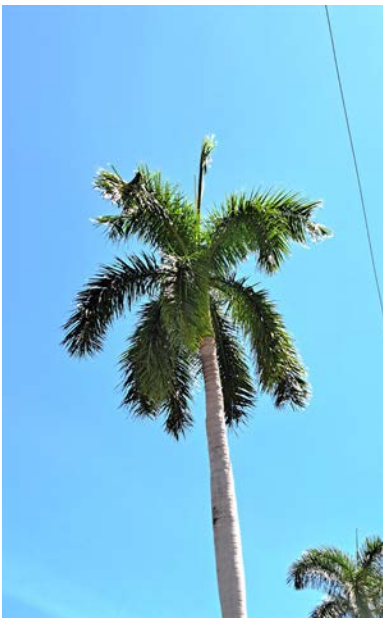
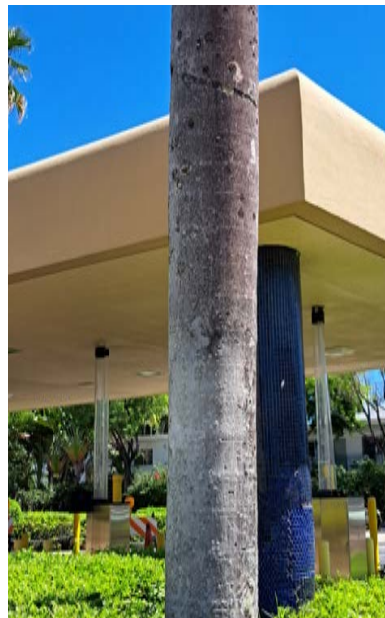
## Tree #30

Tree #30 is a Royal Palm located on the south side of the property. It is in fair condition with a narrowing trunk. Overhead wires are nearby.

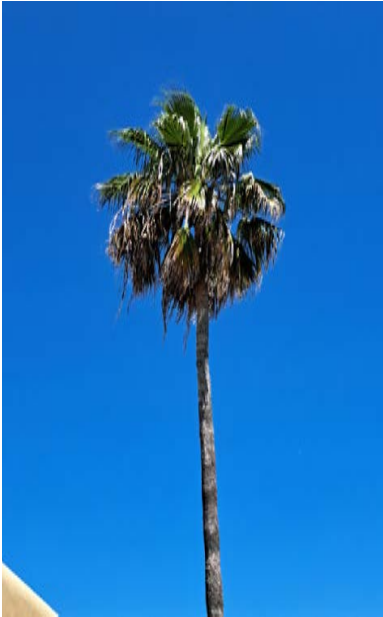
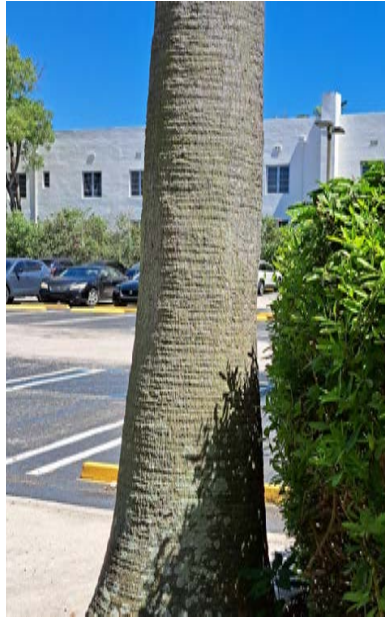
## Tree #31

Tree #31 is a Mexican Fan Palm located in the existing parking lot. It is in good condition. Prune to remove the lower dead fronds.

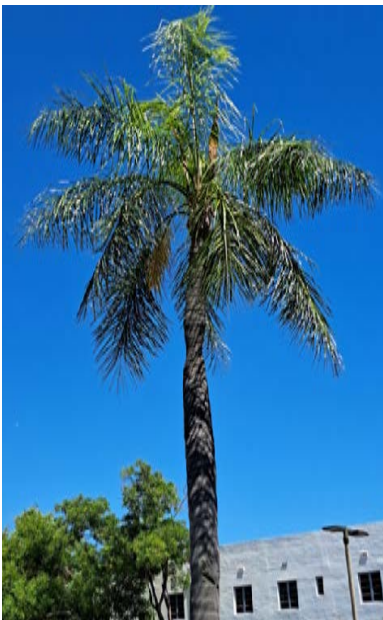
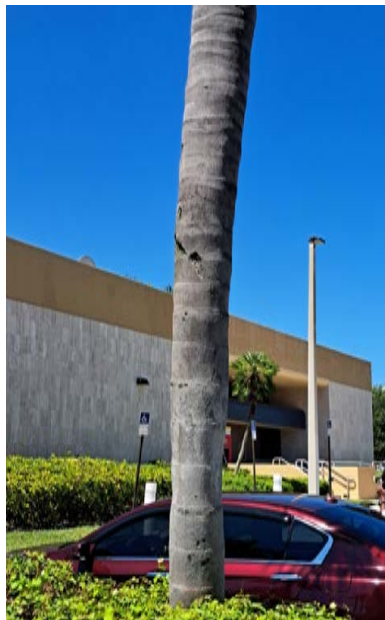
## Tree #32

Tree #32 is a Queen Palm located in the existing parking lot. It is in poor condition with a trunk constriction and a thin, chlorotic canopy.

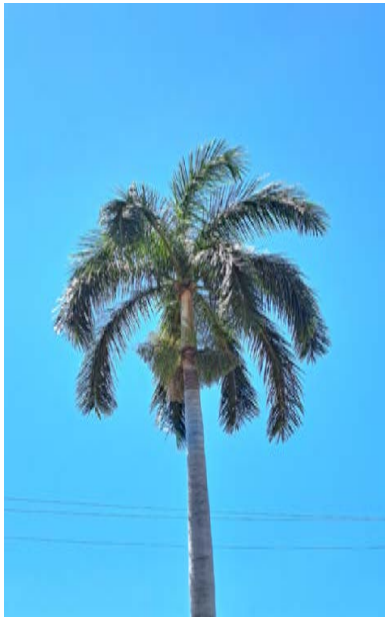
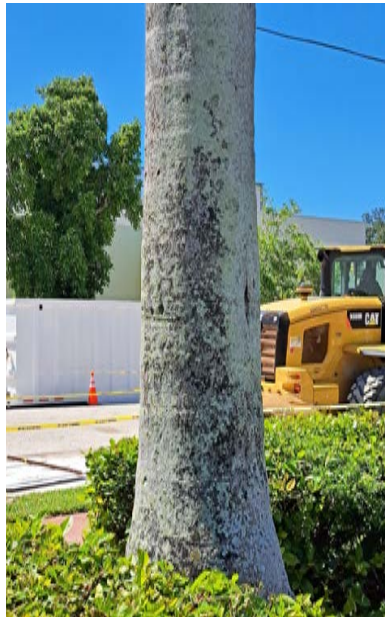
## Tree #33

Tree #33 is a Royal Palm located on the south side of the property. It is in good condition. Overhead wires are nearby.
