# Arborist Report

1901 Alton Road

Miami Beach

9/13/2023

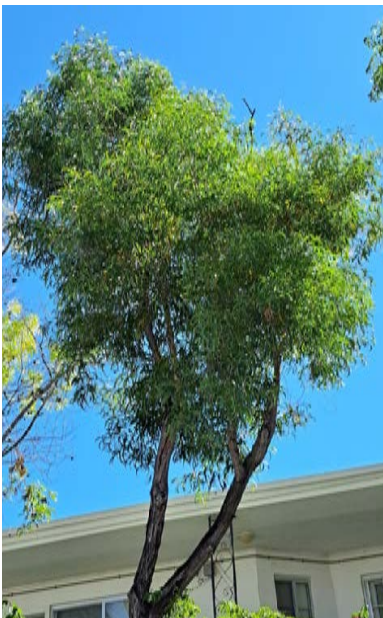
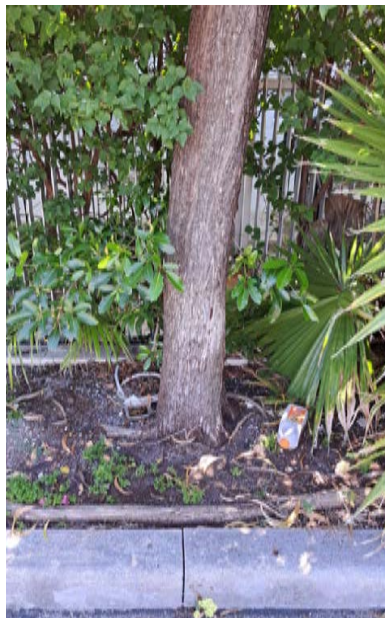
### Tree #4

Tree #4 is an Earleaf Acacia located on the eastern side of the property. It is in fair condition. There is limited rooting space. Large surface roots are present. The tree has a small, asymmetrical canopy with a low live crown ratio. Continue to prune to remove deadwood. This species is highly invasive in South Florida and this tree will therefore need to be removed.

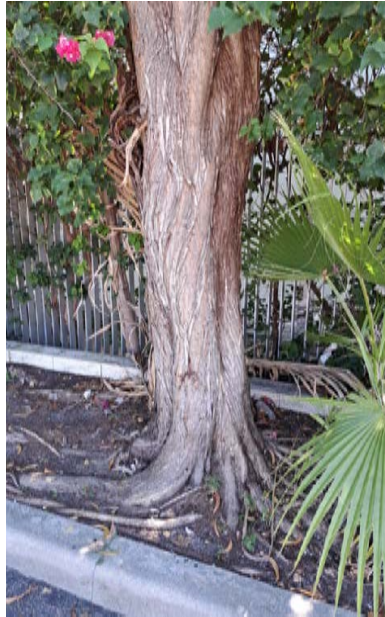
## Tree #7

Tree #7 is an Earleaf Acacia located on the east side of the property. The tree is in poor condition. There are large, hanging dead limbs in the canopy. There is limited rooting space and many large surface roots. Prune to remove the deadwood as soon as possible since it is over the parking lot. This species is highly invasive in South Florida and this tree will therefore need to be removed.

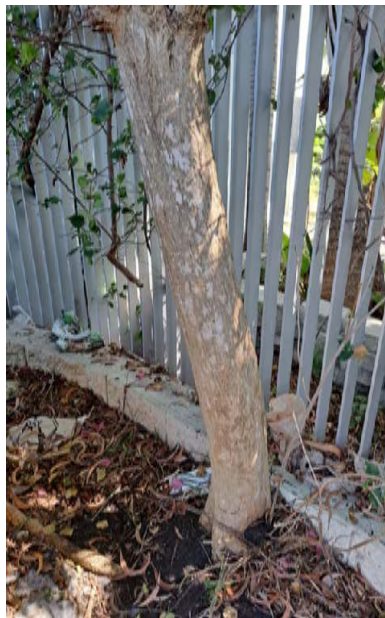
## Tree #8

Tree #8 is a Pink Trumpet Tree located on the northeast side of the property. It is in poor condition. There is limited rooting space. There are pest issues affecting the foliage. The canopy is thin.

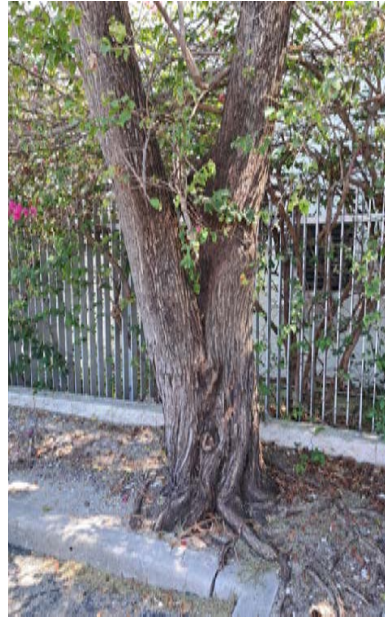
## Tree #9

Tree #9 is an Earleaf Acacia located on the northeast side of the property. It is in fair condition. There is limited rooting space and there are many large surface roots. The trunk divides into two with included bark. The tree has a low live crown ratio. Continue to prune to remove deadwood. This species is highly invasive in South Florida and this tree will therefore need to be removed.

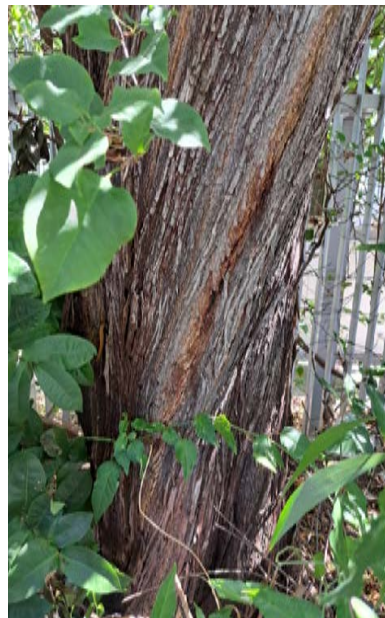
## Tree #10

Tree #10 is an Earleaf Acacia located on the northeast side of the property. It is in poor condition. There is limited rooting space. The secondary leader has died. The tree has low vigor and extensive dieback. Prune to remove the deadwood as soon as possible since it is over the parking lot. This species is highly invasive in South Florida and this tree will therefore need to be removed.

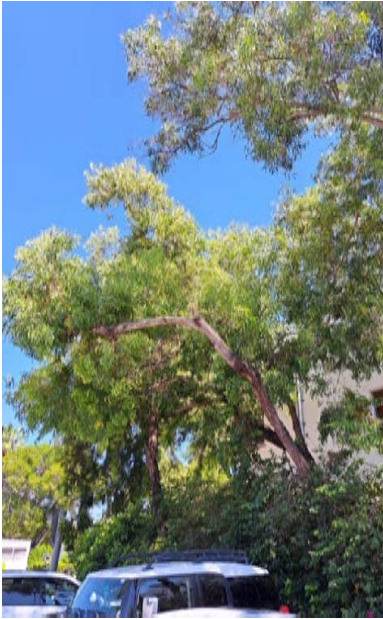
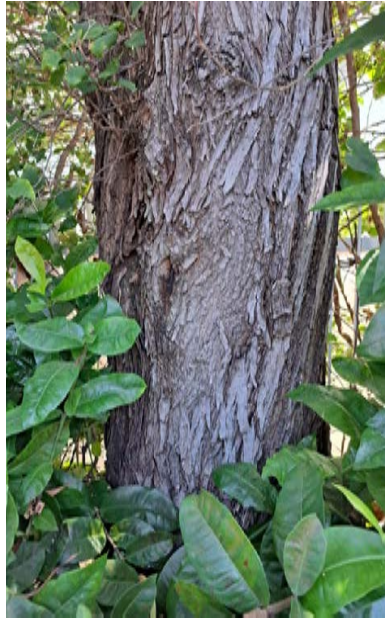
## Tree #11

Tree #11 is an Earleaf Acacia located on the northeast side of the property. It is in fair condition. There is limited rooting space. There are large, over-extended limbs. The tree has poor form. There is included bark between the limbs.

Continue to prune to remove deadwood and to maintain clearance over the parking lot. This species is highly invasive in South Florida and this tree will therefore need to be removed.

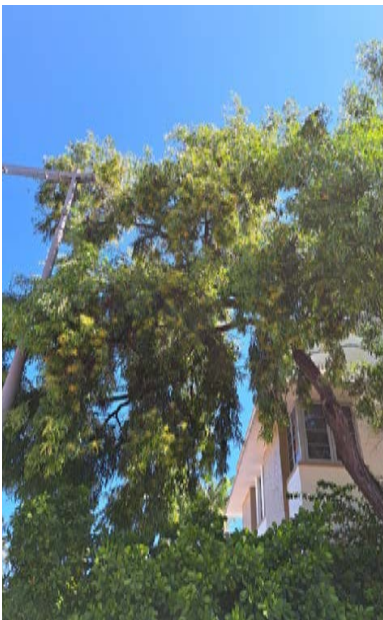
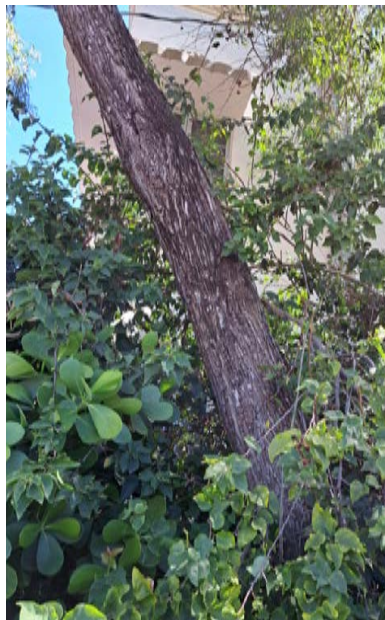
## Tree #12

Tree #12 is an Earleaf Acacia located on the northeast side of the property. It is in fair condition. There is limited rooting space. The tree has a corrected lean.

Continue to prune to remove deadwood and to maintain clearance over the parking lot. This species is highly invasive in South Florida and this tree will therefore need to be removed.

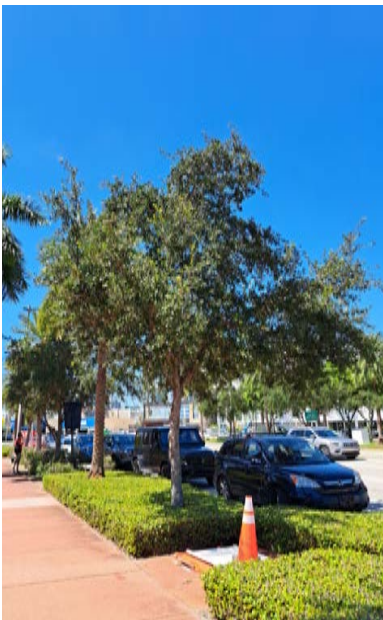
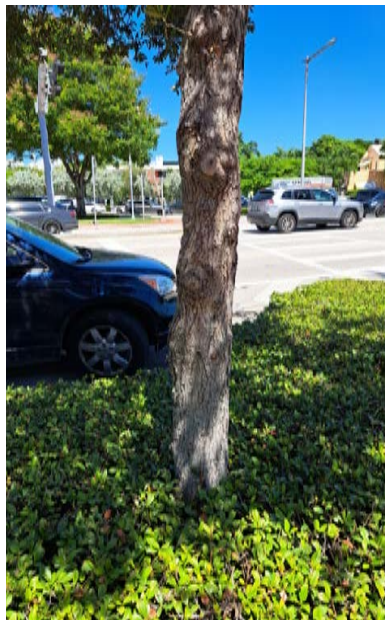
## Tree #18

Tree #18 is a Live Oak street tree located along Alton Road. It is in good condition and is growing in a 10ft wide planting swale. Prune to increase clearance over the sidewalk and the street.

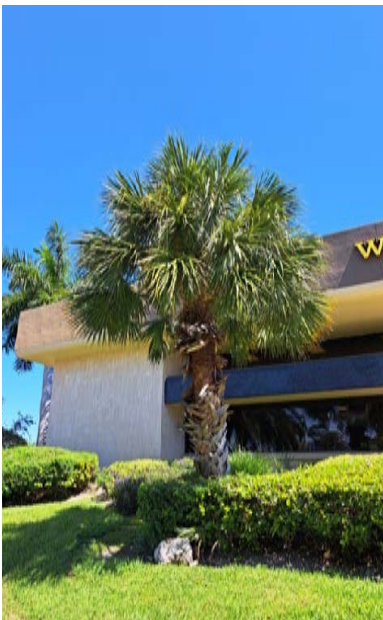
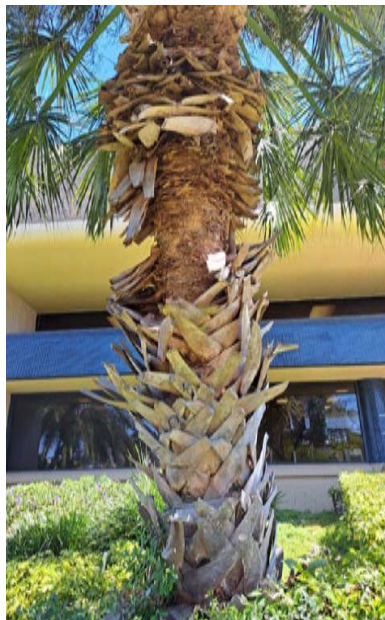
## Tree #26

Tree #26 is a Sabal Palm located in the southwest corner of the property. It is in good condition.
