October 4, 2023

4330 Nautilus Dr. Arborist Report

RE: 4330 Nautilus Dr. Miami Beach FL, 33140

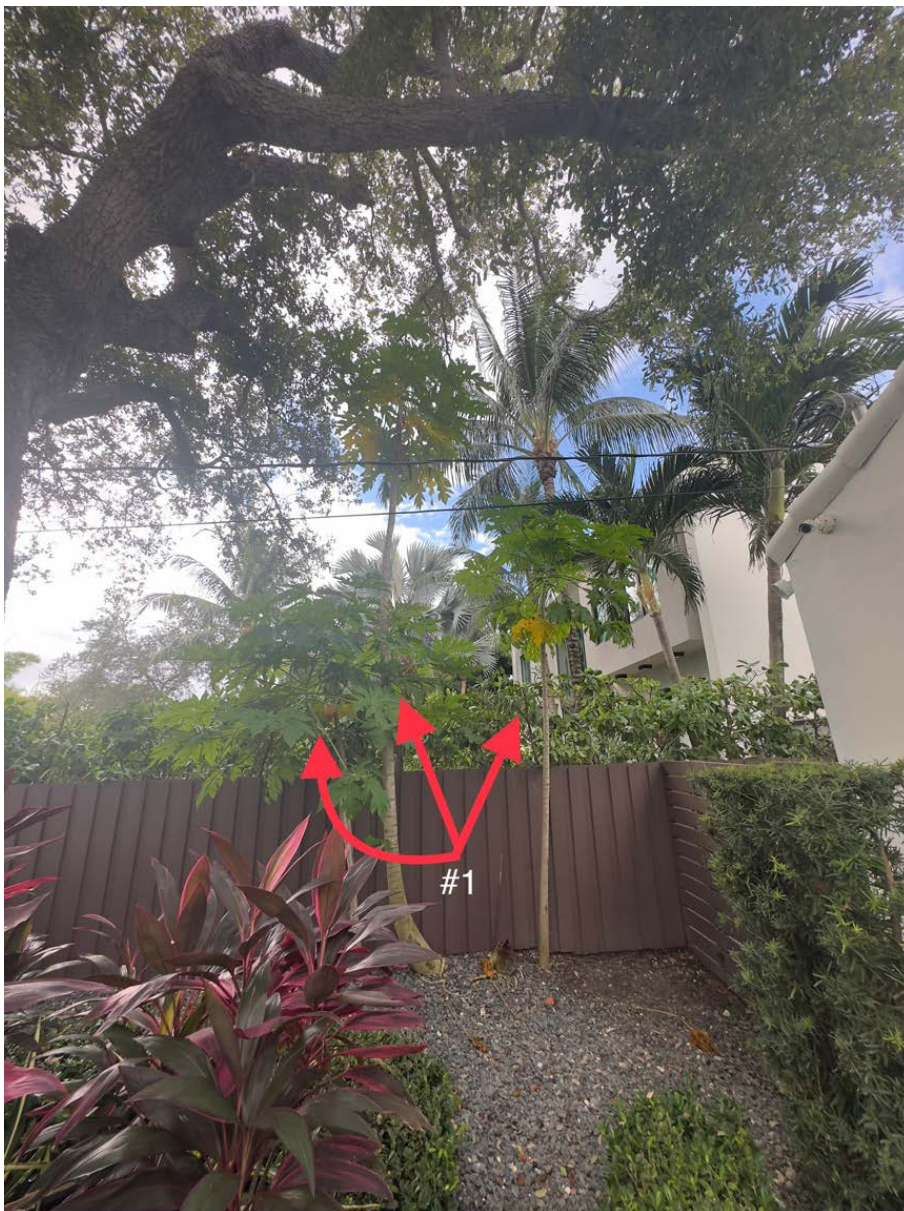
1. *Carica papaya* (Papaya tree) (3) DBH 1"-4" ea., Spread 4'-6'ea., Height 10'-20'ea. these trees conditions are fair (Class B 80%). These trees are in the southeast quadrant of property. Minimum 2' radius from trunk Tree protection zone shall be installed to protect 4' Critical root zone of these trees and done under ANSI A-300 guidelines should these trees need protection during construction. These trees are scheduled to remain.

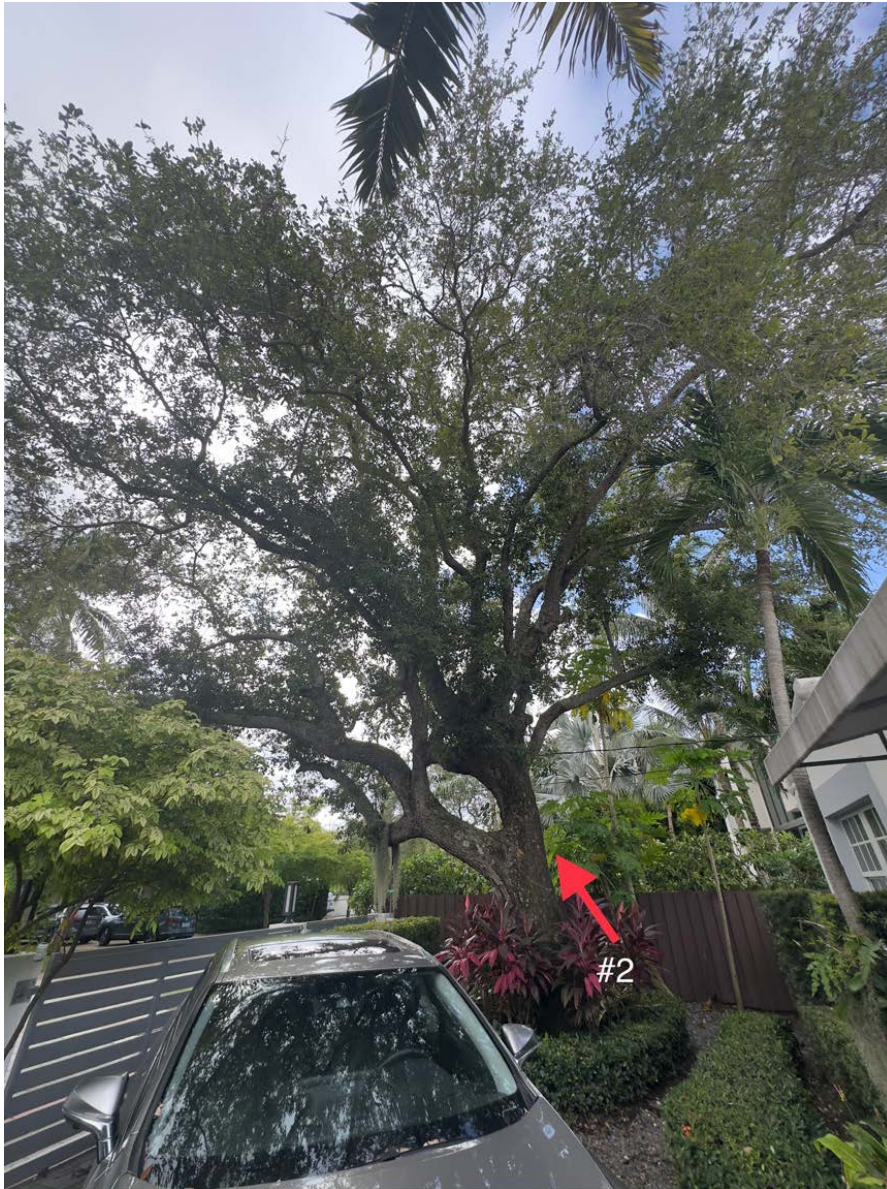
2. *Quercus virginiana* (Live Oak tree) DBH 27", Spread 50', Height 42' this tree's condition is fair (Class A 80%). This tree is in the southeast quadrant of property. Minimum 13.5' radius from trunk Tree protection zone shall be installed to protect 27' Critical root zone of this tree and done under ANSI A-300 guidelines should this tree need protection during construction. This tree is scheduled to remain.

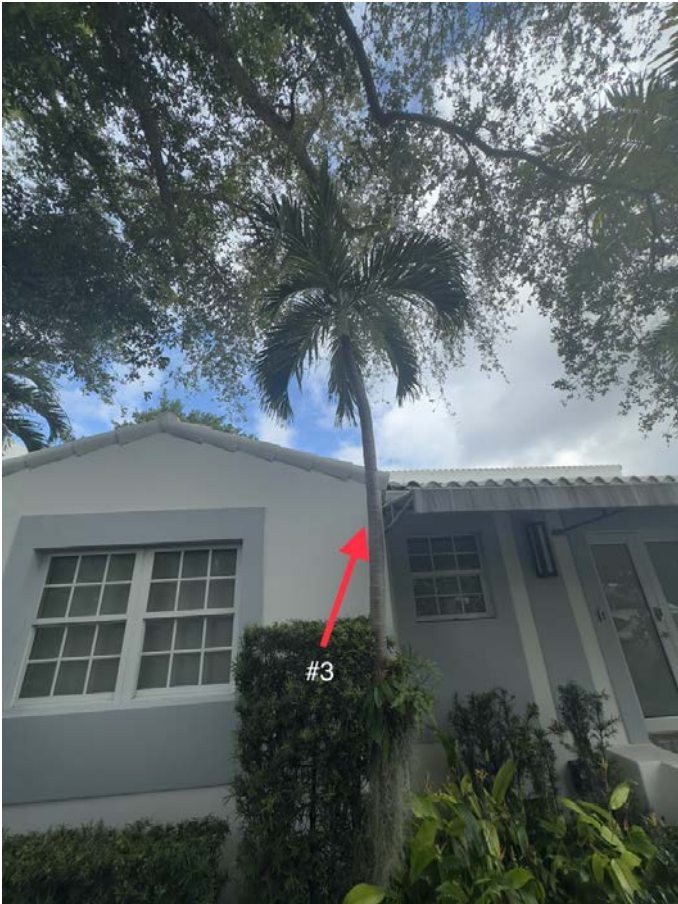
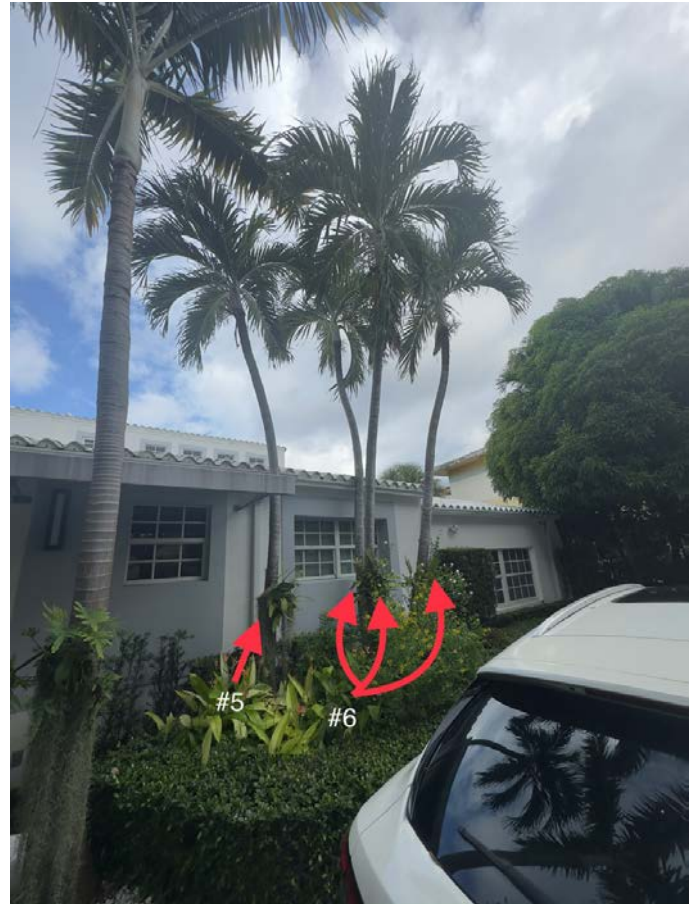
3,5,6. *Adonidia merrillii* (Christmas palm tree) (5) DBH 4" ea., Spread 8' ea., Height 20'-25' ea. these trees conditions are fair (Class PALM 80%). These trees are on the east side of existing house on this property. Minimum 2' radius from trunk Tree protection zone shall be installed to protect 4' Critical root zone of these trees and done under ANSI A-300 guidelines should these trees need protection during construction. These trees are scheduled to remain.

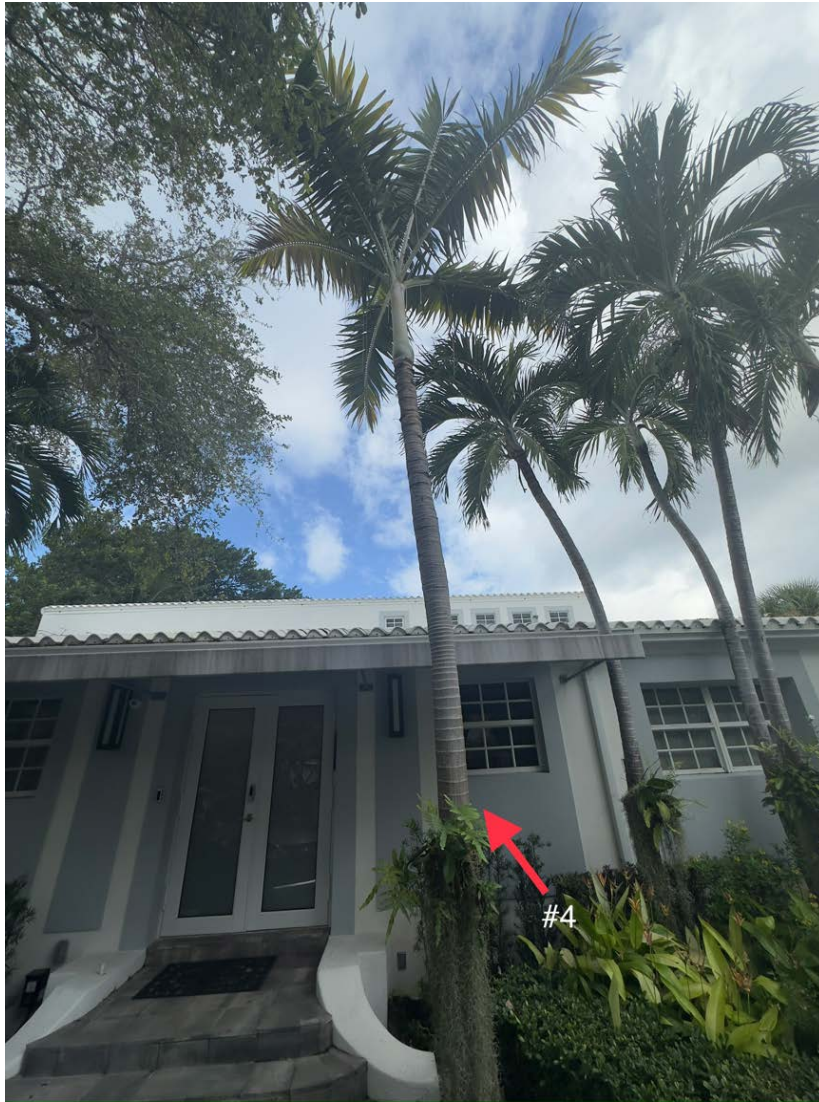
4. *Veitchia arecina* (Montgomery palm tree) DBH 5", Spread 8', Height 26' this trees condition is fair (Class PALM 80%). This tree is on the east side of existing house on this property. Minimum 3' radius from trunk Tree protection zone shall be installed to protect 6' Critical root zone of this tree and done under ANSI A-300 guidelines should this tree need protection during construction. This tree is scheduled to remain.

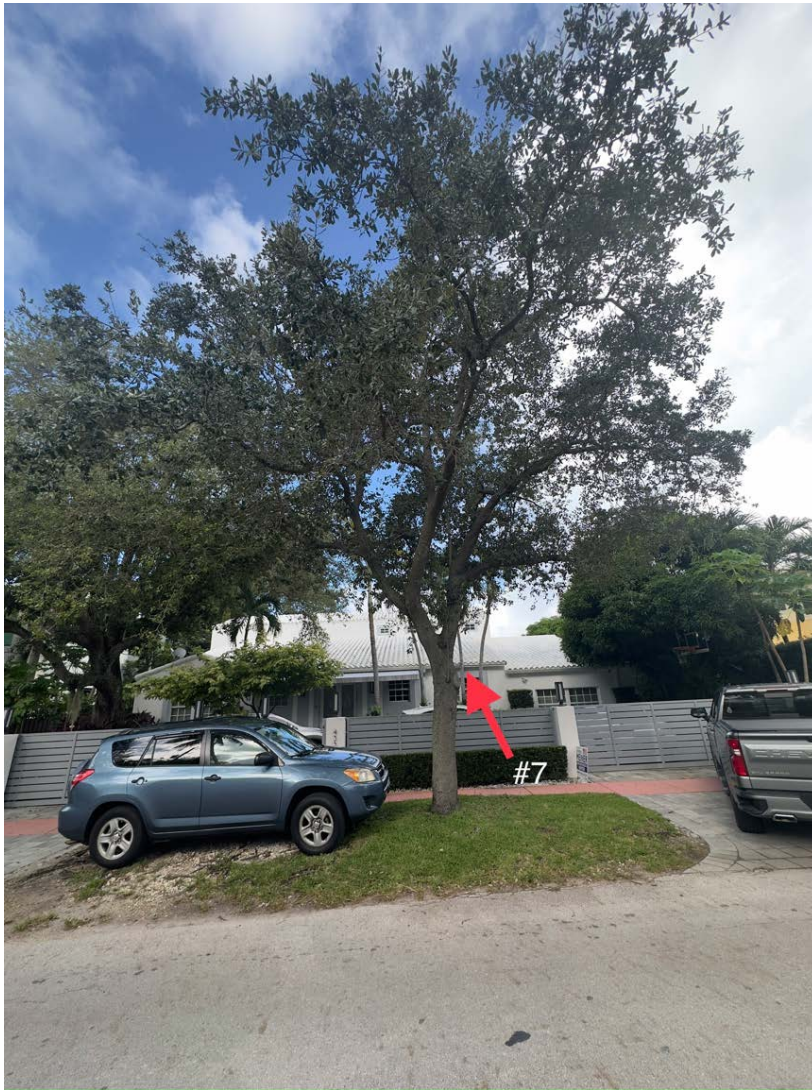
7. *Quercus virginiana* (Live Oak tree) DBH 13", Spread 38', Height 37' this trees condition is fair (Class A 80%). This tree is in the east side of property, on the right of way. Minimum 6.5' radius from trunk Tree protection zone shall be installed to protect 13' Critical root zone of this tree and done under ANSI A-300 guidelines should this tree need protection during construction. This tree is scheduled to remain.

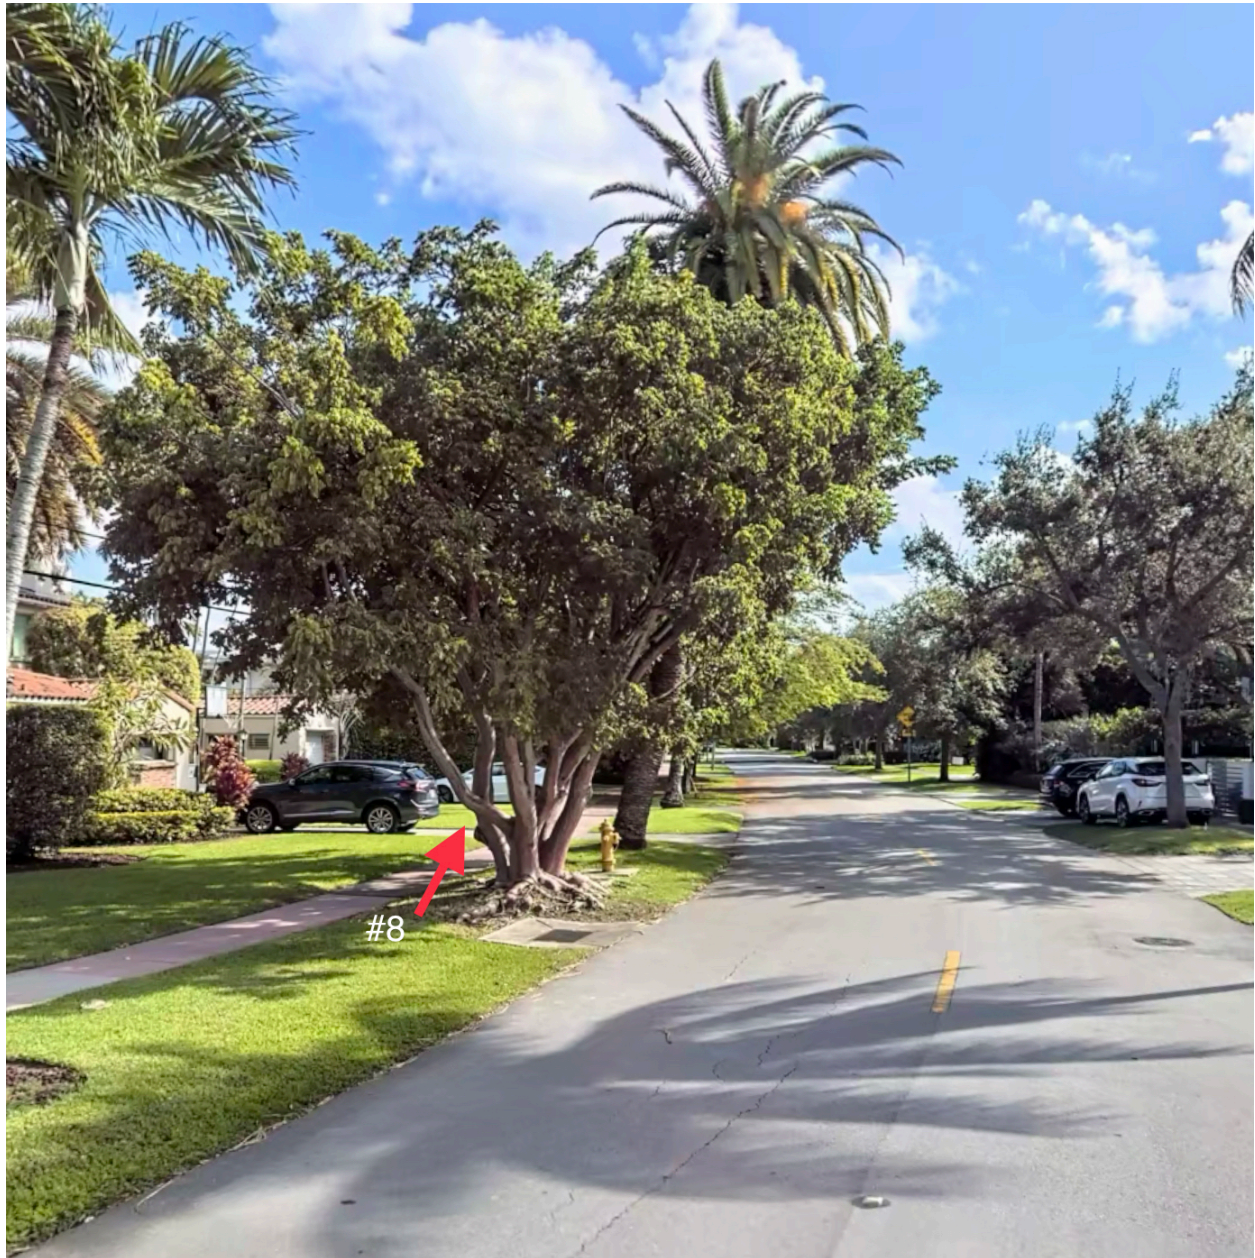
8. *Bursera simaruba* (Gumbo Limbo tree) DBH 70", Spread 50', Height 28' this trees condition is moderate (Class A 70%). This tree is in the east side of property, on the right of way opposite side of Nautilus Dr. Minimum 6' radius from trunk Tree protection zone shall be installed to protect 40' Critical root zone of this tree and done under ANSI A-300 guidelines should this tree need protection during construction. This tree is scheduled to remain.

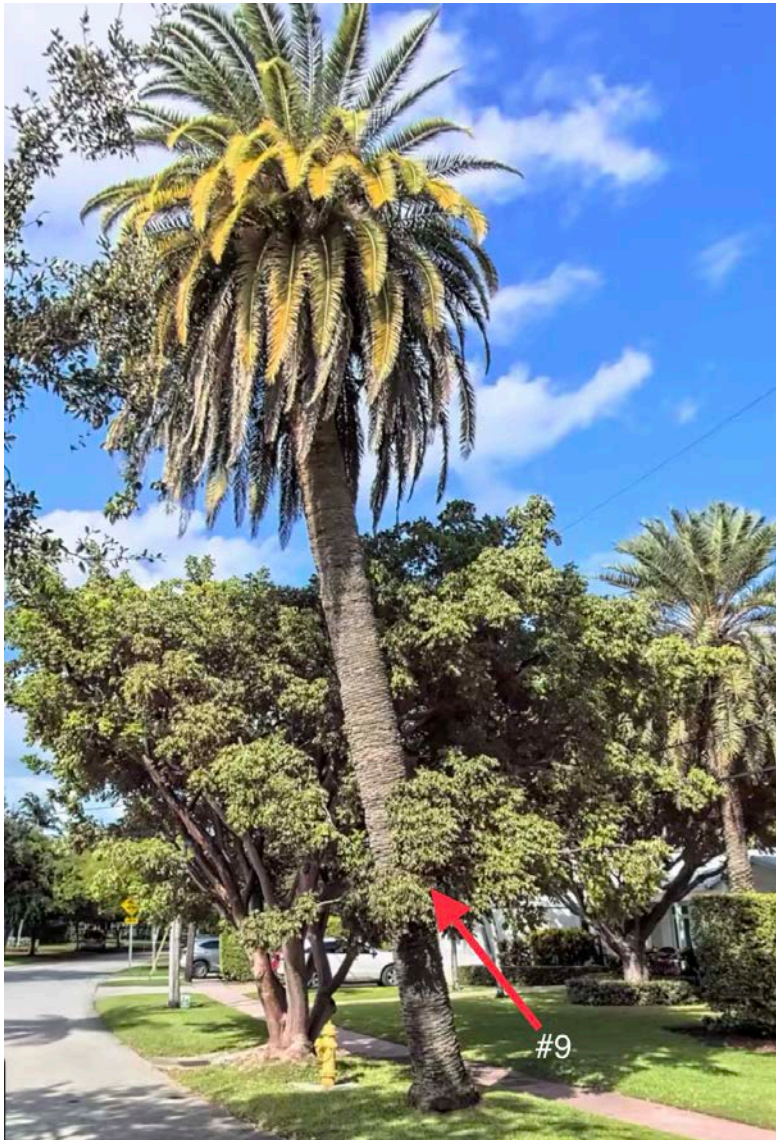
9. Phoenix canariensis (Canary Island Date palm tree) DBH 20", Spread 20', Height 48' this trees condition is moderate (Class PALM 60%). This tree is in the east side of property, on the right of way opposite side of Nautilus Dr. Minimum 3' radius from trunk Tree protection zone shall be installed to protect 6' Critical root zone of this tree and done under ANSI A-300 guidelines should this tree need protection during construction. This tree is scheduled to remain.

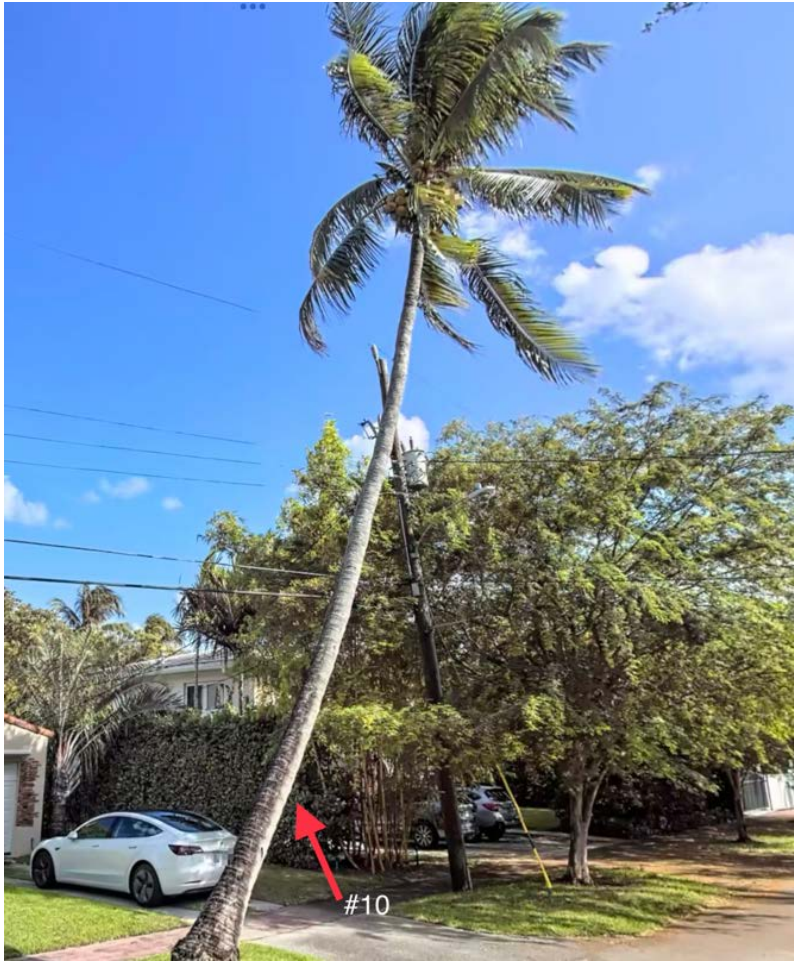
10. *Coco nucifera* (Coconut palm tree) DBH 12", Spread 20', Height 38' this trees condition is fair (Class PALM 80%). This tree is in the east side of property, on the right of way opposite side of Nautilus Dr. Minimum 3' radius from trunk Tree protection zone shall be installed to protect 6' Critical root zone of this tree and done under ANSI A-300 guidelines should this tree need protection during construction. This tree is scheduled to remain.

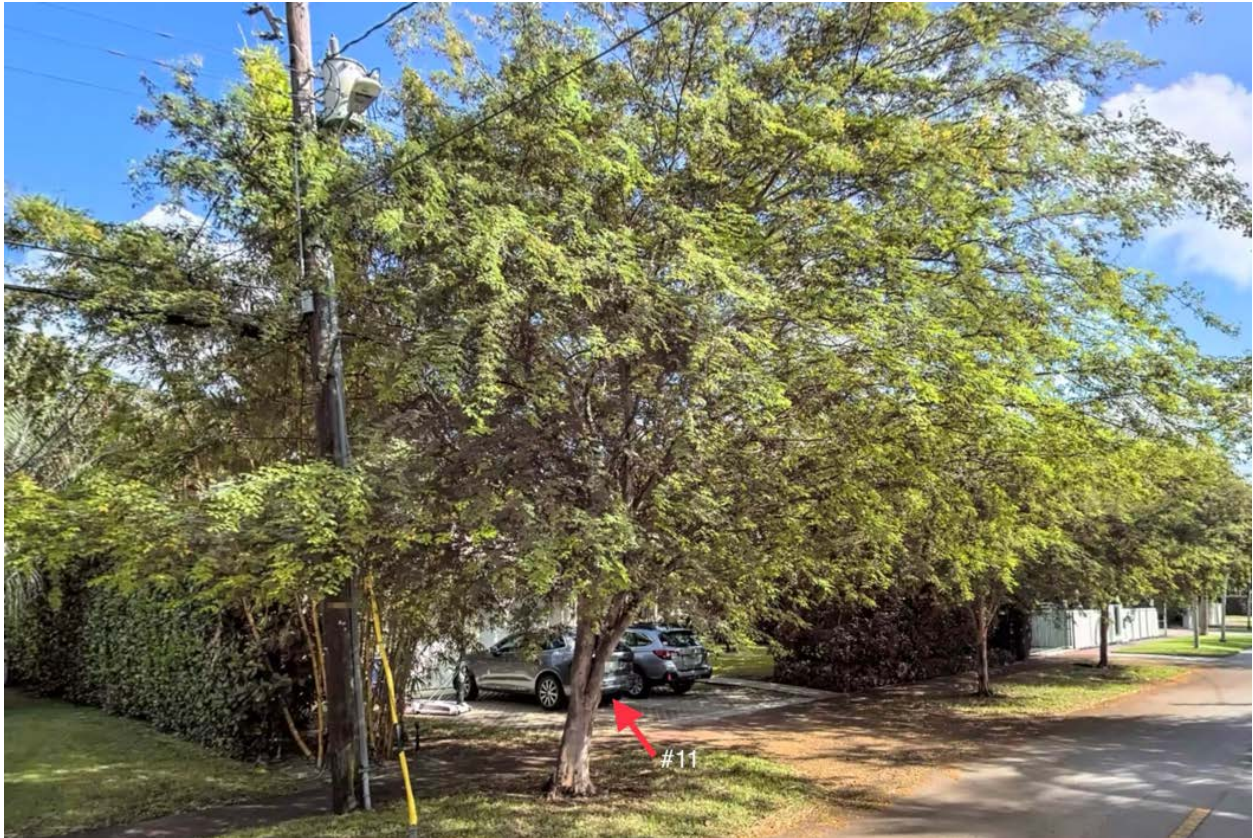
11. *Caesalpinia granadillo* (Bridalveil tree) DBH 12", Spread 50', Height 31' this trees condition is fair (Class A 80%). This tree is in the east side of property, on the right of way opposite side of Nautilus Dr. Minimum 6' radius from trunk Tree protection zone shall be installed to protect 12' Critical root zone of this tree and done under ANSI A-300 guidelines should this tree need protection during construction. This tree is scheduled to remain.

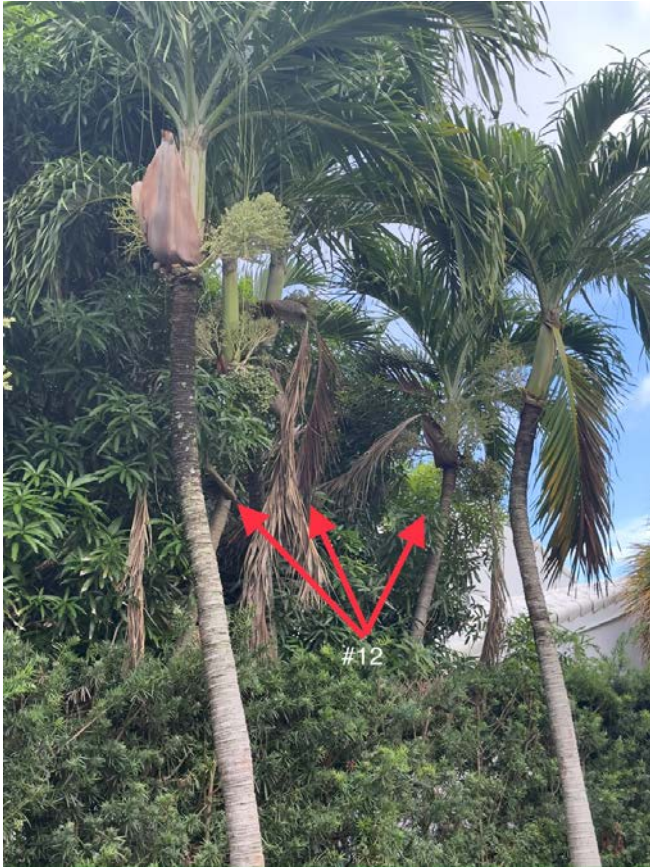
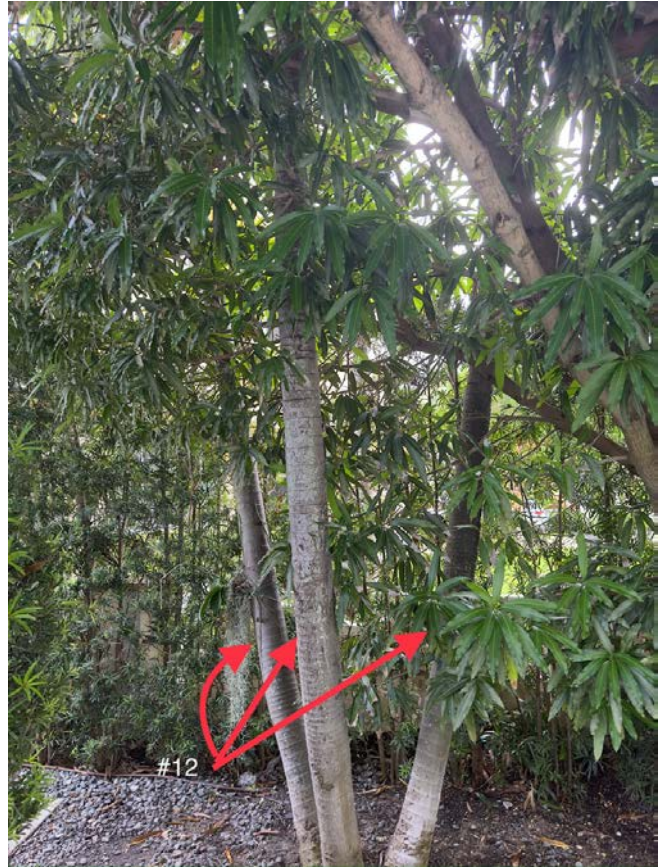
12. *Adonidia merrillii* (Christmas palm tree) (3) DBH 4" ea., Spread 8' ea., Height 20'-25' ea. these trees conditions are fair (Class PALM 80%). These trees are on the northeast quadrant of this property. Minimum 2' radius from trunk Tree protection zone shall be installed to protect 4' Critical root zone of these trees and done under ANSI A-300 guidelines should these trees need protection during construction. These trees are scheduled to remain.

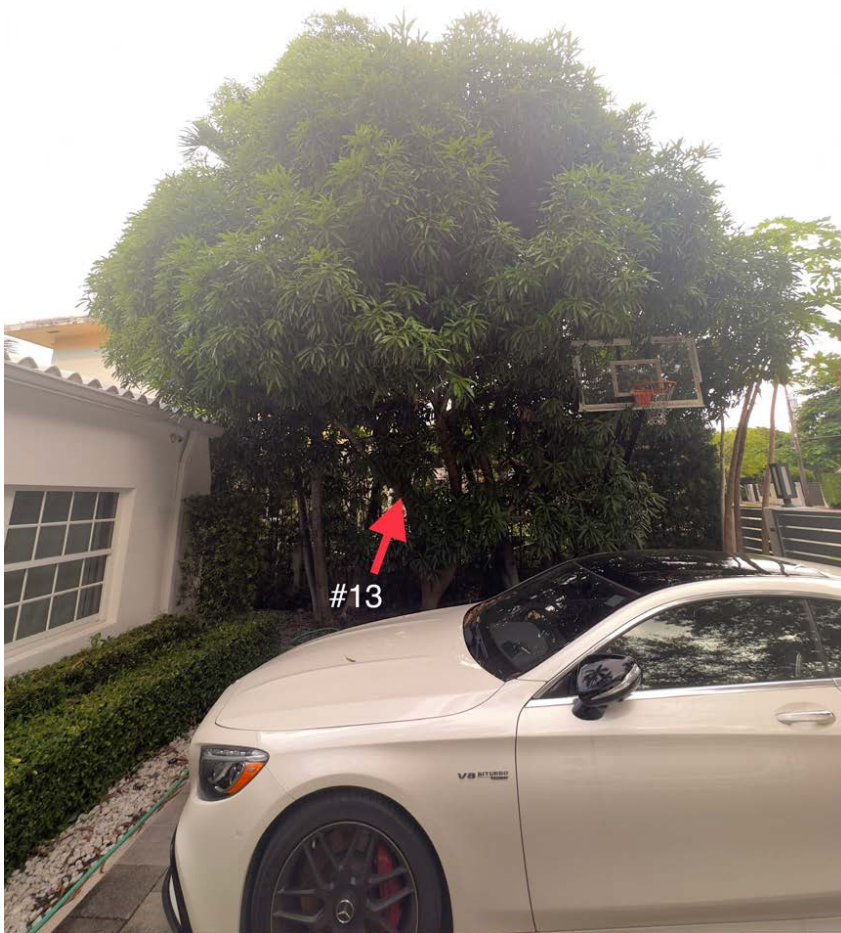
13. *Mangifera indica* (Mango tree) DBH 12", Spread 36', Height 25' this tree's condition is fair (Class B 80%). This tree is in the northeast quadrant of property. Minimum 6' radius from trunk Tree protection zone shall be installed to protect 12' Critical root zone of this tree and done under ANSI A-300 guidelines should this tree need protection during construction. This tree is scheduled to remain.

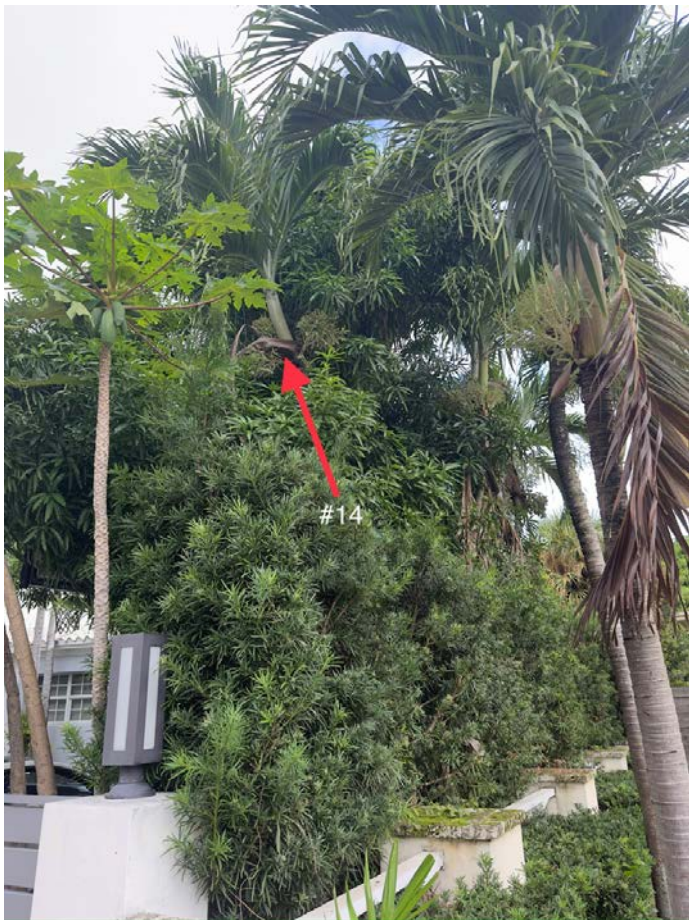
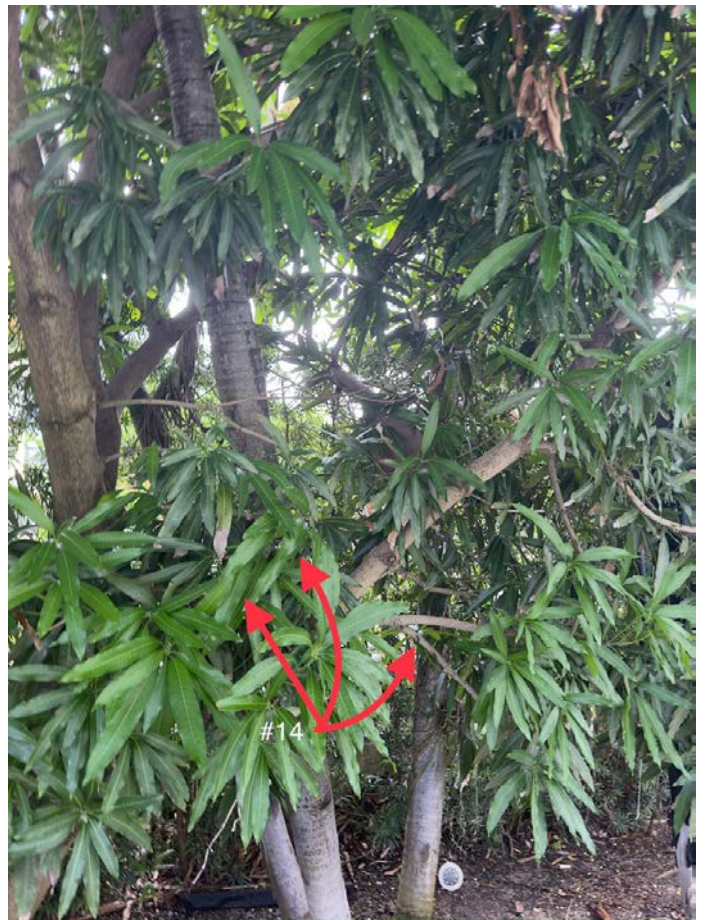
14. *Adonidia merrillii* (Christmas palm tree) (3) DBH 4" ea., Spread 8' ea., Height 20'-25' ea. these trees conditions are fair (Class PALM 80%). These trees are on the northeast quadrant of this property. Minimum 2' radius from trunk Tree protection zone shall be installed to protect 4' Critical root zone of these trees and done under ANSI A-300 guidelines should these trees need protection during construction. These trees are scheduled to remain.

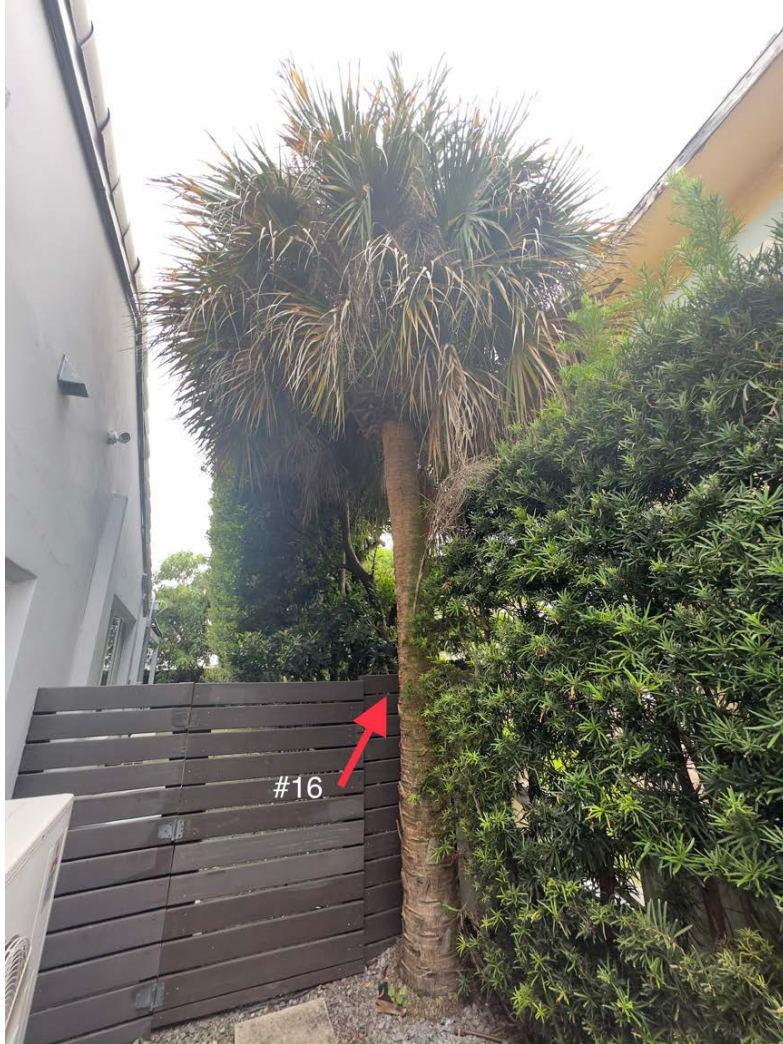
16. Sabal palmetto (Cabbage palm tree) DBH 11", Spread 8', Height 20' this trees condition is fair (Class PALM 80%). This tree is on the north side of property. Minimum 6' radius from trunk Tree protection zone shall be installed to protect 12' Critical root zone of this tree and done under ANSI A-300 guidelines should this tree need protection during construction. This tree is scheduled to remain.

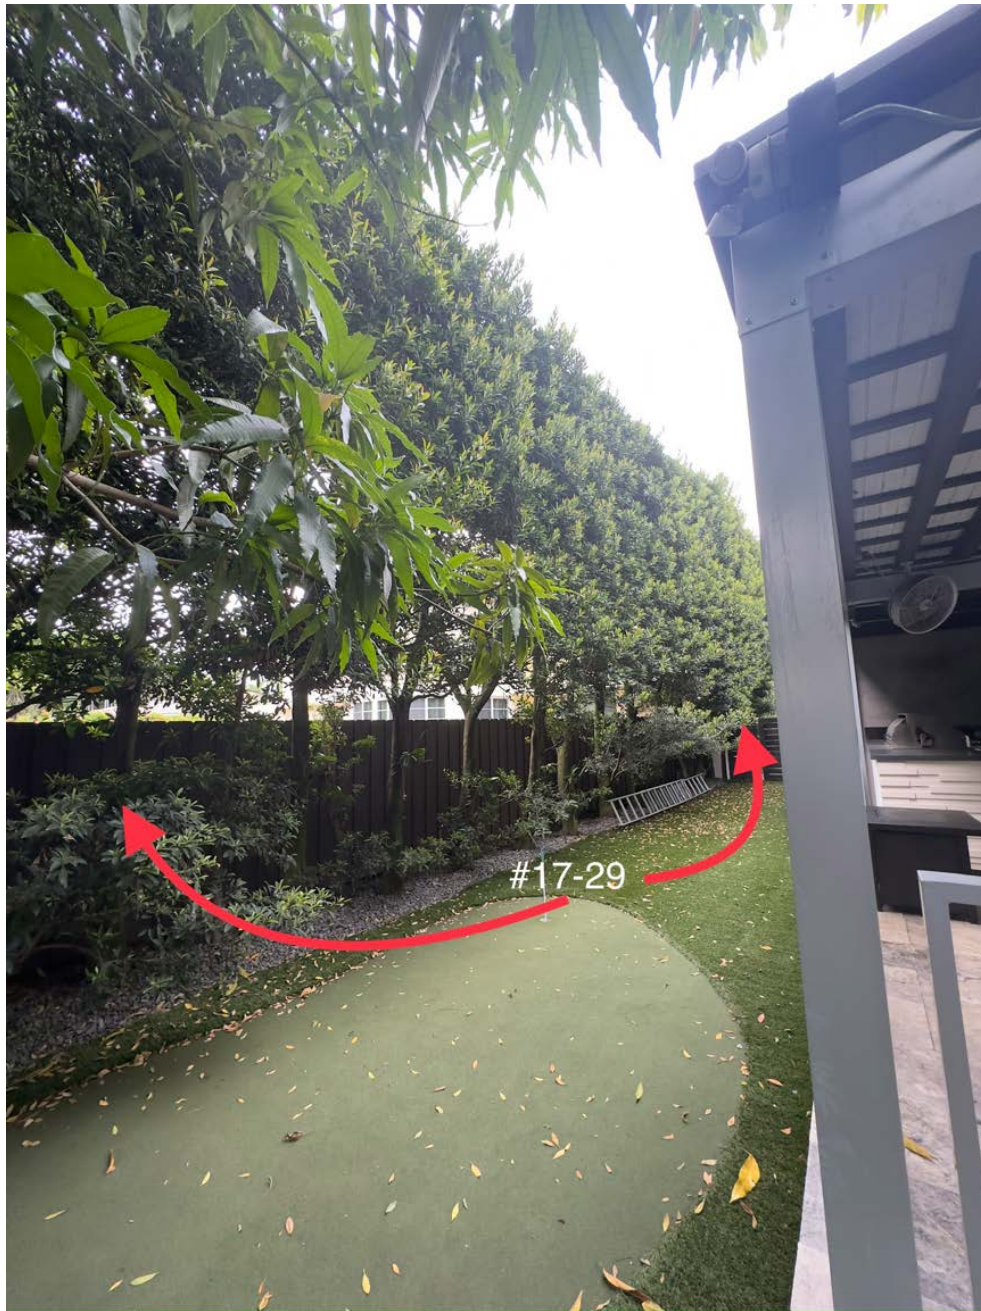
17-29. *Elaeocarpus decipiens* (Japanese Blueberry tree) (13) DBH 3"-8" ea., Spread 8'-10' ea., Height 20' ea. these trees conditions are fair (Class B 80%). These trees are in the north side of property. Minimum 4' radius from trunk Tree protection zone shall be installed to protect 8' Critical root zone of these trees and done under ANSI A-300 guidelines should these trees need protection during construction. These trees are scheduled to remain.

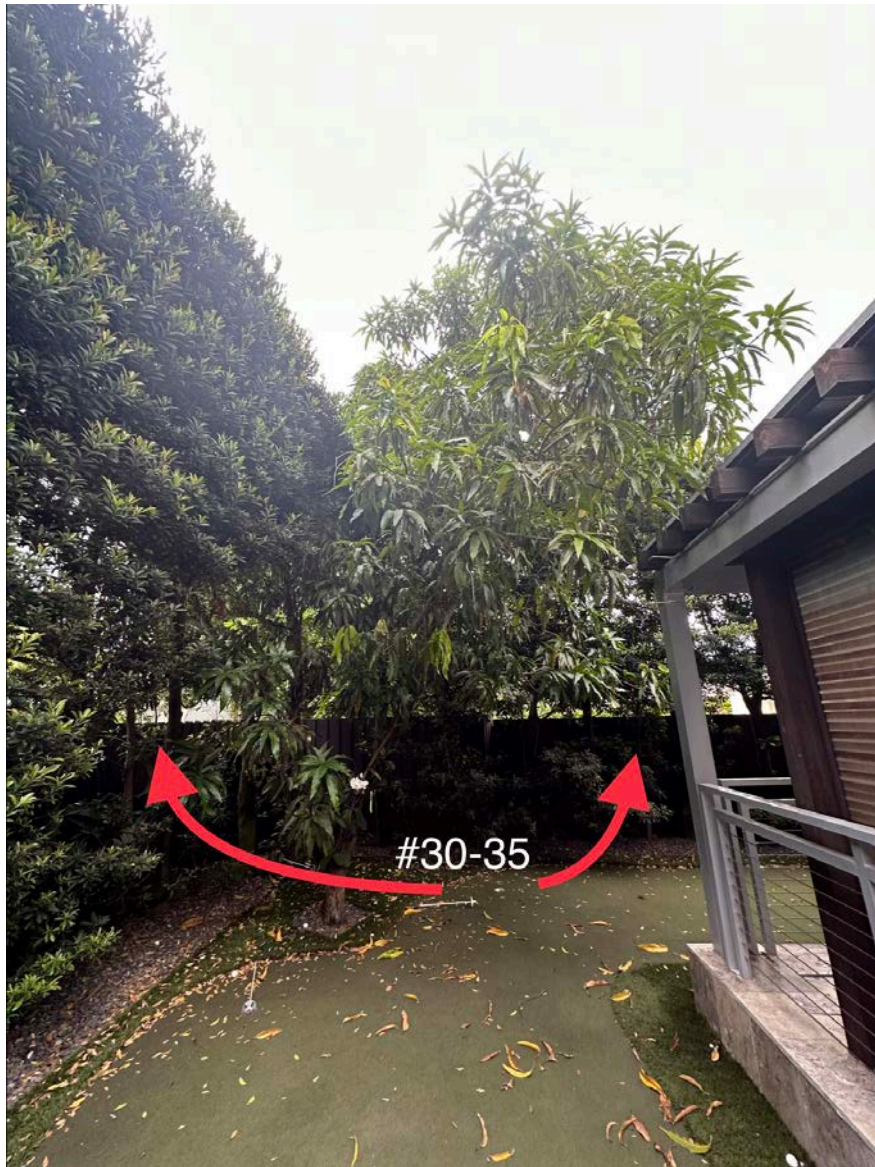
30-35. *Elaeocarpus decipiens* (Japanese Blueberry tree) (6) DBH 3"-8" ea., Spread 8'-10' ea., Height 20' ea. these trees conditions are fair (Class B 80%). These trees are in the northwest quadrant of property. Minimum 4' radius from trunk Tree protection zone shall be installed to protect 8' Critical root zone of these trees and done under ANSI A-300 guidelines should these trees need protection during construction. These trees are scheduled to remain.

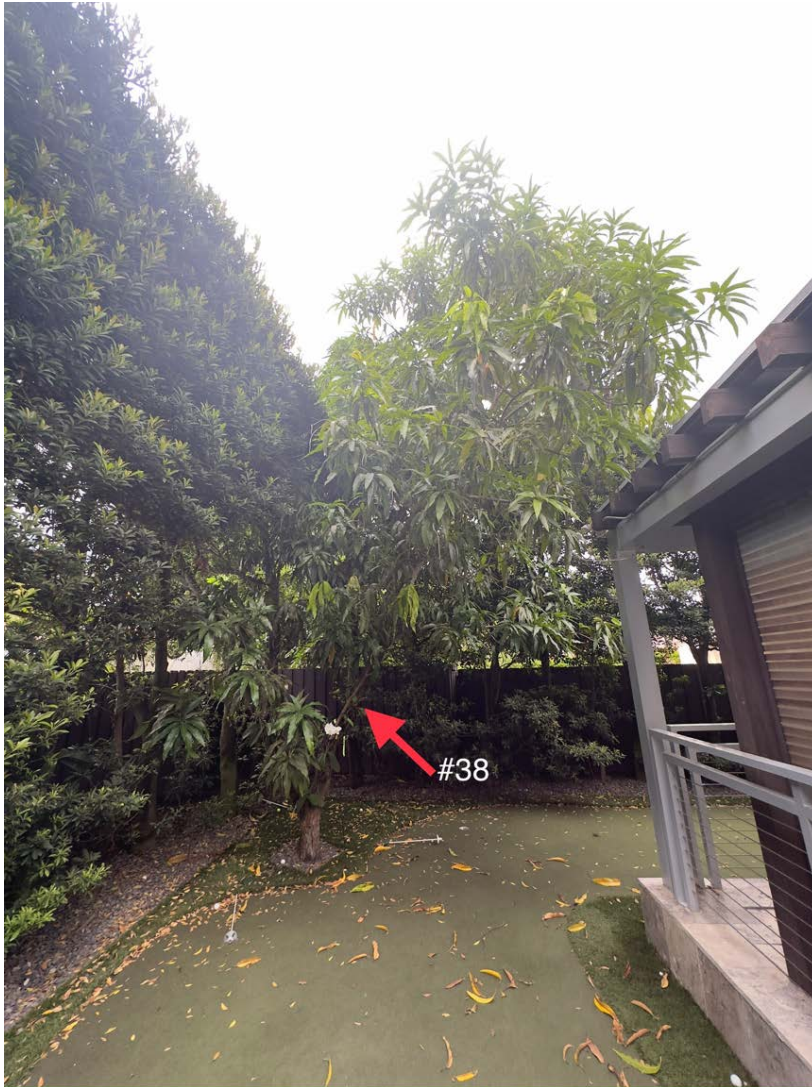
38. *Mangifera indica* (Mango tree) DBH 9", Spread 25', Height 23' this trees condition is moderate (Class B 70%). This tree is in the northwest quadrant of property. Minimum 4.5' radius from trunk Tree protection zone shall be installed to protect 9' Critical root zone of this tree and done under ANSI A-300 guidelines should this tree need protection during construction. This tree is scheduled to remain.

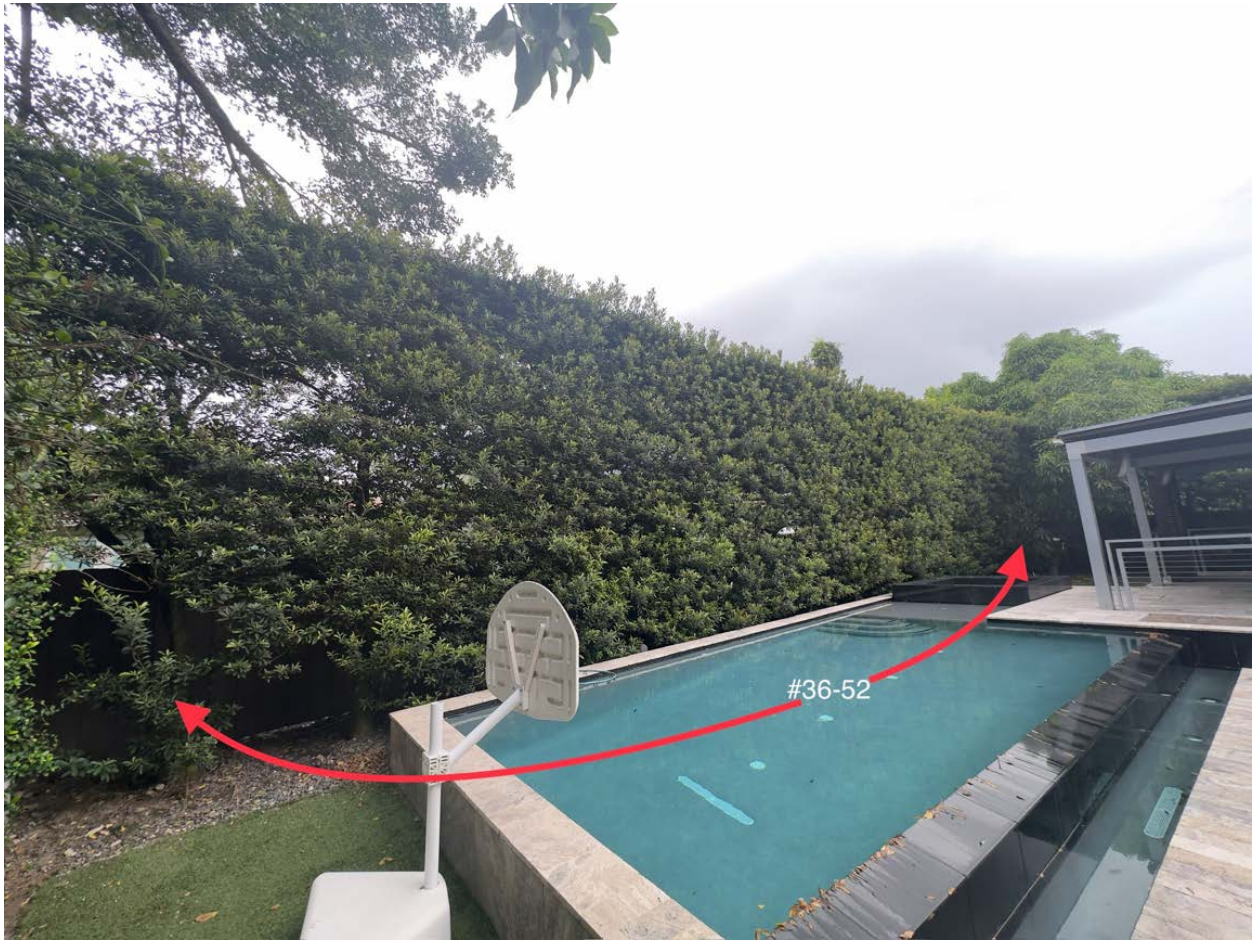
36-52, excluding 38. *Elaeocarpus decipiens* (Japanese Blueberry tree) (16) DBH 3"-8" ea., Spread 8'-10'ea., Height 20'ea. these trees conditions are fair (Class B 80%). These trees are in the west side of property. Minimum 4' radius from trunk Tree protection zone shall be installed to protect 8' Critical root zone of these trees and done under ANSI A-300 guidelines should these trees need protection during construction. These trees are scheduled to remain.

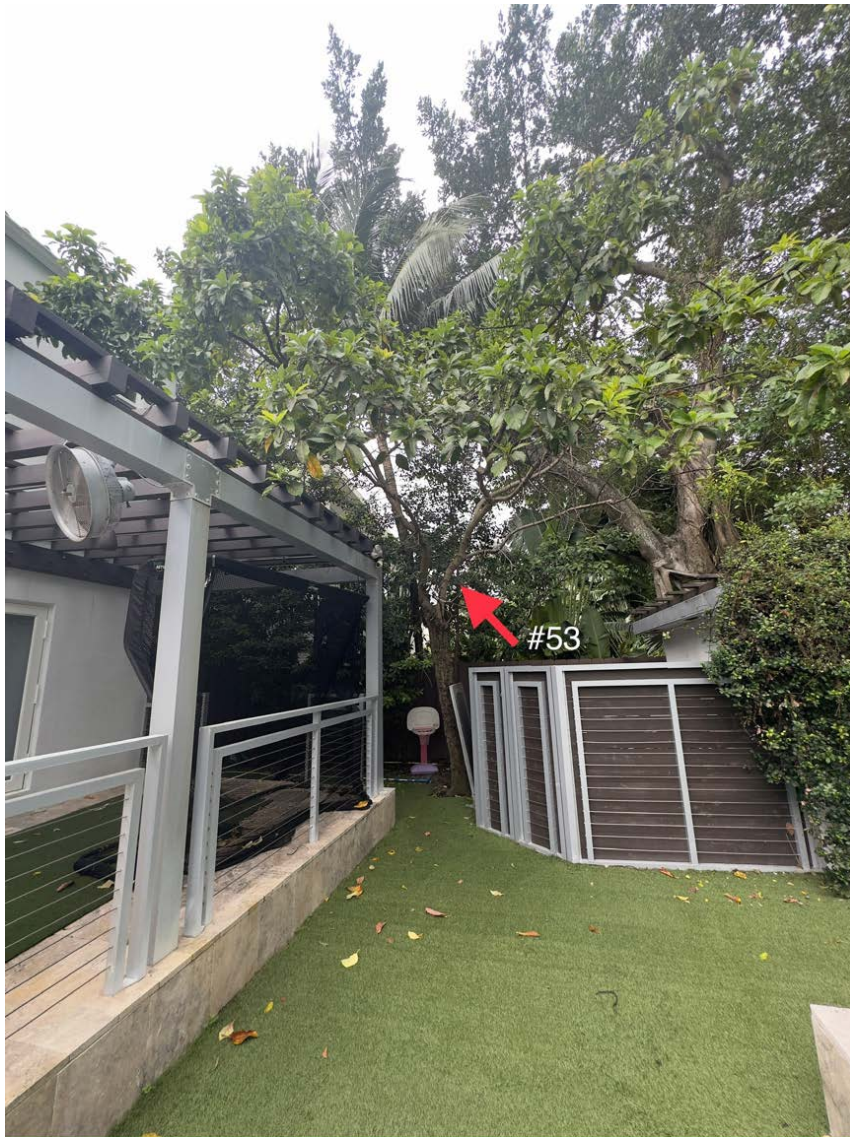
53. *Persea americana* (Avocado tree) DBH 10", Spread 38', Height 28' this trees condition is moderate (Class B 60%). This tree is in the southwest quadrant of property. Minimum 5' radius from trunk Tree protection zone shall be installed to protect 10' Critical root zone of this tree and done under ANSI A-300 guidelines should this tree need protection during construction. This tree is scheduled to remain.

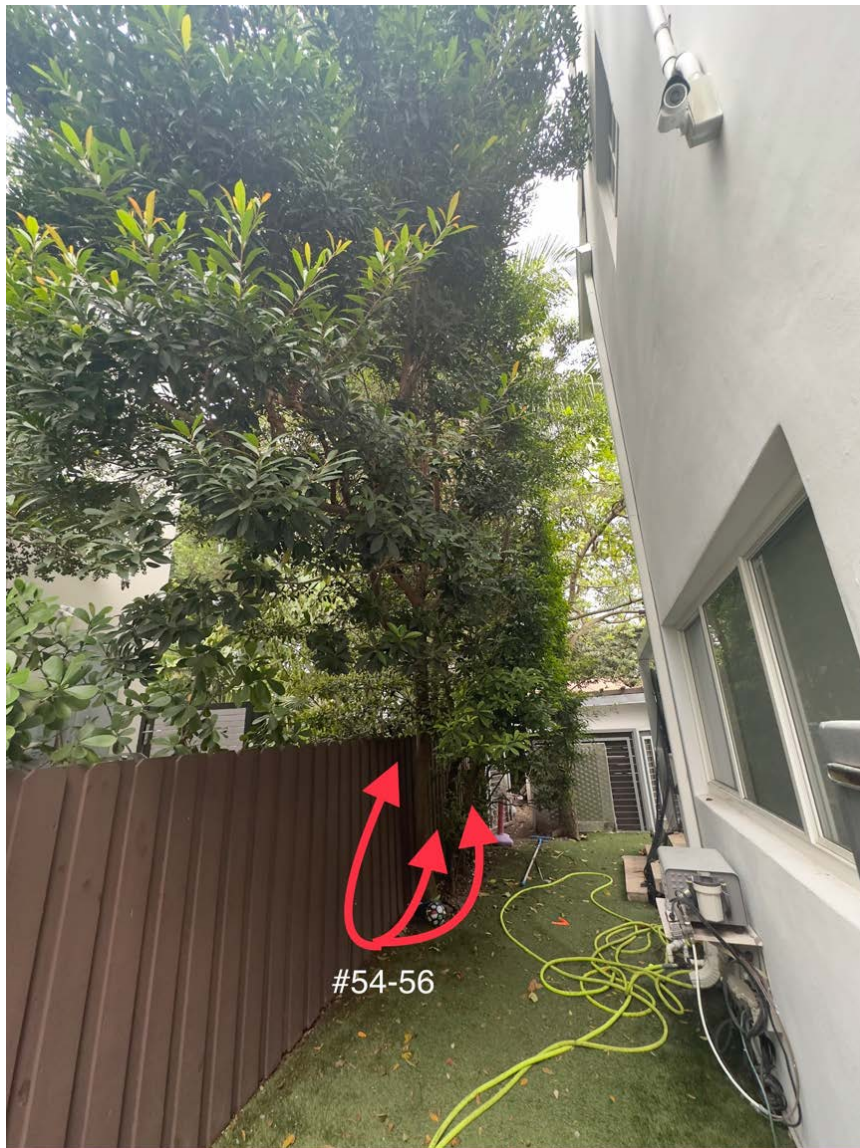
54-56. *Elaeocarpus decipiens* (Japanese Blueberry tree) (3) DBH 3"-6" ea., Spread 8'-15'ea., Height 20'-25'ea. these trees conditions are fair (Class B 80%). These trees are in the south side of property. Minimum 3' radius from trunk Tree protection zone shall be installed to protect 6' Critical root zone of these trees and done under ANSI A-300 guidelines should these trees need protection during construction. These trees are scheduled to remain.
