October 4, 2023

4330 Nautilus Dr. Arborist Report

RE: 4330 Nautilus Dr. Miami Beach FL, 33140

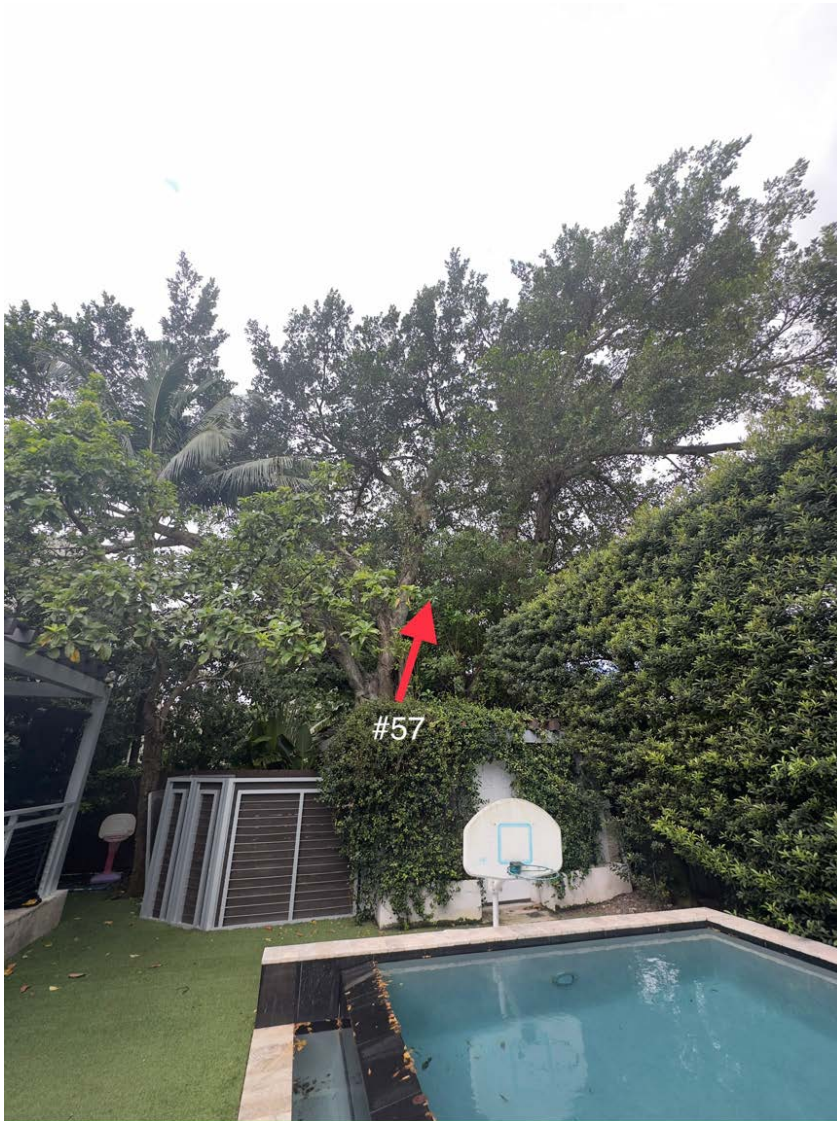
57. Ficus aurea (Strangler Fig tree) DBH 86", Spread 70', Height 50' this trees condition is fair (Class A 80%). This tree on the neighboring property line, in the southwest quadrant of property. Minimum 20' radius from trunk Tree protection zone shall be installed to protect 40' Critical root zone of this tree and done under ANSI A-300 guidelines should this tree need protection during construction. This tree is scheduled to remain.

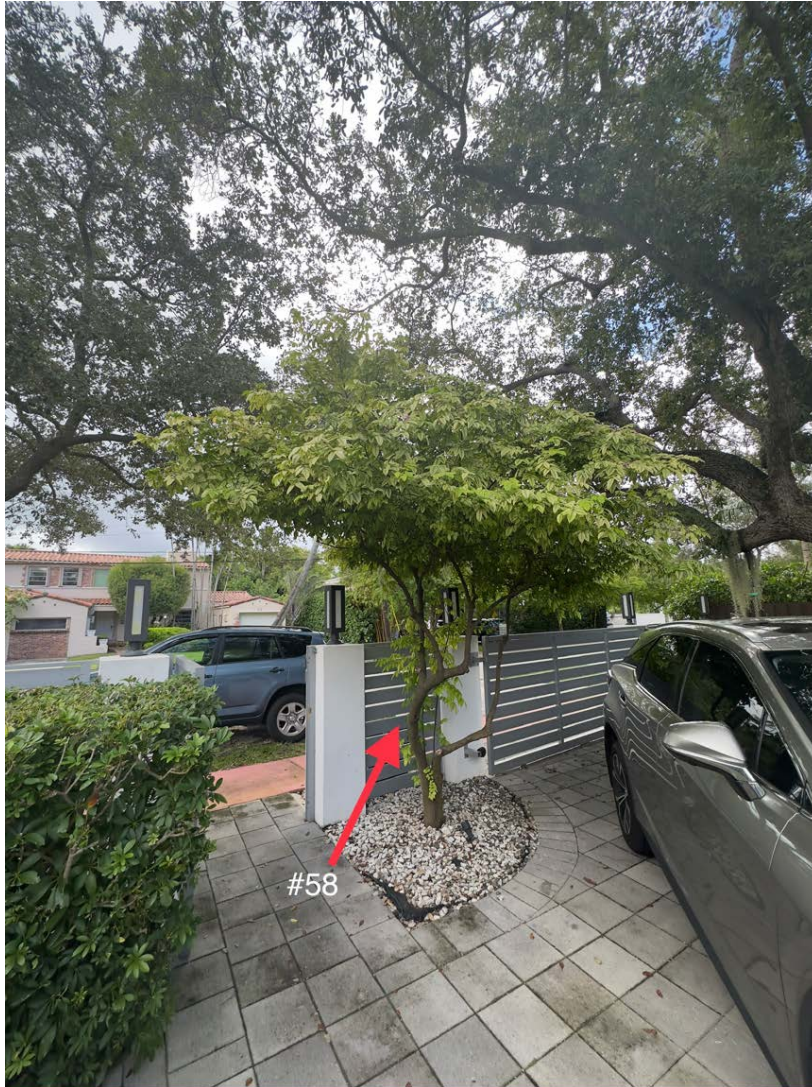
58. *Averrhoa carambola* (Starfruit tree) DBH 4", Spread 20', Height 15' this tree's condition is fair (Class B 80%). This tree is on the east side of the property. A minimum 3' radius tree protection zone shall be installed to protect the 6' critical root zone of this tree and done under ANSI A-300 guidelines should this tree need protection during construction. This tree is scheduled to remain.
