October 4, 2023

4330 Nautilus Dr. Arborist Report

RE: 4330 Nautilus Dr. Miami Beach FL, 33140

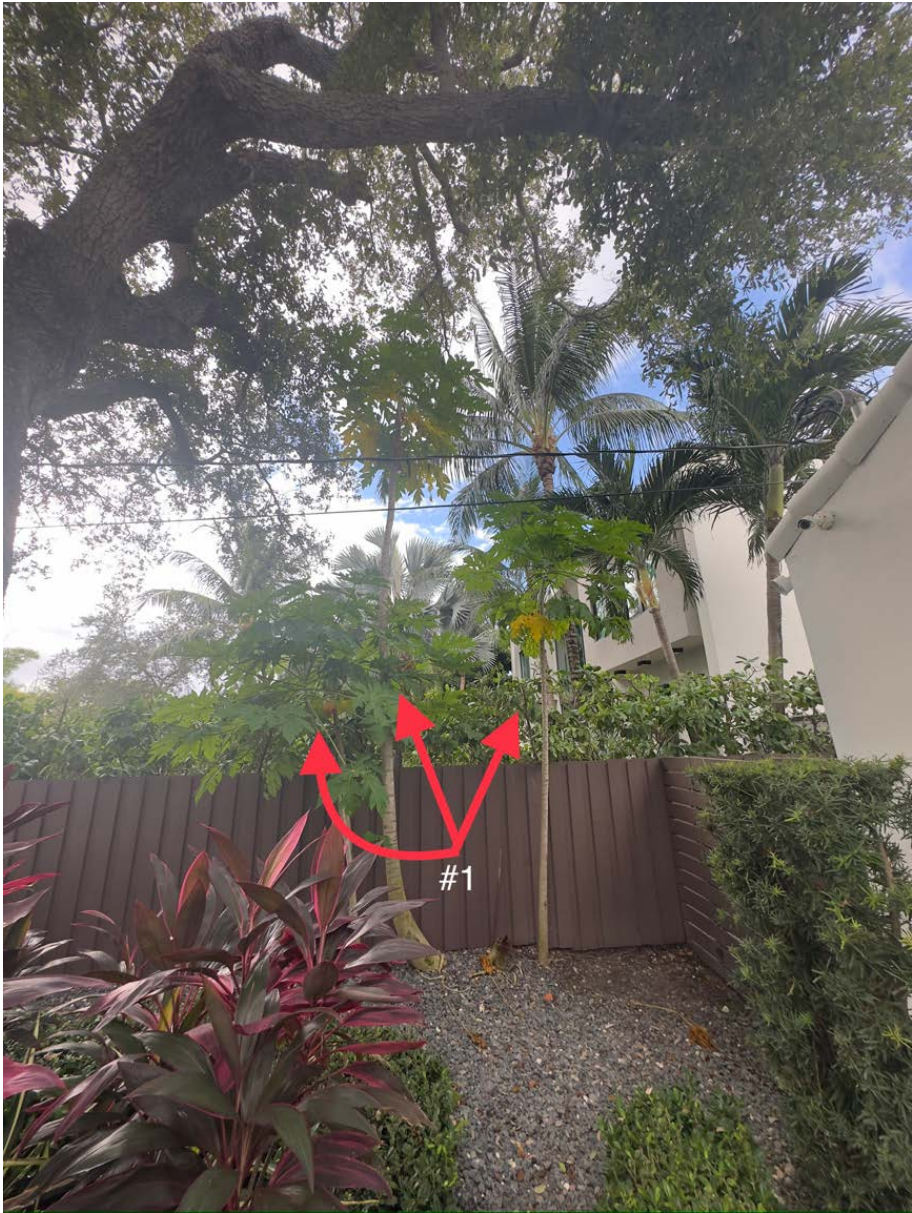
1. Carica papaya (Papaya tree) (3) DBH 1"-4" ea., Spread 4'-6'ea., Height 10'-20'ea. these trees conditions are fair (Class B 80%). These trees are in the southeast quadrant of property. Minimum 2' radius from trunk Tree protection zone shall be installed to protect 4' Critical root zone of these trees and done under ANSI A-300 guidelines should these trees need protection during construction. These trees are scheduled to remain.

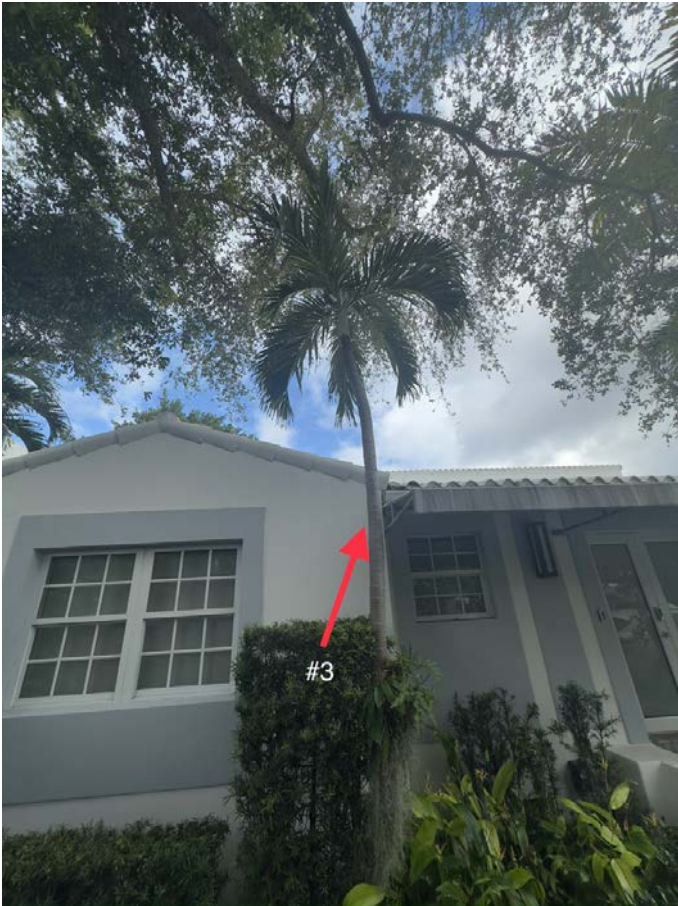
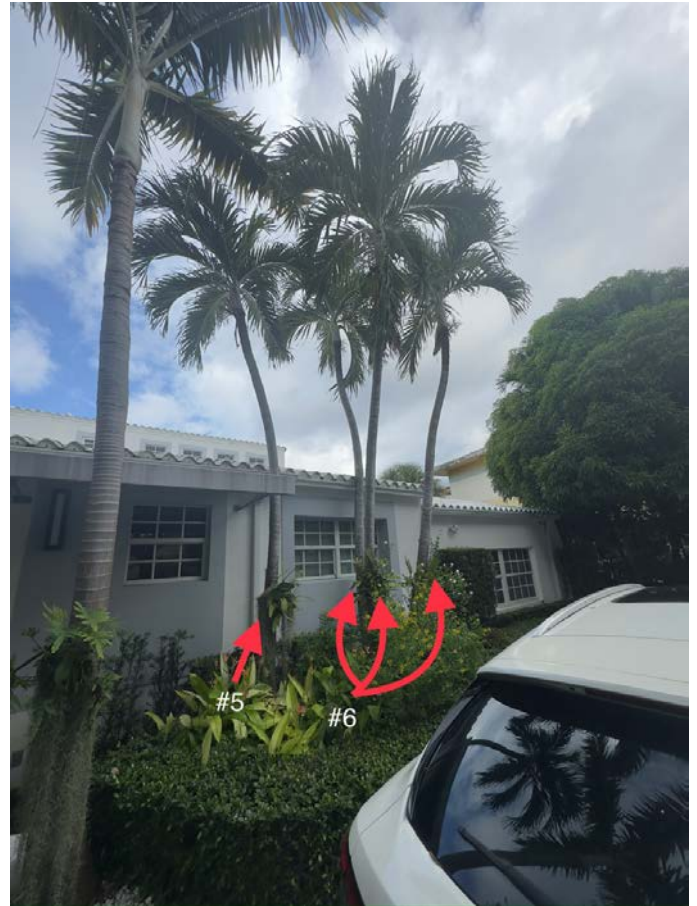
3,5,6. *Adonidia merrillii* (Christmas palm tree) (5) DBH 4" ea., Spread 8' ea., Height 20'-25' ea. these trees conditions are fair (Class PALM 80%). These trees are on the east side of existing house on this property. Minimum 2' radius from trunk Tree protection zone shall be installed to protect 4' Critical root zone of these trees and done under ANSI A-300 guidelines should these trees need protection during construction. These trees are scheduled to remain.

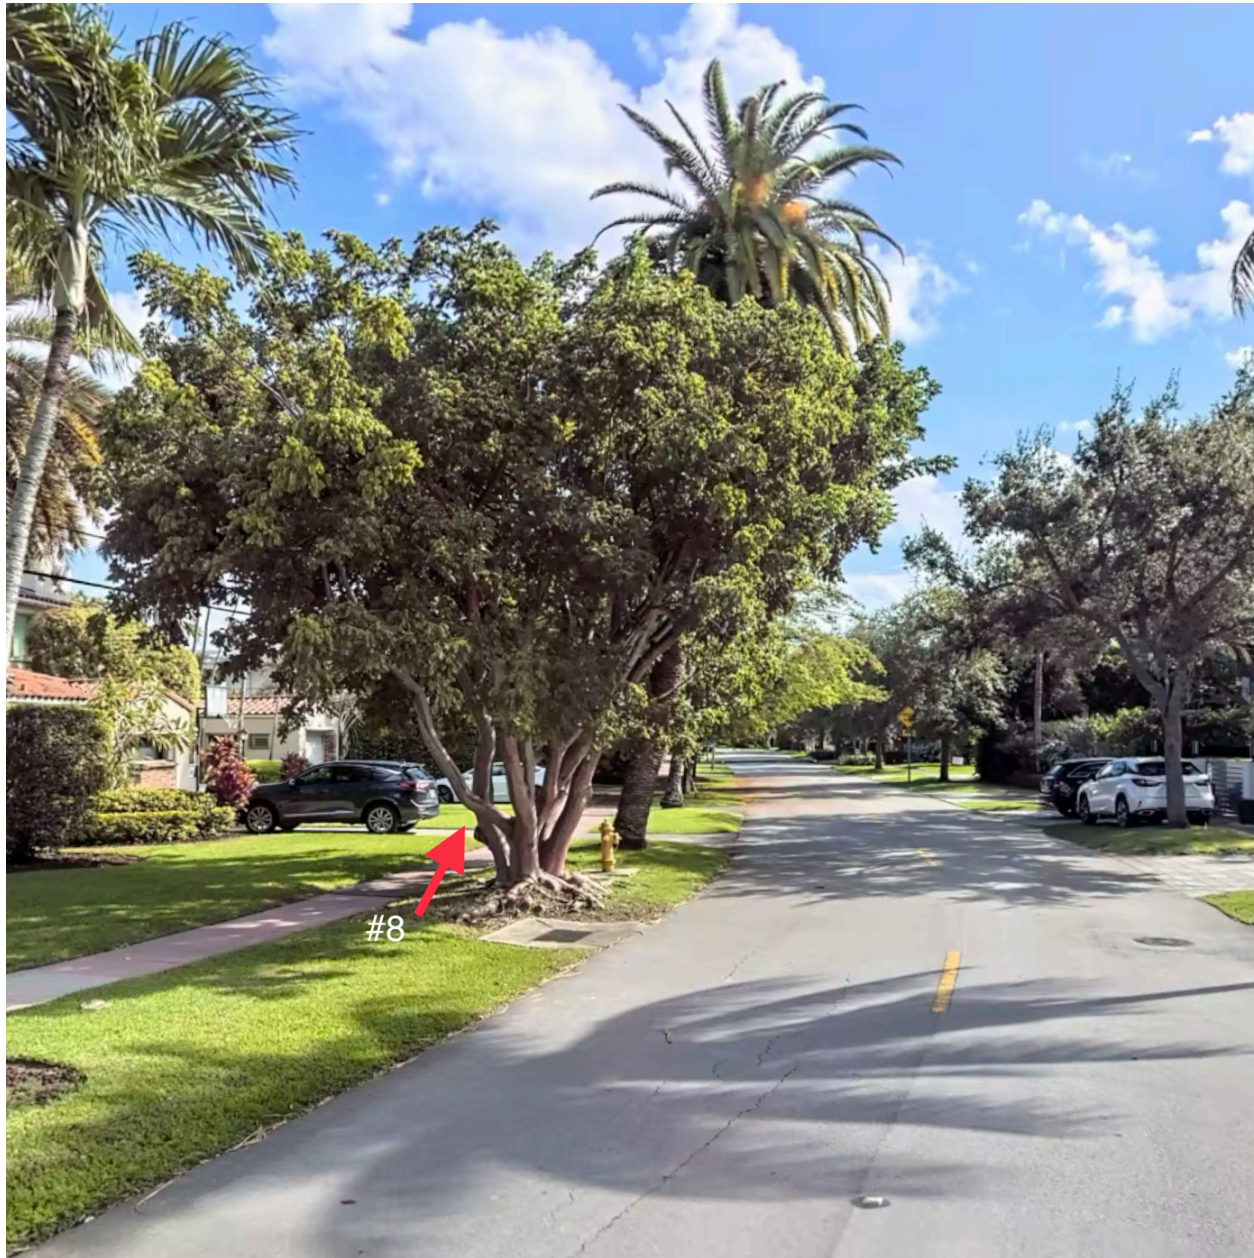
8. *Bursera simaruba* (Gumbo Limbo tree) DBH 70", Spread 50', Height 28' this trees condition is moderate (Class A 70%). This tree is in the east side of property, on the right of way opposite side of Nautilus Dr. Minimum 6' radius from trunk Tree protection zone shall be installed to protect 40' Critical root zone of this tree and done under ANSI A-300 guidelines should this tree need protection during construction. This tree is scheduled to remain.
