# Arborist Report

1901 Alton Road

Miami Beach

9/13/2023

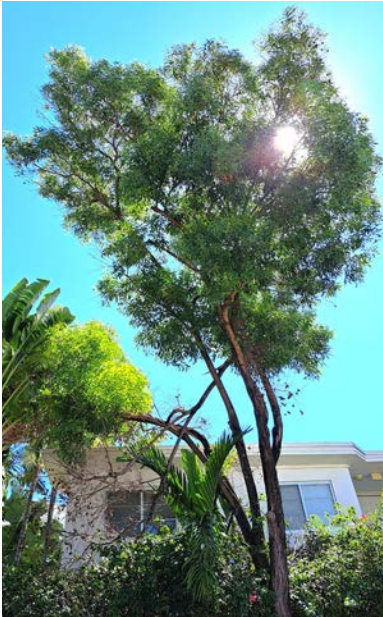
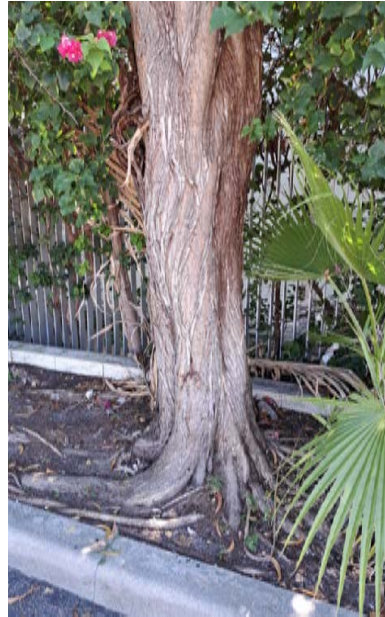
## Tree #7

| NUMBER | COMMON NAME | SCIENTIFIC NAME | DBH (IN) | HT (FT) | SP (FT) | CONDITION | NATIVE? | NOTES |
|---|---|---|---|---|---|---|---|---|
| 7 | EARLEAF ACACIA | ACACIA AURICULIFORMIS | 18.5 | 40 | 20 | POOR | INVASIVE | HANGING BROKEN LIMB; PRUNE TO REMOVE DEADWOOD ASAP |

Tree #7 is an Earleaf Acacia located on the east side of the property. The tree is in poor condition. There are large, hanging dead limbs in the canopy. There is limited rooting space and many large surface roots. Prune to remove the deadwood as soon as possible since it is over the parking lot. This species is highly invasive in South Florida and this tree will therefore need to be removed.

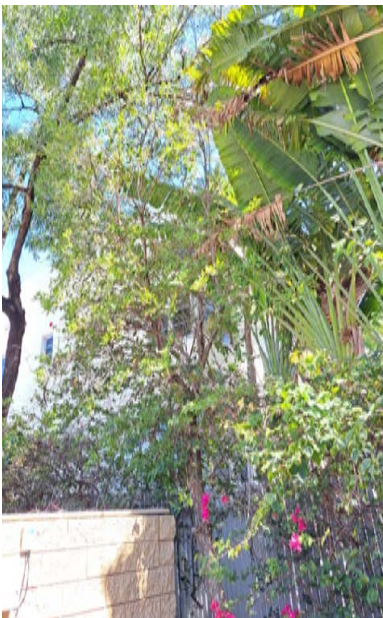
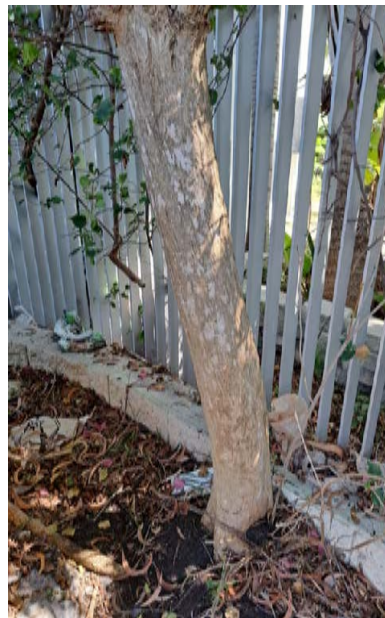
## Tree #8

Tree #8 is a Pink Trumpet Tree located on the northeast side of the property. It is in poor condition. There is limited rooting space. There are pest issues affecting the foliage. The canopy is thin.

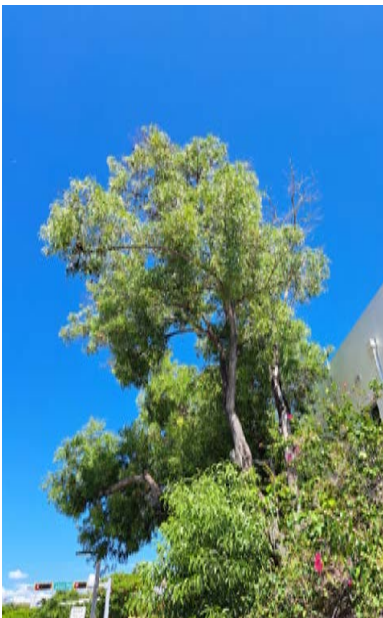
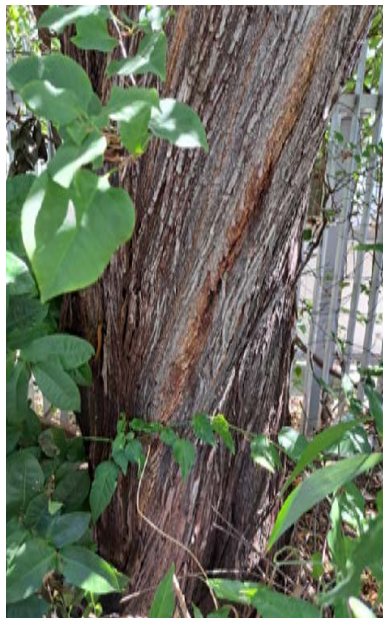
## Tree #10

| NUMBER | COMMON NAME | SCIENTIFIC NAME | DBH (IN) | HT (FT) | SP (FT) | CONDITION | NATIVE? | NOTES |
|---|---|---|---|---|---|---|---|---|
| 10 | EARLEAF ACACIA | ACACIA AURICULIFORMIS | 24 | 40 | 18 | POOR | INVASIVE | LARGE DEADWOOD; PRUNE TO REMOVE DEADWOOD ASAP |

Tree #10 is an Earleaf Acacia located on the northeast side of the property. It is in poor condition. There is limited rooting space. The secondary leader has died. The tree has low vigor and extensive dieback. Prune to remove the deadwood as soon as possible since it is over the parking lot. This species is highly invasive in South Florida and this tree will therefore need to be removed.

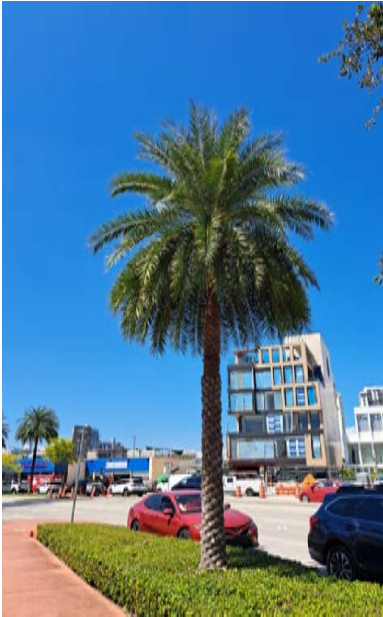
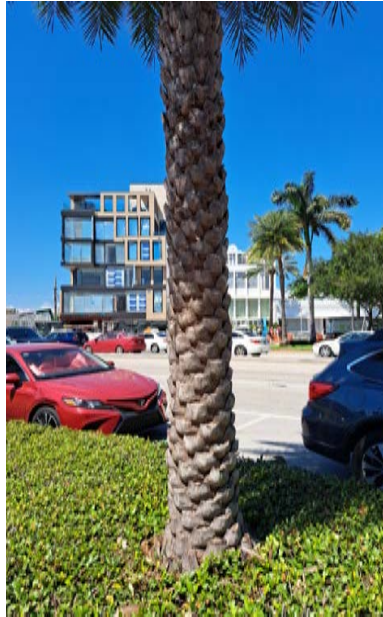
## Tree #23

Tree #23 is a Sylvester Palm street tree located along Alton Road. It is in good condition and is growing in a 10ft wide planting swale.

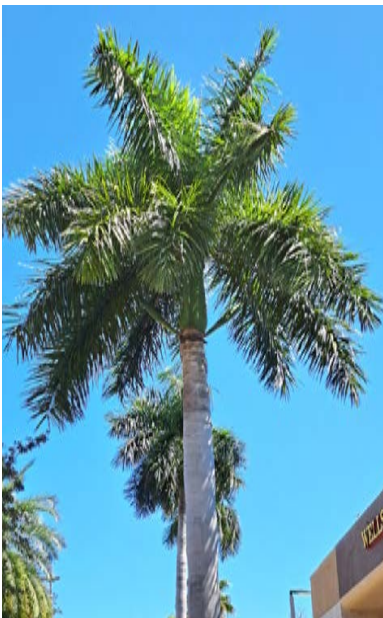
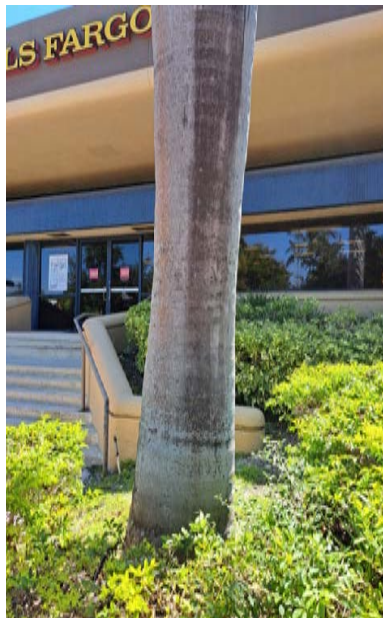
## Tree #24

Tree #24 is a Royal Palm located on the western side of the property. It is in good condition with healthy green fronds.
