# Arborist Report

94 Palm Avenue

Miami Beach

11/14/2022

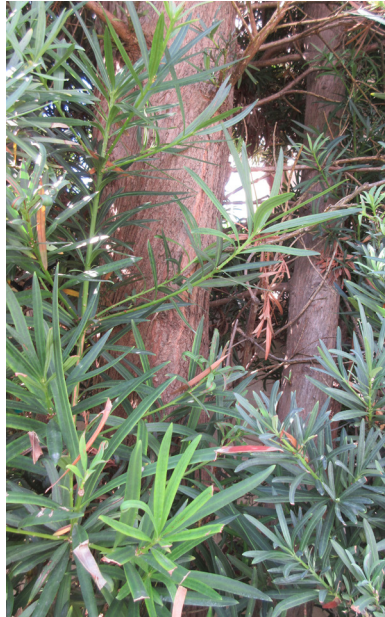
## Tree #1

Tree #1 is a Podocarpus located at the front of the house. It is double-trunked and in good condition. The foliage is dense and healthy.

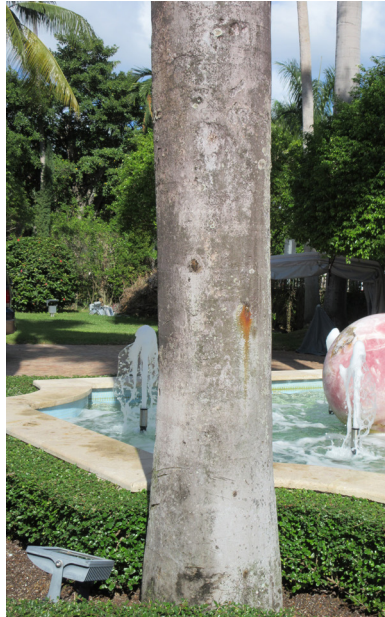
## Tree #3

Tree #3 is a Royal Palm located next to the front fountain. It is in good condition.

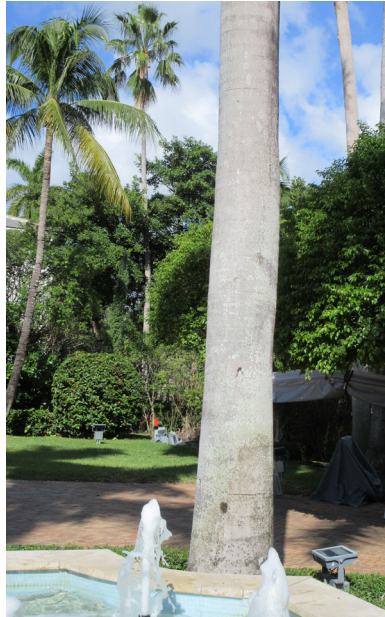
## Tree #5

Tree #5 is a Royal Palm located next to the front fountain. It is in fair condition with a pencilling trunk.

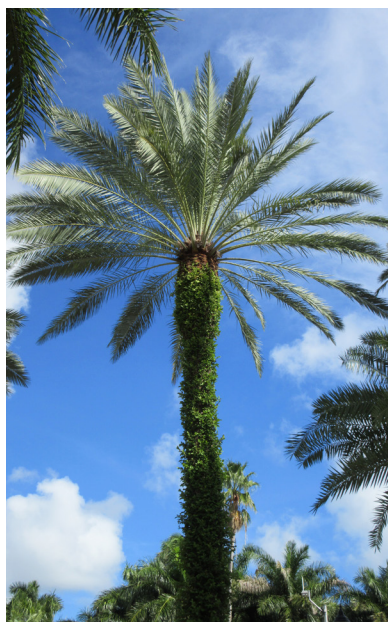
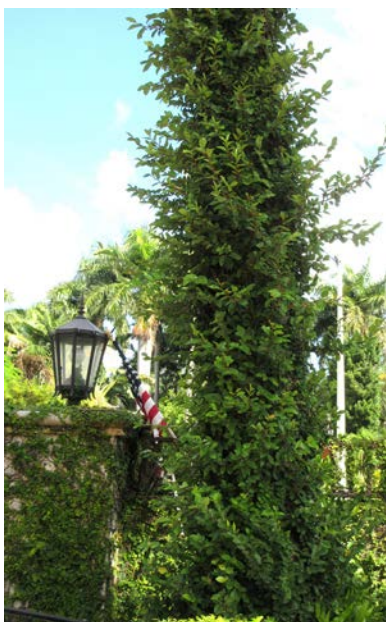
## Tree #11

Tree #11 is a Date Palm located at the front entrance. It is in good condition. Vines are on the trunk.

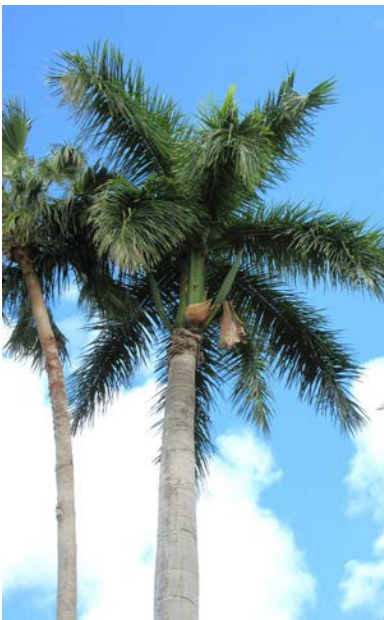
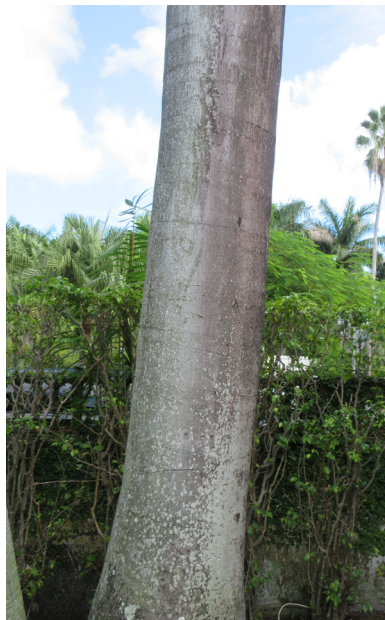
## Tree #14

Tree #14 is a Royal Palm located at the front of the property. It is in good condition.

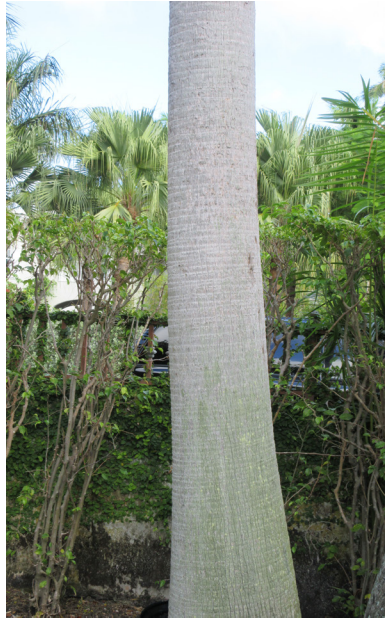
## Tree #15

Tree #15 is a Washingtonia Palm located at the front of the property. It is in good condition.

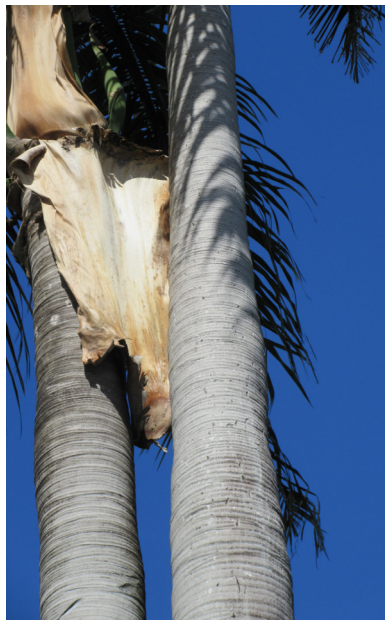
## Tree #24

Tree #24 is a Royal Palm located on the west side of the property. It is in fair condition with a pencilling trunk and frizzled foliage.

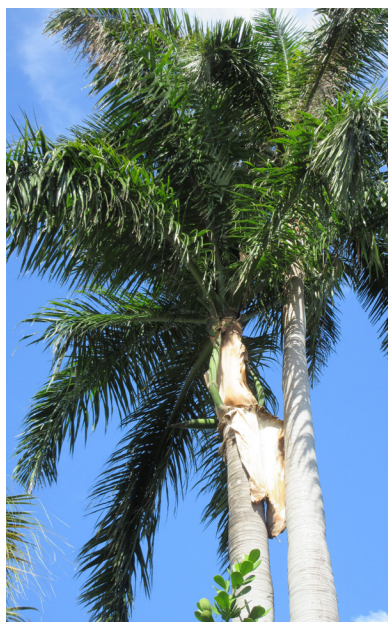
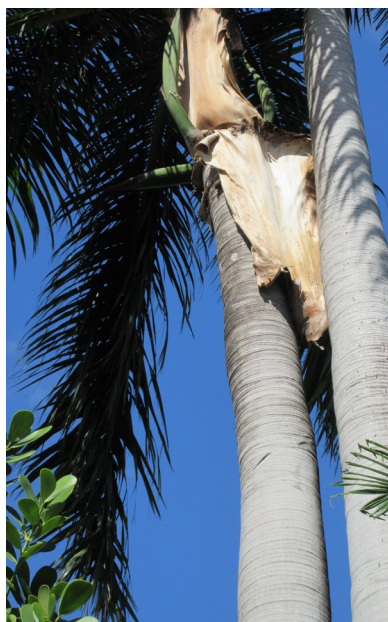
## Tree #25

Tree #25 is a Royal Palm located on the west side of the property. It is directly next to Royal Palm #24 and is in good condition.

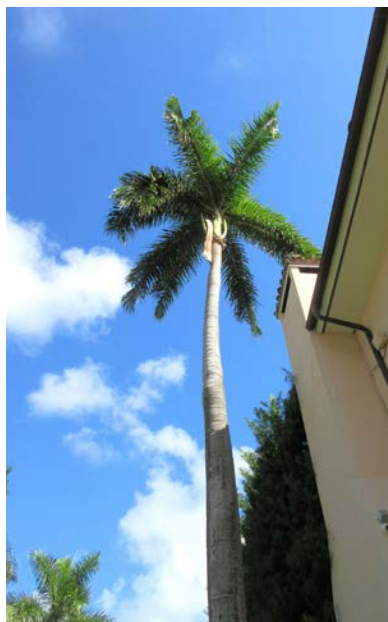
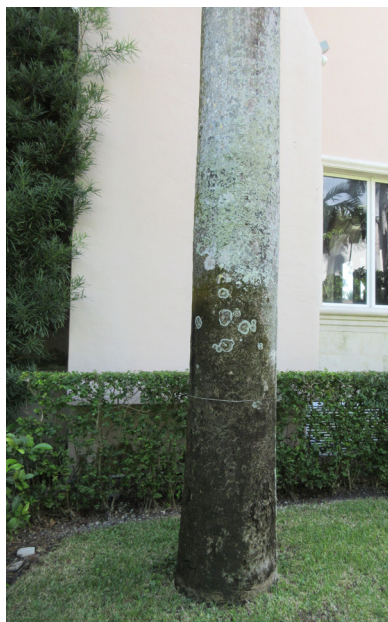
## Tree #26

Tree #26 is a Royal Palm located on the west side of the house. It is in good condition.

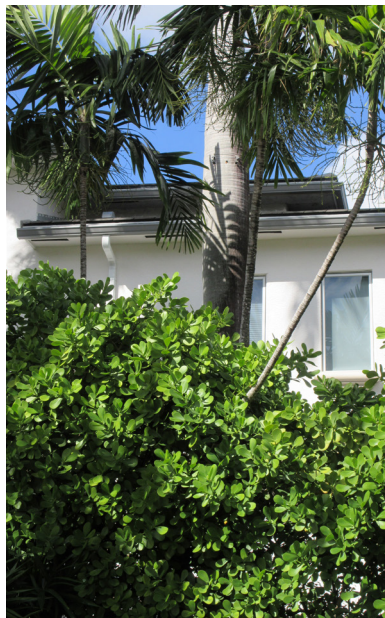
Tree #28 is a triple Alexander Palm located on the west side of the property. It is in fair condition.

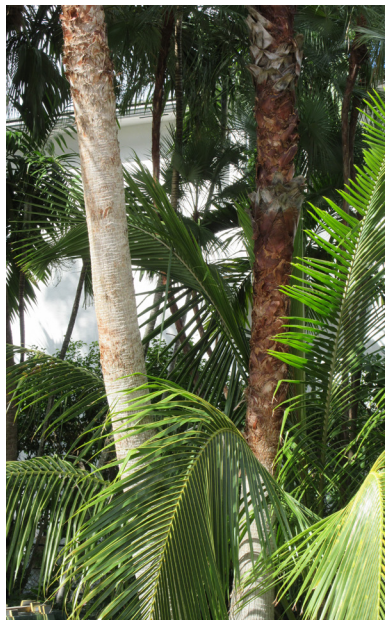
Tree #30 is a double Washingtonia Palm located on the west side of the property. It is in good condition.

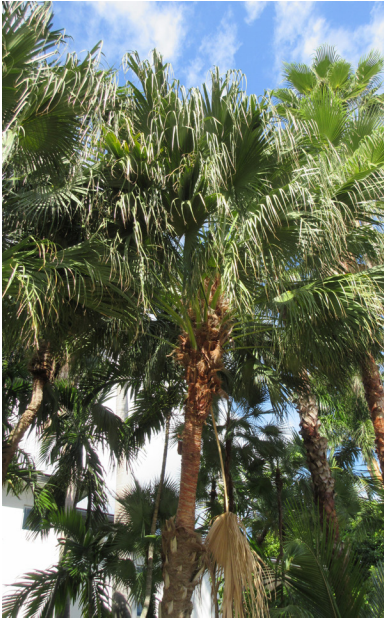
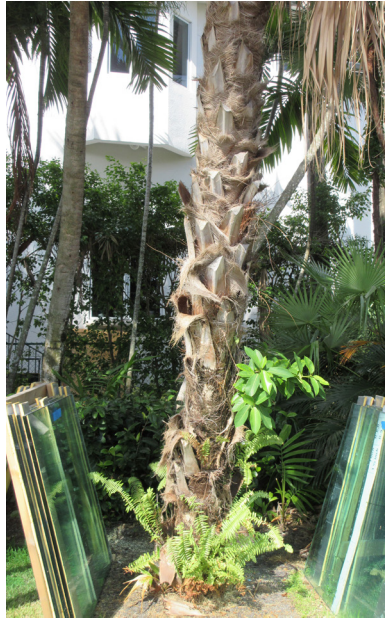
## Tree #33

Tree #33 is a Chinese Fan Palm located on the western side of the property. It is in good condition.

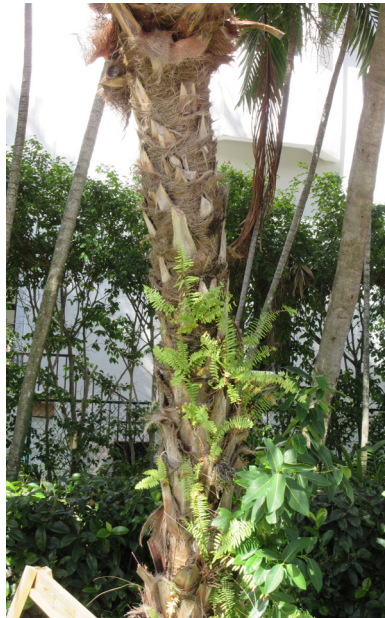
## Tree #34

Tree #34 is a Chinese Fan Palm located on the western side of the property. It is in good condition.

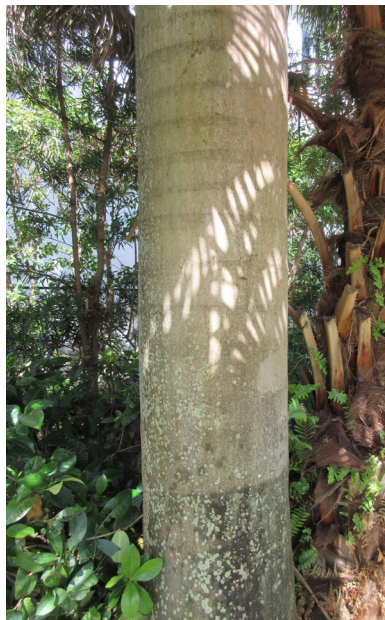
Tree #36 is a Royal Palm located on the western side of the property. It is in good condition.

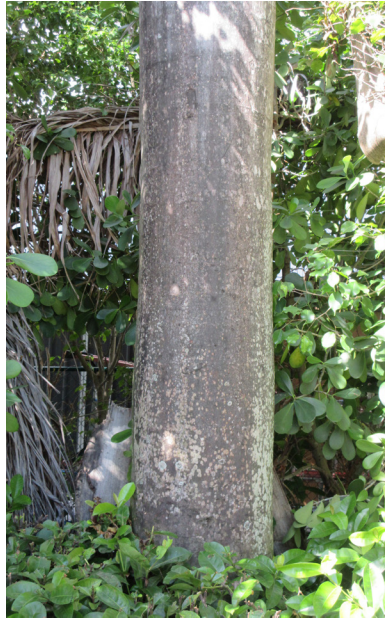
## Tree #37

Tree #37 is a Royal Palm located on the western side of the property. It is in good condition. The lower fronds have been overpruned.

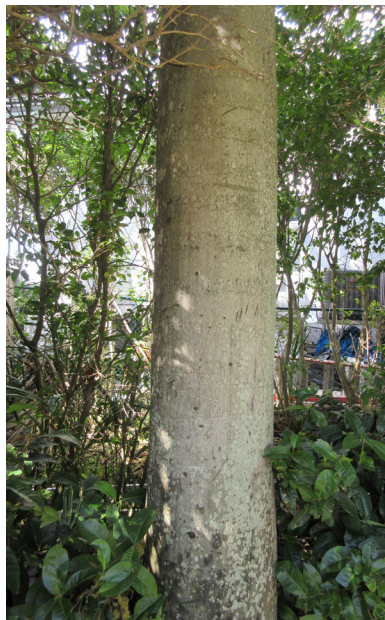
## Tree #38

Tree #38 is a Royal Palm located on the western side of the property. It is in good condition. The lower fronds have been overpruned.

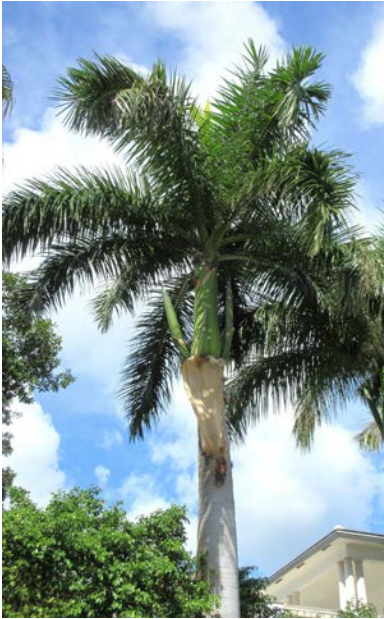
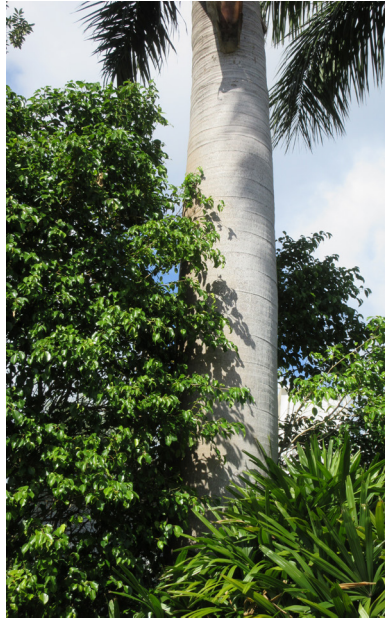
## Tree #39

Tree #39 is a Royal Palm located on the western side of the property. It is in good condition.

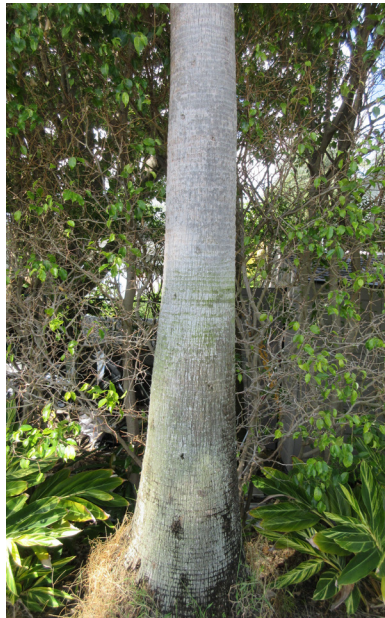
## Tree #40

Tree #40 is a Washingtonia Palm located towards the southwest corner of the property. It is in good condition.

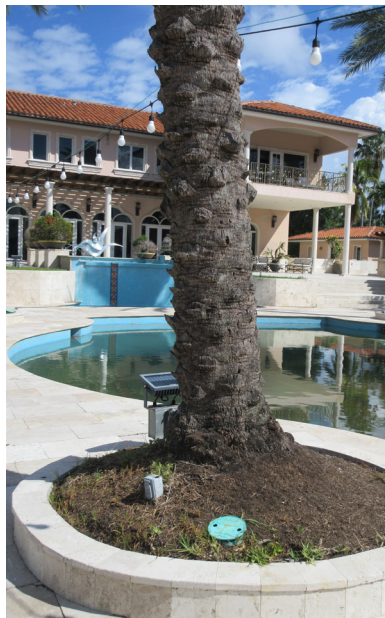
Tree #44 is a Date Palm located next to the pool. It is growing in a raised planter with limited rooting space. The tree is good condition.

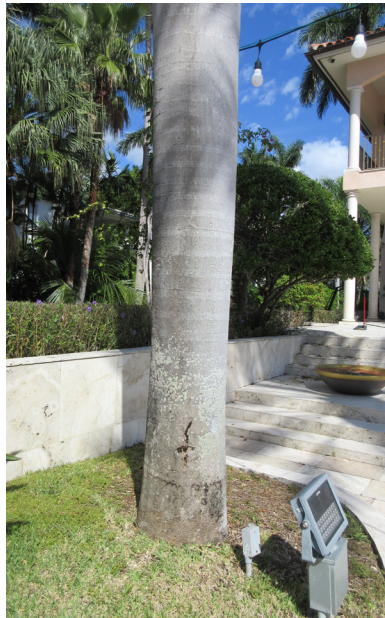
Tree #46 is a Royal Palm located next to the pool. It is in good condition.

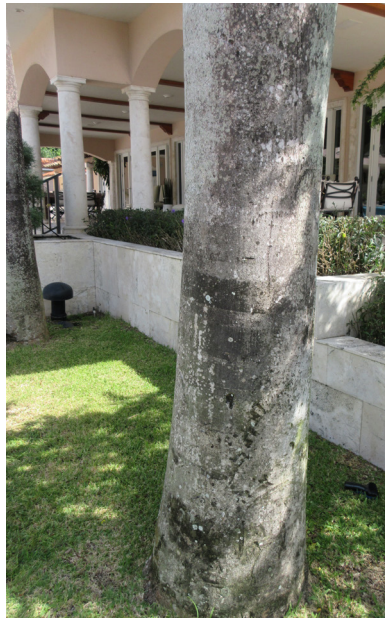
Tree #54 is a Royal Palm located towards the southeast corner of the property. It is in good condition.

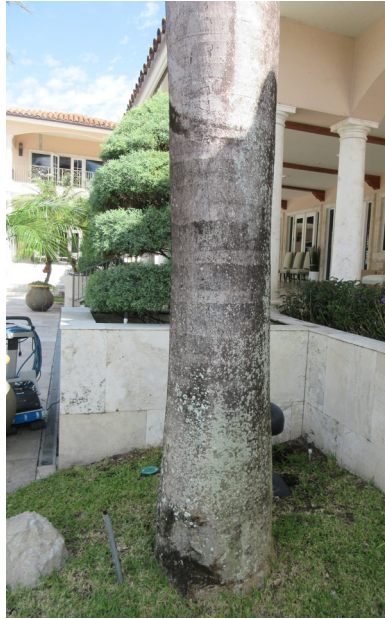
## Tree #55

Tree #55 is a Royal Palm located towards the southeast corner of the property. It is in good condition.

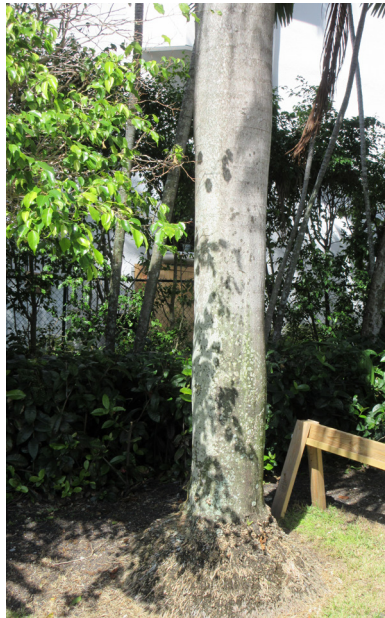
## Tree #56

Tree #56 is a Royal Palm located on the western side of the property. It is in good condition.

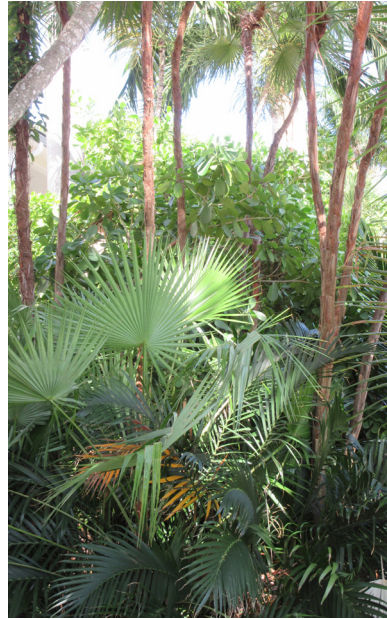
## Tree #57

Tree #57 is a Purotis Palm located on the western side of the property. It is in fair condition and is competing with the nearby trees.

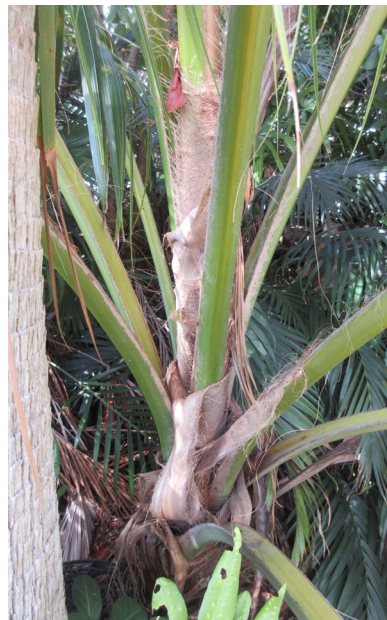
## Tree #58

Tree #58 is a small Coconut Palm located on the western side of the property. It is in good condition.

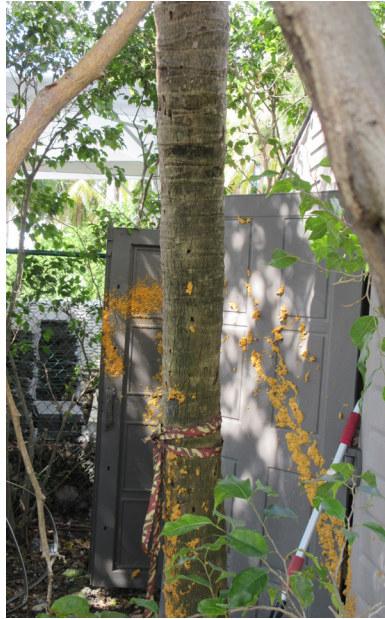
## Tree #65

Tree #65 is a Coconut Palm located in the southwestern corner of the property. It is in good condition.

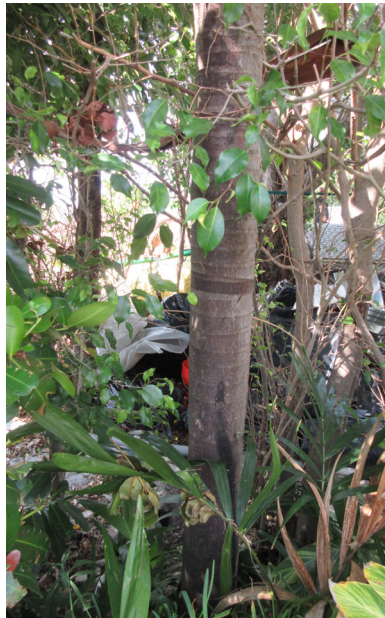
## Tree #66

Tree #66 is a Christmas Palm located in the southwestern corner of the property. It is in good condition with some yellow spotting on the fronds.

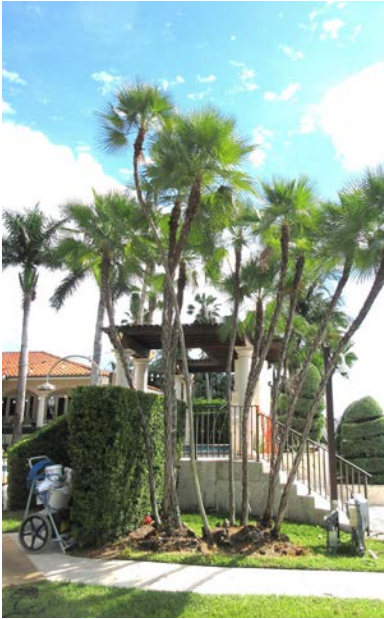
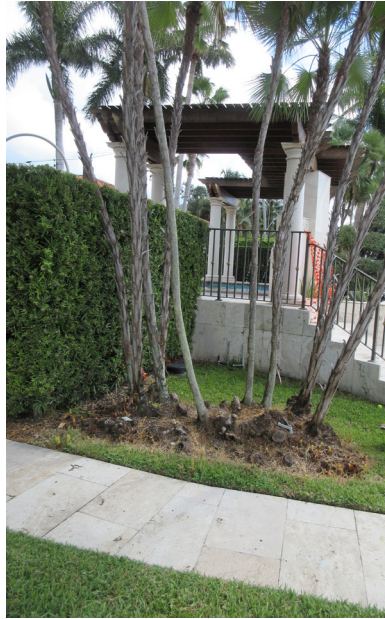
## Tree #67

Tree #67 is a Paurotis Palm located at the rear of the property. It is in good condition.

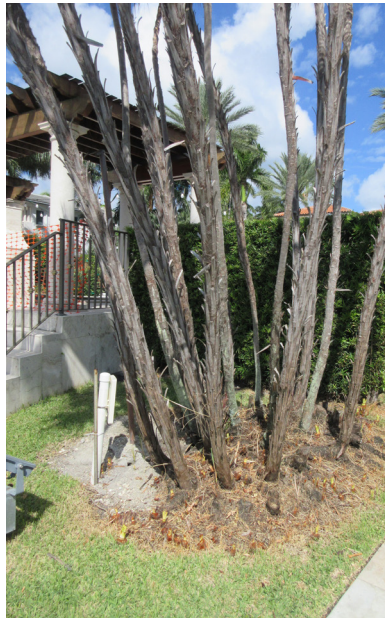
## Tree #68

Tree #68 is a Paurotis Palm located at the rear of the property. It is in good condition.

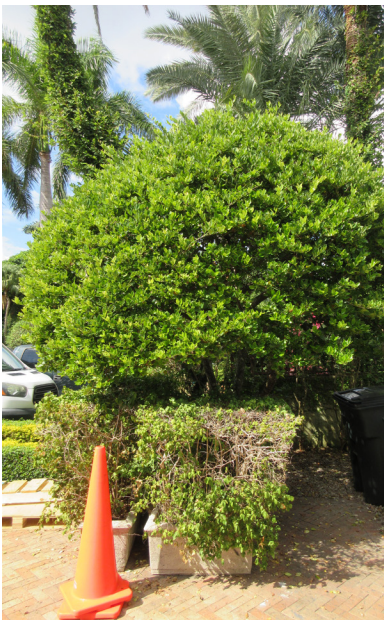
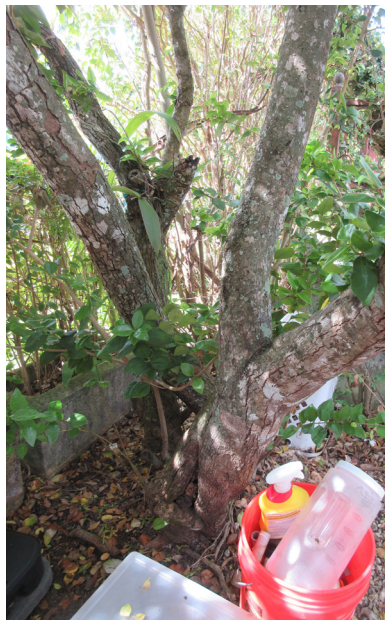
Tree #70 is a Japanese Privet located at the front of the property. It is multi-trunked and in fair condition. The canopy has been shaped.

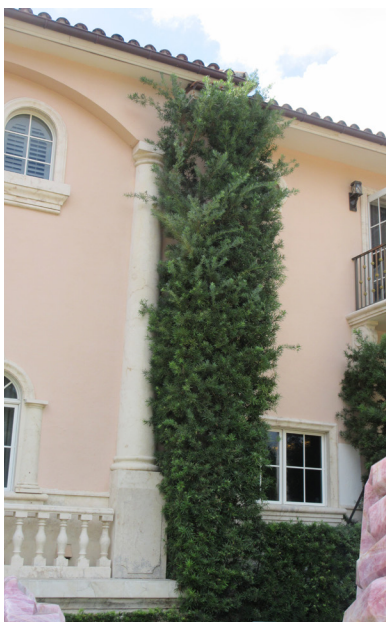
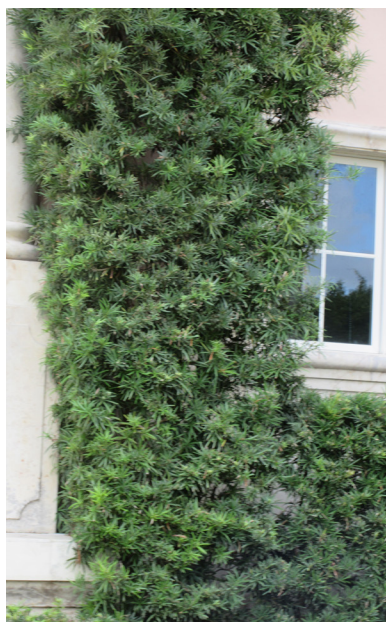
## Tree #71

Tree #71 is a Podocarpus located at the front of the house. It is in good condition with dense foliage.

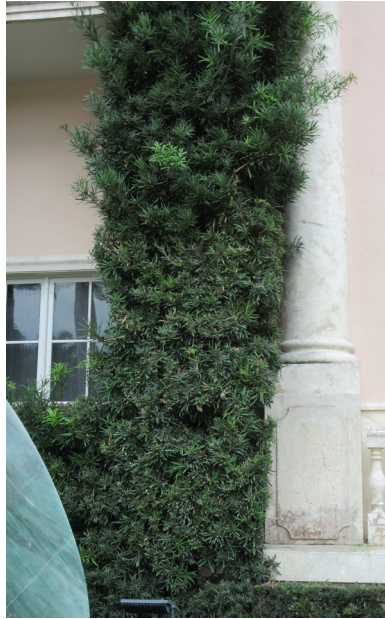
## Tree #73

Tree #73 is a Podocarpus located at the front of the house. It is in good condition with dense foliage.

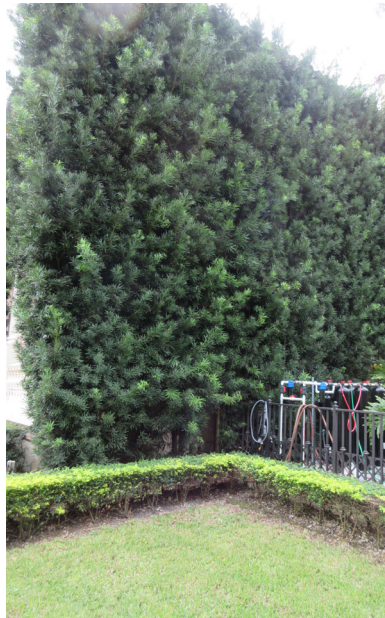
## Tree #74

Tree #74 is a Podocarpus hedge located on the western side of the house. It is in good condition.

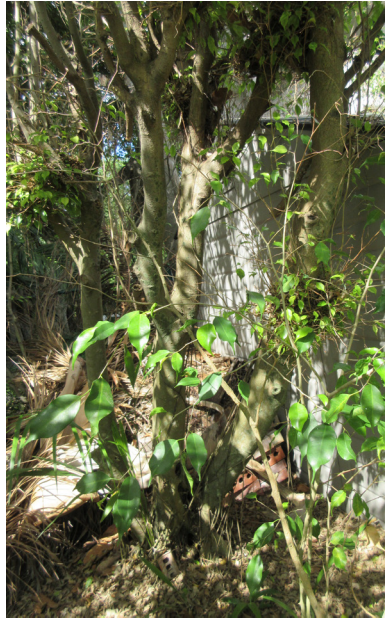
## Tree #75

Tree #75 is a Weeping Fig located on the western side of the property. It is multi-trunked and in fair condition. The canopy has been shaped and there is thrips damage to the foliage.

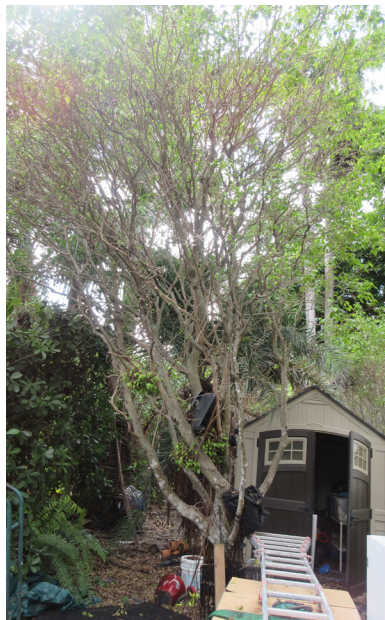
## Tree #76

Tree #76 is a Weeping Fig located on the western side of the property. It is multi-trunked and in fair condition. The canopy is thin and there is thrips damage to the foliage.

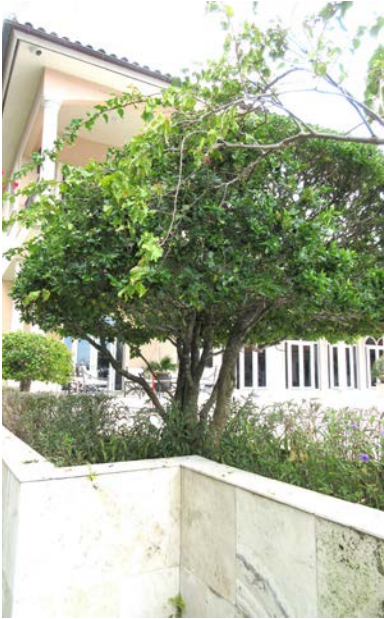
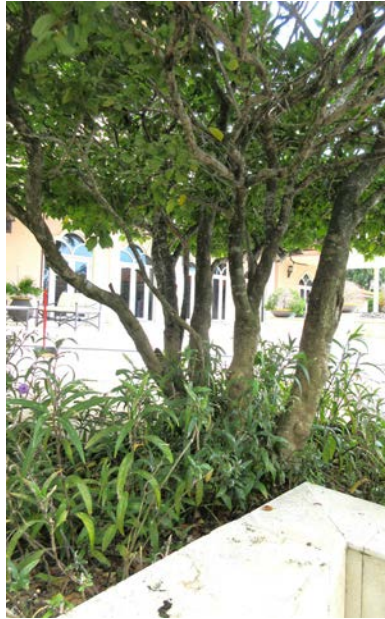
## Tree #77

Tree #77 is a Japanese Privet located in a raised planter in the backyard. It is multi-trunked and in fair condition. The canopy has been shaped.
