RE: **Request for After-the-Fact Certificate of Appropriateness for Demolition** - Letter of Intent for After-the-fact Certificate of Appropriateness for Demolition regarding 1525 Lenox Avenue, Miami Beach

### STRUCTURAL CONDITION ASSESSMENT 1525 Lenox Ave Miami Beach, Florida

STRUCTURAL CONDITION ASSESSMENT for  
1525 Lenox Ave  
Miami Beach, Florida

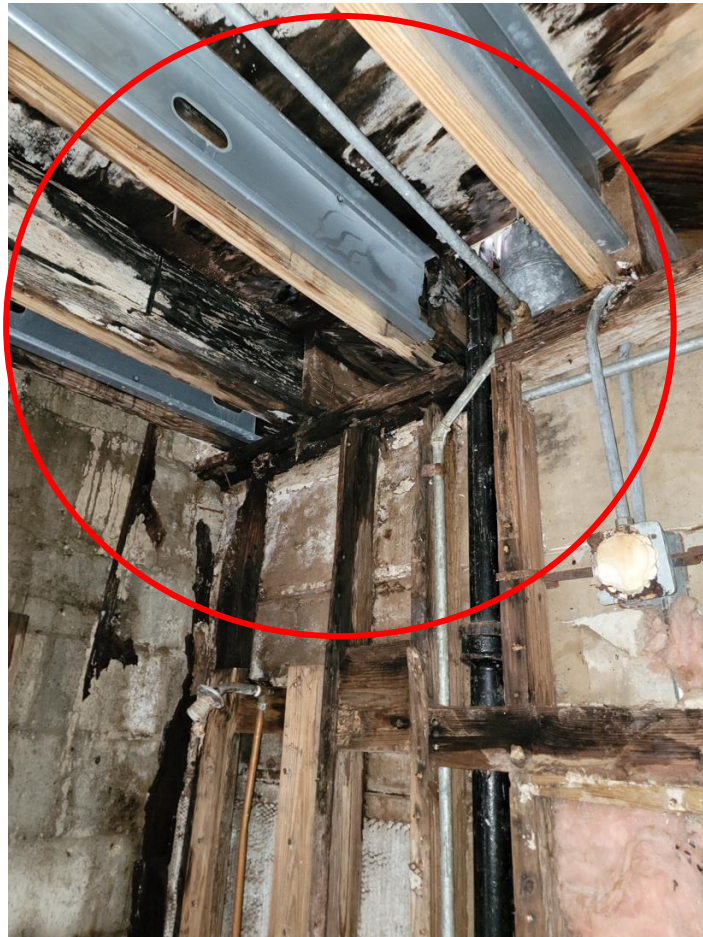
The wood decking and the roof joists are water damaged and deteriorated in several loactions.

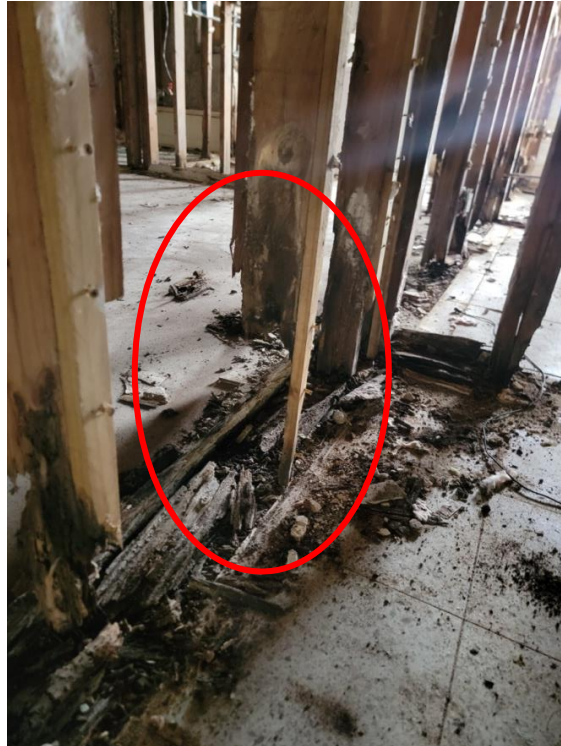
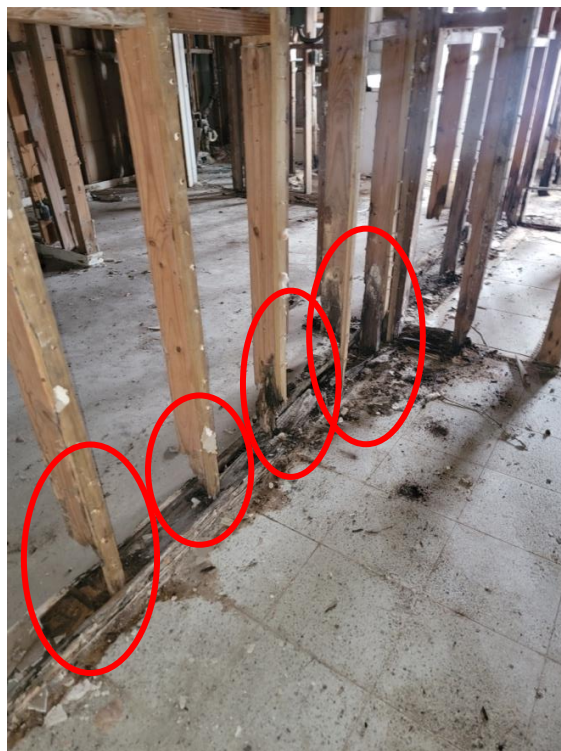
80% of the load bearing wood stud walls have failed 100% with completely deteriorated bottom and lost 100% of its capacity.

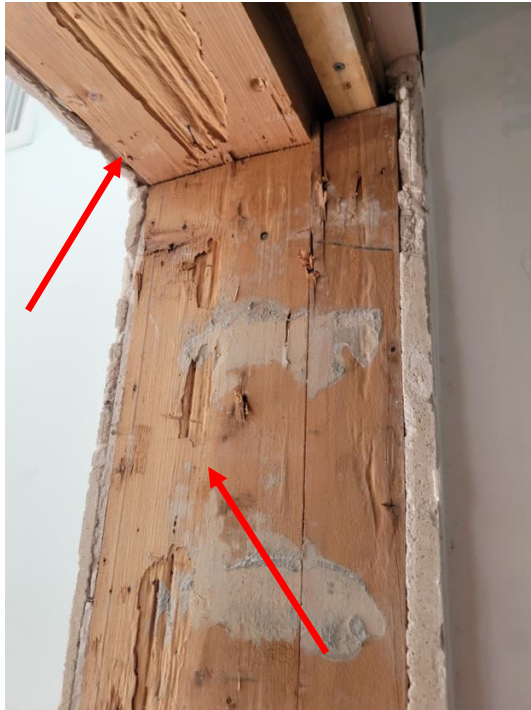
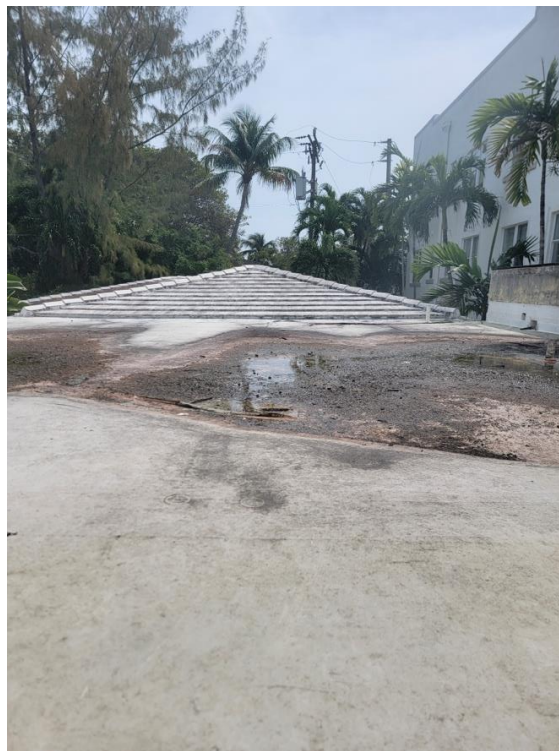
Termite damage is also evident throughout the building, see below

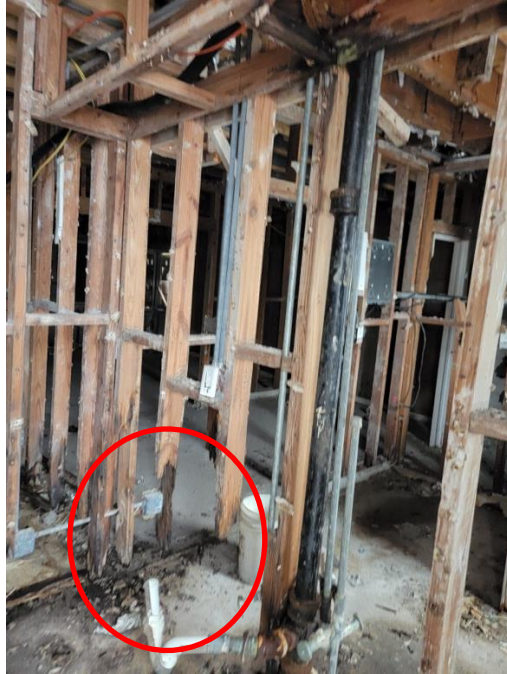
Throughout the building, there is loadbearing wall, stud deterioration, and loss of capacity up to 100%

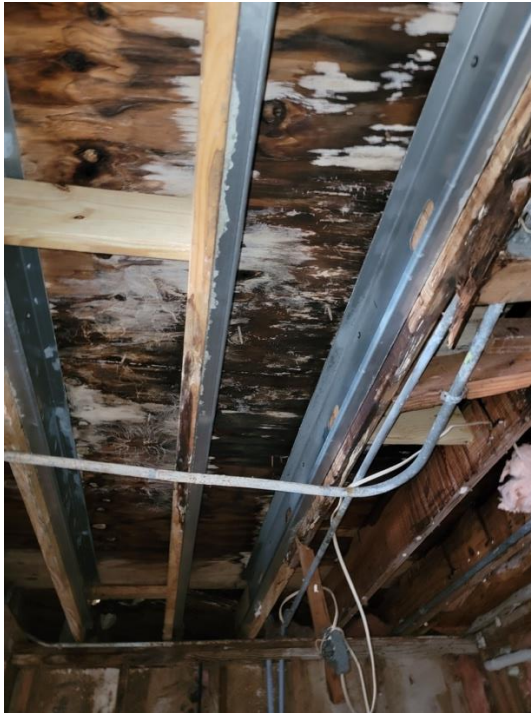
Throughout the building, there is loadbearing wall, stud deterioration, and loss of capacity up to 100%

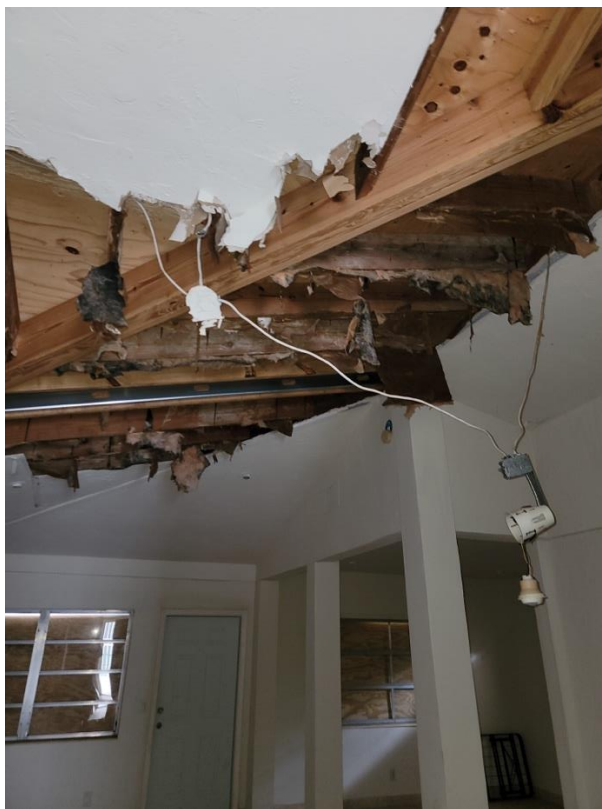
Water intrusion from the roof lead to damage of roof decking, and roof joists

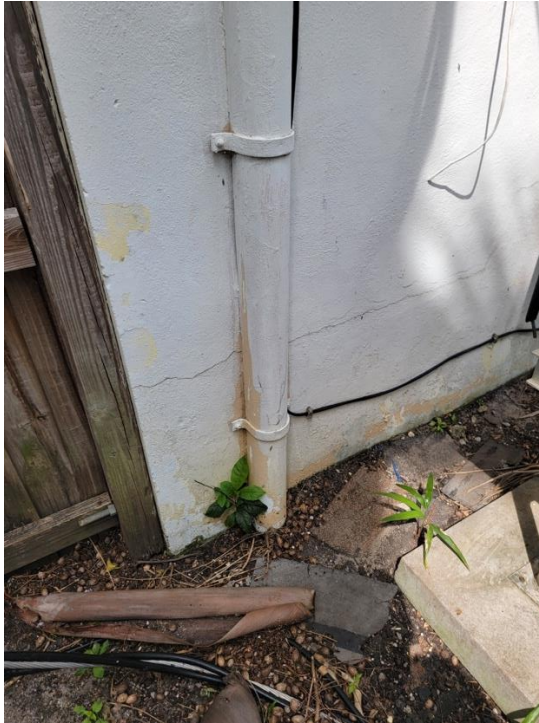
Stucco cracking and spalling

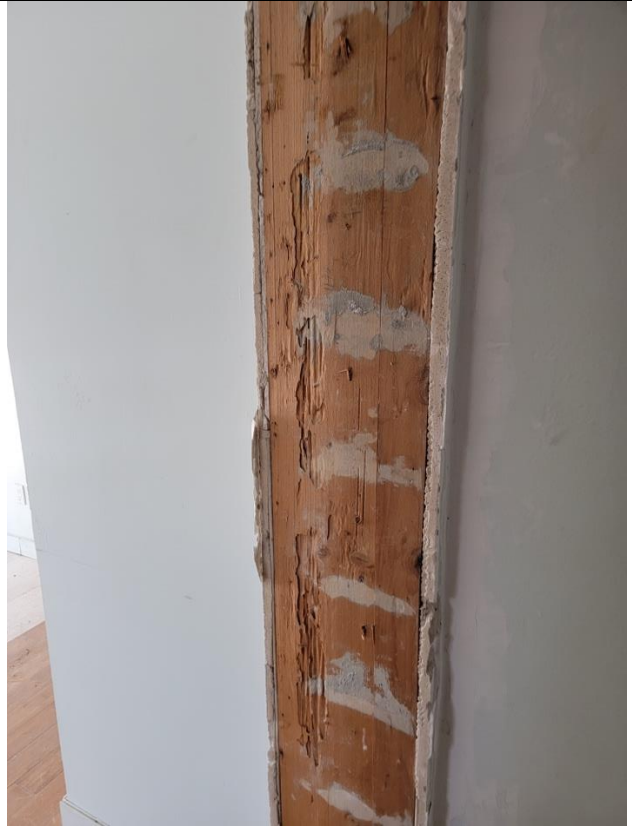
Termite Damage

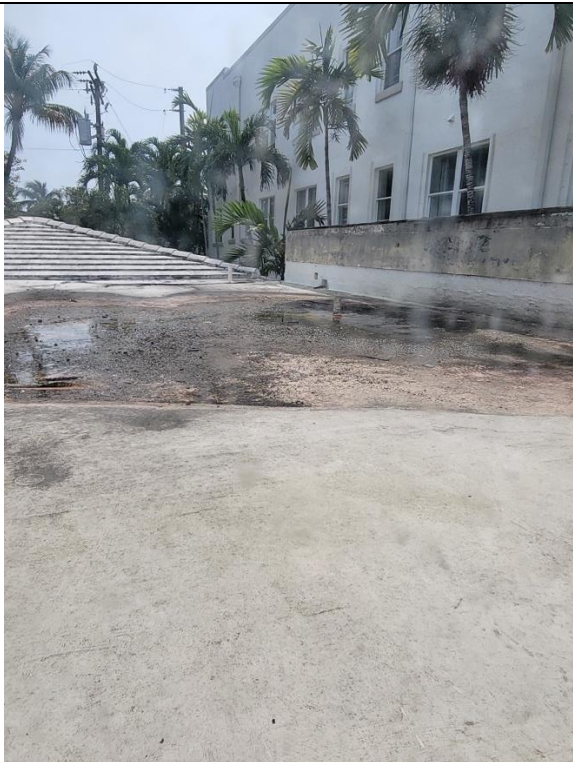
Waterproofing membrane failure

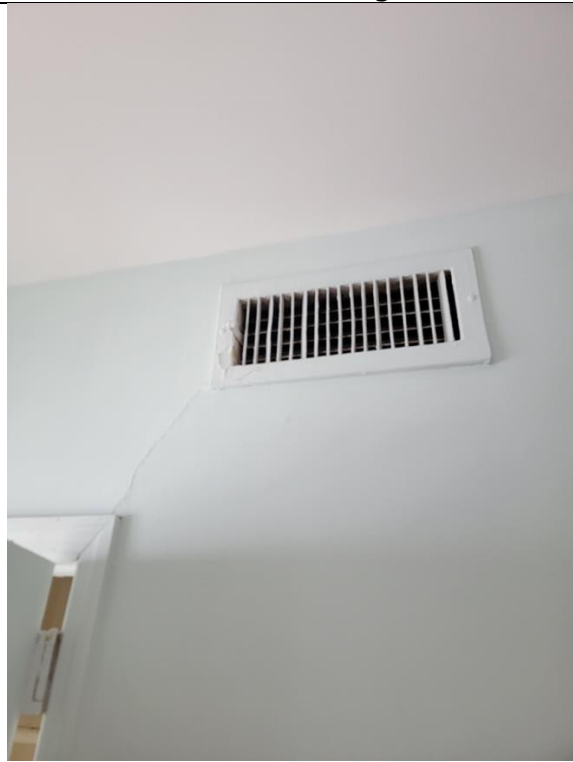
Settlement cracking

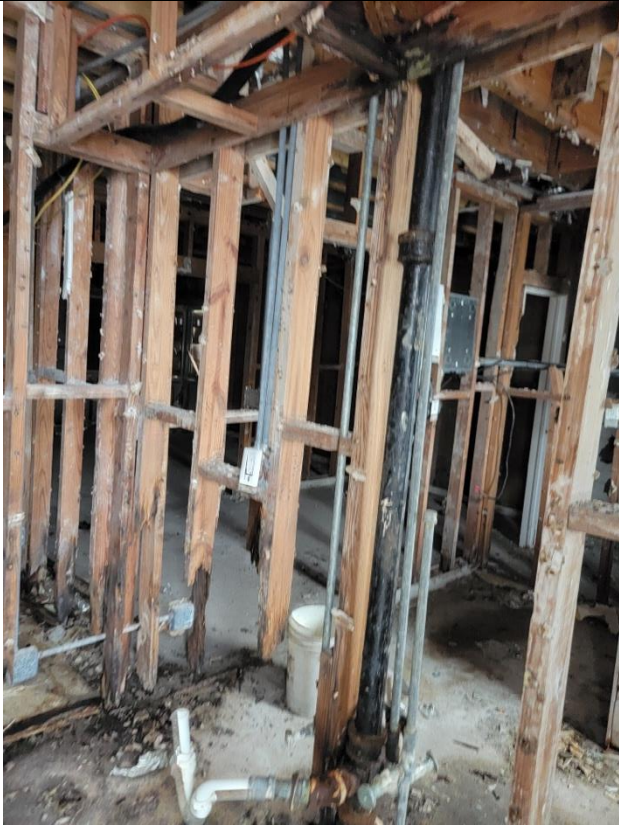
Load bearing stud walls 100% failure

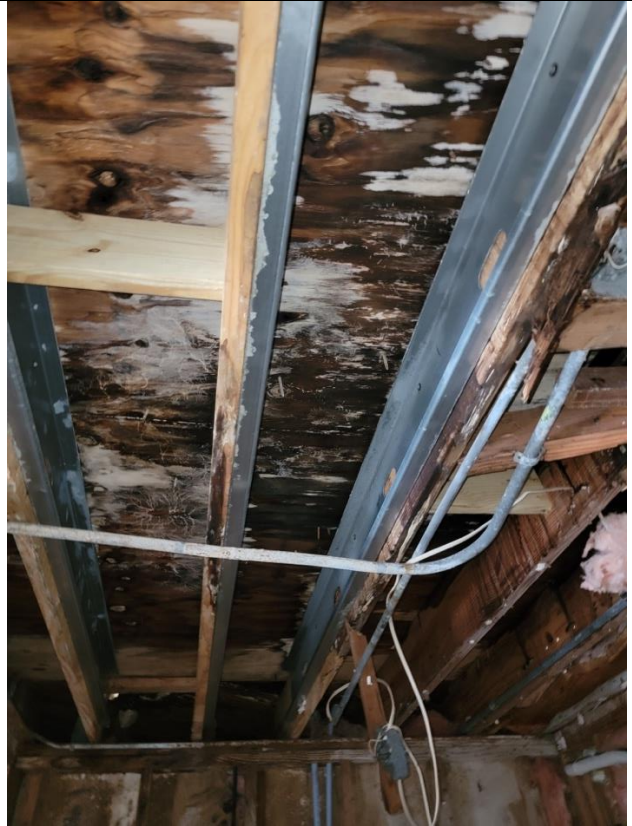
Moisture intrusion damage

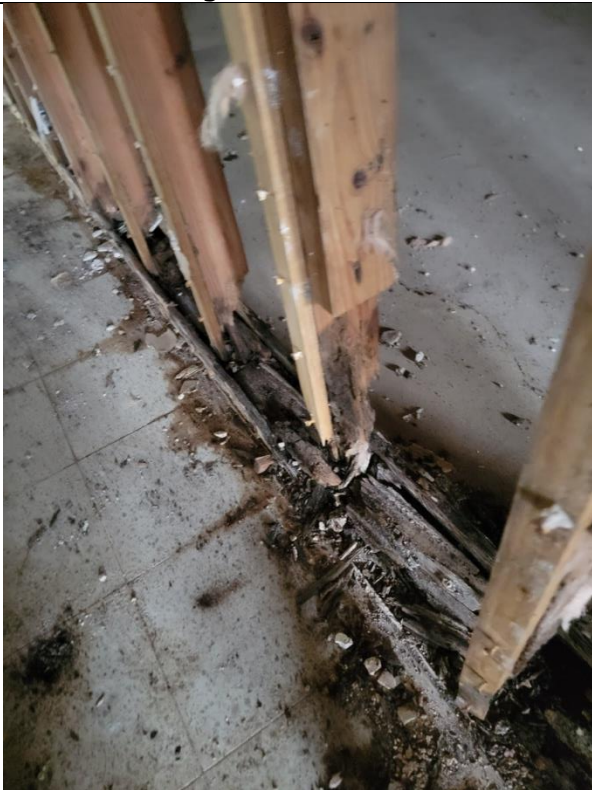
Load bearing stud walls 100% failure

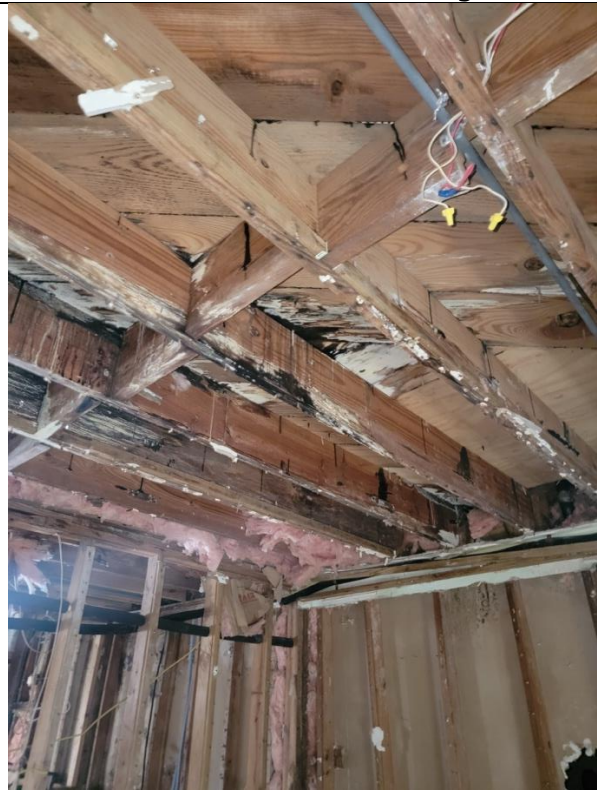
Moisture intrusion damage

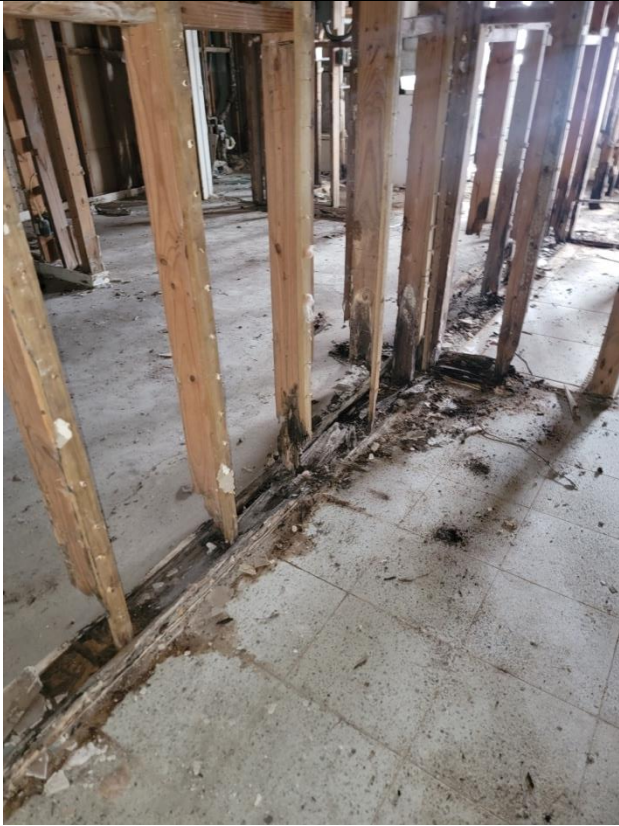
Load bearing stud walls 100% failure

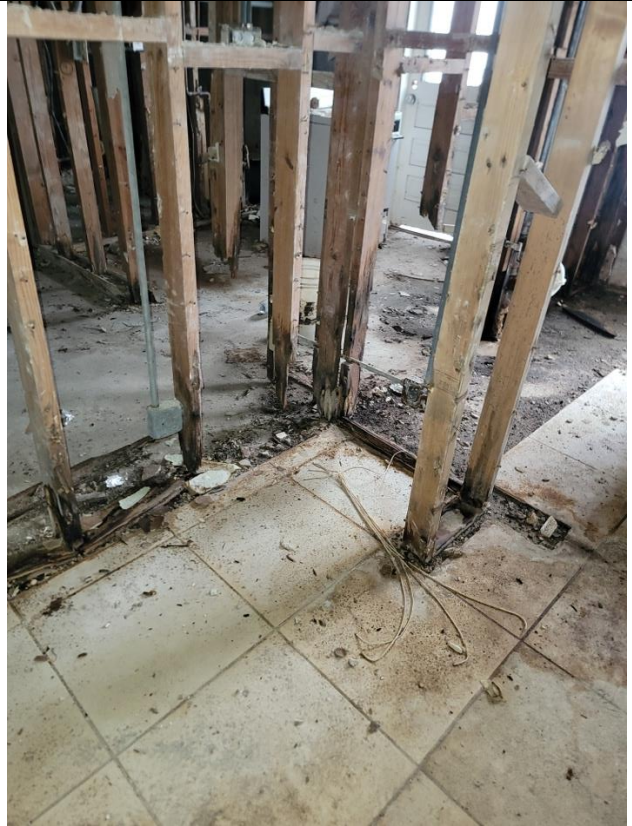
Load bearing stud walls 100% failure

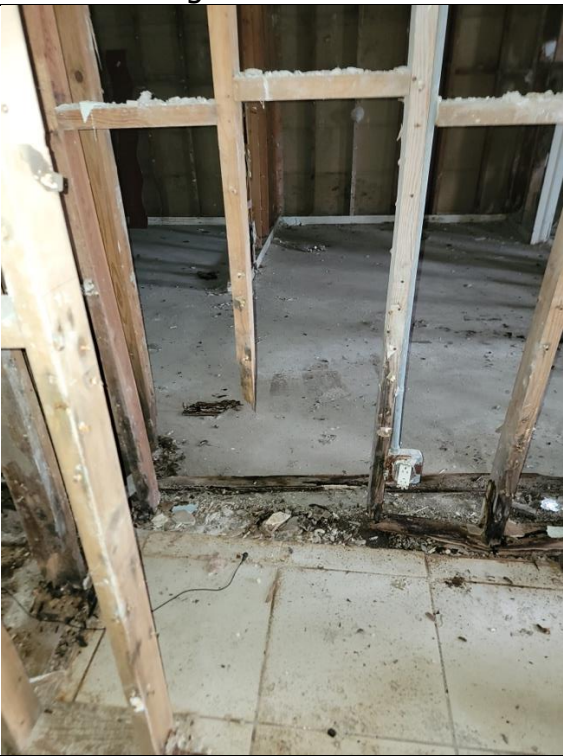
Load bearing stud walls 100% failure

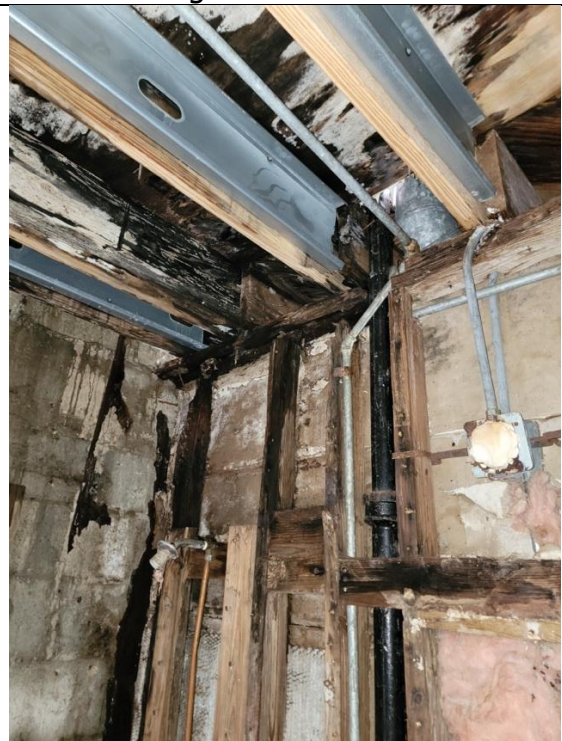
Moisture intrusion damage
