**PATRICK HANNAH,**  
Certified Arborist LLC

February 2, 2023

829 4<sup>th</sup> ST. Arborist Report

Re: 829 4<sup>th</sup> ST. Miami Beach FL, 33139

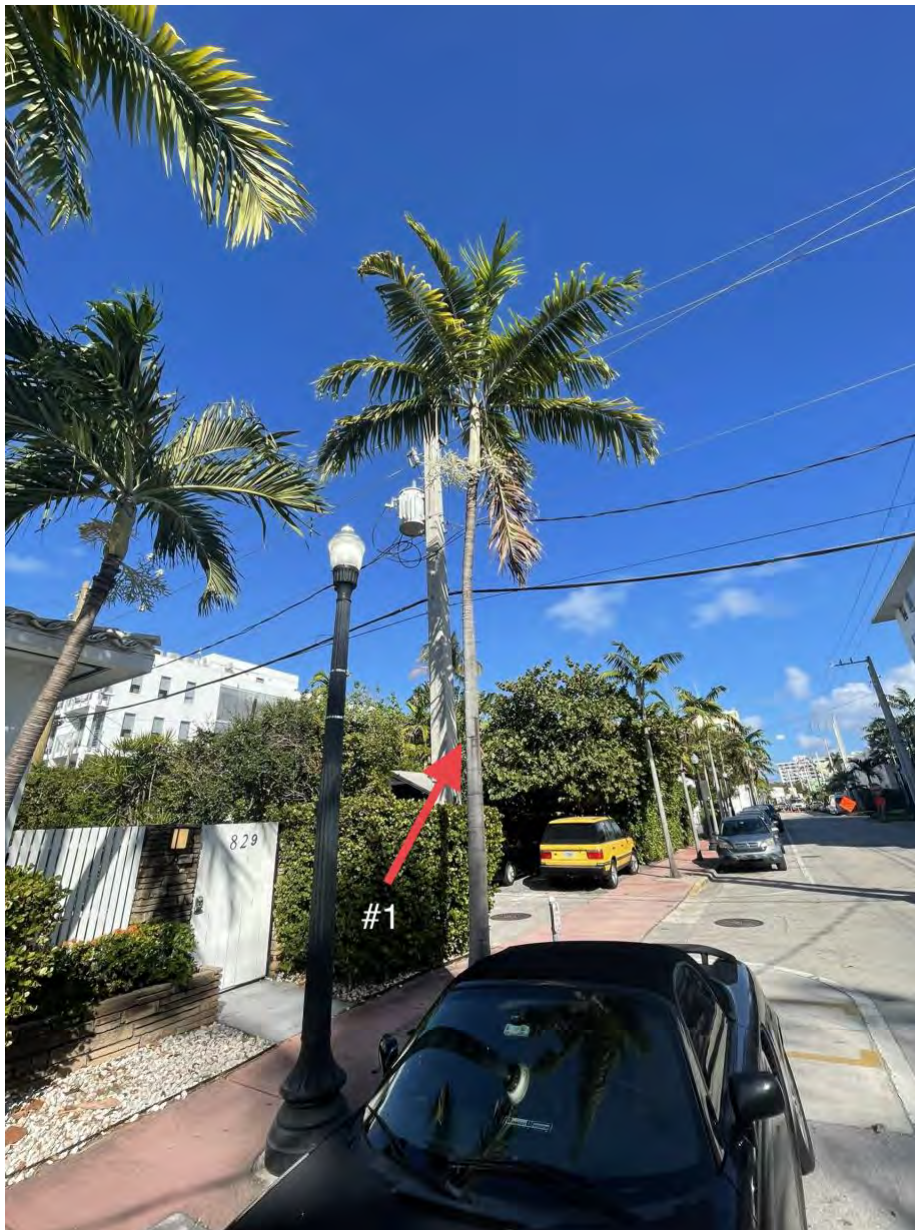
1. *Veitchia montgomeryana* (Montgomery palm tree) DBH 7", Spread 10', Height 22', this trees condition is good . This tree is on the south east corner of property, on ROW. Minimum 4' TPZ shall be installed to protect 4' CRZ of this tree and done under ANSI A-300 guidelines should this tree need protection during construction. This tree is scheduled to remove.

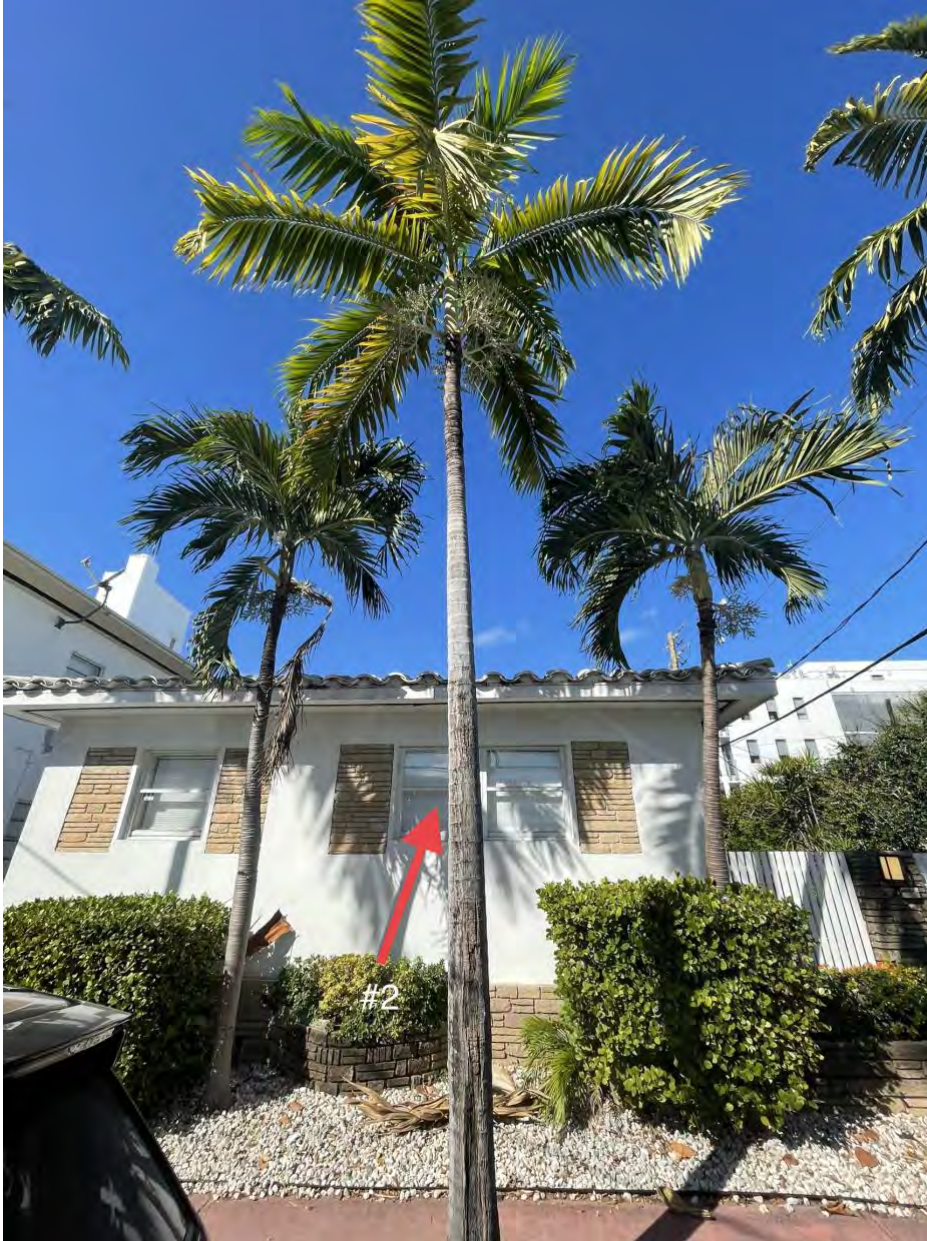
2. *Veitchia montgomeryana* (Montgomery palm tree) DBH 6", Spread 10', Height 21', this tree's condition is moderate. This tree is on the south side of property, on ROW. Minimum 4' TPZ shall be installed to protect 4' CRZ of this tree and done under ANSI A-300 guidelines should this tree need protection during construction. This tree is scheduled to remain.

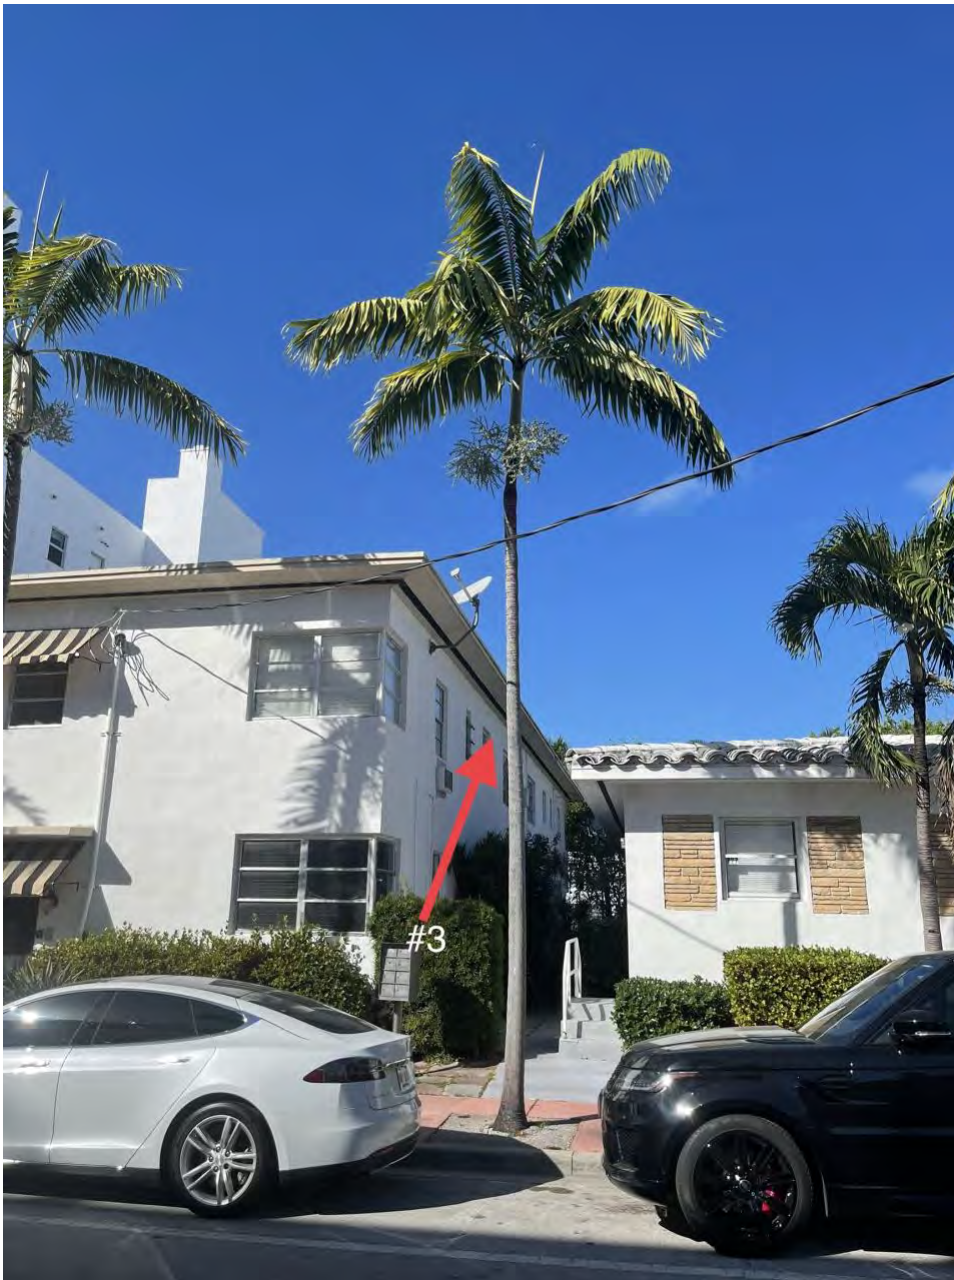
3. *Veitchia montgomeryana* (Montgomery palm tree) DBH 6", Spread 10', Height 23', this tree's condition is fair. This tree is on the south west corner of property, on ROW. Minimum 4' TPZ shall be installed to protect 4' CRZ of this tree and done under ANSI A-300 guidelines should this tree need protection during construction. This tree is scheduled to remain.

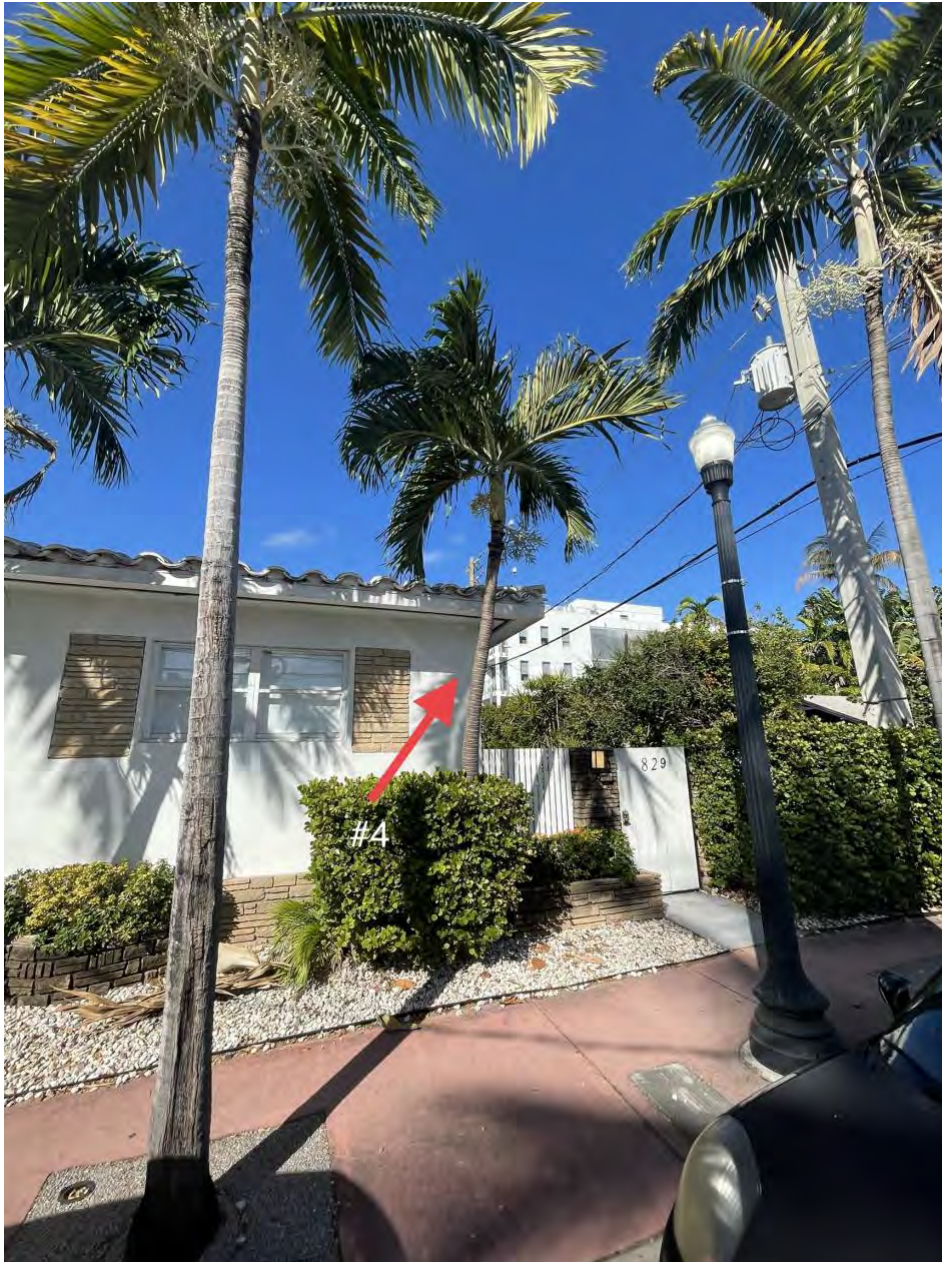
4. *Adonidia merrillii* (Christmas palm tree) DBH 4", Spread 8', Height 15', this tree's condition is fair. This tree is on the south east corner of property. Minimum 4' TPZ shall be installed to protect 4' CRZ of this tree and done under ANSI A-300 guidelines should this tree need protection during construction. This tree is scheduled to remain.

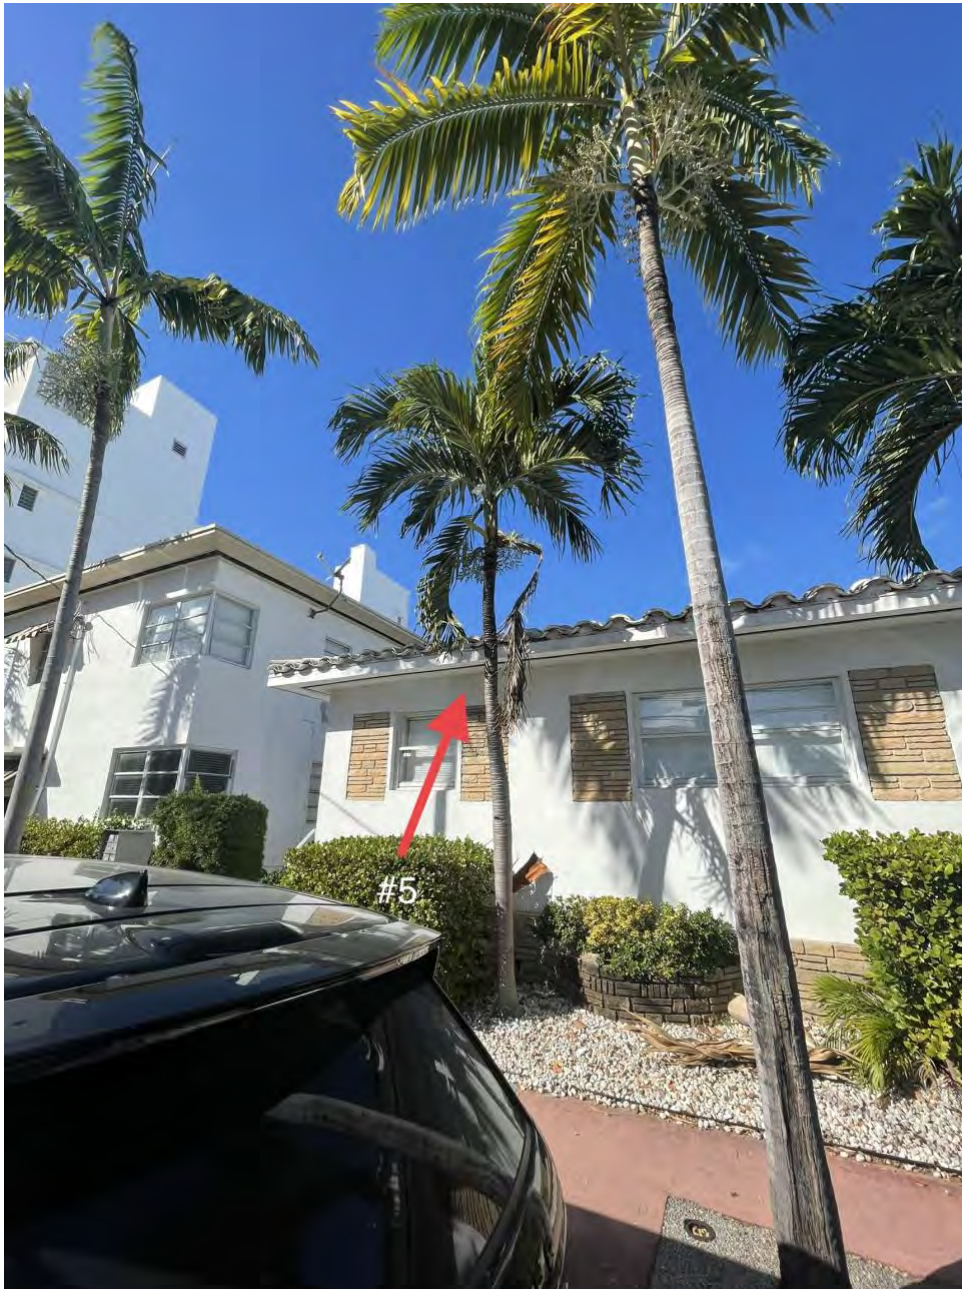
5. *Adonidia merrillii* (Christmas palm tree) DBH 4", Spread 8', Height 15', this tree's condition is fair. This tree is on the south side of property. Minimum 4' TPZ shall be installed to protect 4' CRZ of this tree and done under ANSI A-300 guidelines should this tree need protection during construction. This tree is scheduled to remain.

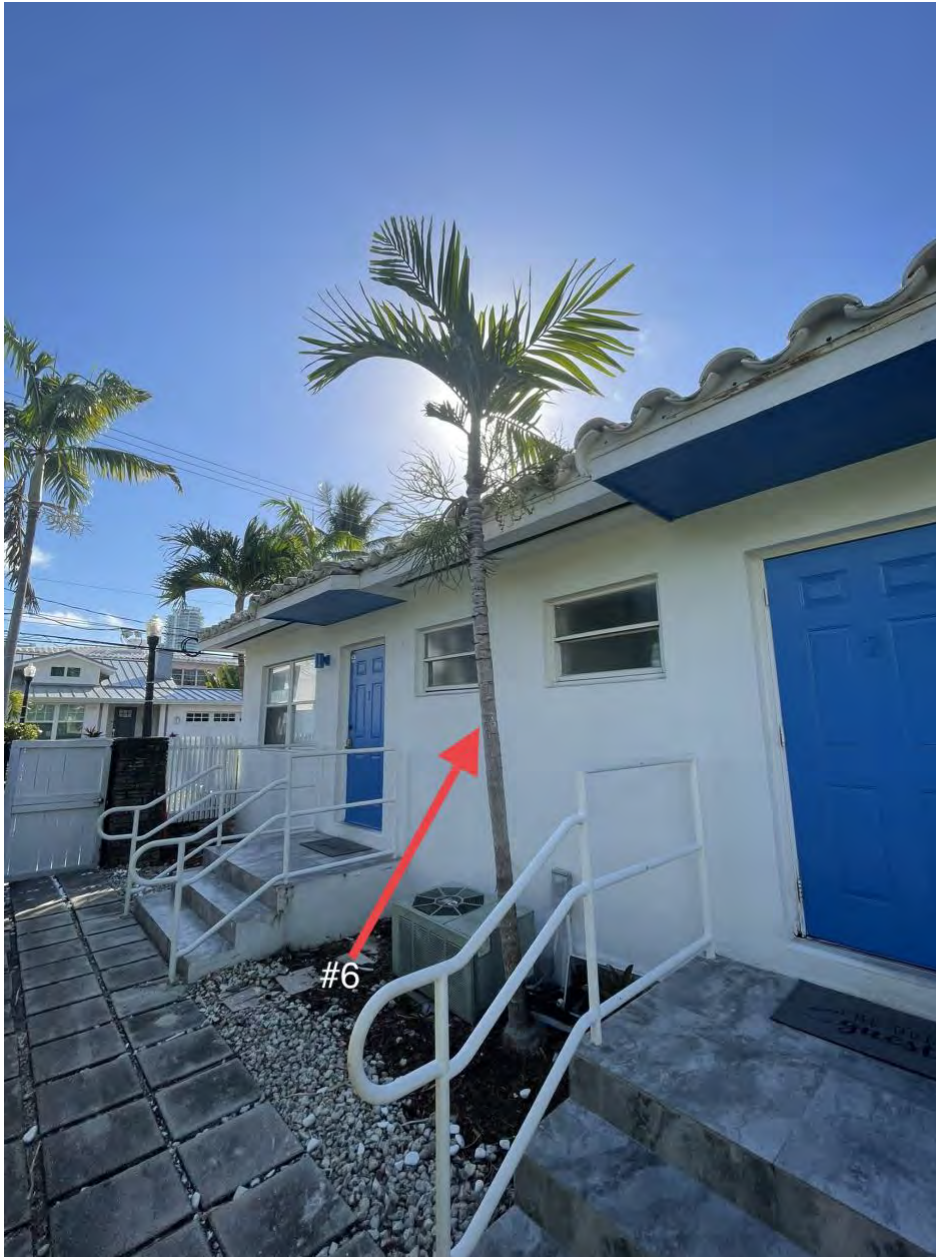
6. *Ptychosperma elegans* (Solitaire palm tree) DBH 3", Spread 6', Height 14', this tree's condition is fair. This tree is on the east side of property. Minimum 4' TPZ shall be installed to protect 4' CRZ of this tree and done under ANSI A-300 guidelines should this tree need protection during construction. This tree is scheduled to remove.

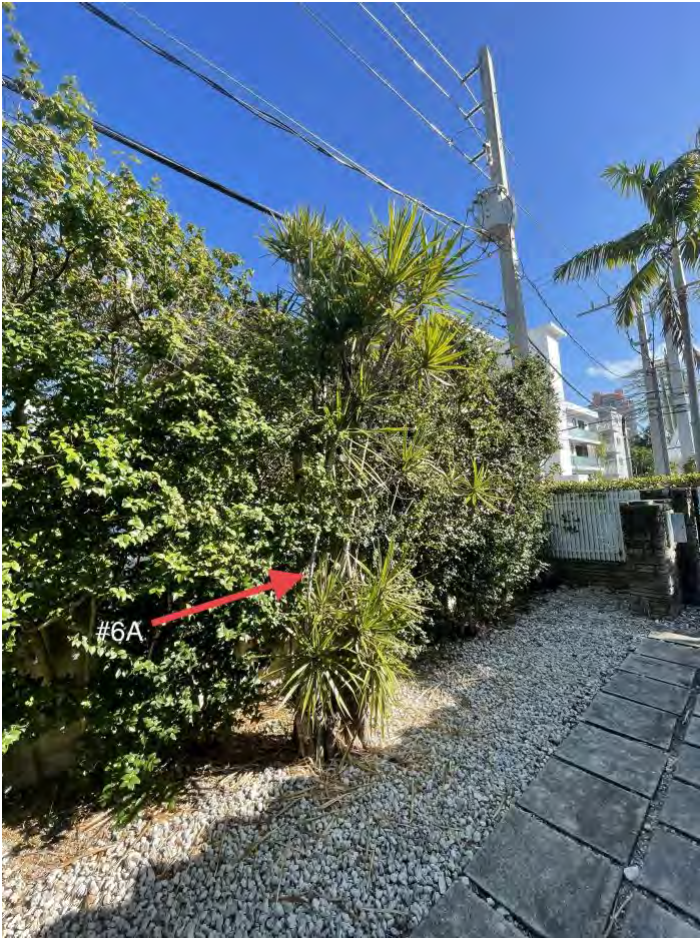
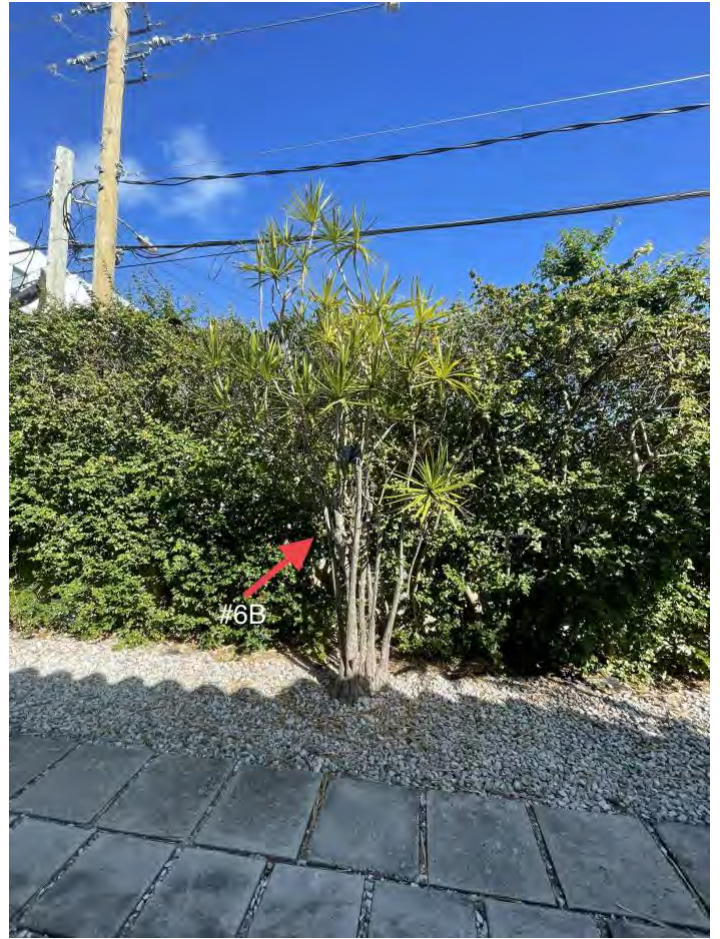
6A,B. *Dracaena marginata* (Dragon tree) DBH 6" ea., Spread 6'-7' ea., Height 10'-12' ea., these trees conditions are moderate. These trees are on the east side of property. Minimum 4' TPZ ea. shall be installed to protect 4' CRZ's of these trees and done under ANSI A-300 guidelines should these trees need protection during construction. These trees are scheduled to remove.

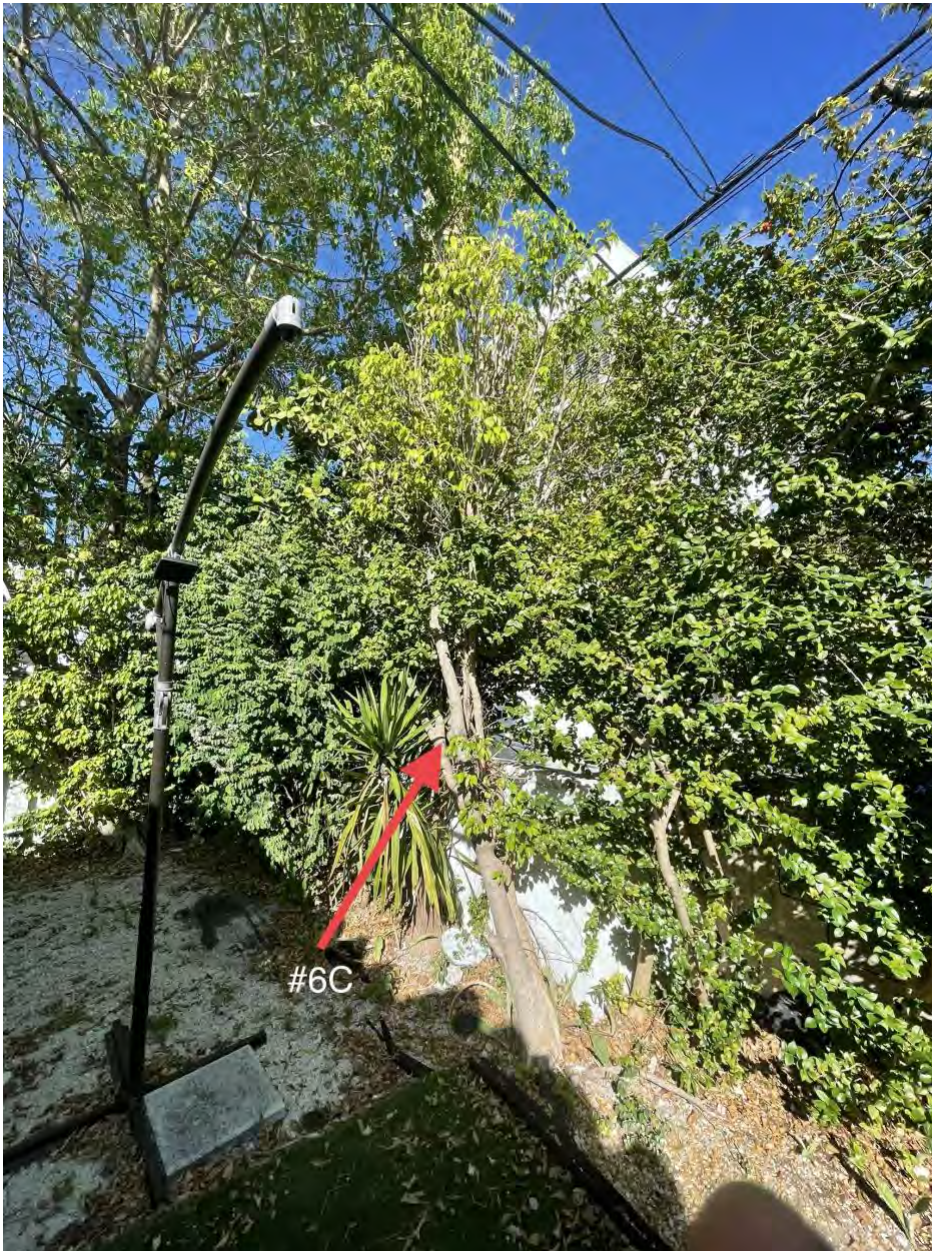
6C. *Ficus benjamina* (Weeping Fig tree) DBH 4", Spread 7', Height 13', this tree's condition is poor. This tree is on the east side of property. Minimum 6' TPZ shall be installed to protect 6' CRZ of this tree and done under ANSI A-300 guidelines should this tree need protection during construction. This tree is scheduled to remove.

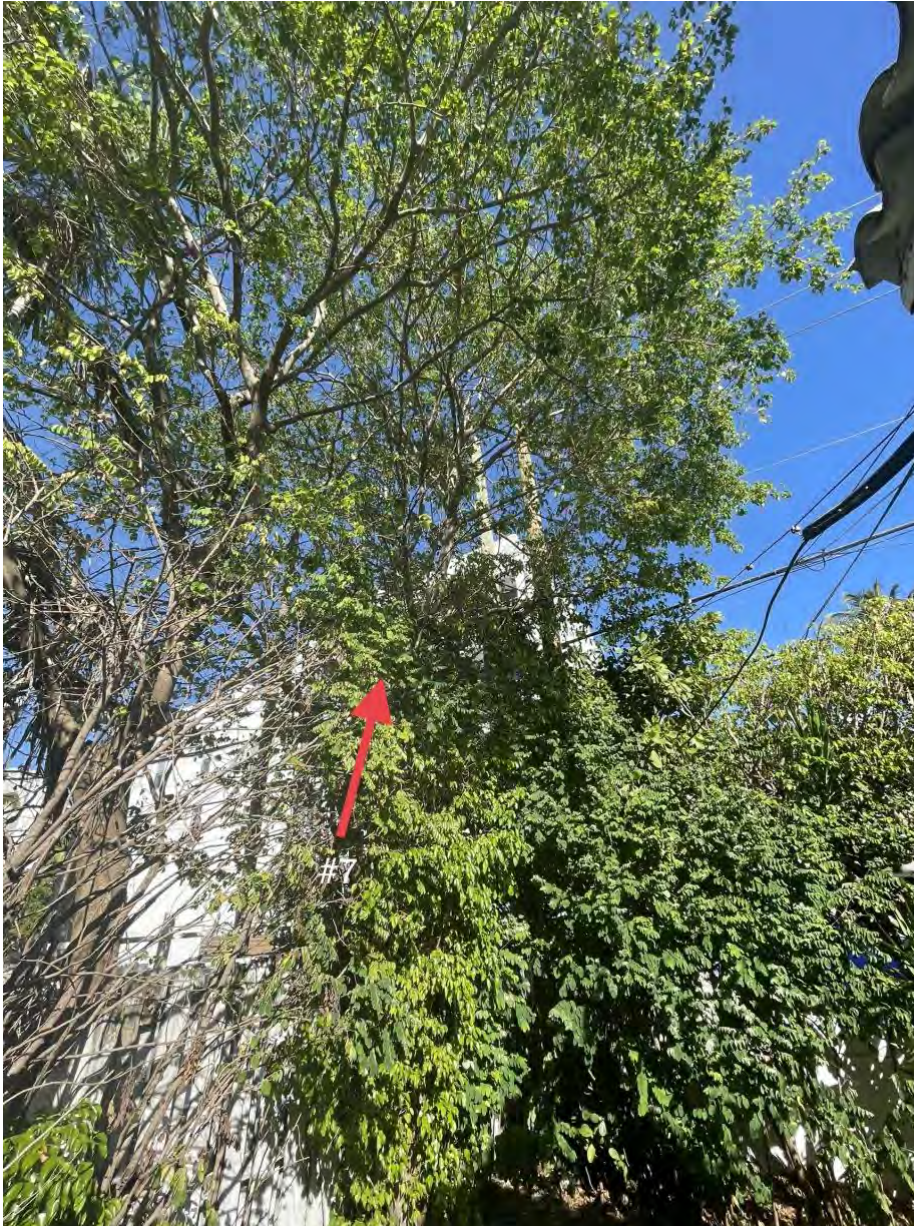
7. *Ficus benjamina* (Weeping Fig tree) DBH 9", Spread 20', Height 20', this tree's condition is poor. This tree is on the north east corner of property. Minimum 9' TPZ shall be installed to protect 9' CRZ of this tree and done under ANSI A-300 guidelines should this tree need protection during construction. This tree is scheduled to be removed.

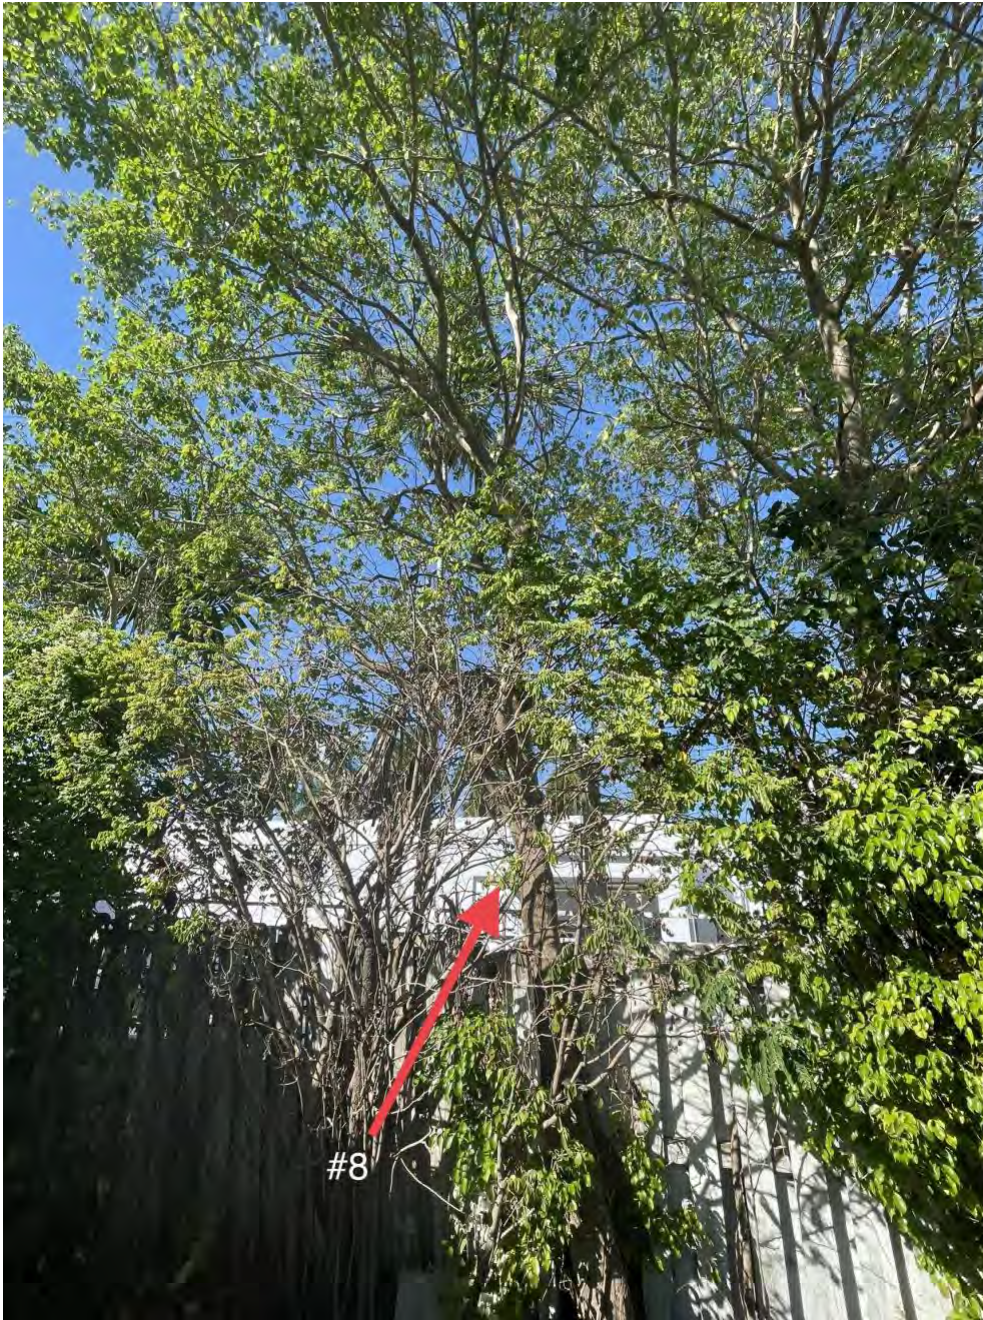
8. Ficus benjamina (Weeping Fig tree) DBH 6", Spread 20', Height 20', this trees condition is moderate. This tree is on the north side of property. Minimum 6' TPZ shall be installed to protect 6' CRZ of this tree and done under ANSI A-300 guidelines should this tree need protection during construction. This tree is scheduled to remove.

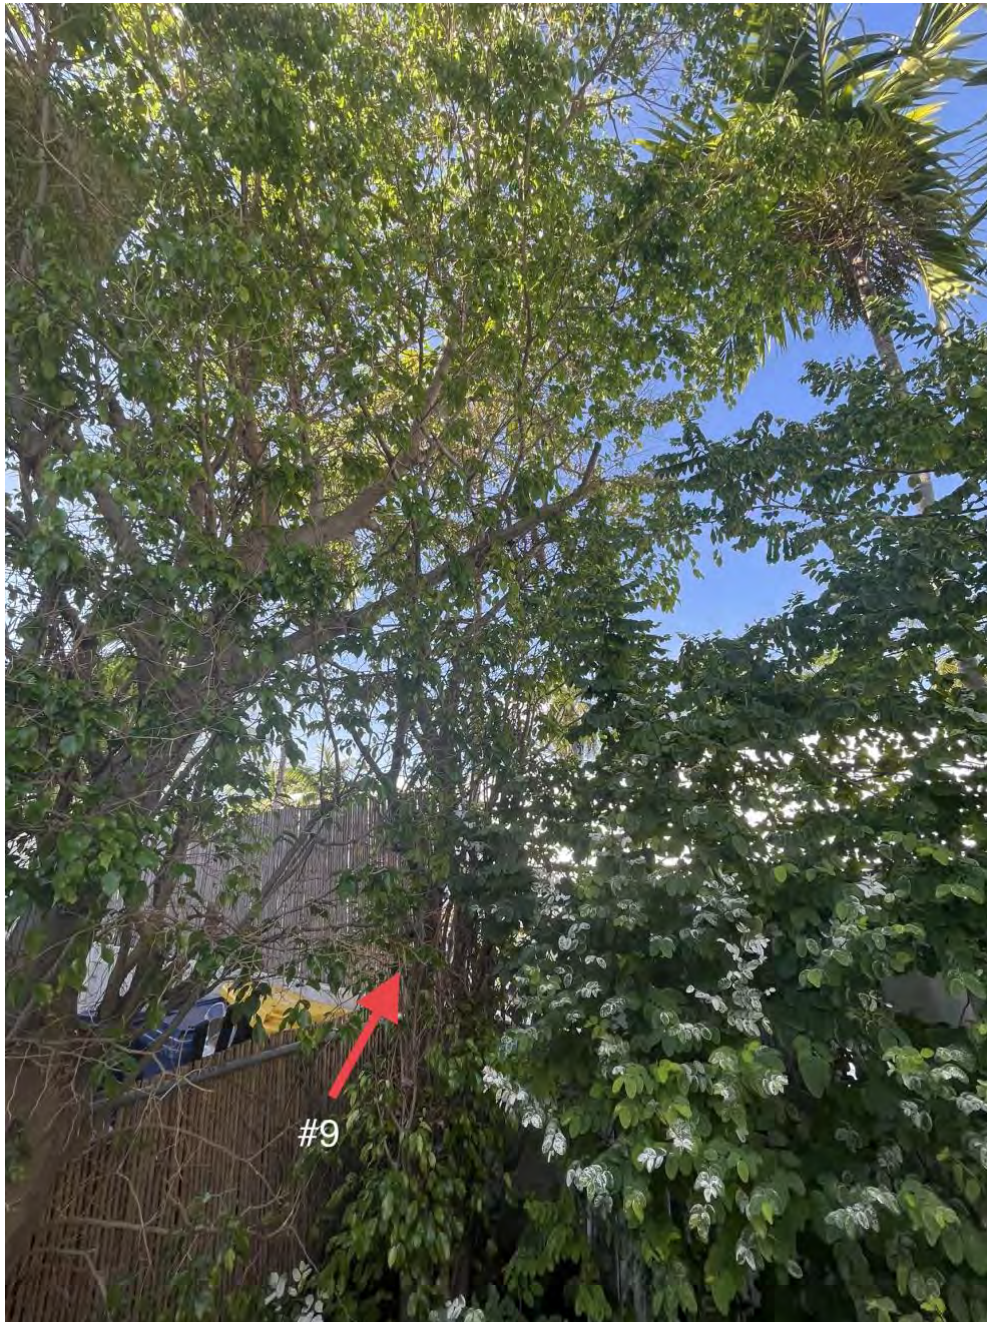
9. *Ficus benjamina* (Weeping Fig tree) DBH 6", Spread 15', Height 20', this tree's condition is moderate. This tree is on the north west corner of property. Minimum 6' TPZ shall be installed to protect 6' CRZ of this tree and done under ANSI A-300 guidelines should this tree need protection during construction. This tree is scheduled to be removed.

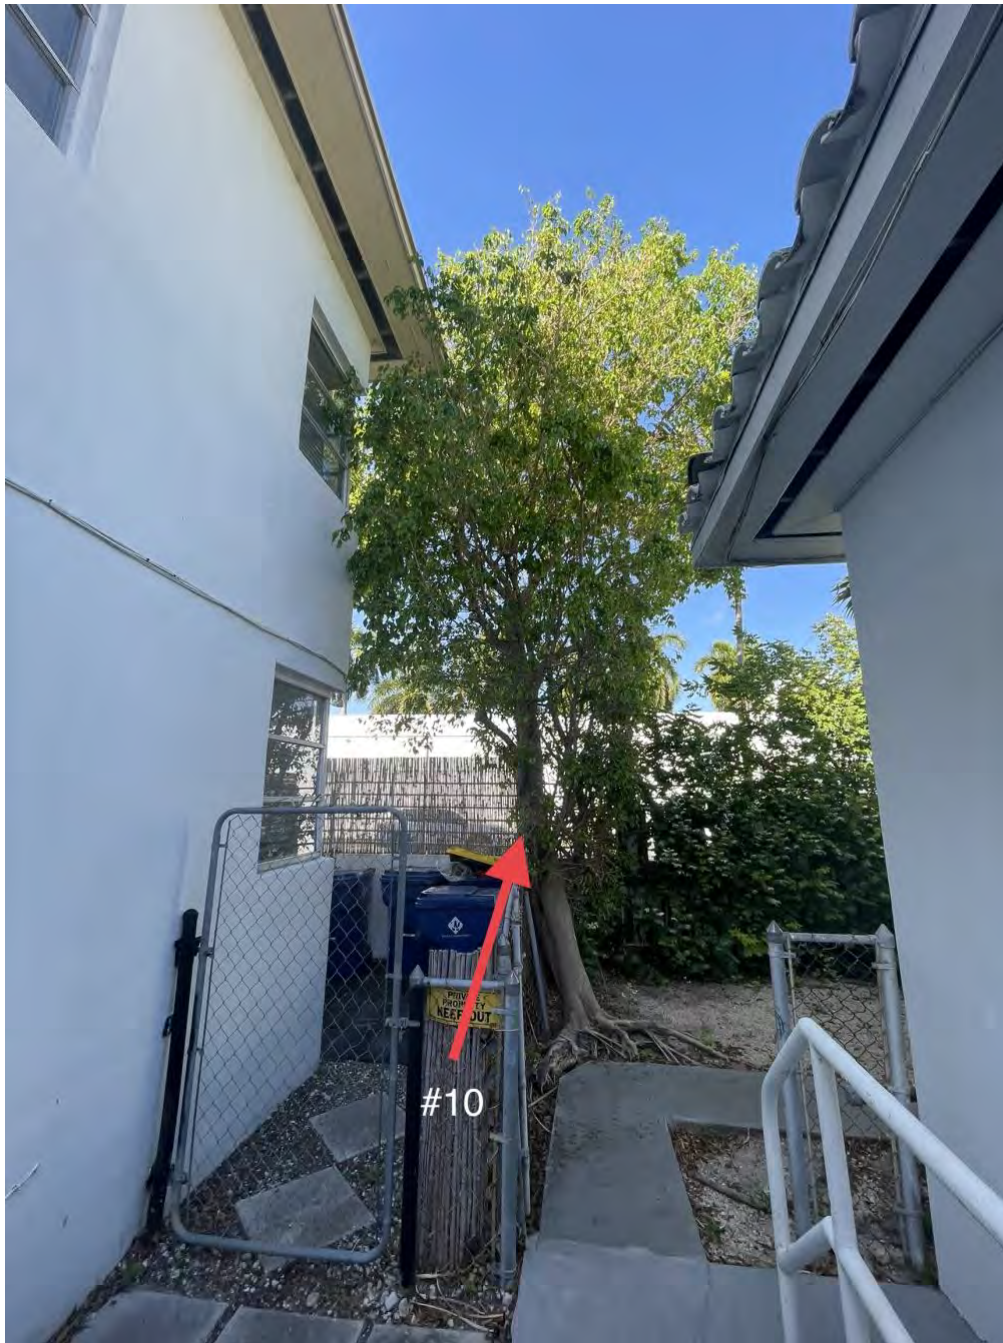
10. Ficus benjamina (Weeping Fig tree) DBH 11", Spread 15', Height 20', this trees condition is very poor. This tree is on the north west corner of property. Minimum 11' TPZ shall be installed to protect 11' CRZ of this tree and done under ANSI A-300 guidelines should this tree need protection during construction. This tree is scheduled to remove.
