*EVALUATION REPORT*

*For Project located at: 7801 ATLANTIC WAY. MIAMI BEACH, FLORIDA. 33141*

I, Alioskar Ganem, PE for the state of Florida, license : 74745, was contracted to prepare an evaluation report of the current conditions of the building located at 7801 Atlantic Way, Miami Beach FL 3314. The report will consist of two major components, First component will address FEMA evaluation and the existing home conditions as it pertains to the 100 year flood guidelines. Second component will address the structural integrity of the building based on site visit and studies conducted. The intent of this report is to assess if the conditions of the current home allow for building remodeling.

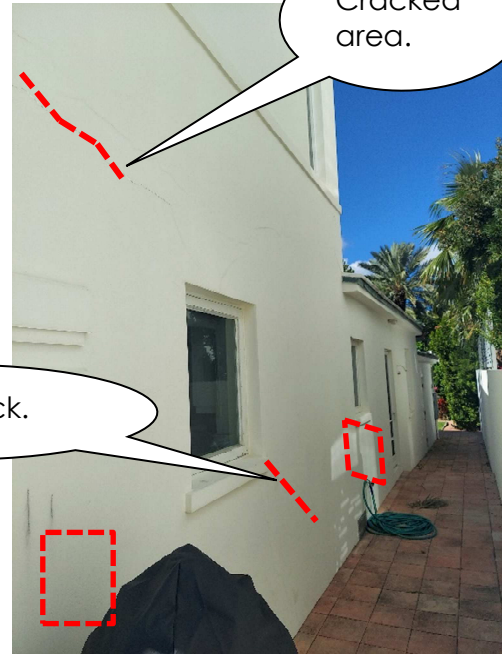
Cracked area.

Hairline crack.
