**GANEM CONSULTING ENGINEERING**

*EVALUATION REPORT*

*For Project located at: 7801 ATLANTIC WAY. MIAMI BEACH, FLORIDA. 33141*

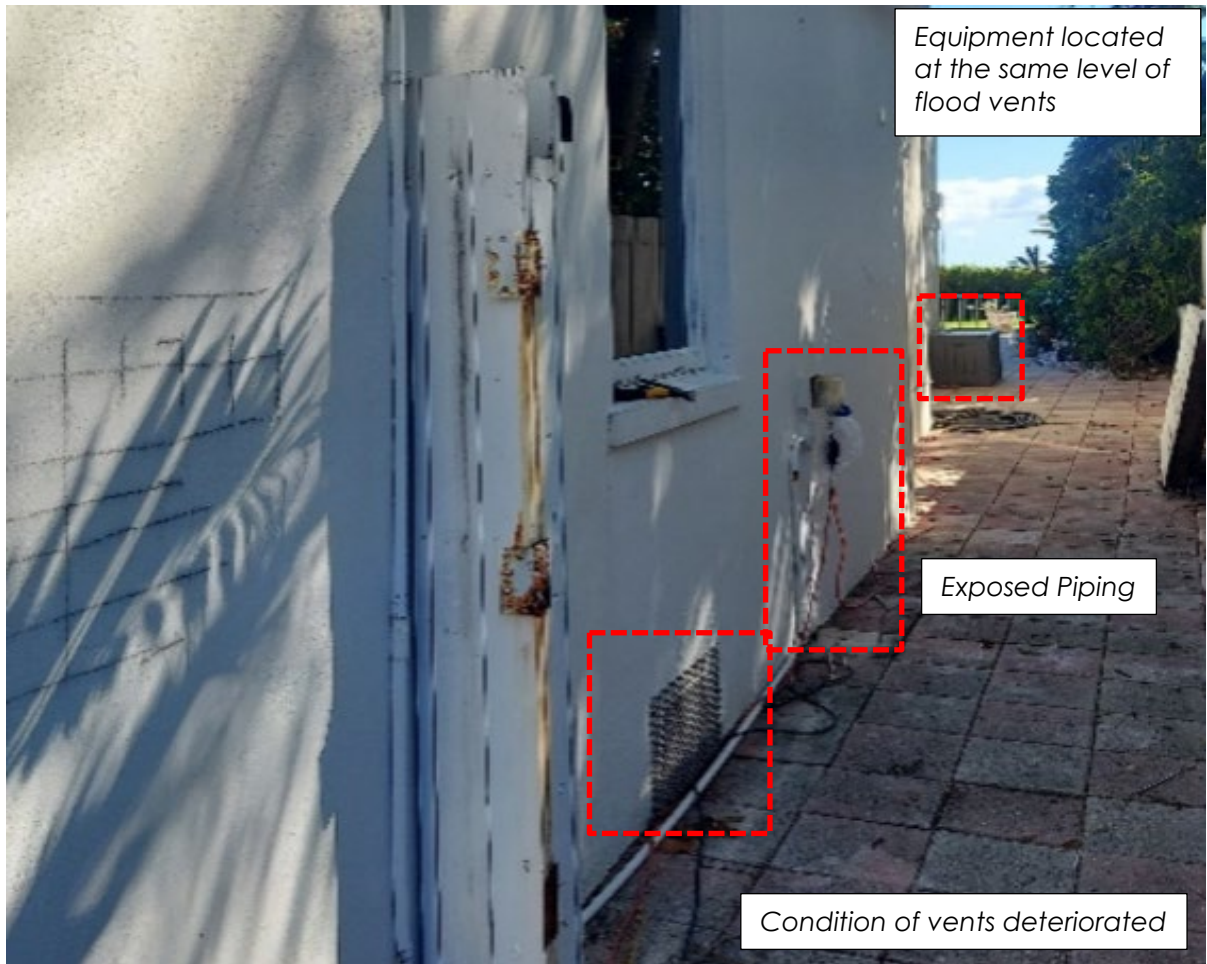
**Figure 1.**

*The current design incorporates flood vents below the recommended 18.2' level and below the slab, which is problematic. Flood vents are openings intended to enable the free flow of water during a flood, reducing the pressure on a building's walls and minimizing structural damage. However, since the habitable space of the building was constructed below the current recommended level, the absence of breakaway walls and the use of flood vents will result in damage to the masonry walls from the wave crest. Electrical equipment and piping below the recommended 18.2' create a hazardous environment, such equipment per code should always be designed above the flood elevation. It is the architect and engineer's responsibility to ensure the safety of occupants, and in this case, demolishing the structure should be considered as an option to provide a safer environment.*

*Figure 1, below, shows the dangerous existing infrastructure. The existing flood vents are in poor condition and are not considered resilient for the preservation of the home in the event of a major storm or flood. Figure 1 also shows the improper location of a/c equipment and the exposed piping from the slab.*

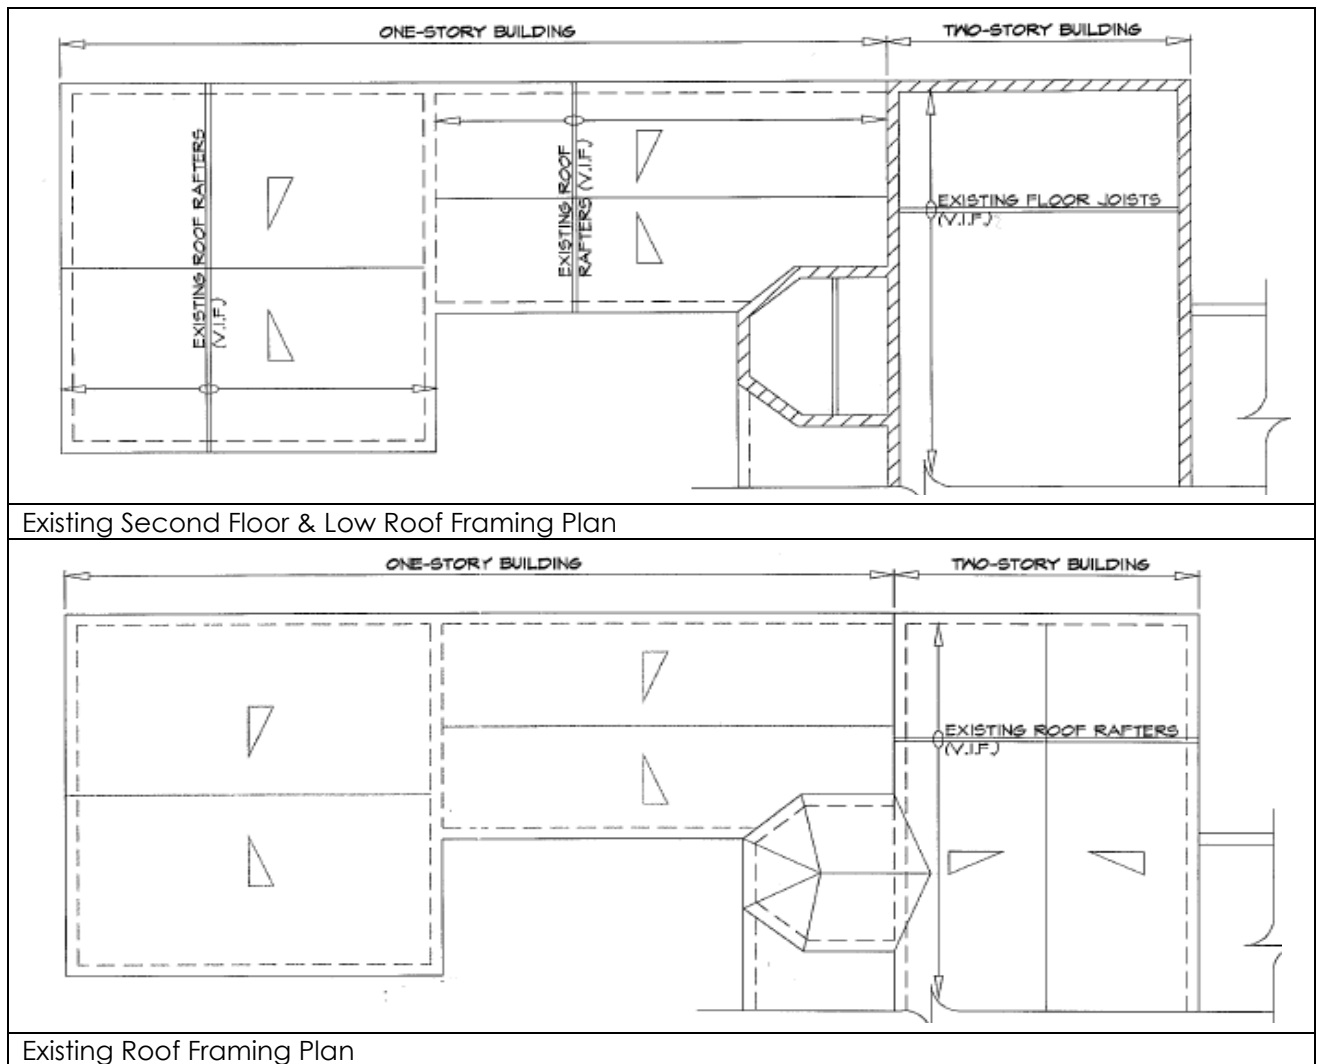
Figure 2.

The existing building consists of a two-story residential home. The existing Structural System is composed of masonry walls, with concrete beams and columns acting as load-bearing elements in the open areas and critical structural zones. See Figure 2 below. The load-bearing diaphragm of the second level consists of joists and roof rafters as part of the composition of the structural system of the home.

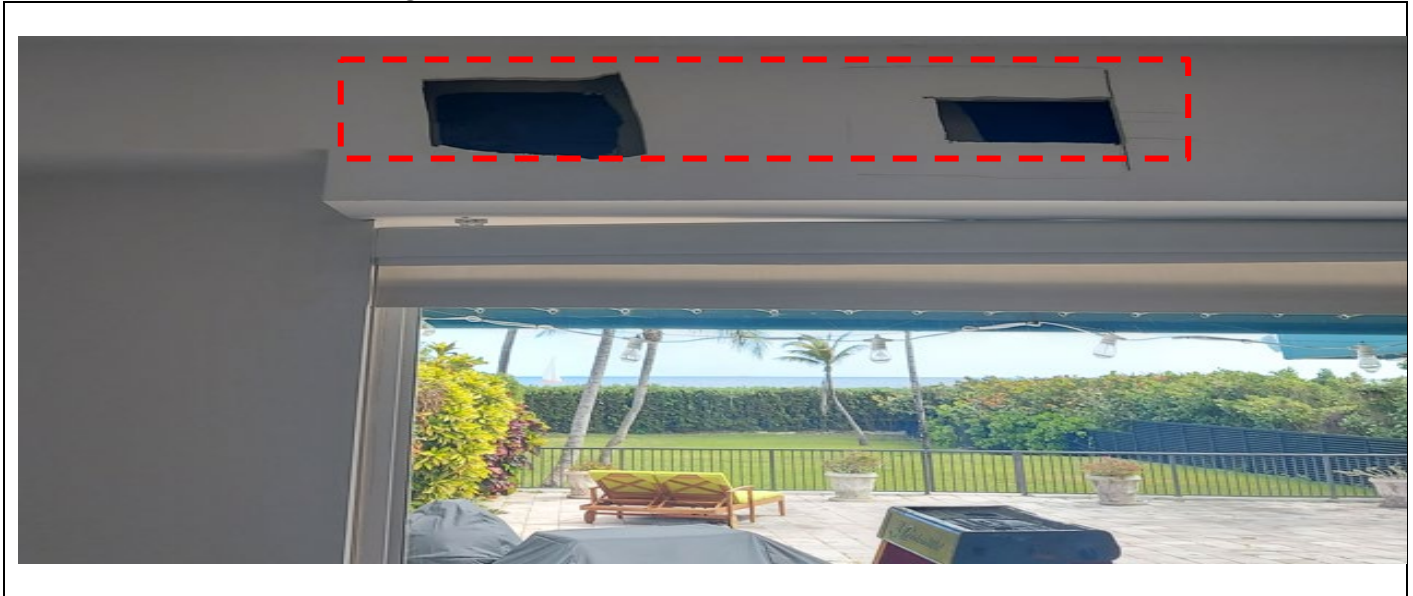
**Figure 3.** Cracking of the concrete in Main beam due to sulphation of the concrete and oxidation of the reinforcing steel

As a result of the visual inspection, cracks were observed in bearing elements of reinforced concrete. See Figure 3 below. This is produced as a consequence of the increase in volume of the reinforcing steel produced by an oxidation state. Sulfates attack concrete, forming expansive compounds that cause cracking. Chlorides, if they reach the rebars, cause its corrosion. The cracking caused by sulfates facilitates the penetration of chlorides and the corrosion of the reinforcement. Once the concrete cracks, the integrity and design capacity of the structural element are not guaranteed.

Cracking of the concrete in Main beam due to sulphation of the concrete and oxidation of the reinforcing steel

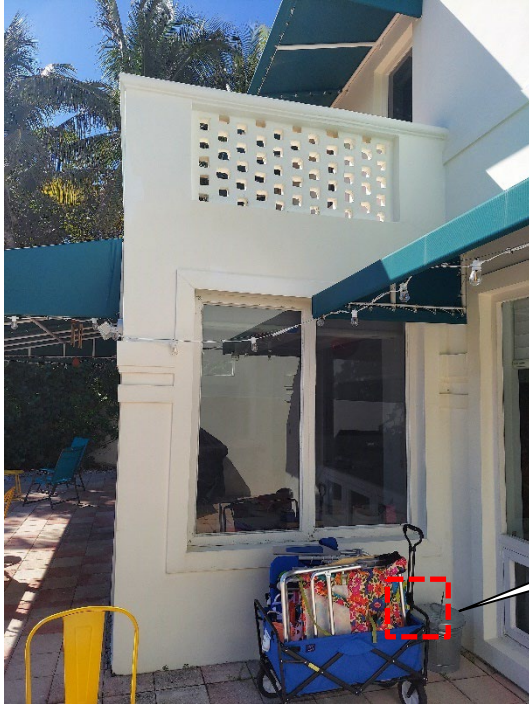
East side

Stucco in poor condition

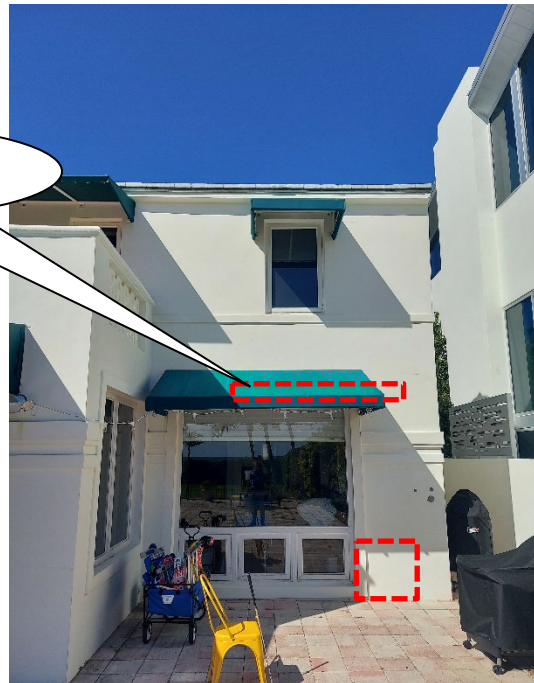
East side

Cracked beam.

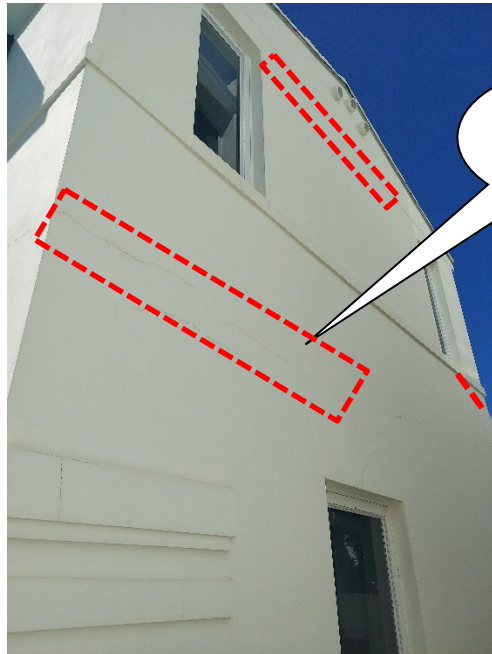
Cracked area.

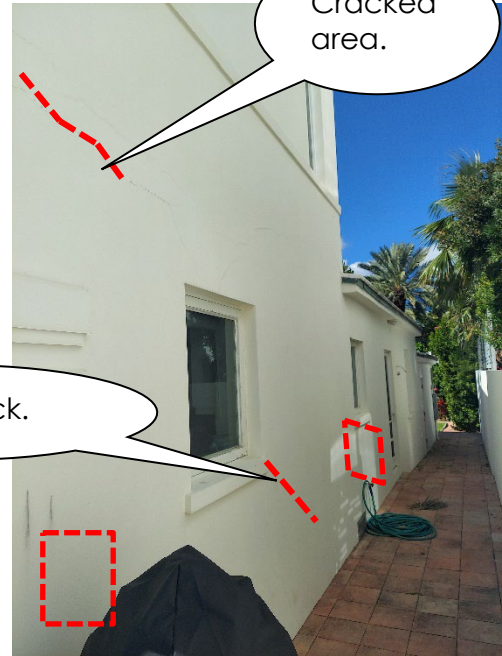
Cracked area.

Hairline crack.

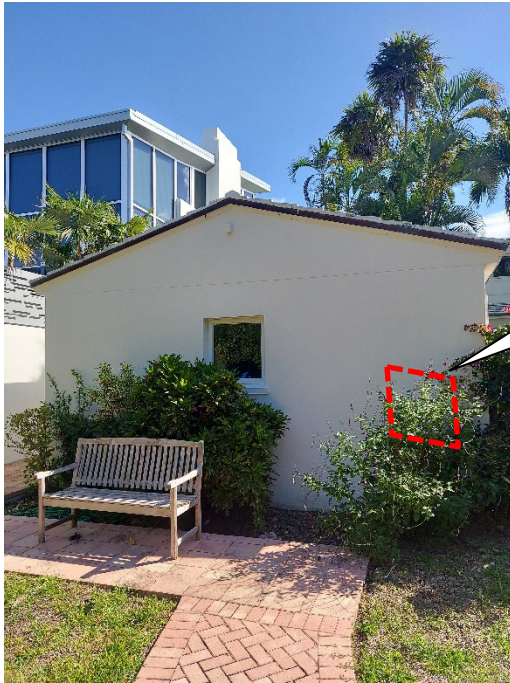
Stucco in  
poor  
condition

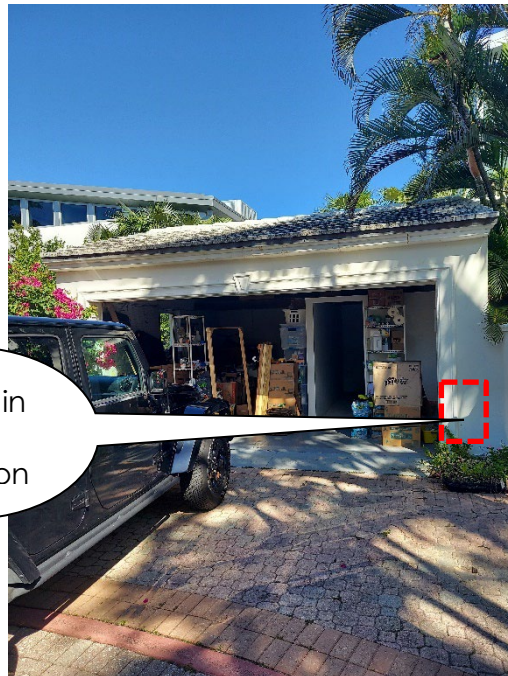
West side

Stucco in  
poor  
condition

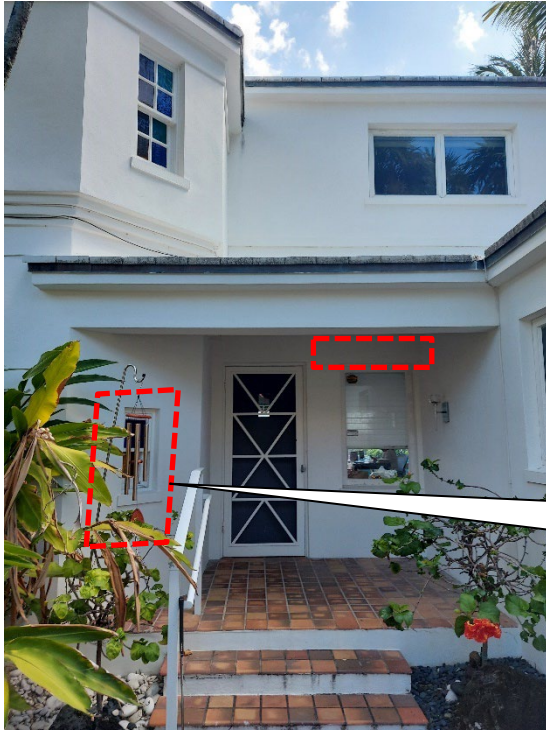
Main entrance

Stucco in  
poor  
condition
