*EVALUATION REPORT*

*For Project located at: 7801 ATLANTIC WAY. MIAMI BEACH, FLORIDA. 33141*

### **OBSERVATION, EVALUATION AND RECOMMENDATIONS**

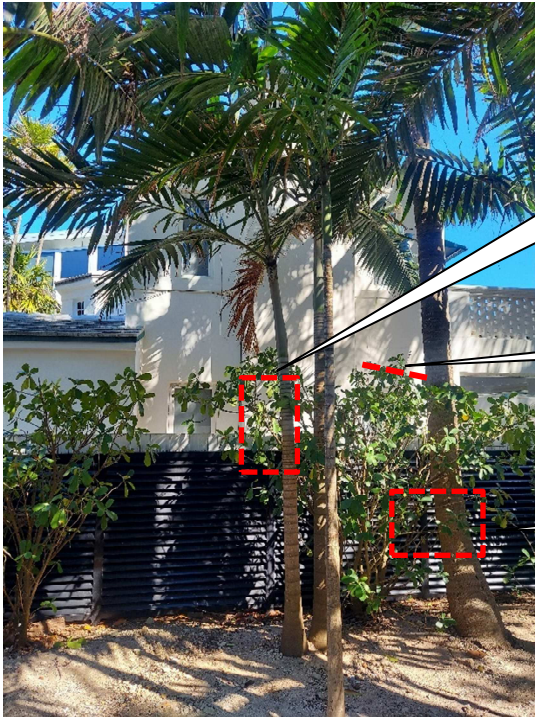
South façade

Stucco in poor condition

Hairline crack.

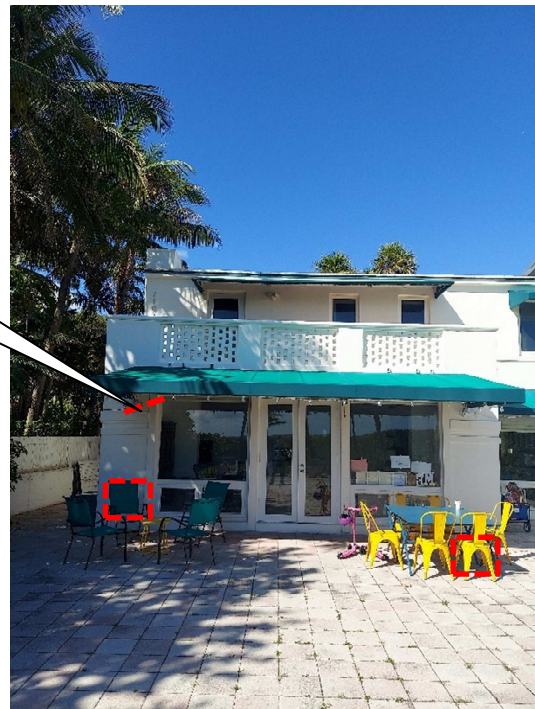
East façade

Stucco in poor condition

Hairline crack.

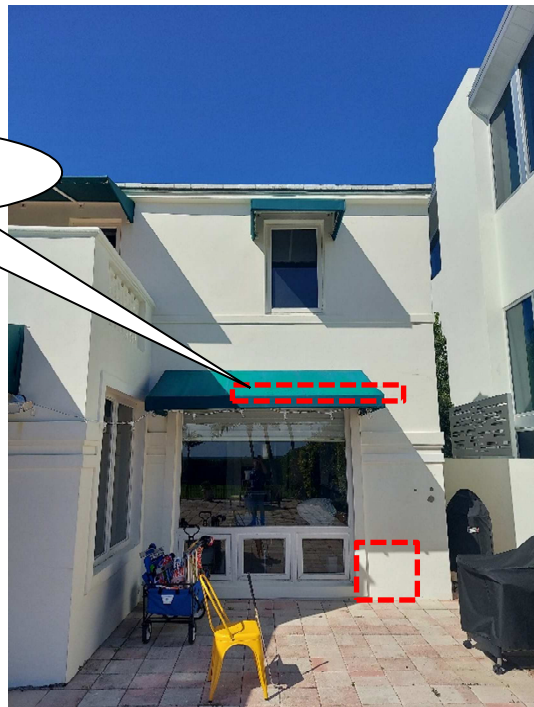
East side

Additionally, as a result of the visual inspection, cracks were observed in bearing elements of reinforced concrete. This is produced as a consequence of the increase in volume of the reinforcing steel produced by an oxidation state. Sulfates attack concrete, forming expansive compounds that cause cracking. Chlorides, if they reach the rebars, cause its corrosion. The cracking caused by sulfates facilitates the penetration of chlorides and the corrosion of the reinforcement. Once the concrete cracks, the integrity and design capacity of the structural element are not guaranteed.

Cracked beam.

It is possible to selectively restore, repair or reconstruct some structural elements in the case of localized failure. However, Failure to meet the required concrete resistance cannot be solved; That is why, based on the results obtained from the tests carried out, a total demolition of the structure is recommended. Future and more exhaustive tests can be carried out to determine additional concealed damages in the different structural elements.
