*EVALUATION REPORT*

*For Project located at: 7801 ATLANTIC WAY. MIAMI BEACH, FLORIDA. 33141*

The inspection of the building in reference (See Exhibit 1 for graphical representation), located at 7801 Atlantic Way, Miami Beach FL 33141, took place on Wednesday February 22nd, 2023, and was performed by Mr. Alioskar Ganem P.E. The main objective of the inspection was to identify general areas and critical details of the building components that may compromise the integrity of the Structure and represent a hazard to the users of this property. The following report examines the strength and viability of the structure from the slab to the roof.

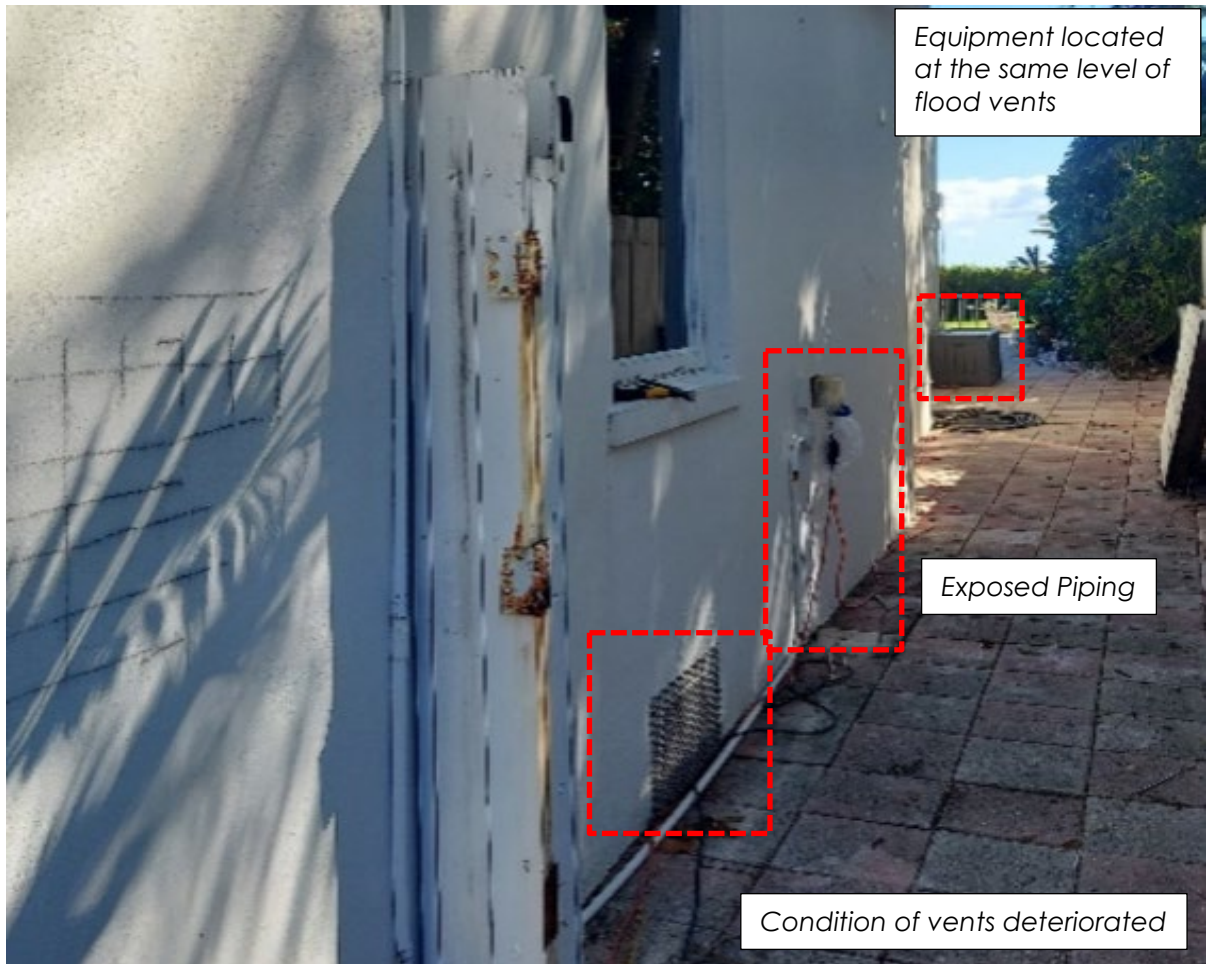
**Figure 1.**

*The current design incorporates flood vents below the recommended 18.2' level and below the slab, which is problematic. Flood vents are openings intended to enable the free flow of water during a flood, reducing the pressure on a building's walls and minimizing structural damage. However, since the habitable space of the building was constructed below the current recommended level, the absence of breakaway walls and the use of flood vents will result in damage to the masonry walls from the wave crest. Electrical equipment and piping below the recommended 18.2' create a hazardous environment, such equipment per code should always be designed above the flood elevation. It is the architect and engineer's responsibility to ensure the safety of occupants, and in this case, demolishing the structure should be considered as an option to provide a safer environment.*

*Figure 1, below, shows the dangerous existing infrastructure. The existing flood vents are in poor condition and are not considered resilient for the preservation of the home in the event of a major storm or flood. Figure 1 also shows the improper location of a/c equipment and the exposed piping from the slab.*

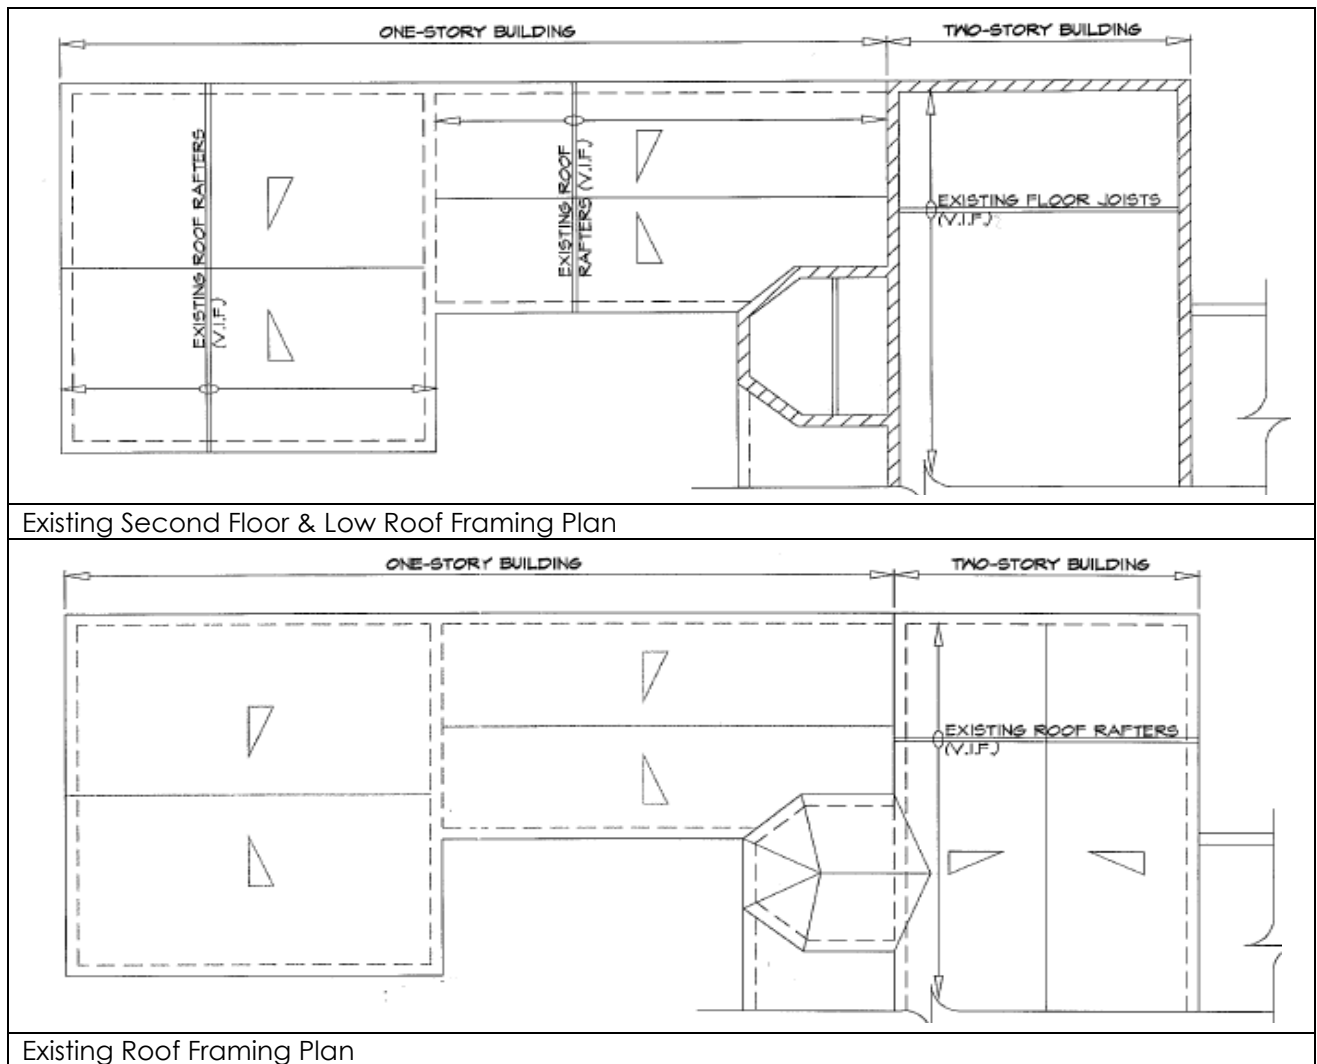
**Figure 2.**

The existing building consists of a two-story residential home. The existing Structural System is composed of masonry walls, with concrete beams and columns acting as load-bearing elements in the open areas and critical structural zones. See Figure 2 below. The load-bearing diaphragm of the second level consists of joists and roof rafters as part of the composition of the structural system of the home.

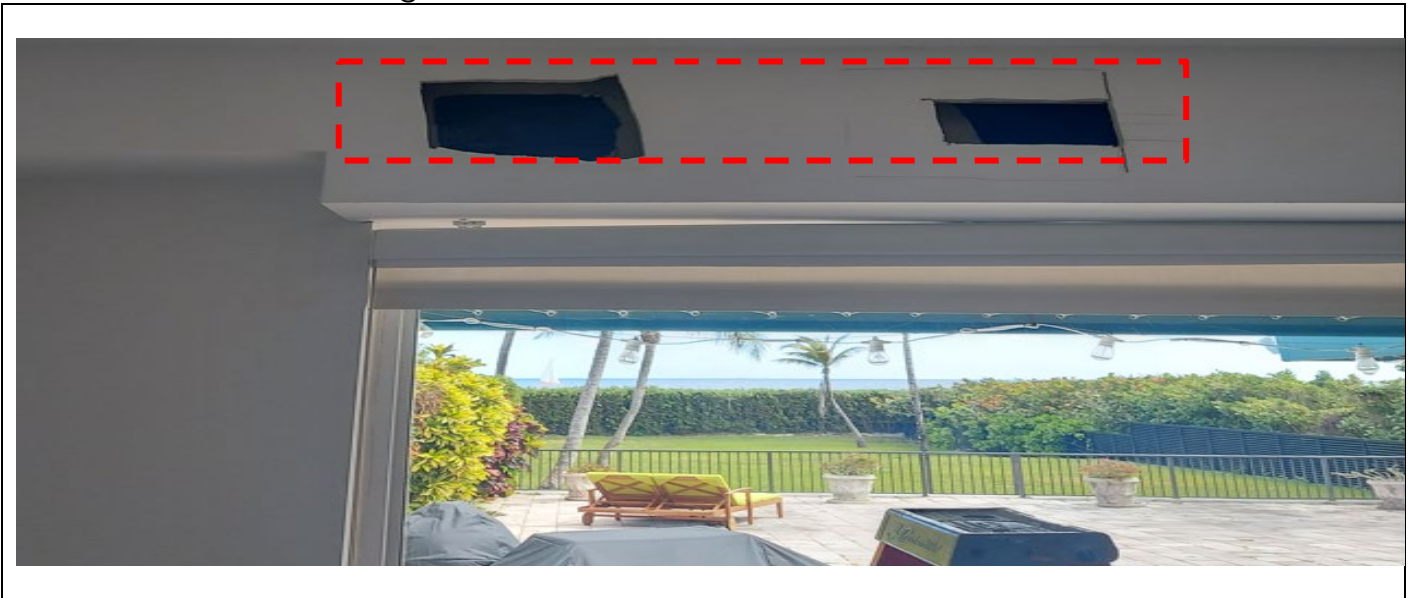
**Figure 3.** Cracking of the concrete in Main beam due to sulphation of the concrete and oxidation of the reinforcing steel

As a result of the visual inspection, cracks were observed in bearing elements of reinforced concrete. See Figure 3 below. This is produced as a consequence of the increase in volume of the reinforcing steel produced by an oxidation state. Sulfates attack concrete, forming expansive compounds that cause cracking. Chlorides, if they reach the rebars, cause its corrosion. The cracking caused by sulfates facilitates the penetration of chlorides and the corrosion of the reinforcement. Once the concrete cracks, the integrity and design capacity of the structural element are not guaranteed.

Cracking of the concrete in Main beam due to sulphation of the concrete and oxidation of the reinforcing steel

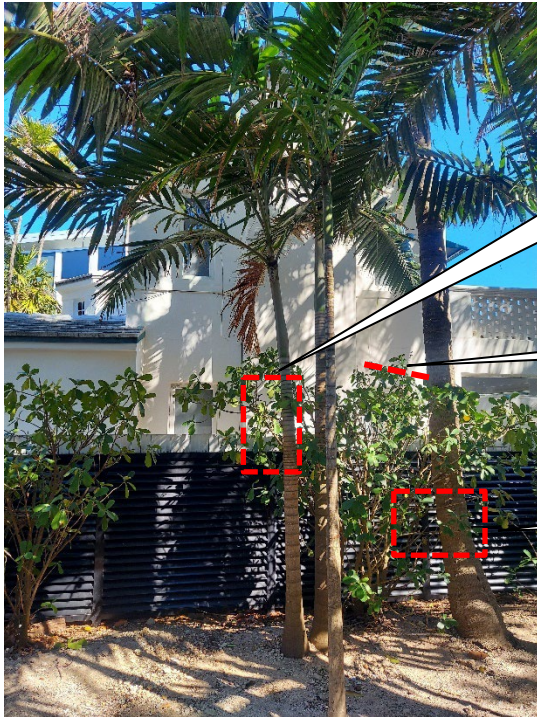
South façade

Stucco in poor condition

Hairline crack.

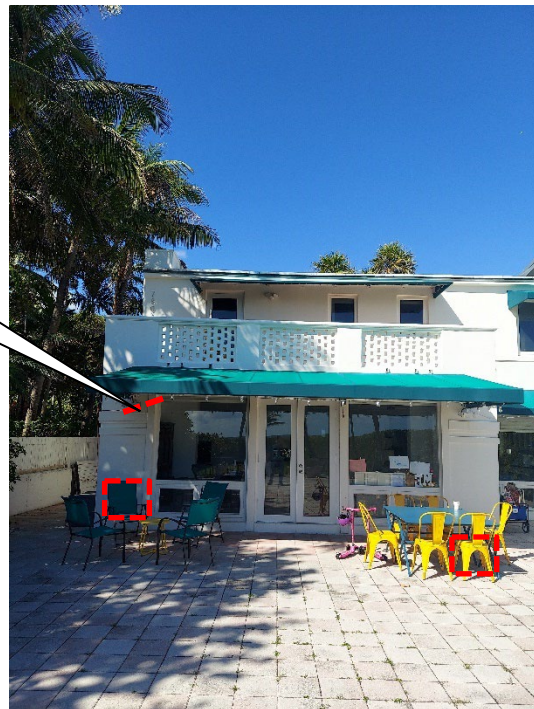
East façade

Stucco in poor condition

Hairline crack.

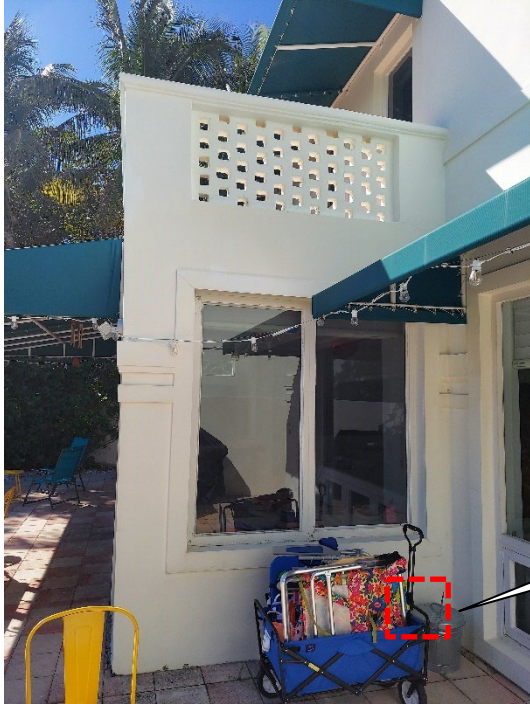
East side

Stucco in poor condition

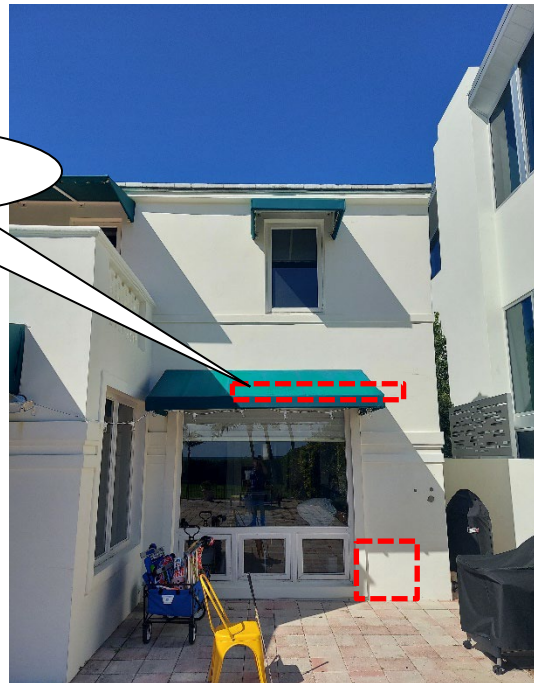
East side

Cracked beam.

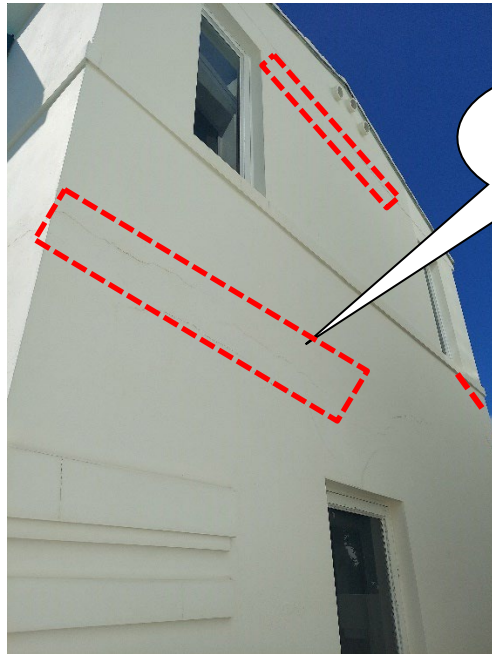
Cracked area.

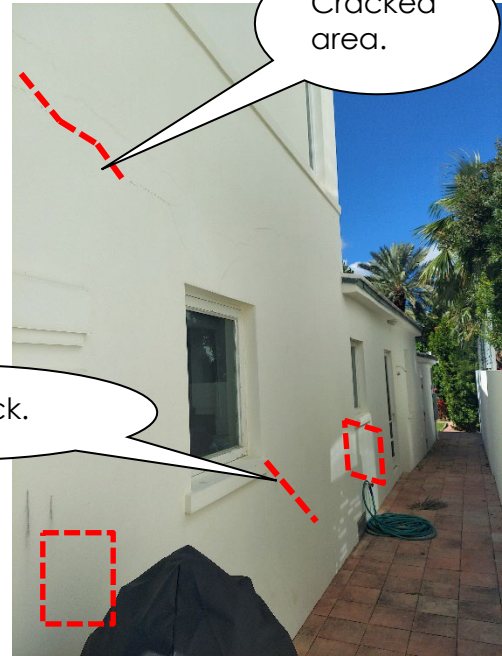
Cracked area.

Hairline crack.

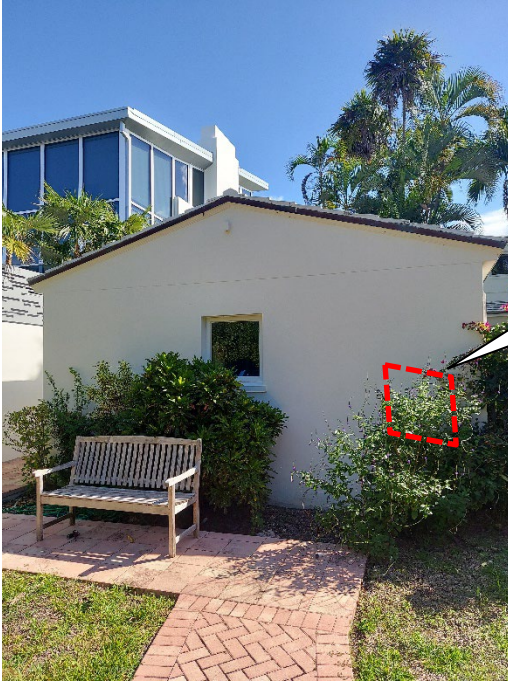
West side

Stucco in  
poor  
condition

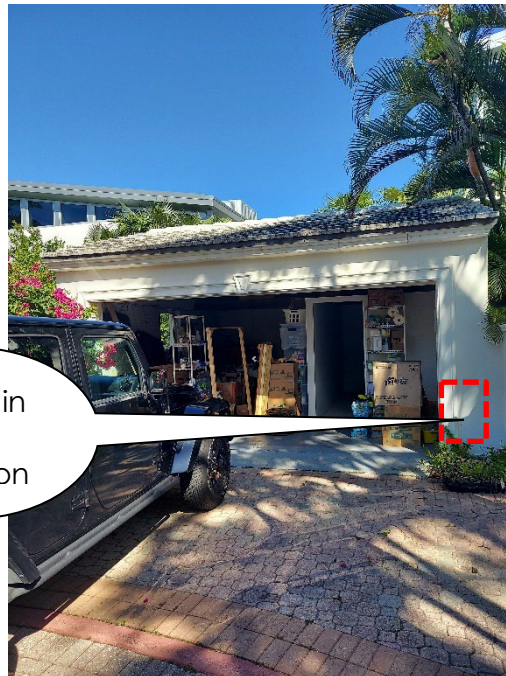
Stucco in  
poor  
condition

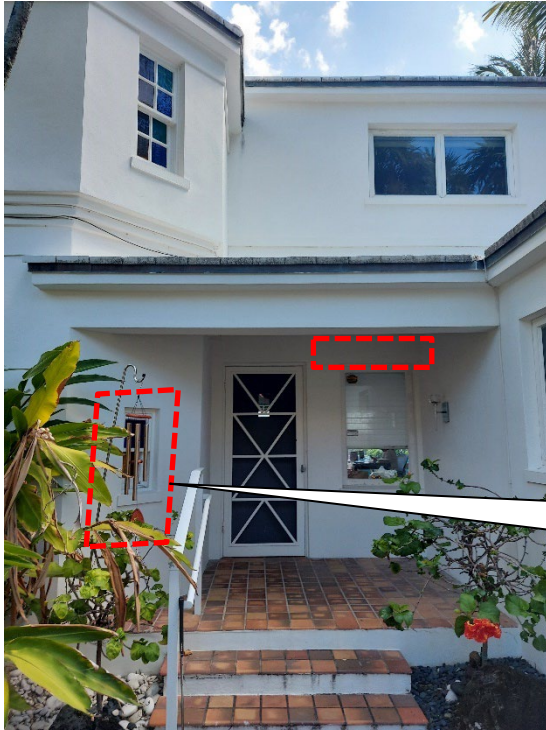
Main entrance

Stucco in  
poor  
condition

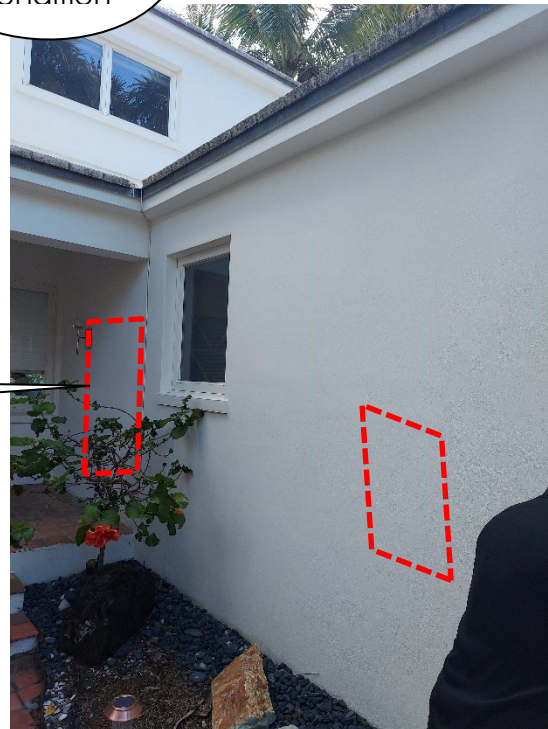
Stucco in  
poor  
condition

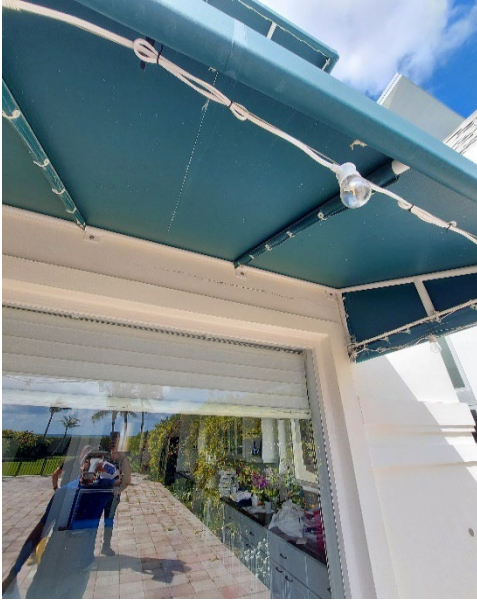
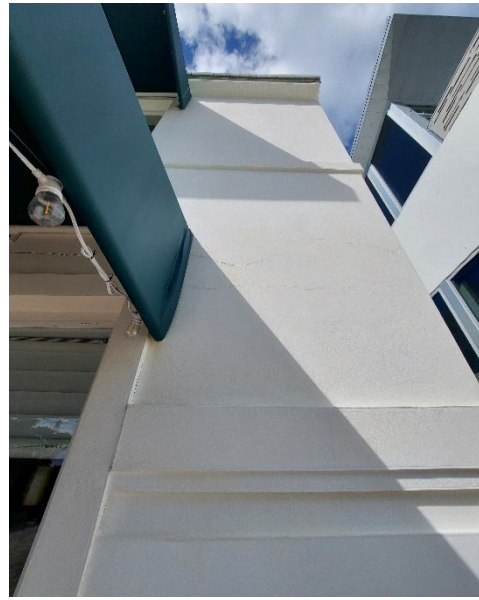
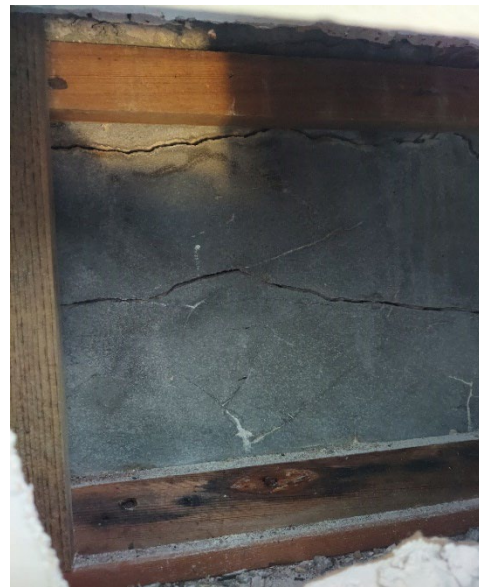
## Cracked beam, east side.
