*EVALUATION REPORT*

*For Project located at: 7801 ATLANTIC WAY. MIAMI BEACH, FLORIDA. 33141*

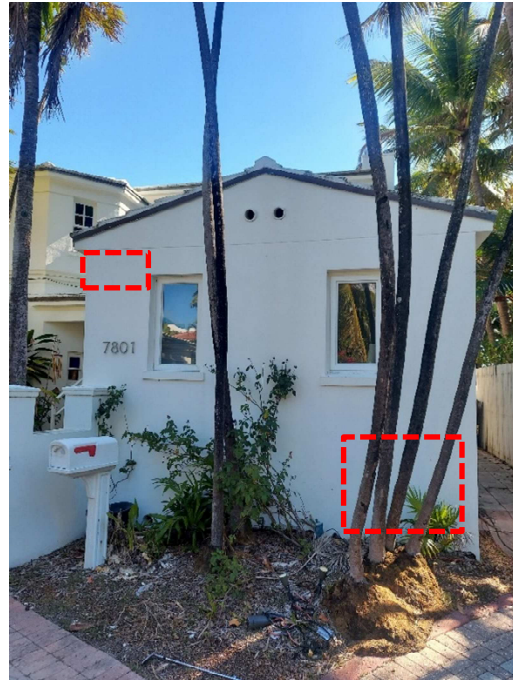
West facade

### Stucco repair areas at facades

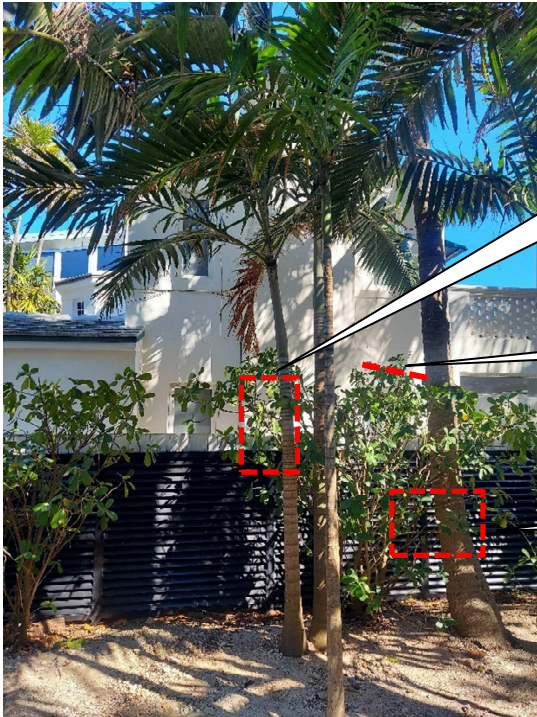
South façade

Stucco in poor condition

Hairline crack.

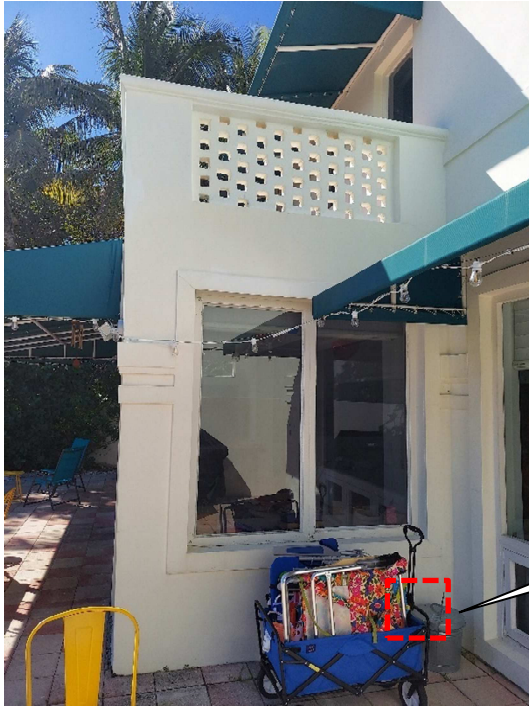
East side

Stucco in poor condition

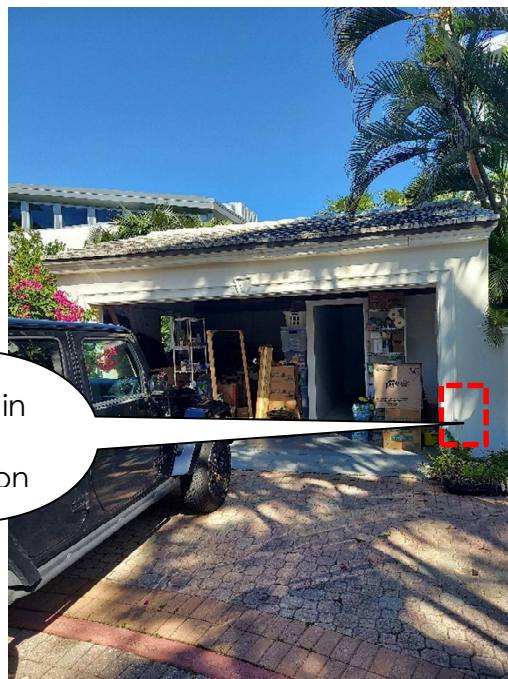
West side

Stucco in  
poor  
condition

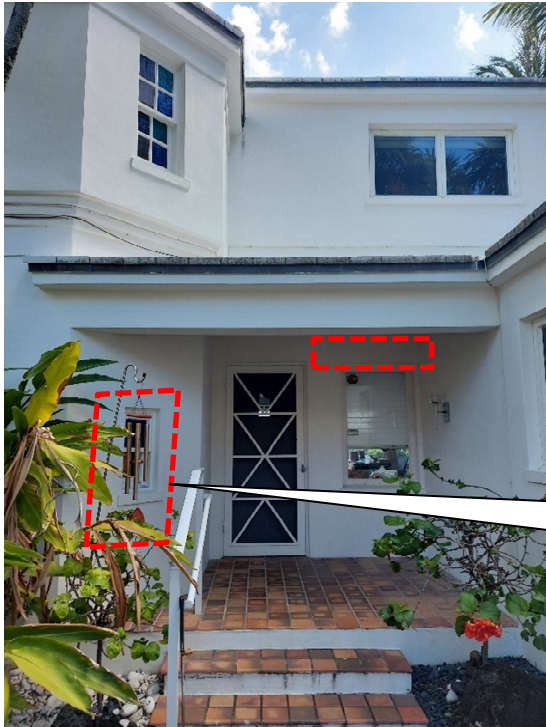
Main entrance

Stucco in  
poor  
condition
