## GANEM CONSULTING ENGINEERING

### EVALUATION REPORT

For Project located at: 7801 ATLANTIC WAY. MIAMI BEACH, FLORIDA. 33141

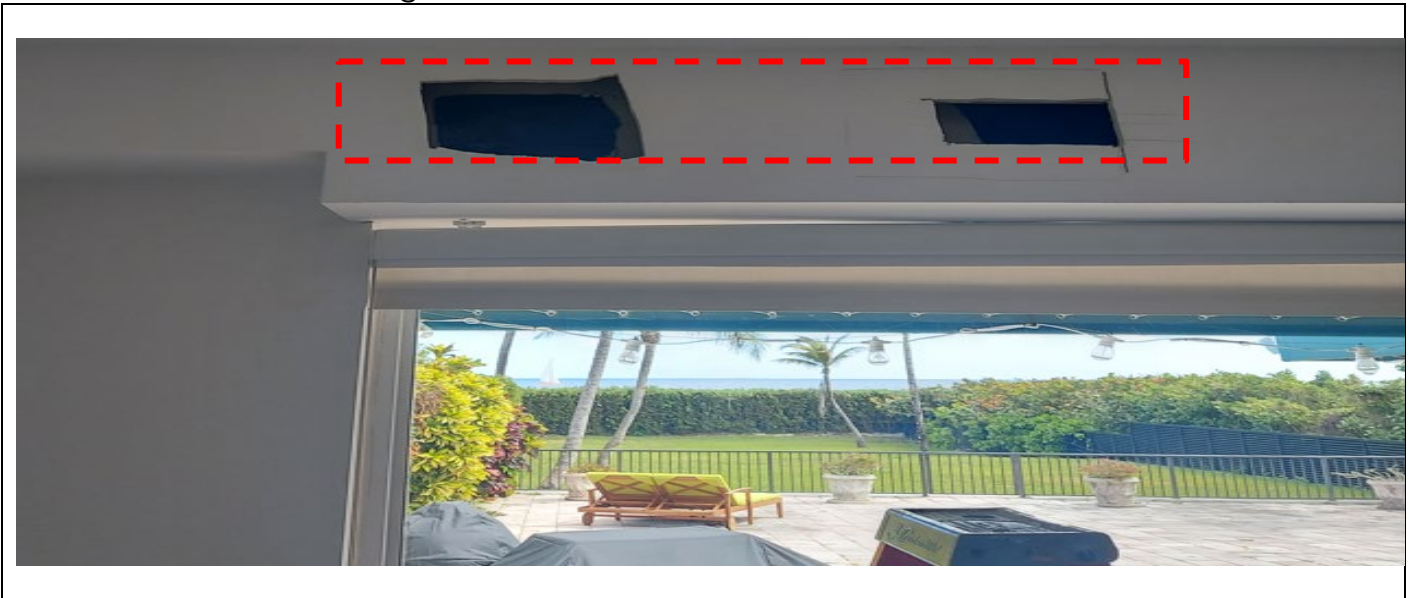
**Figure 3.** Cracking of the concrete in Main beam due to sulphation of the concrete and oxidation of the reinforcing steel

As a result of the visual inspection, cracks were observed in bearing elements of reinforced concrete. See Figure 3 below. This is produced as a consequence of the increase in volume of the reinforcing steel produced by an oxidation state. Sulfates attack concrete, forming expansive compounds that cause cracking. Chlorides, if they reach the rebars, cause its corrosion. The cracking caused by sulfates facilitates the penetration of chlorides and the corrosion of the reinforcement. Once the concrete cracks, the integrity and design capacity of the structural element are not guaranteed.

Cracking of the concrete in Main beam due to sulphation of the concrete and oxidation of the reinforcing steel

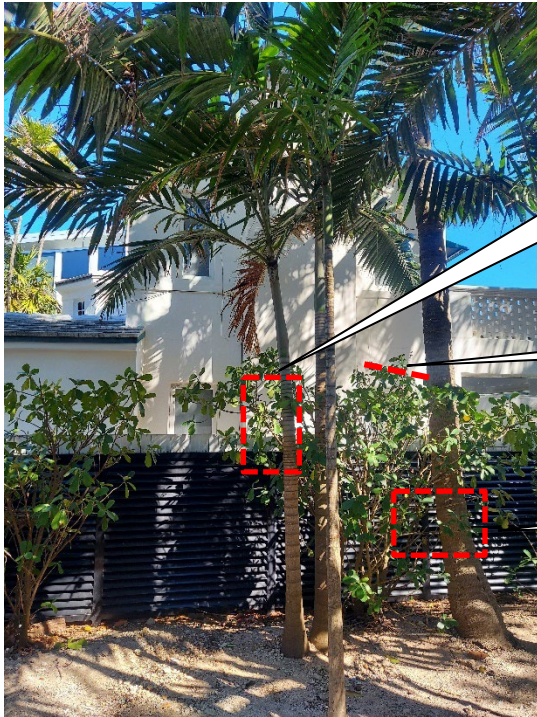
South façade

Stucco in poor condition

Hairline crack.

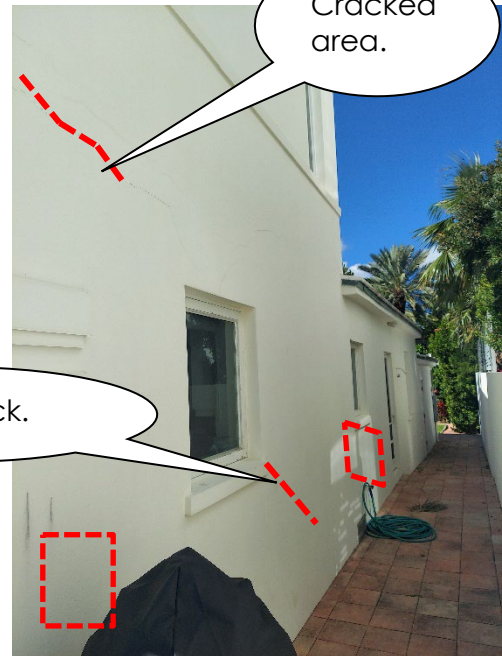
Cracked area.

Hairline crack.

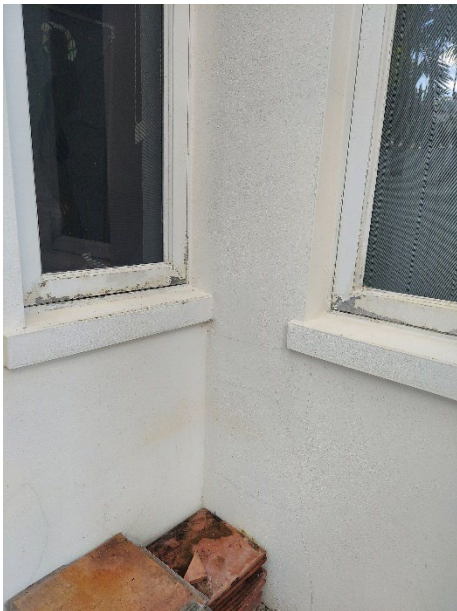
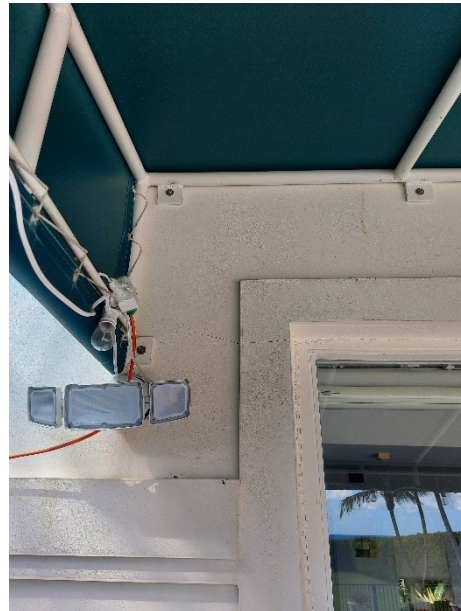
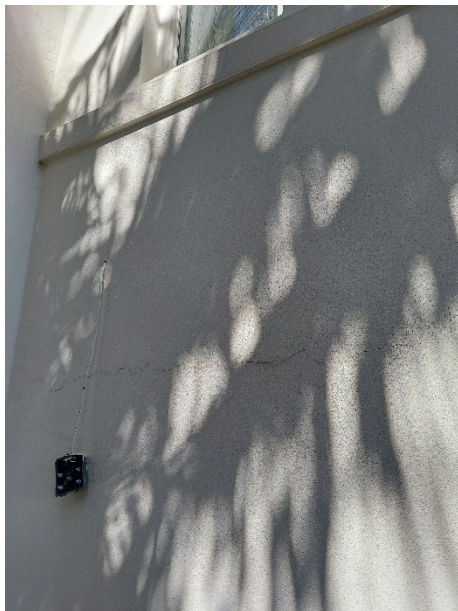
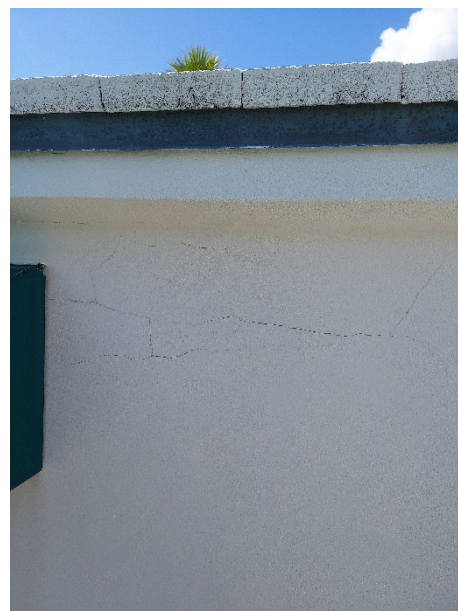
# Façade stucco condition

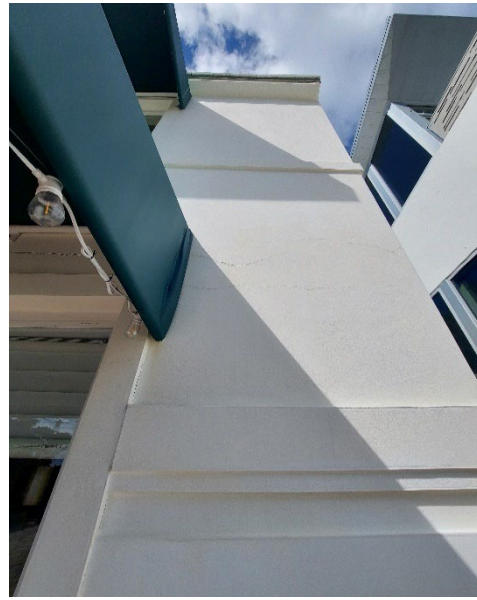
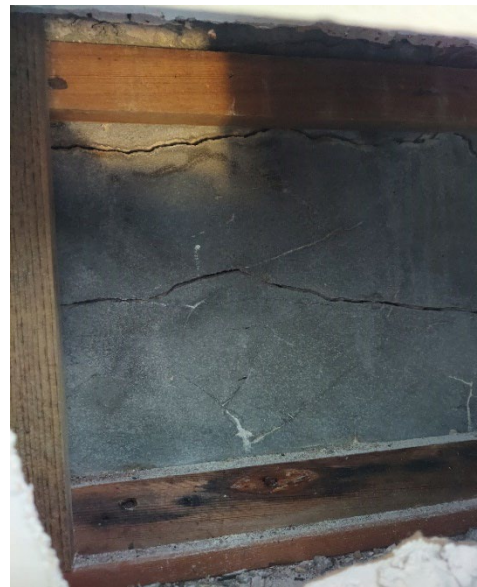
## Cracked beam, east side.
