# ARBORIST REPORT

1265 N. Biscayne Point Rd.  
Miami Beach, FL 33141

Treage LLC was contacted by Andres Montero of AMLA Studio to conduct a Certified Arborist Report at 1265 N. Biscayne Point Rd., Miami Beach, FL

The site consists of an existing single-family home proposed for demolition and new construction of a single-family home. There are 34 trees located onsite, as well as 5 trees located offsite, that are referenced below.

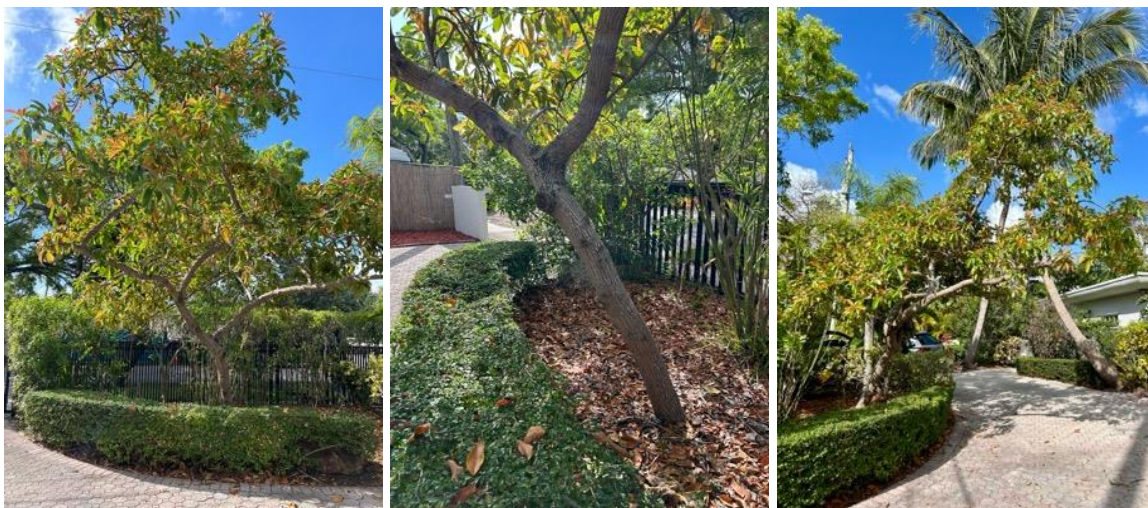
**Tree #1 – *Persea americana*, Avocado** – this tree is growing on the northeast side of the circular driveway cutout on the southeast side of the property. It has a slightly weak structure with minor lean. There are some small poor cuts present. Overall, it is in moderate to borderline fair condition. It is just under regulation size, so it should be eligible for removal without regulation; however, it is advised to confirm with the City prior to conducting any removals.

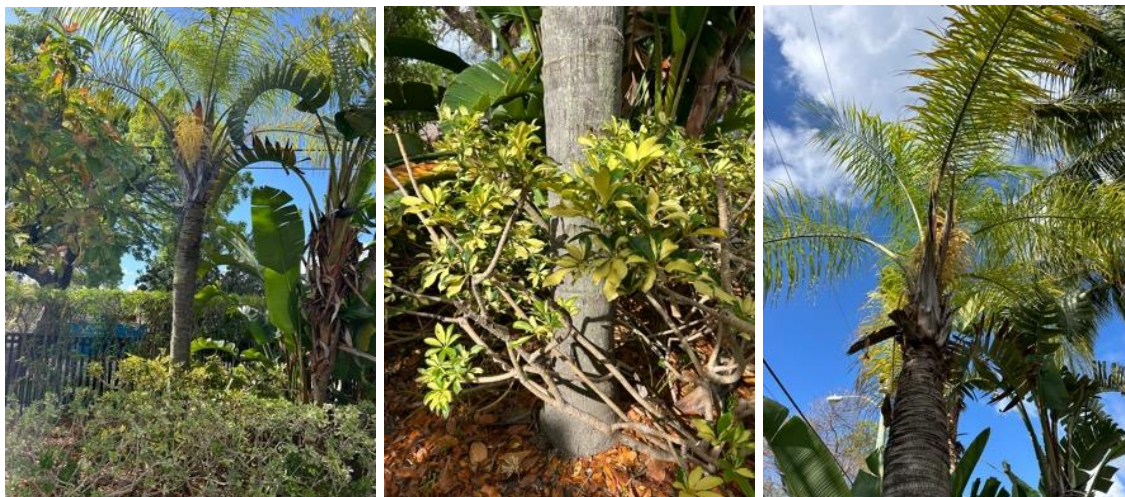
**Tree #2 – *Syagrus romanzoffiana*, Queen Palm** – this palm is located slightly southwest of Tree #1 in the circular driveway cutout. It shows signs of nutrient deficiency and is in borderline fair condition. It is just under regulation size, so it should be eligible for removal without regulation if necessary. It is also a possible, although not ideal, candidate for relocation onsite per specifications below; it is recommended for fertilization per BMP's if it remains or is relocated.

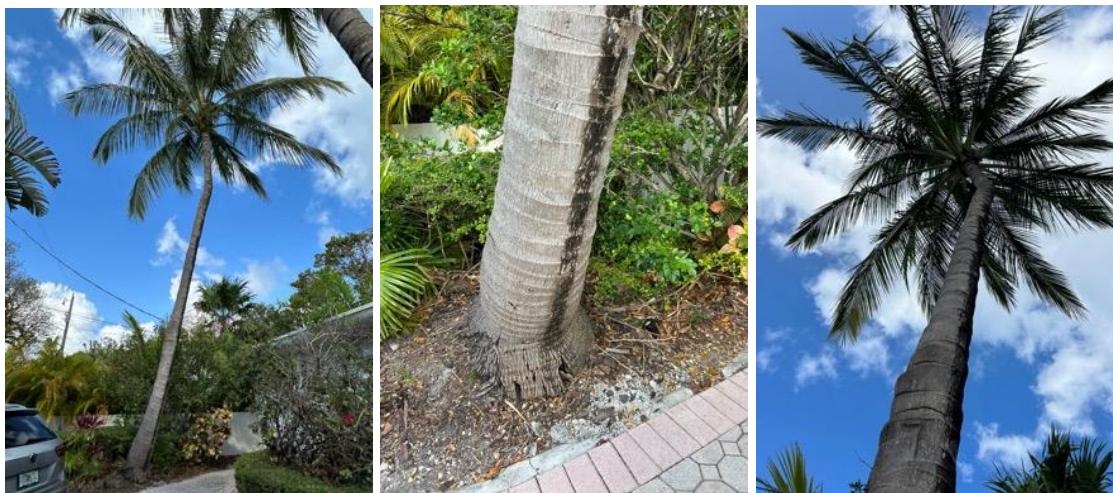
**Tree #3 – *Cocos nucifera*, Coconut** – this palm is located on the southwest side of the driveway area within 1' of the driveway. It is in fair condition with a bend in the trunk but no other significant defects. This palm is a possible candidate to remain with protection due to its compact root zone and location near the perimeter of the property.

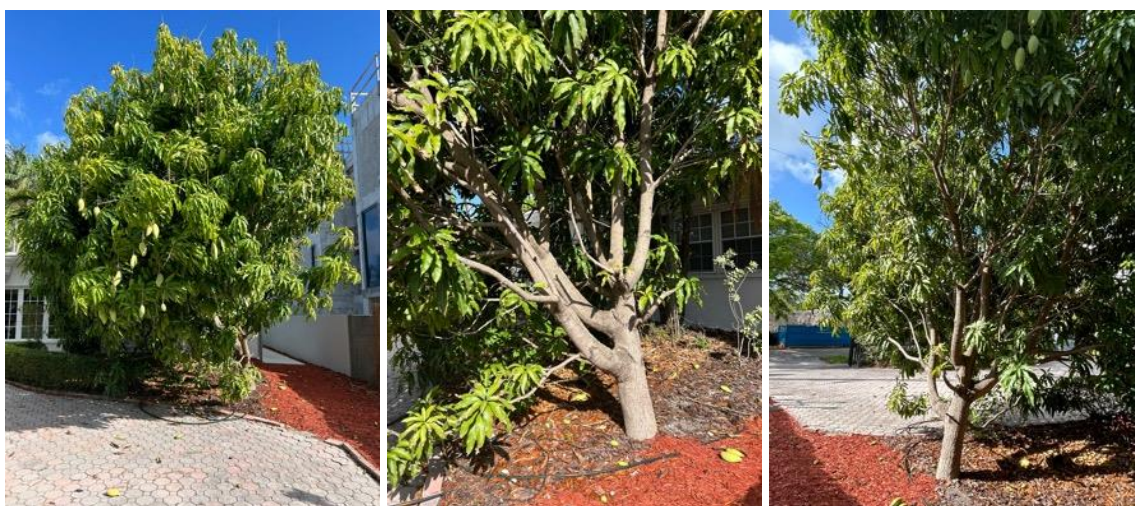
**Tree #4 – *Mangifera indica*, Mango** – this tree is located near the northeast side of the driveway in front of the southeast corner of the residence. It splits into multiple trunks between 3-4' height. It is slightly crowded with a dense canopy, minor deadwood and small tears along the east side of the canopy adjacent to the walkway. Overall, it is in fair condition.

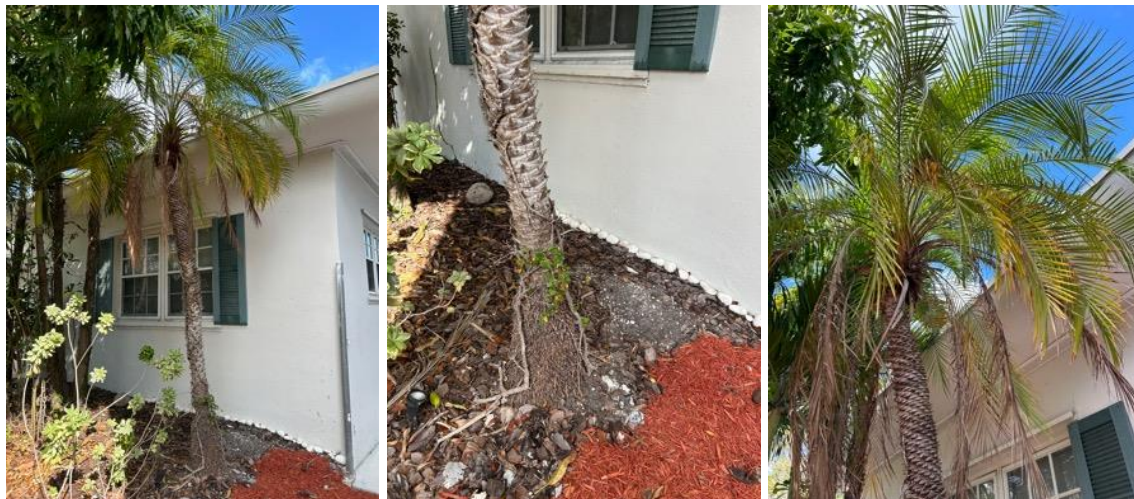
**Tree #5 – *Phoenix roebellini*, Pygmy Date Palm** – this palm is located within 3.5’ of the southeast corner of the existing residence. It exhibits minor chlorosis and is in fair condition. It is under regulation size, so it should be eligible for removal without regulation if necessary.

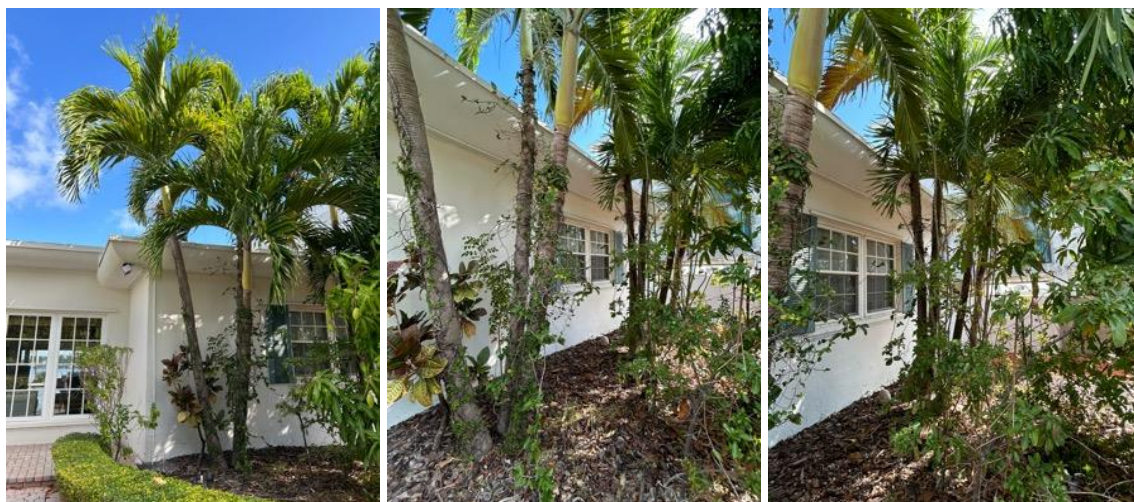
**Tree #6 – *Adonidia merrillii*, Christmas Palm** – this refers to a triple palm growing just south of the southeast side of the existing residence. It is crowded and has a slightly weak growth habit as a result. Overall, it is in fair condition. It will require a permit and mitigation if it is removed. It is a possible candidate for relocation onsite; see Relocation Specifications below.

**Tree #7 – *Adonidia merrillii*, Christmas Palm** – this refers to a triple palm growing just west of Tree #6 on the east side of the entrance to the existing residence. It is slightly crowded with minor chlorosis but otherwise is in fair condition. It will require a permit and mitigation if it is removed. It is a possible candidate for relocation onsite; see Relocation Specifications below.

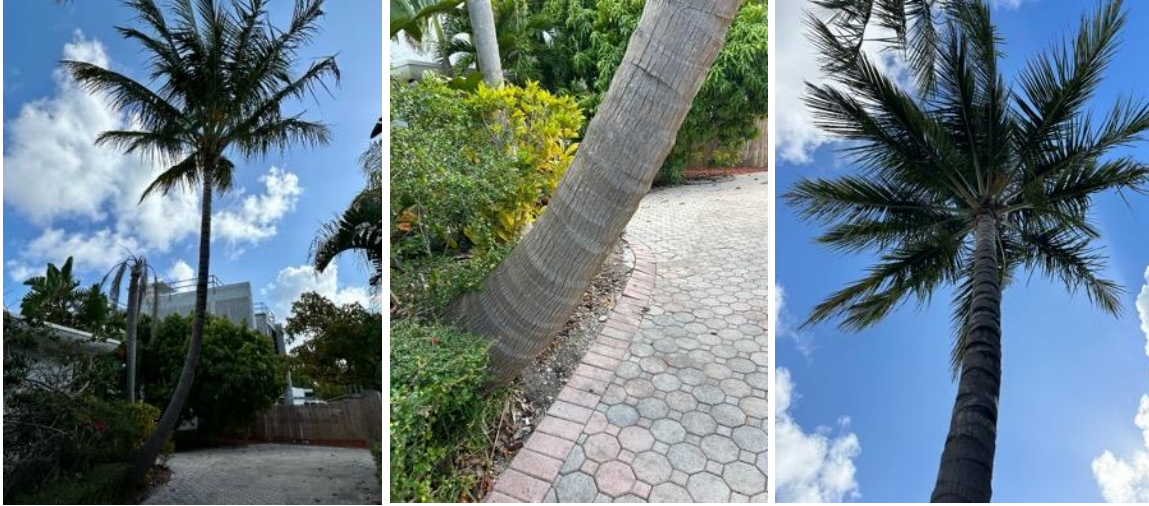
**Tree #8 – *Cocos nucifera*, Coconut** – this palm is located in a planting area on the north side of the driveway and west side of the entrance to the house. It is slightly crowded and is leaning over the driveway. It exhibits signs of minor nutrient deficiency but overall is in fair condition. This palm will likely require removal with a permit and mitigation, but if it remains it will require protection per measures below.

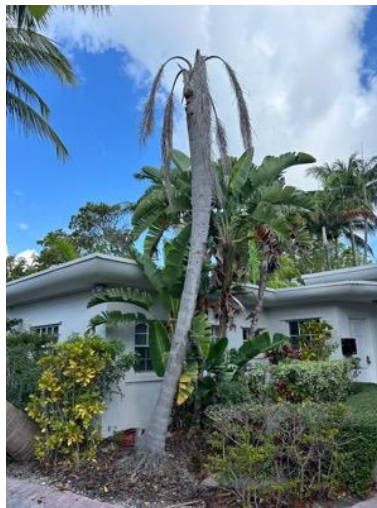
**Tree #9 – *Syagrus romanzoffiana*, Queen Palm** – this palm is located just northeast of Tree #8 on the west side of the front walkway/entrance. It is dead with no remaining live fronds. It should be eligible for removal without regulation, to be confirmed by the City.

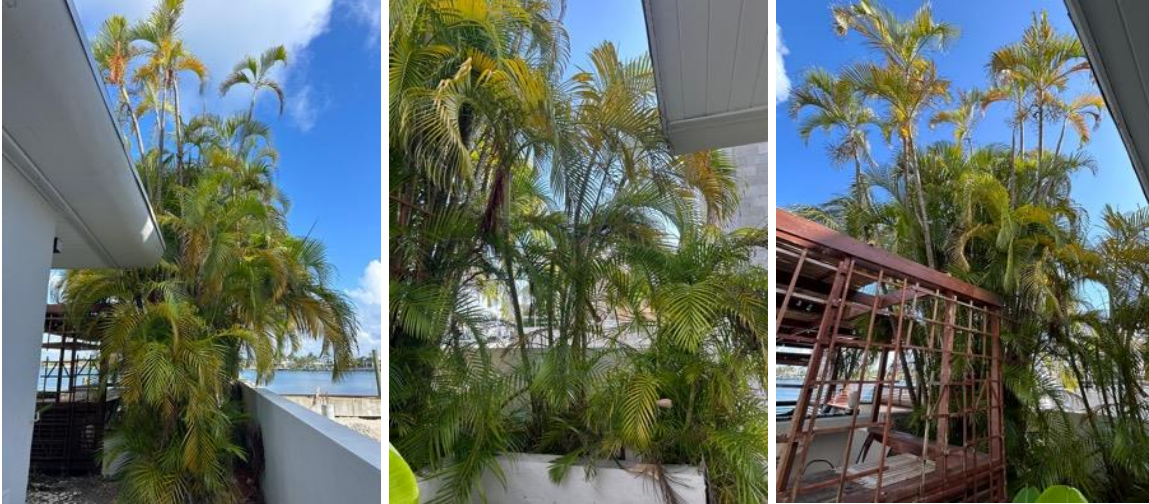
**Trees #10-12 – *Dypsis lutescens*, Areca Palm** – this refers to 3 Areca clusters growing in a planter on the southeast side of the wooden pergola in the northeast corner of the property. They are all crowded and chlorotic. Trees #10-11 are under regulation size and should be eligible for removal without regulation; Tree #12 is over regulation size and will require a permit and mitigation if it is removed.

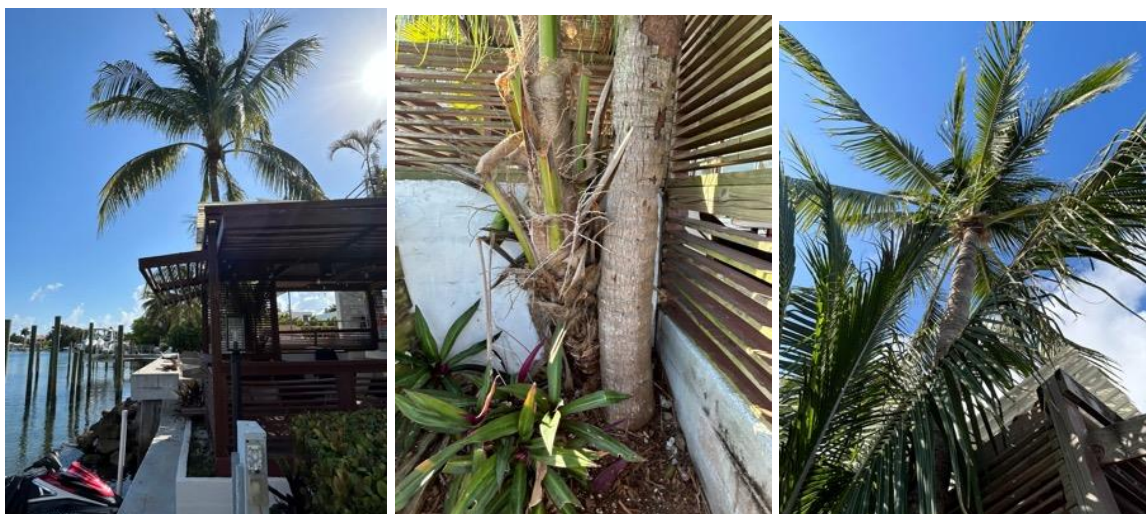
**Tree #13 – *Cocos nucifera*, Coconut** – this palm is growing in the northeast corner of the property near the seawall. It is growing next to a pergola and is within less than 1' of a CBS wall. It has moderate trunk damage but otherwise is in fair condition. It will require a permit and mitigation if it is removed. Otherwise, it will require very careful protection per measures below during all work activities, including demolition. There is a small seedling Coconut next to it with no clear trunk; it is under regulation size and should be eligible for removal without regulation.

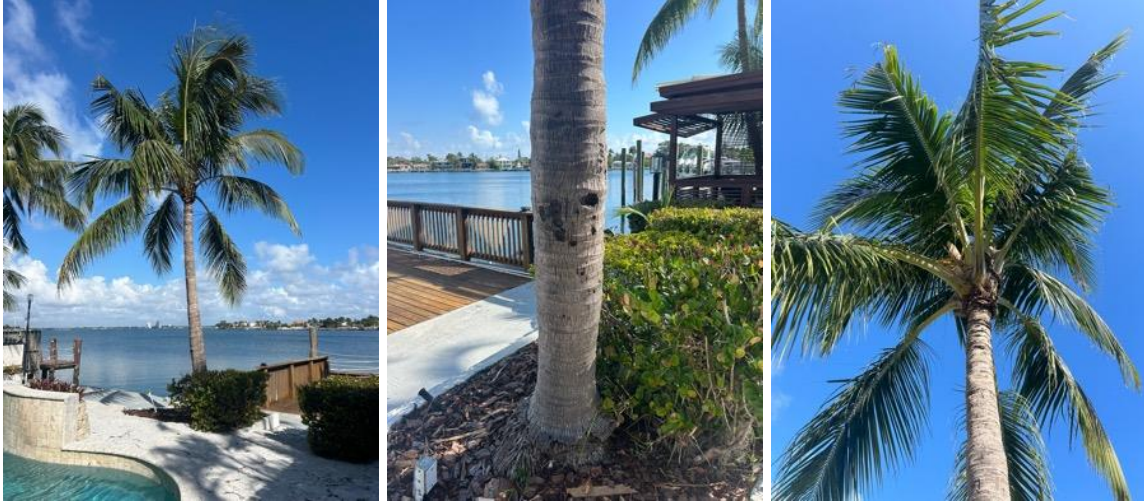
**Tree #14 – *Cocos nucifera*, Coconut** – this palm is growing on the north side of the pool in a small planting area near the seawall. It has minor trunk damage but otherwise is in fair condition. It will require a permit and mitigation if it is removed. Otherwise, it will require very careful protection per measures below during all work activities, including demolition.

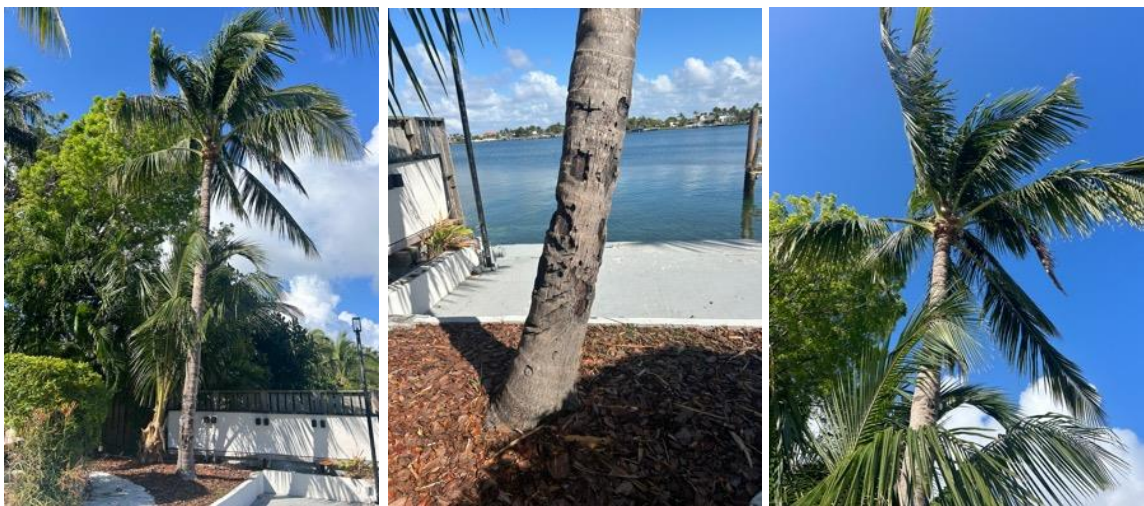
**Tree #15 – *Cocos nucifera*, Coconut** – this palm is growing on the northwest side of the property/pool area near the seawall and within 3' of the limestone path. It has minor to moderate trunk damage but otherwise is in fair condition. It is a possible candidate to remain with protection due to its compact root zone and location near the perimeter of the property. Otherwise, it will require a permit and mitigation if it is removed. There is a small seedling Coconut approximately 5' behind it with no clear trunk that should be eligible for removal without regulation.

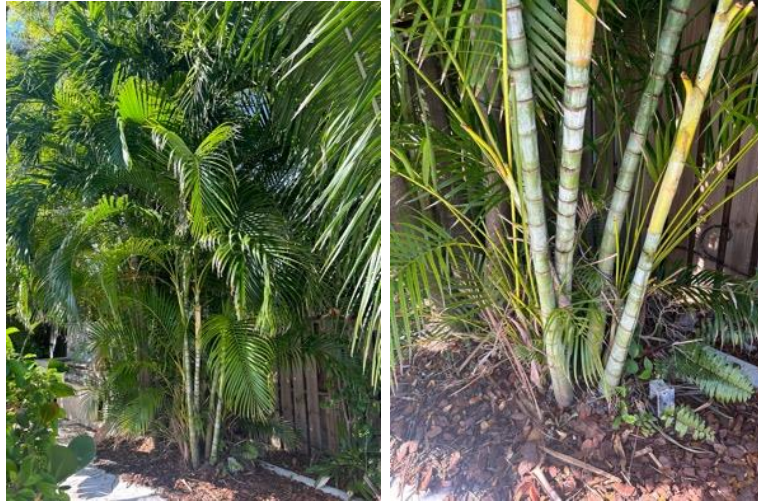
**Tree #16 – *Dypsis lutescens*, Areca Palm** – this palm is growing next to the property line in the northwest corner of the property. It is very crowded but otherwise in fair condition. It is under regulation height, so it should be eligible for removal without regulation if necessary. Otherwise, it is recommended for protection per measures below if it remains.

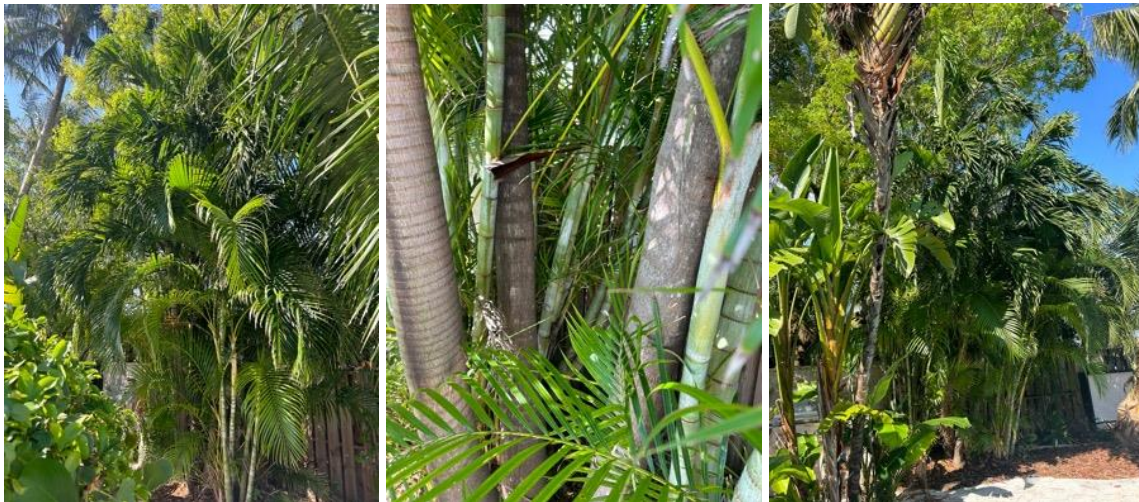
**Tree #17 – *Adonidia merrillii*, Christmas Palm** – this refers to a triple palm growing next to Tree #16. It is very crowded but otherwise in fair condition. It will require a permit and mitigation if it is removed, or protection per measures below if it remains.

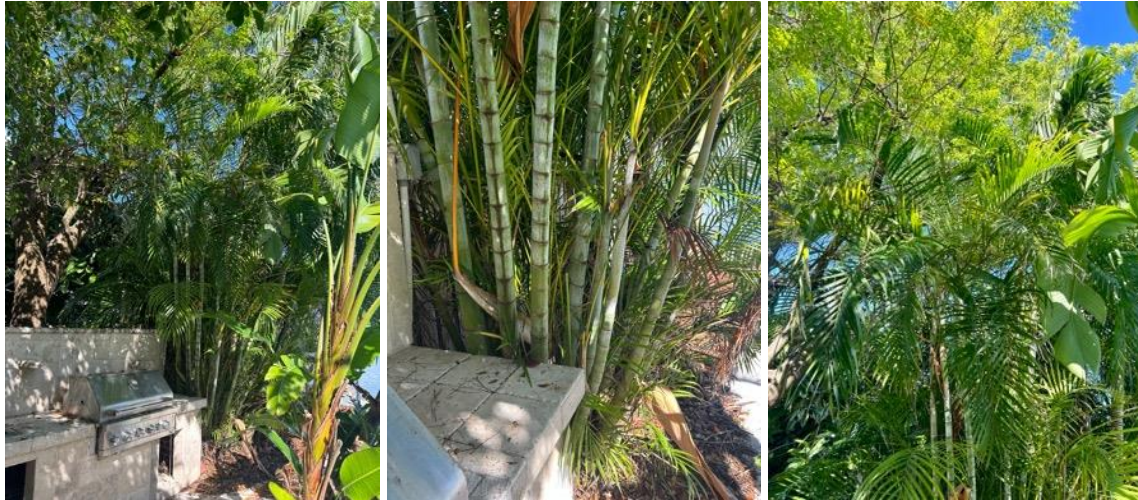
**Tree #18 – *Dypsis lutescens*, Areca Palm** – this refers to a small Areca cluster growing on the south side of Tree #17. It is very crowded but otherwise in fair condition. It is under regulation height, so it should be eligible for removal without regulation if necessary. Otherwise, it is recommended for protection per measures below if it remains.

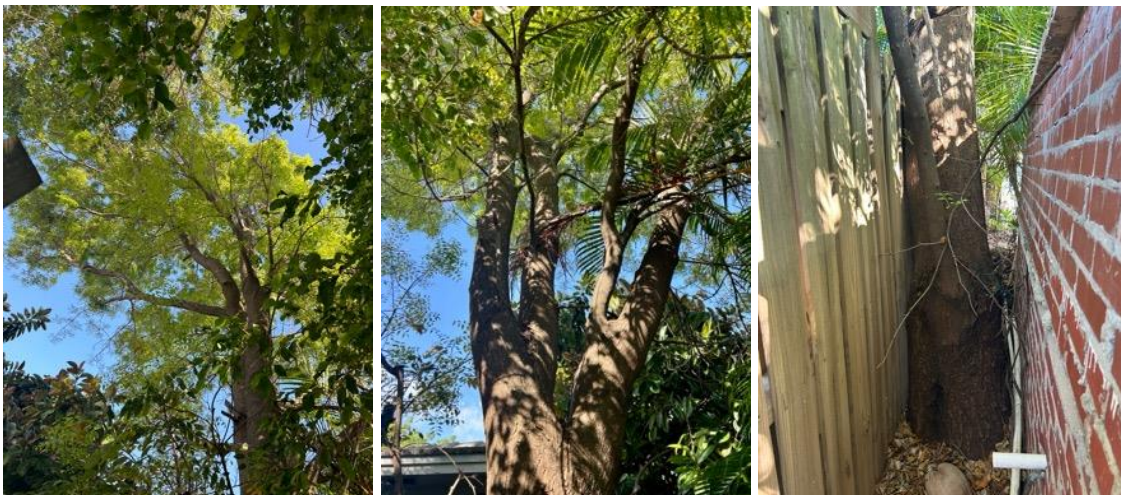
**Tree #19 – *Swietenia mahogani*, Mahogany** – this tree is growing between the fence line and an outdoor kitchen area on the northwest side of the property. It is very crowded and its DBH could not be exactly measured due to the fence. It has a somewhat poor branching structure with multiple areas of codominance and included bark. The canopy is constricted and is growing largely over the neighboring property with limited visibility. Overall, this tree appears to be in moderate to borderline fair condition. It will require careful protection per measures below if it remains onsite. Otherwise it will require a permit and mitigation if it is removed.

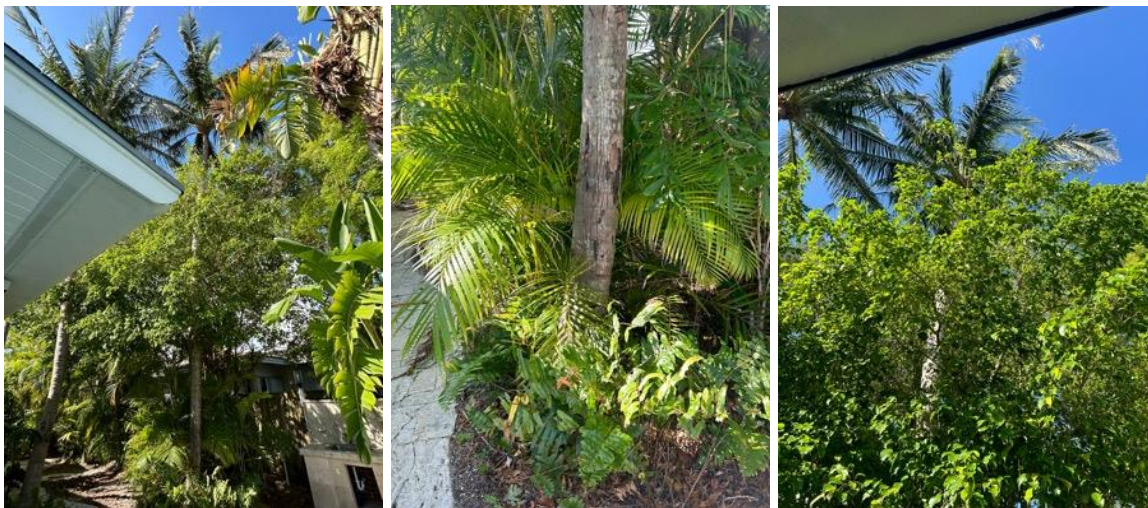
**Tree #20 – *Cocos nucifera*, Coconut** – this palm is growing along the walkway on the southwest side of the residence. It is crowded with minor trunk damage but otherwise is in fair condition. It will require a permit and mitigation if it is removed. Otherwise, it will require very careful protection per measures below during all work activities, including demolition.

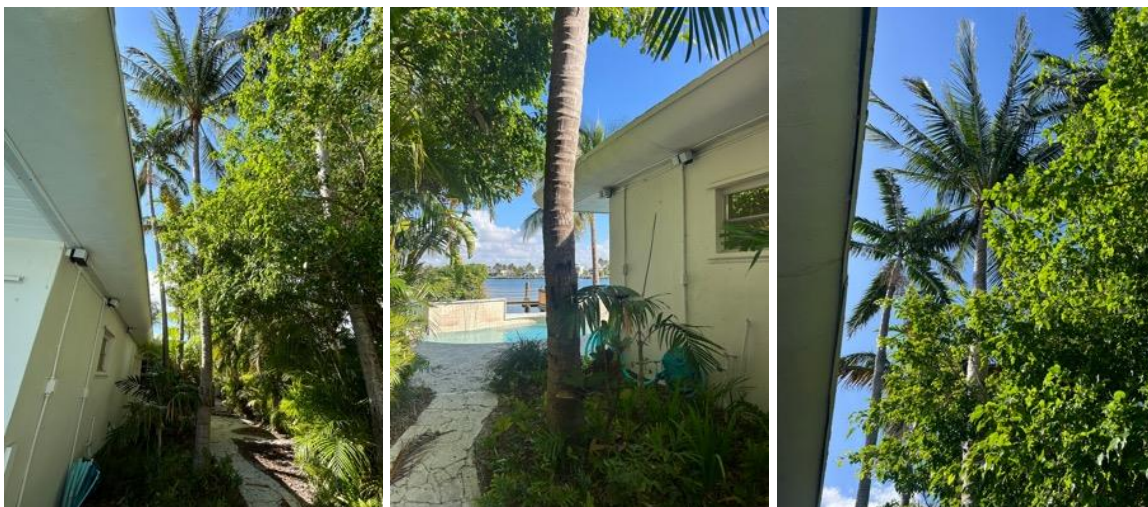
**Tree #21 – *Cocos nucifera*, Coconut** – this palm is growing on the opposite side of the walkway just southeast of Tree #20; it is within 2' of the path and 6' of the existing residence. It has minor to moderate trunk damage present but otherwise is in fair condition. It will require a permit and mitigation if it is removed. Otherwise, it will require very careful protection per measures below during all work activities, including demolition.

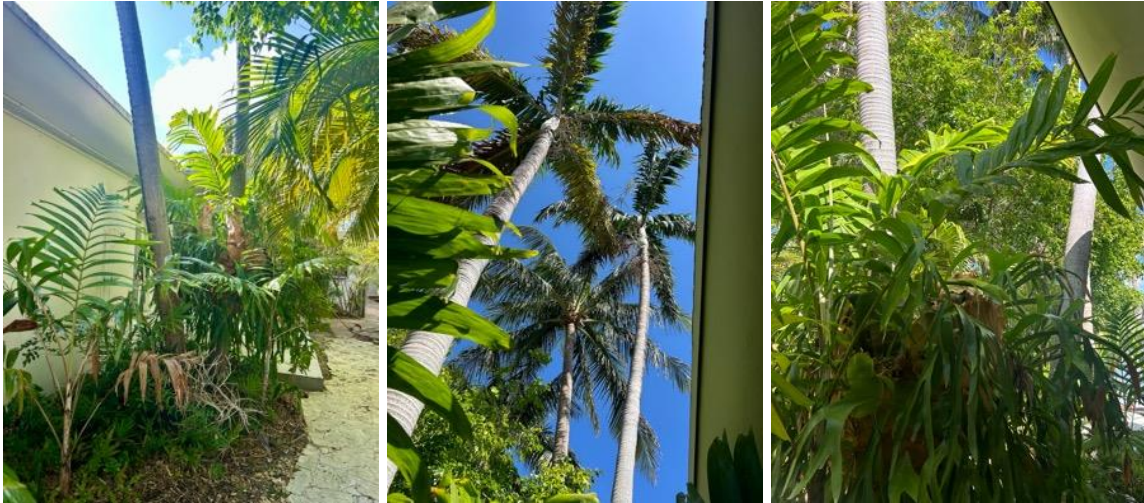
**Trees #22-23 – *Veitchia arecina*, Montgomery Palm** – this refers to 2 palms growing within less than 2' of each other southeast of Tree #21 between the side walkway and the residence. They are both slightly crowded with some epiphytes growing up their trunks, but otherwise they are in fair condition. They will require careful protection per measures below during all work activities if they remain, or a permit and mitigation if they are removed. They are also possible candidates for relocation onsite per measures below as an alternative to removal; see Relocation Specifications below.

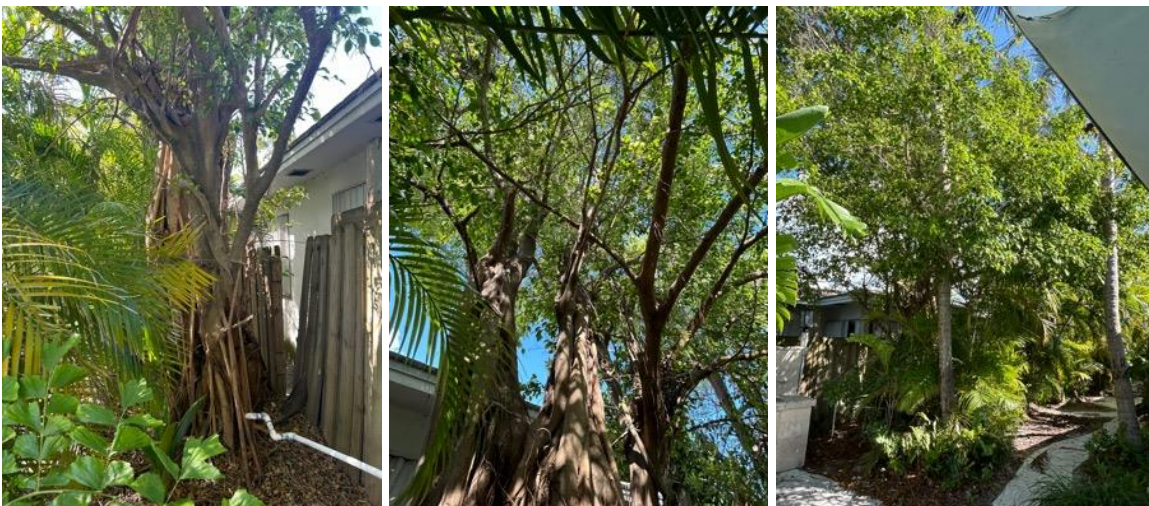
**Tree #24 – *Ficus benjamina*, Weeping Fig** – this tree is growing within less than 1' of the west fence line just southeast of Tree #19 and the outdoor kitchen; it appears to be putting pressure on the fence which is broken in vicinity of this tree. It is crowded and somewhat overgrown with minor deadwood, small tears, and an uneven canopy due to pruning cuts over the neighboring property. Overall, it is in moderate condition. If it remains, it will require protection per measures below and is recommended for canopy cleaning/maintenance pruning per ANSI Standards. Otherwise, it will require a permit and mitigation if it is removed.

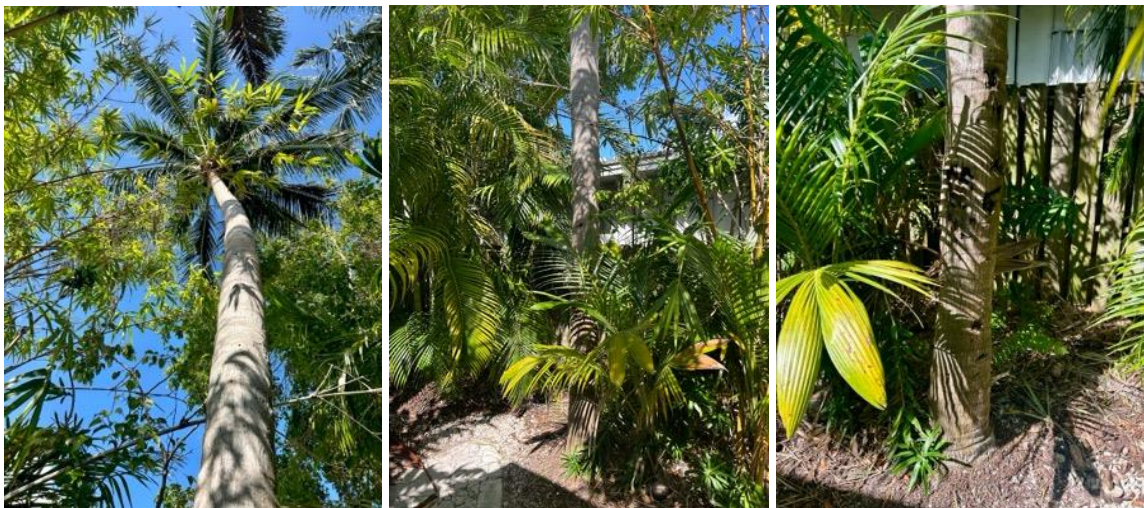
**Tree #25 – *Dypsis lutescens*, Areca Palm** – this palm is growing on the southeast side of Tree #24. It is crowded but otherwise in fair condition. It is under regulation size, so it should be eligible for removal without a permit or mitigation if necessary.

**Tree #26 – *Cocos nucifera*, Coconut** – this palm is growing slightly southeast of Tree #24 on the west side of the walkway. It is slightly crowded with minor trunk damage but otherwise is in fair condition. It will require a permit and mitigation if it is removed. Otherwise, it will require very careful protection per measures below during all work activities, including demolition.

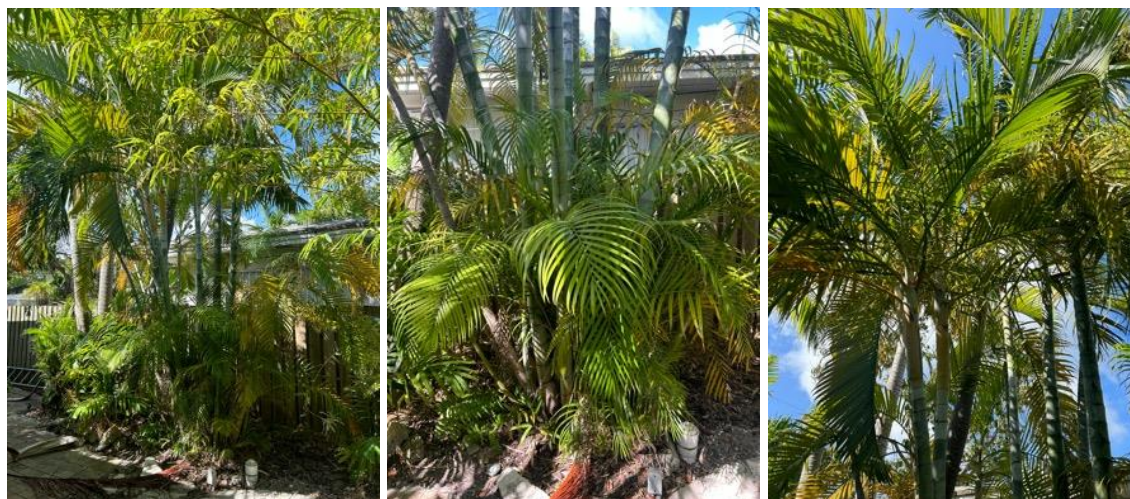
**Tree #27 – *Dypsis lutescens*, Areca Palm** – this palm cluster is growing approximately 7' southeast of Tree #26 and within 4' of the wall and 5' of the path on the west side of the property. It is crowded and overgrown but otherwise in fair condition. It is under regulation height so it should be eligible for removal without regulation if necessary.

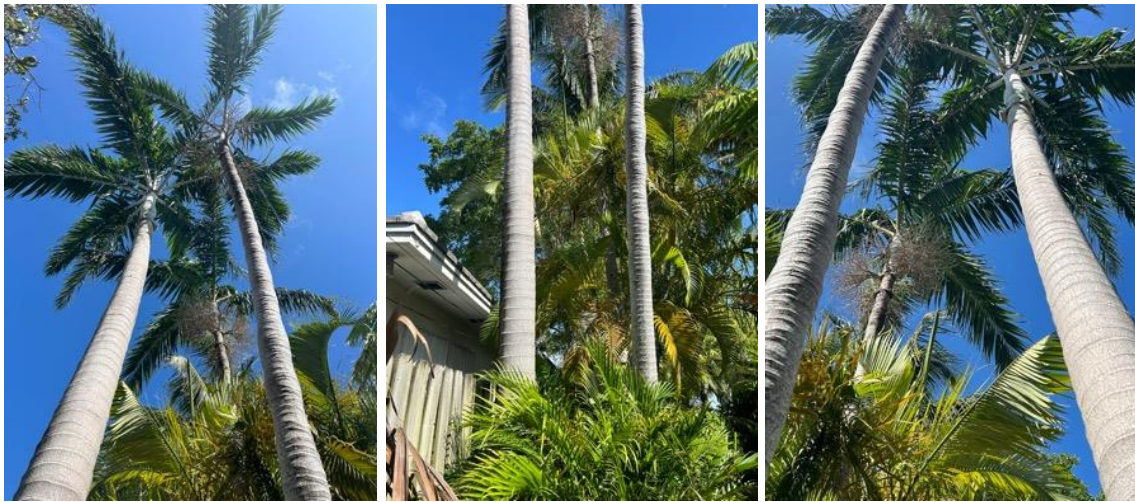
**Trees #28-30 – *Veitchia arecina*, Montgomery Palm** - this refers to 3 palms growing within approximately 3' of each other on the southeast side of Tree #27. They are all somewhat crowded but otherwise in fair to good condition. They are possible candidates to remain with protection during construction per measures below due to their compact root zones and location on the perimeter of the property. If they are removed, they will require a permit and mitigation. They are also possible candidates for relocation onsite as an alternative to removal; see Relocation Specifications below.

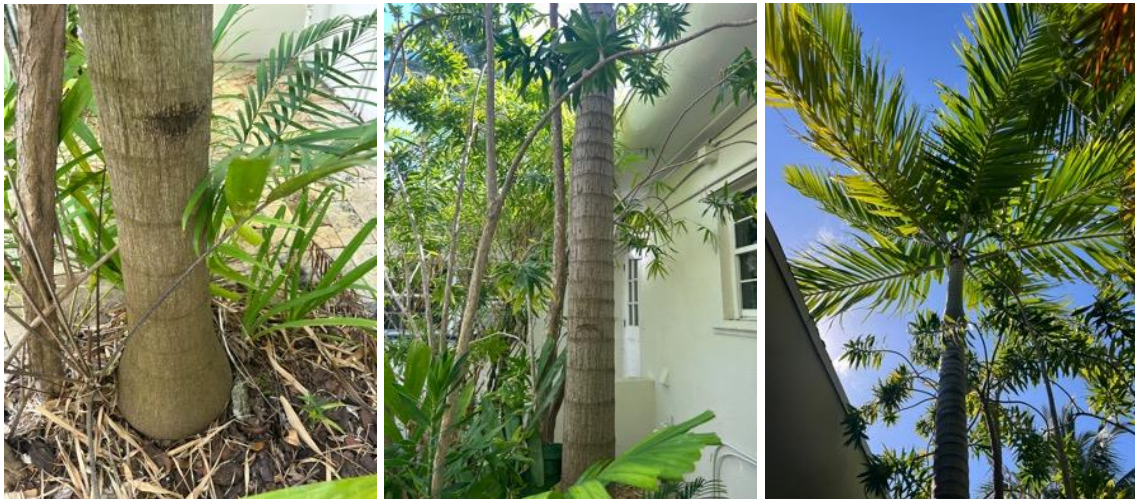
**Tree #31 – *Veitchia arecina*, Montgomery Palm** – this palm is growing on the south side of the AC unit on the east side of the path. It is slightly crowded and slightly chlorotic, but overall it is in fair condition. It is just under regulation height, so it may be eligible for removal without a permit or mitigation.

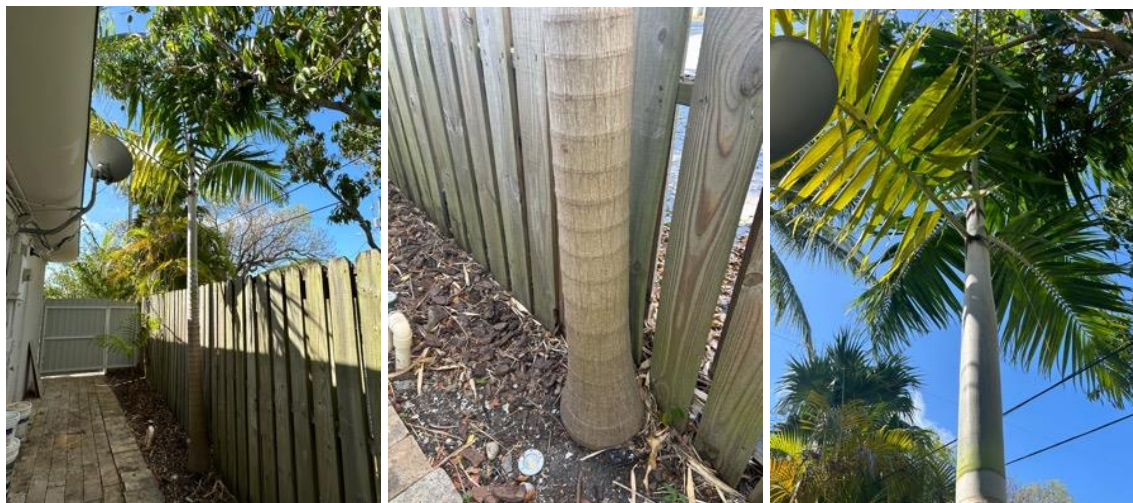
**Tree #32 – *Veitchia arecina*, Montgomery Palm** – this palm is growing against the fence line near the southwest corner of the existing residence. It is likely a volunteer/seedling. It is slightly crowded and slightly chlorotic but overall in fair condition. It is just under regulation size, so it should be eligible for removal without a permit or mitigation. It is also a possible candidate for relocation onsite per specifications below.

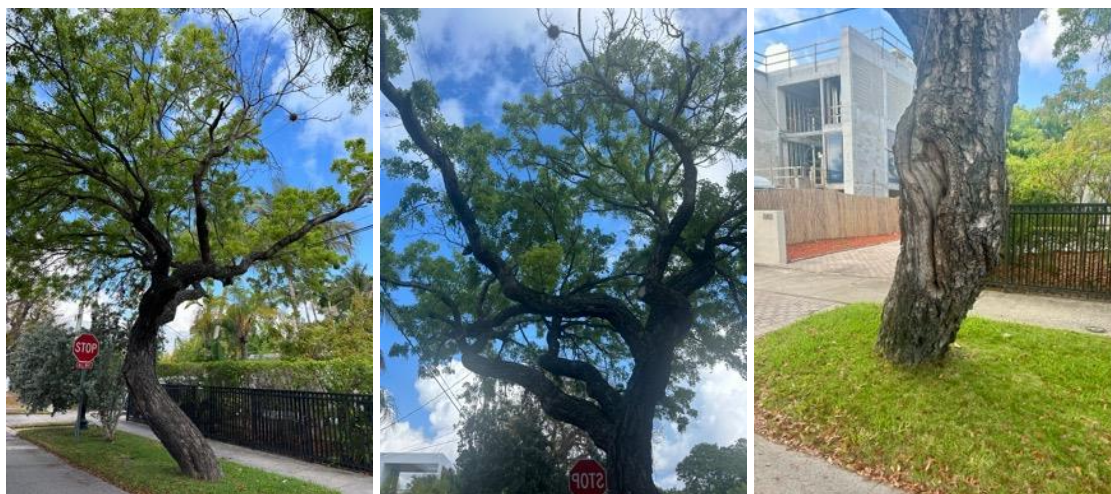
**Tree #33 – *Swietenia mahogani*, Mahogany** – this tree is growing in the ROW. It is leaning slightly and has a somewhat poor branching structure. It is growing in contact with the adjacent utility lines and there are poor cuts with deadwood, dieback and localized decay in this area. There is also a large tear on the trunk from approximately 3.5-5.5' height; it has been fairly well compartmentalized. Overall, this tree is in moderate to borderline fair condition. It will require careful protection per measures below during any staging/access activities within its TPZ, or a permit and likely doubled mitigation if it is removed due to its specimen size.

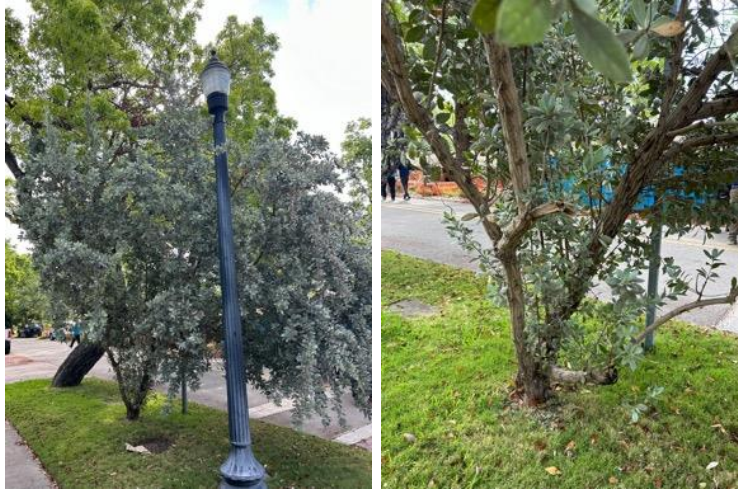
**Tree #34 – *Conocarpus erectus* var. *sericeus*, Silver Buttonwood** – this tree is growing just southwest of Tree #1 in the ROW. It splits into multiple small diameter trunks near ground level with some small tears present along the trunk and lower limbs. It is slightly crowded but otherwise is in fair condition. It is under regulation height, but it is recommended for protection per measures below during all staging/access activities.

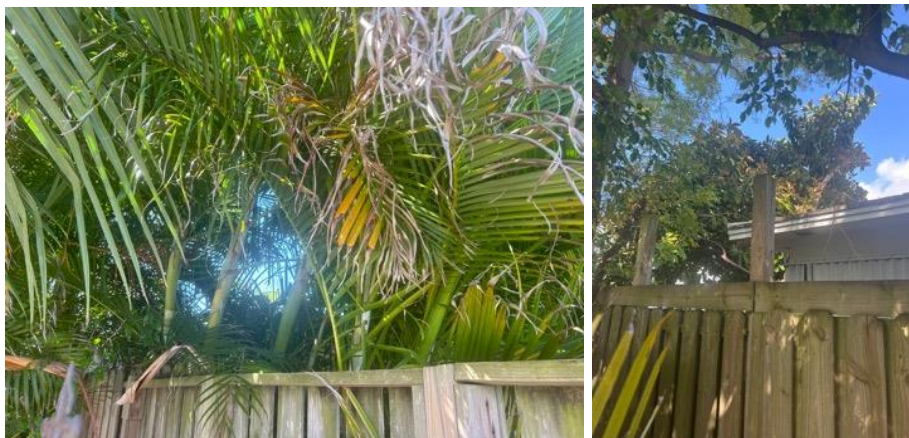
***Dypsis lutescens*, Areca Palm** – this palm cluster is growing outside of the northwest fence line adjacent to Trees #16-18. It is under regulation size. Its TPZ extends less than 1' over the property line, so it is not expected to be impacted, but protection measures below apply.

***Ficus elastica*, Rubber Tree** – this tree is growing on the property to the west adjacent to the backyard. Neither its canopy nor TPZ extend over the property line, so it is not expected to be impacted. In the unlikely event that any roots are encountered on this property, root pruning specifications below apply.

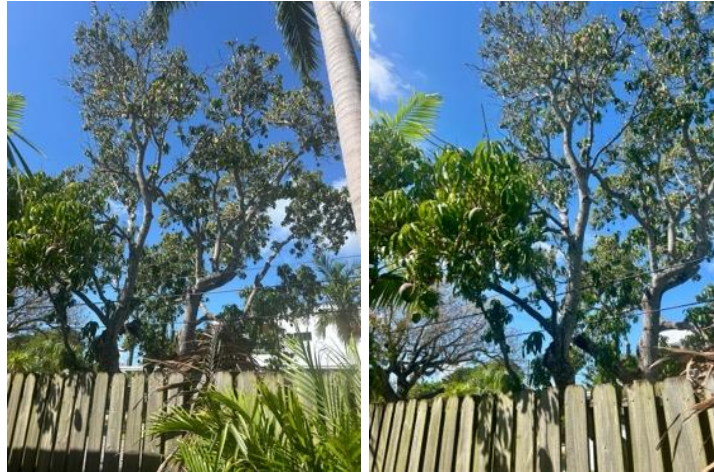
***Mangifera indica*, Mango** – this tree is located on the property to the west. Its trunk is not clearly visible but there is one limb extending approximately 4’ over the property line. This tree will require very careful protection if any work activities take place within its TPZ. Canopy pruning and root pruning specifications below apply.

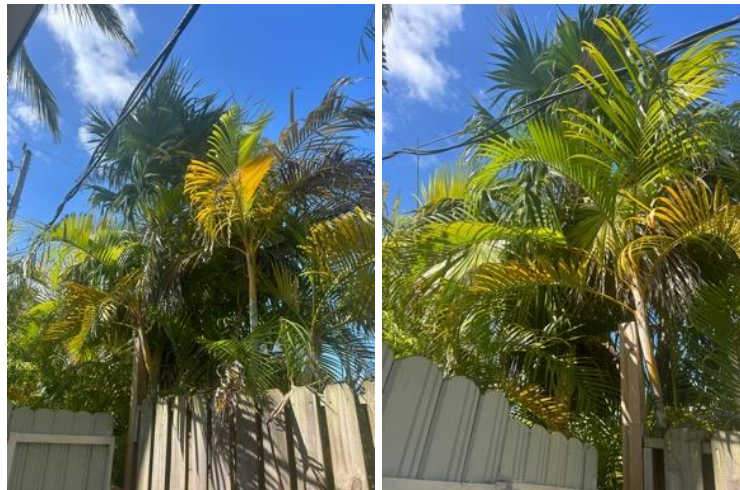
***Dypsis lutescens*, Areca Palm** – this palm cluster is growing outside of the southwest fence line adjacent to Tree #32. It is chlorotic and under regulation size. Its TPZ extends less than 1’ over the property line, so it is not expected to be impacted, but protection measures below apply.

***Thrinax radiata*, Thatch Palm** – this palm is growing in the cluster of Areca Palms on the southwest side of this residence. Its TPZ does not extend over the property line and it should not be impacted.
