## Arborist Report

The Standard Hotel  
40 Island Avenue  
Miami Beach

1/24/2024

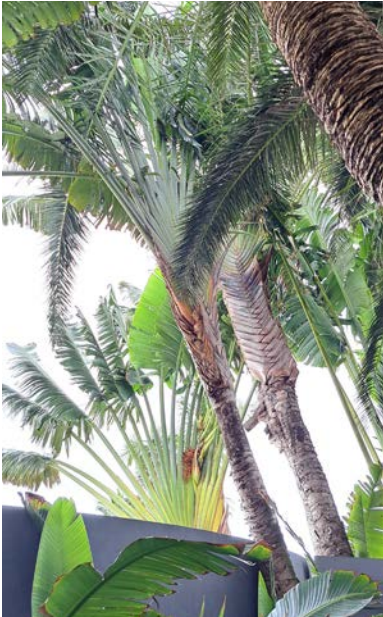
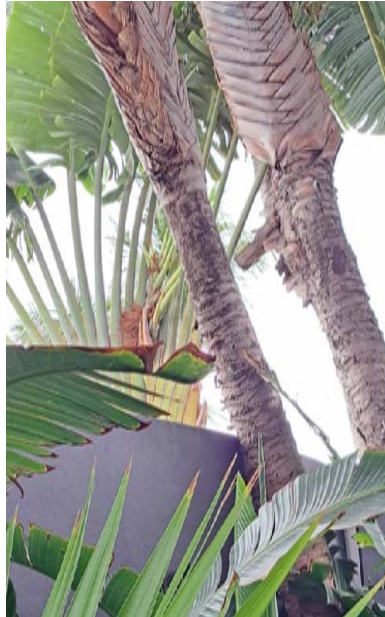
## Tree #3818

Tree #3818 is a Travelers Palm located on the north side of the central gardens. It is in good condition with healthy green fronds.

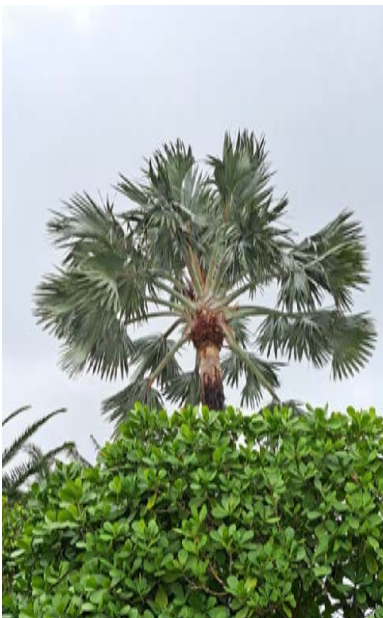
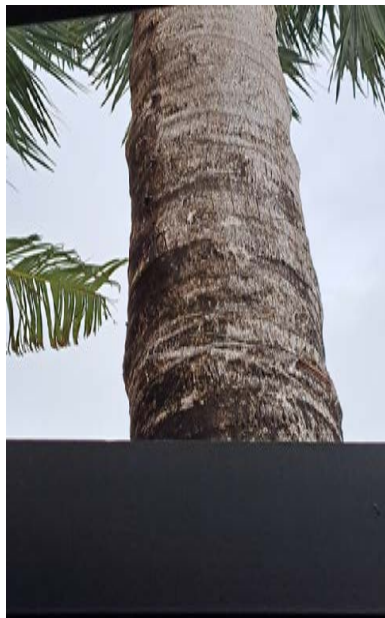
## Tree #3820

Tree #3820 is a Bismarck Palm located on the south side of the pool area. It is in good condition.

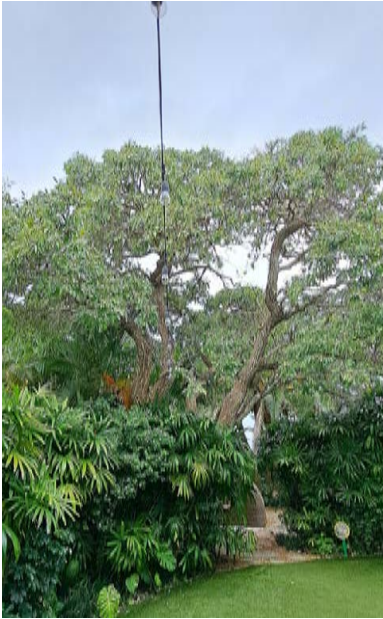
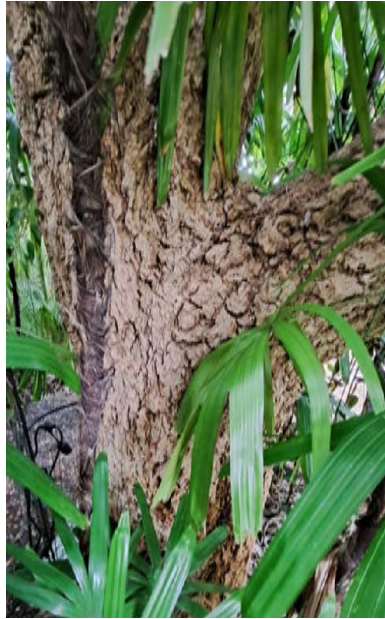
## Tree #3862

Tree #3862 is a Silver Trumpet Tree located in the central gardens. It is in good condition with a nice form. Some small deadwood is present. Prune to remove deadwood and broken limbs.

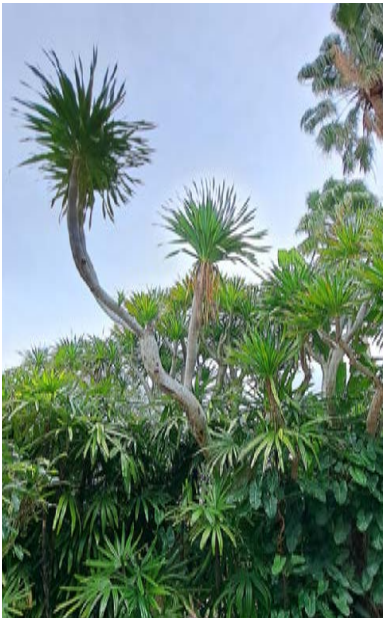
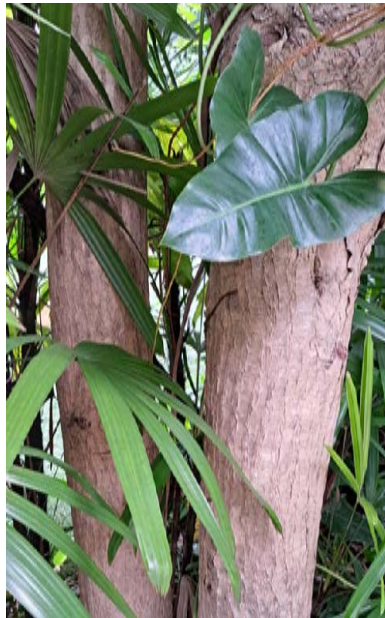
## Tree #3896

Tree #3896 is a Screw Pine located on the west side of the central gardens. It is in fair condition and appears to have been hatracked years ago. There are injuries on a main limb. It is double-trunked.

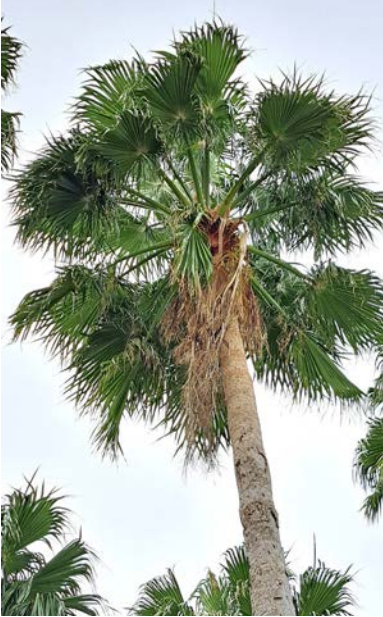
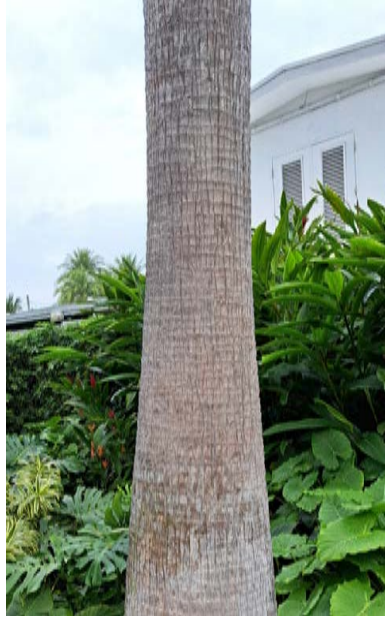
## Tree #3915

Tree #3915 is a Washingtonia Palm located along the central boardwalk area. It is in fair condition. Prune to remove the lower dead fronds.

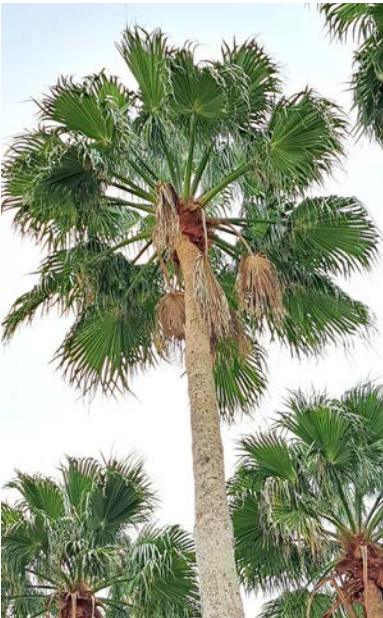
## Tree #3916

Tree #3916 is a Washingtonia Palm located along the central boardwalk area. It is in fair condition. Prune to remove the lower dead fronds.

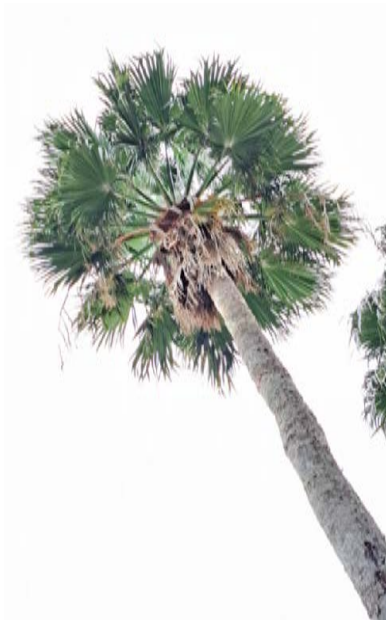
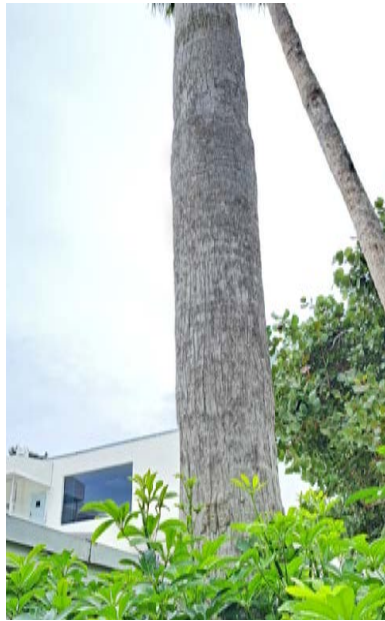
## Tree #3917

Tree #3917 is a Washingtonia Palm located along the central boardwalk area. It is in fair condition with some lower dead fronds.

**Disposition - REMOVE**

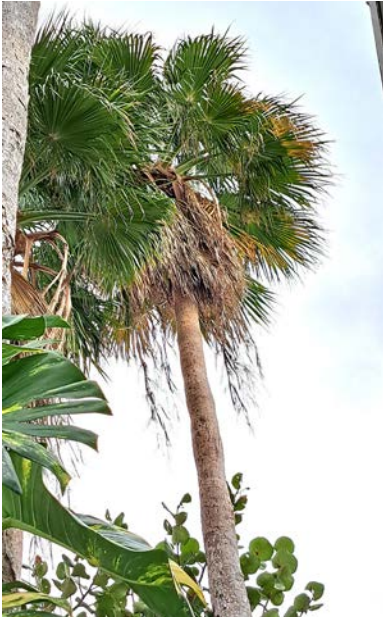
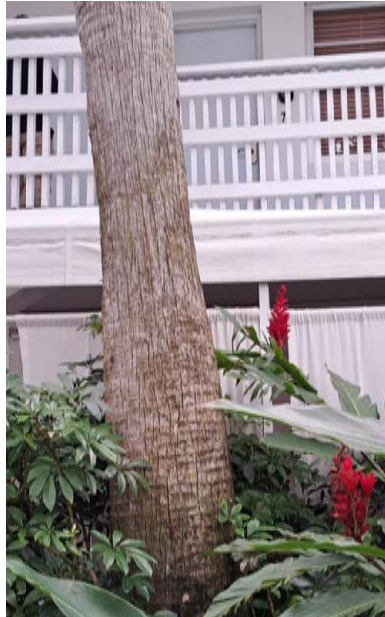
## Tree #3922

Tree #3922 is a Washingtonia Palm located along the central boardwalk area. It is in fair condition with some lower dead fronds.

**Disposition -** REMOVE

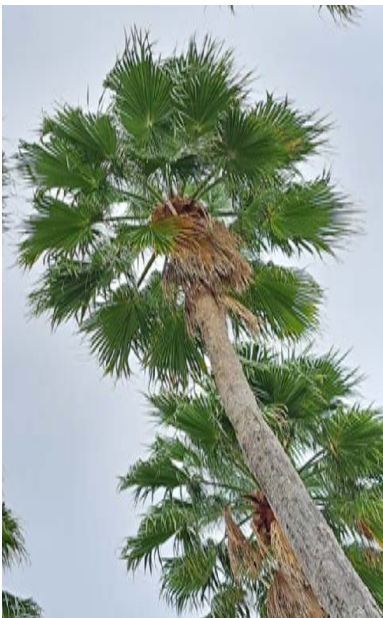
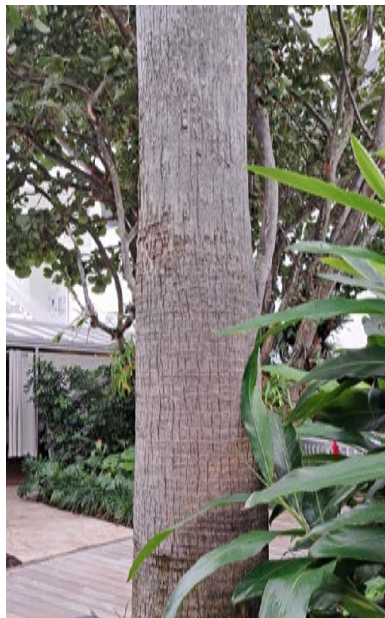
## Tree #3923

Tree #3923 is a Washingtonia Palm located along the central boardwalk area. It is in fair condition. Prune to remove the lower dead fronds.

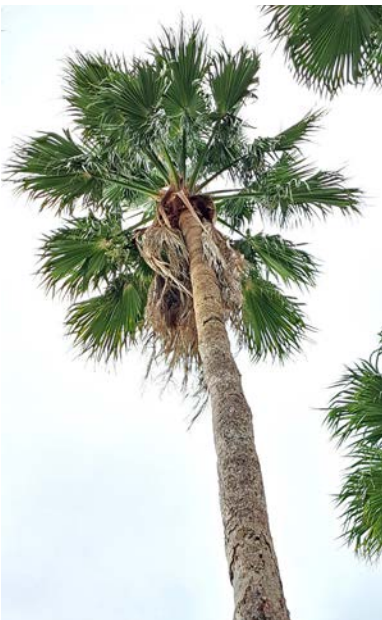
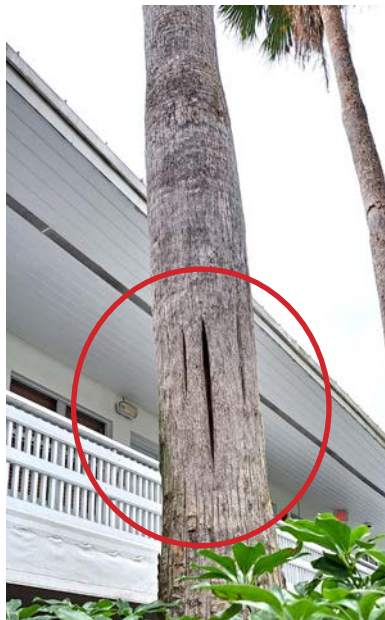
## Tree #3925

Tree #3925 is a Washingtonia Palm located along the central boardwalk area. It is in poor condition with some lower dead fronds. Trunk cracks are present (circled in red).

**Disposition -** REMOVE

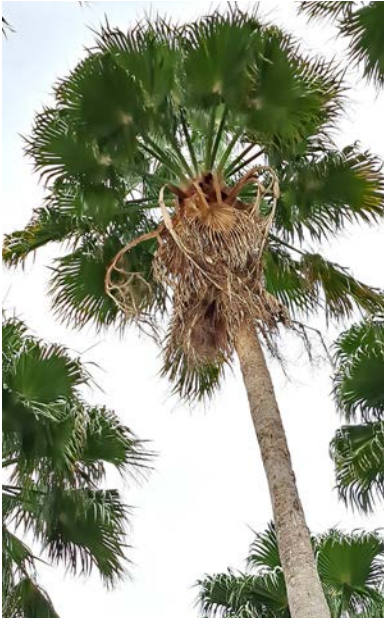
## Tree #3926

Tree #3926 is a Washingtonia Palm located along the central boardwalk area. It is in fair condition. Prune to remove the lower dead fronds.

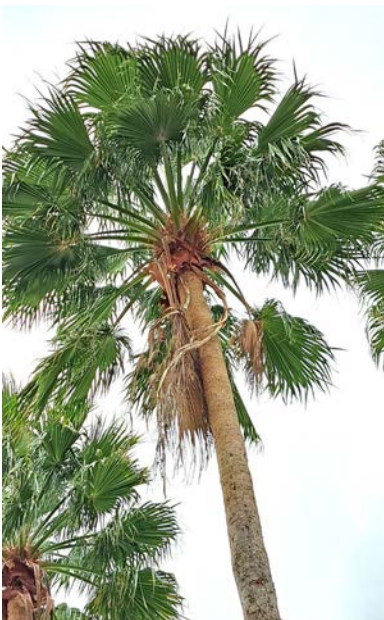
## Tree #3927

Tree #3927 is a Washingtonia Palm located along the central boardwalk area. It is in fair condition. Prune to remove the lower dead fronds.

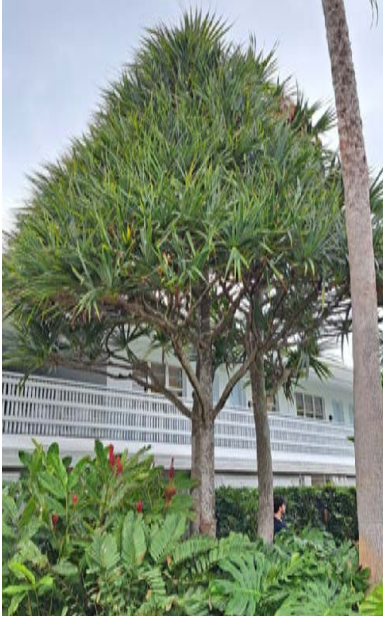
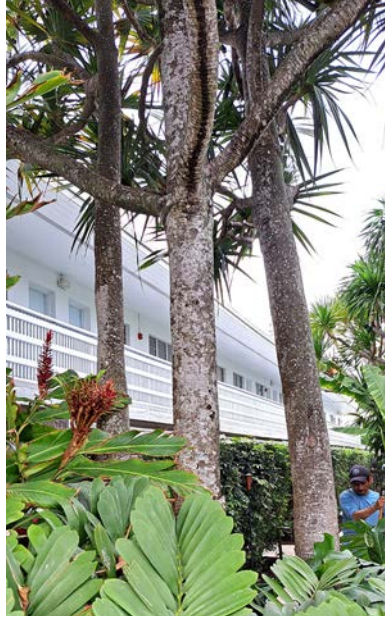
## Tree #3930

Tree #3930 is a Screw Pine located along the central boardwalk area. It is triple-trunked and in good condition. It has been pruned into a tight, pyramidal shape.

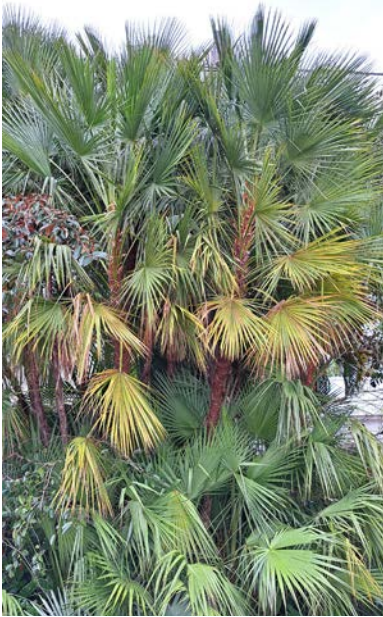
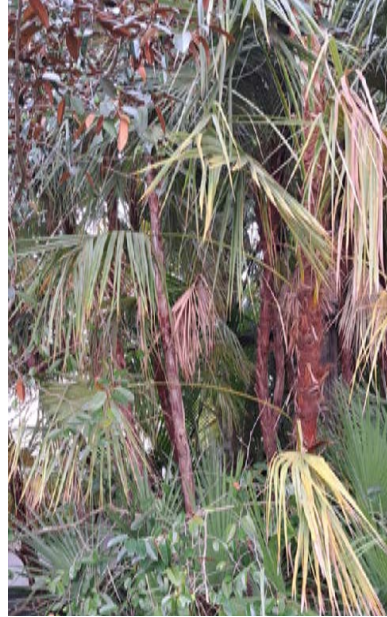
## Tree #3949

Tree #3949 is an Everglades Palm located on the east side of the property. It is multi-trunked and in fair condition with some yellowing fronds.

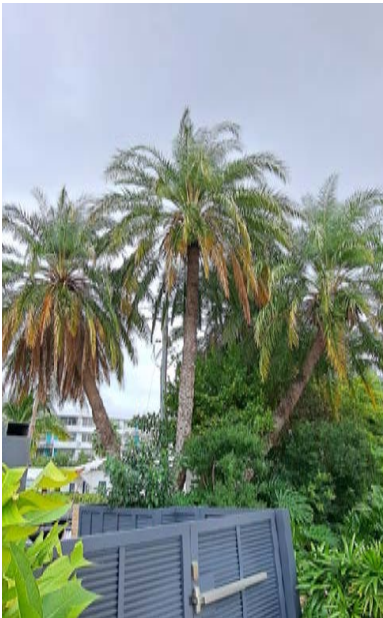
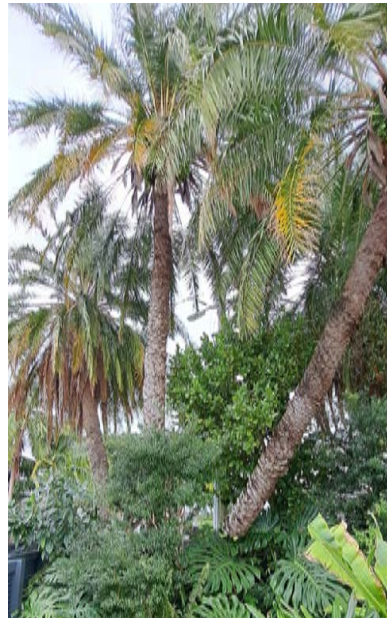
## Trees #3952 - 3955

Trees #3952 - 3955 are four Date Palms located on the east side of the property. They are in fair condition with some lower yellowing and brown fronds. Prune to remove the lower dead fronds.

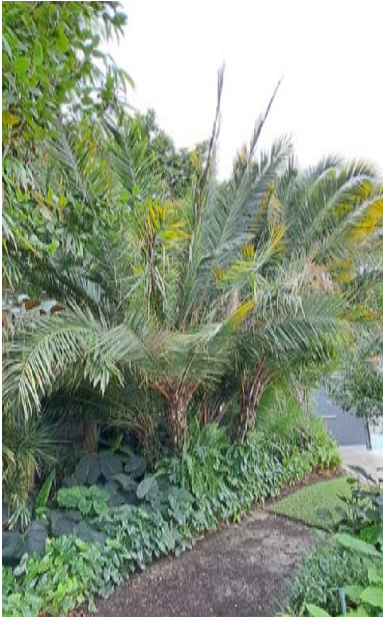
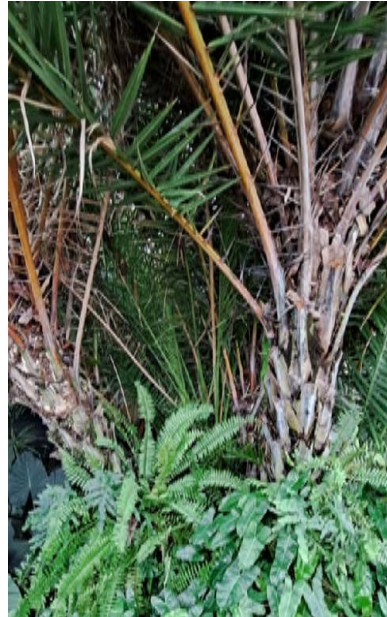
## Tree #3990

Tree #3990 is a triple-trunked Date Palm located on the east side of the property. It is in fair condition with some yellowing on the fronds.

**Disposition -** REMOVE

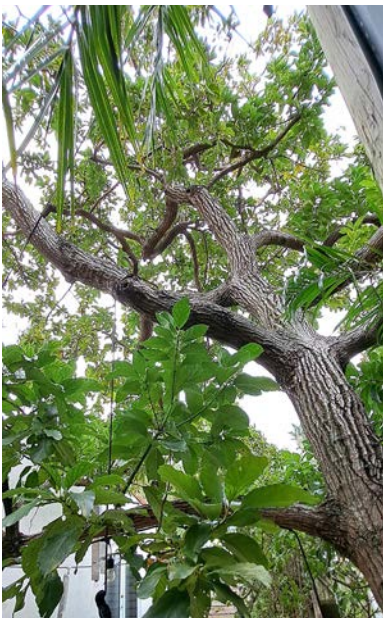
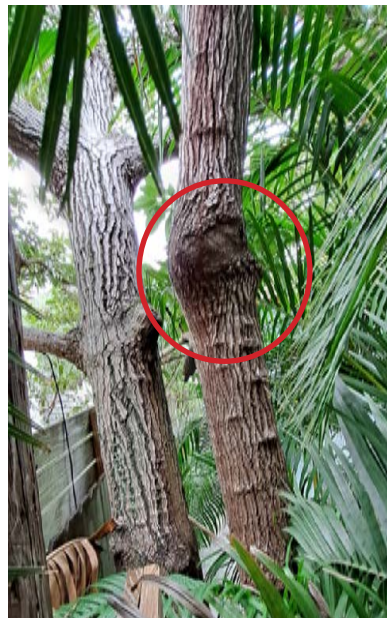
## Tree #4001

Tree #4001 is an Avocado Tree located on the east side of the property. It is located on the other side of the existing fence and the canopy spreads into the neighboring property. The tree is in fair condition. There are small cavities with decay and the tree has low vigor. There is a burl on one of the two main trunks (circled in red).

**Disposition -** REMOVE

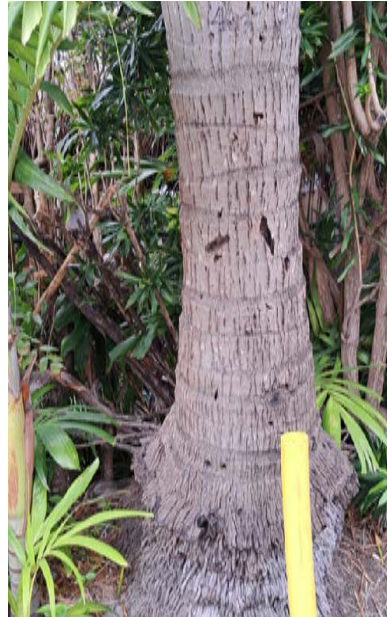
## Tree #4035

Tree #4035 is a Coconut Palm street tree located along Island Avenue. It is in fair condition with climbing spike injuries to the trunk. Continue to remove the coconut fruits.

**Disposition - REMOVE**
