# ARBORIST REPORT

1265 N. Biscayne Point Rd.  
Miami Beach, FL 33141

Treage LLC was contacted by Andres Montero of AMLA Studio to conduct a Certified Arborist Report at 1265 N. Biscayne Point Rd., Miami Beach, FL

The site consists of an existing single-family home proposed for demolition and new construction of a single-family home. There are 34 trees located onsite, as well as 5 trees located offsite, that are referenced below.

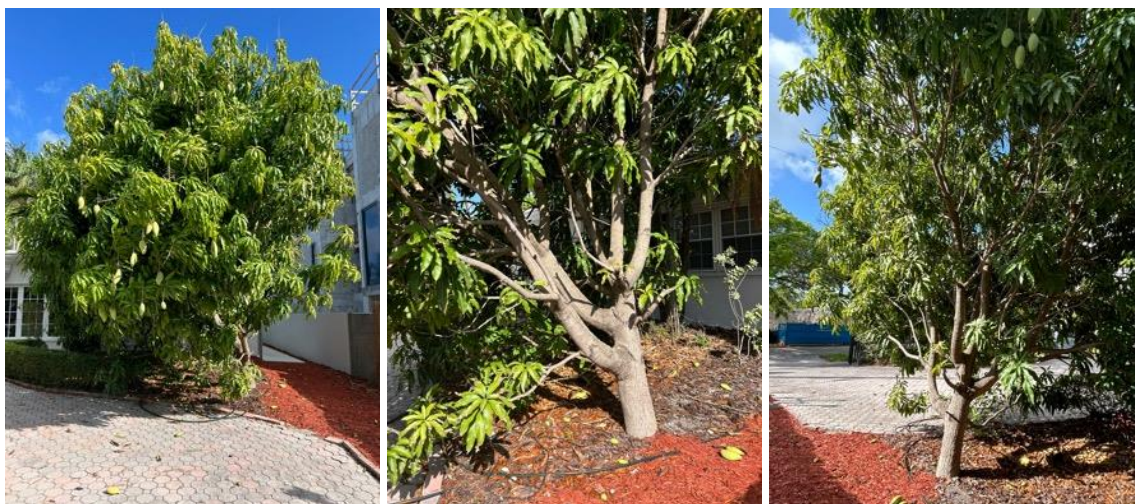
**Tree #4 – *Mangifera indica*, Mango** – this tree is located near the northeast side of the driveway in front of the southeast corner of the residence. It splits into multiple trunks between 3-4' height. It is slightly crowded with a dense canopy, minor deadwood and small tears along the east side of the canopy adjacent to the walkway. Overall, it is in fair condition.

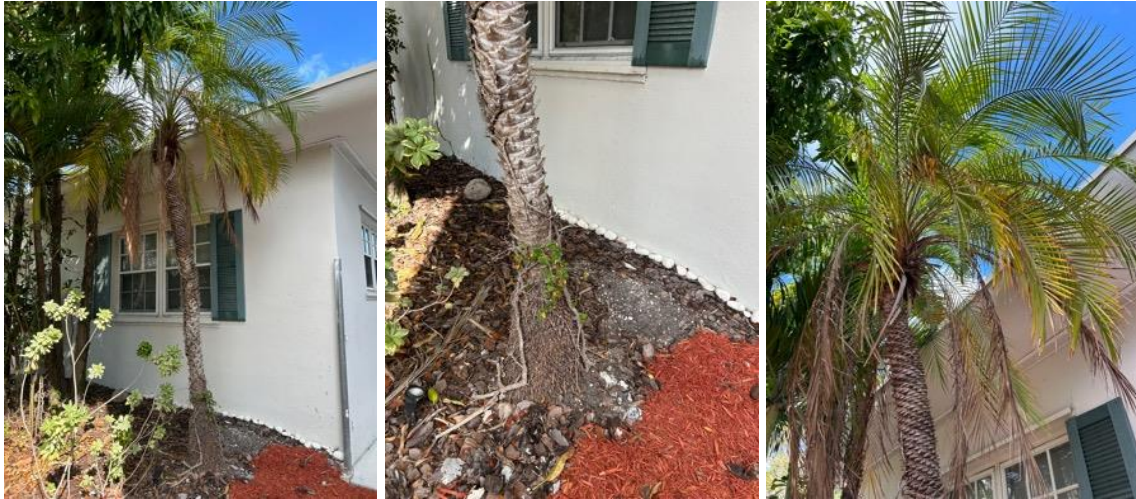
**Tree #5 – *Phoenix roebellini*, Pygmy Date Palm** – this palm is located within 3.5’ of the southeast corner of the existing residence. It exhibits minor chlorosis and is in fair condition. It is under regulation size, so it should be eligible for removal without regulation if necessary.

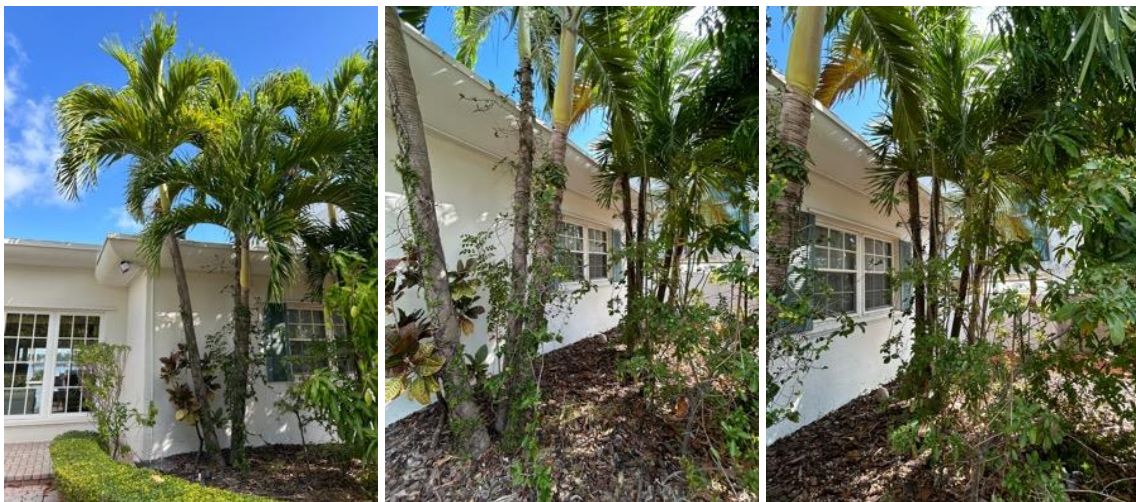
**Tree #6 – *Adonidia merrillii*, Christmas Palm** – this refers to a triple palm growing just south of the southeast side of the existing residence. It is crowded and has a slightly weak growth habit as a result. Overall, it is in fair condition. It will require a permit and mitigation if it is removed. It is a possible candidate for relocation onsite; see Relocation Specifications below.

**Tree #7 – *Adonidia merrillii*, Christmas Palm** – this refers to a triple palm growing just west of Tree #6 on the east side of the entrance to the existing residence. It is slightly crowded with minor chlorosis but otherwise is in fair condition. It will require a permit and mitigation if it is removed. It is a possible candidate for relocation onsite; see Relocation Specifications below.

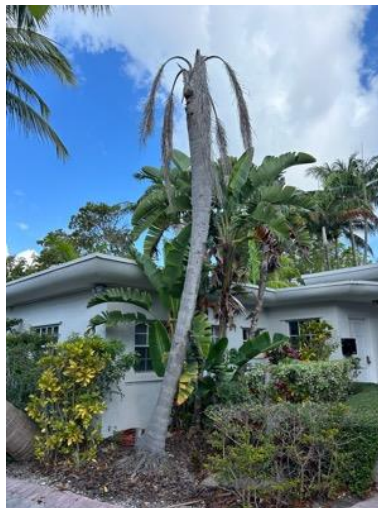
**Tree #9 – *Syagrus romanzoffiana*, Queen Palm** – this palm is located just northeast of Tree #8 on the west side of the front walkway/entrance. It is dead with no remaining live fronds. It should be eligible for removal without regulation, to be confirmed by the City.

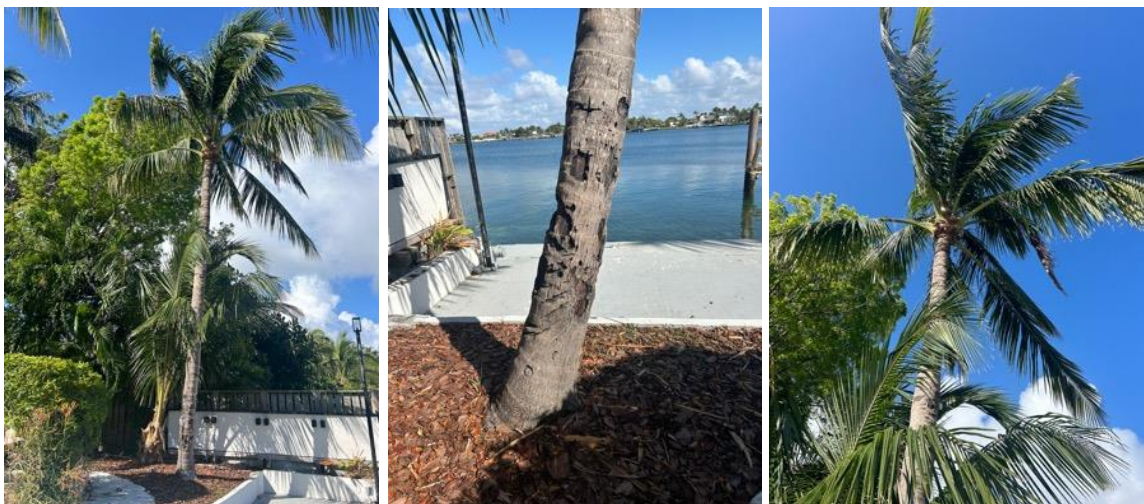
**Tree #15 – *Cocos nucifera*, Coconut** – this palm is growing on the northwest side of the property/pool area near the seawall and within 3' of the limestone path. It has minor to moderate trunk damage but otherwise is in fair condition. It is a possible candidate to remain with protection due to its compact root zone and location near the perimeter of the property. Otherwise, it will require a permit and mitigation if it is removed. There is a small seedling Coconut approximately 5' behind it with no clear trunk that should be eligible for removal without regulation.

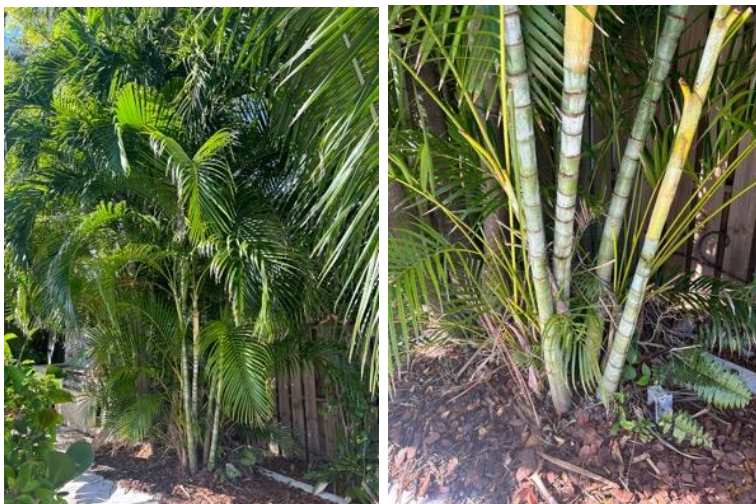
**Tree #16 – *Dypsis lutescens*, Areca Palm** – this palm is growing next to the property line in the northwest corner of the property. It is very crowded but otherwise in fair condition. It is under regulation height, so it should be eligible for removal without regulation if necessary. Otherwise, it is recommended for protection per measures below if it remains.

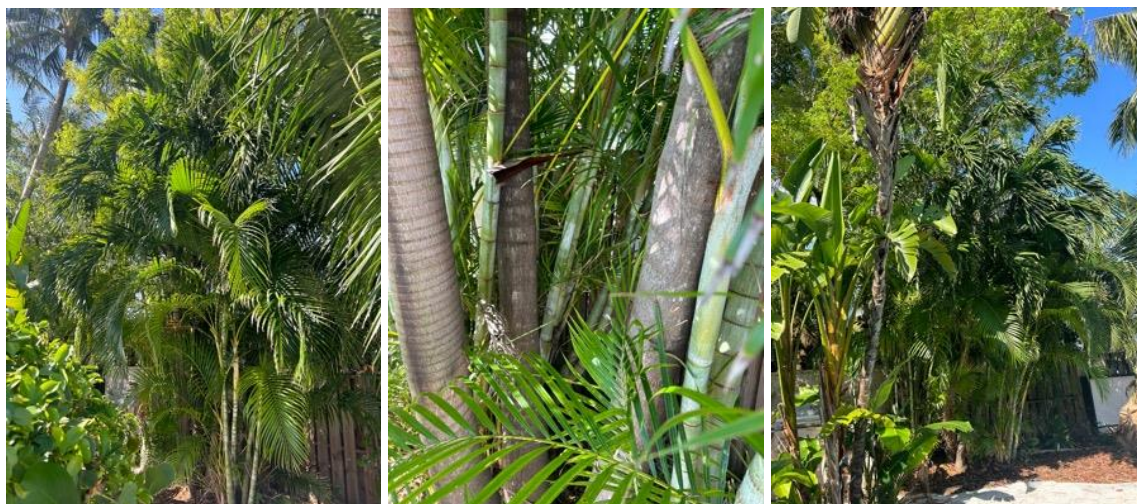
**Tree #17 – *Adonidia merrillii*, Christmas Palm** – this refers to a triple palm growing next to Tree #16. It is very crowded but otherwise in fair condition. It will require a permit and mitigation if it is removed, or protection per measures below if it remains.

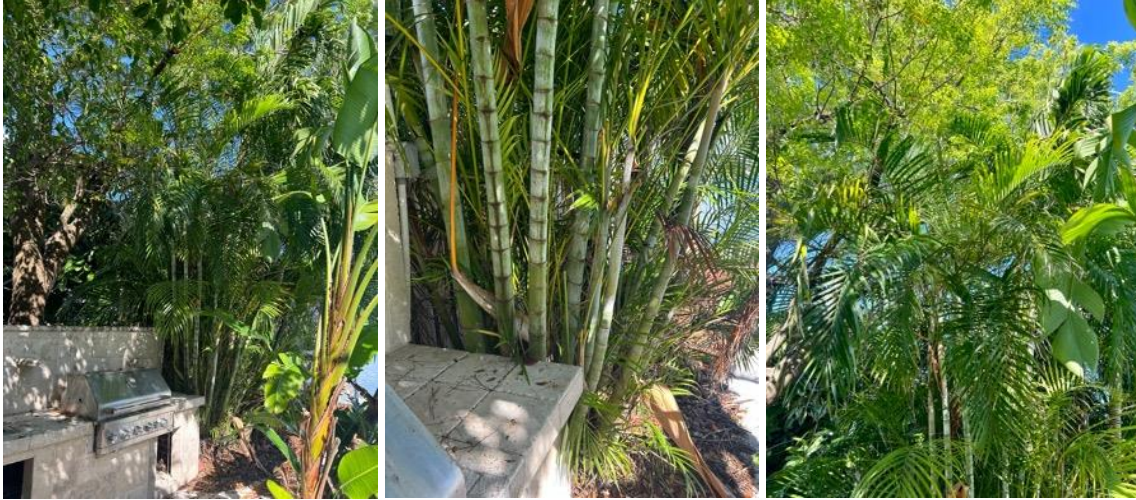
**Tree #18 – *Dypsis lutescens*, Areca Palm** – this refers to a small Areca cluster growing on the south side of Tree #17. It is very crowded but otherwise in fair condition. It is under regulation height, so it should be eligible for removal without regulation if necessary. Otherwise, it is recommended for protection per measures below if it remains.

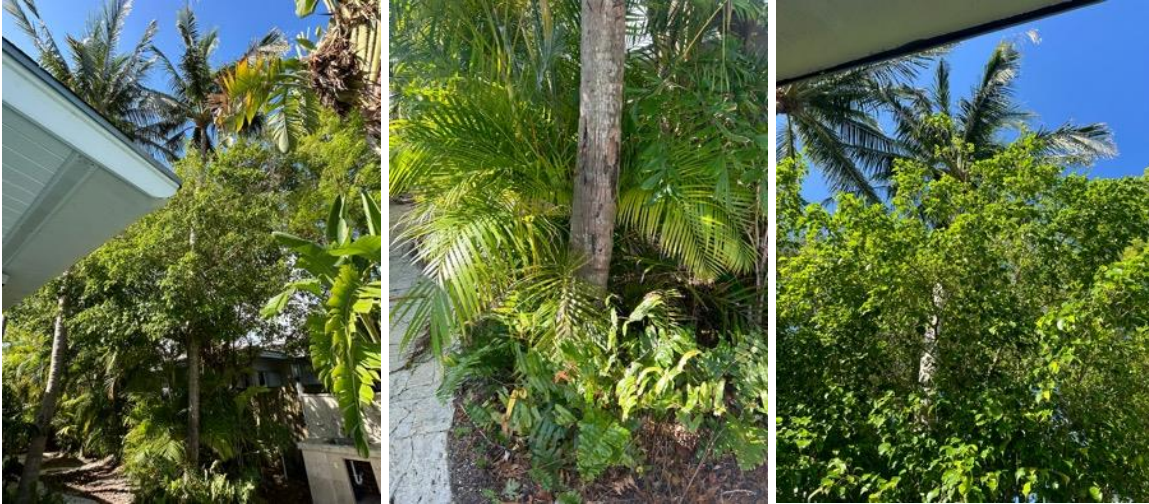
**Tree #20 – *Cocos nucifera*, Coconut** – this palm is growing along the walkway on the southwest side of the residence. It is crowded with minor trunk damage but otherwise is in fair condition. It will require a permit and mitigation if it is removed. Otherwise, it will require very careful protection per measures below during all work activities, including demolition.

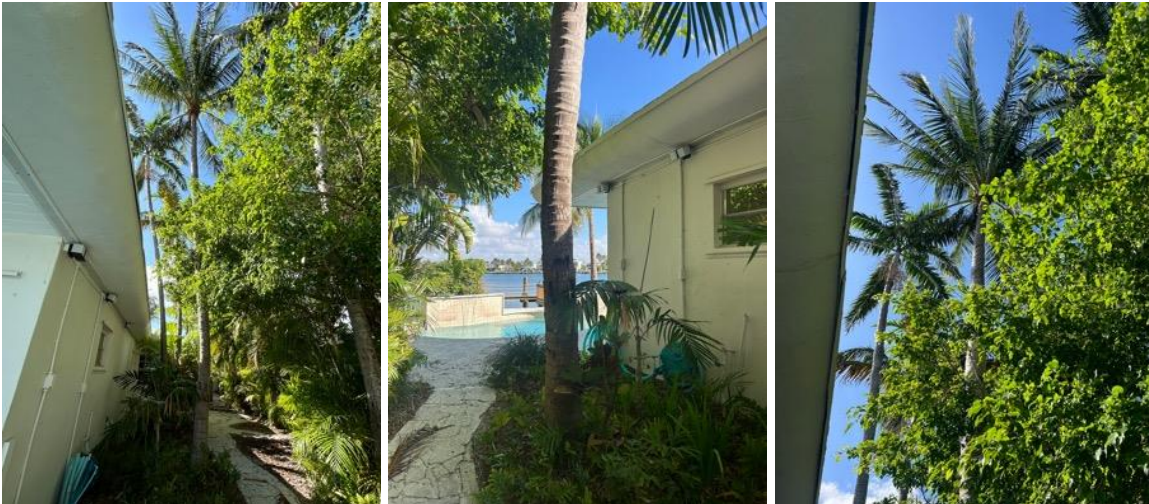
**Tree #21 – *Cocos nucifera*, Coconut** – this palm is growing on the opposite side of the walkway just southeast of Tree #20; it is within 2' of the path and 6' of the existing residence. It has minor to moderate trunk damage present but otherwise is in fair condition. It will require a permit and mitigation if it is removed. Otherwise, it will require very careful protection per measures below during all work activities, including demolition.

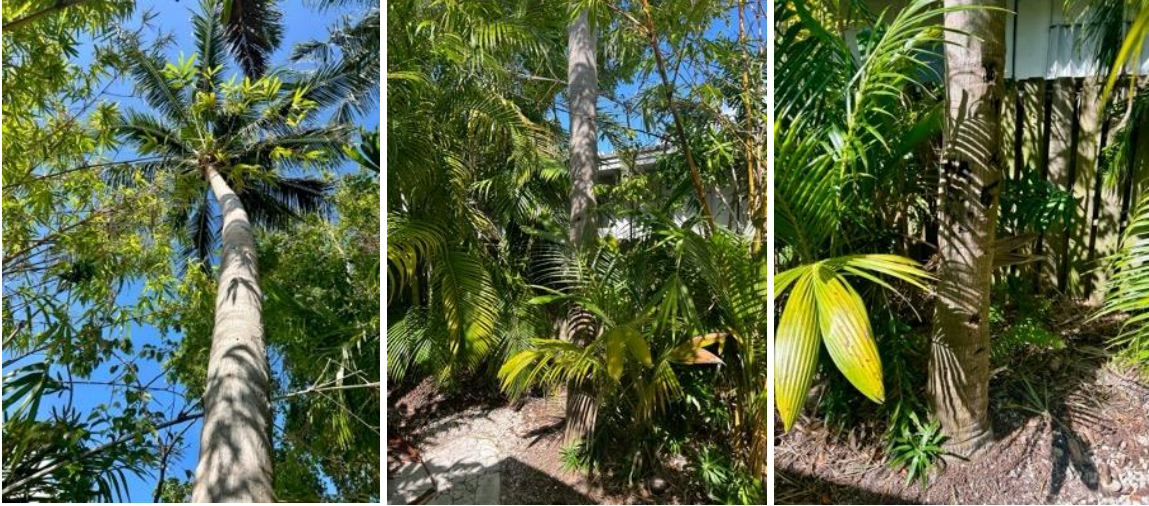
**Tree #25 – *Dypsis lutescens*, Areca Palm** – this palm is growing on the southeast side of Tree #24. It is crowded but otherwise in fair condition. It is under regulation size, so it should be eligible for removal without a permit or mitigation if necessary.

**Tree #26 – *Cocos nucifera*, Coconut** – this palm is growing slightly southeast of Tree #24 on the west side of the walkway. It is slightly crowded with minor trunk damage but otherwise is in fair condition. It will require a permit and mitigation if it is removed. Otherwise, it will require very careful protection per measures below during all work activities, including demolition.

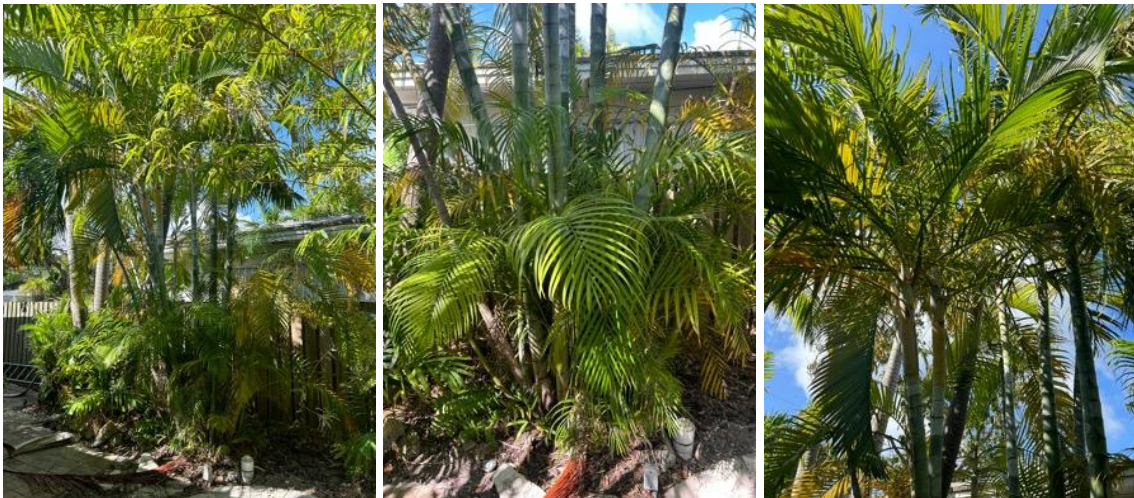
**Tree #27 – *Dypsis lutescens*, Areca Palm** – this palm cluster is growing approximately 7' southeast of Tree #26 and within 4' of the wall and 5' of the path on the west side of the property. It is crowded and overgrown but otherwise in fair condition. It is under regulation height so it should be eligible for removal without regulation if necessary.

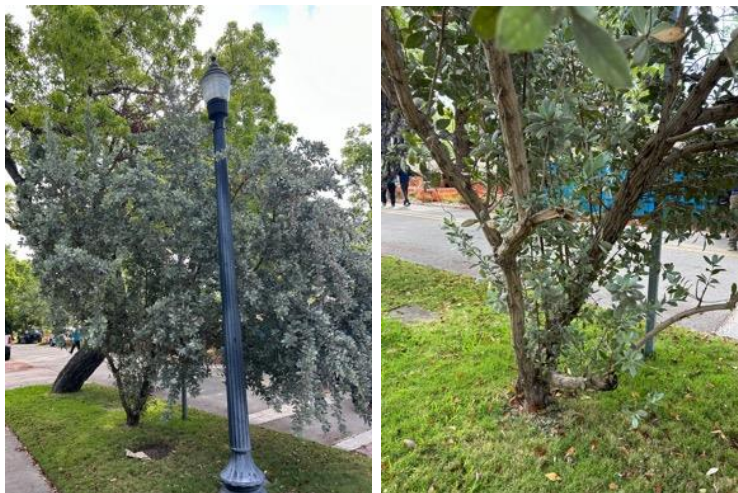
**Tree #34 – *Conocarpus erectus* var. *sericeus*, Silver Buttonwood** – this tree is growing just southwest of Tree #1 in the ROW. It splits into multiple small diameter trunks near ground level with some small tears present along the trunk and lower limbs. It is slightly crowded but otherwise is in fair condition. It is under regulation height, but it is recommended for protection per measures below during all staging/access activities.

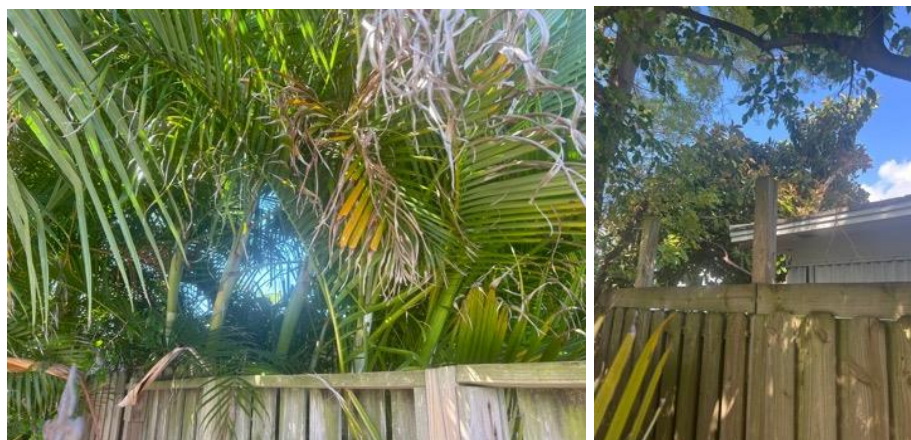
***Dypsis lutescens*, Areca Palm** – this palm cluster is growing outside of the northwest fence line adjacent to Trees #16-18. It is under regulation size. Its TPZ extends less than 1' over the property line, so it is not expected to be impacted, but protection measures below apply.

***Ficus elastica*, Rubber Tree** – this tree is growing on the property to the west adjacent to the backyard. Neither its canopy nor TPZ extend over the property line, so it is not expected to be impacted. In the unlikely event that any roots are encountered on this property, root pruning specifications below apply.

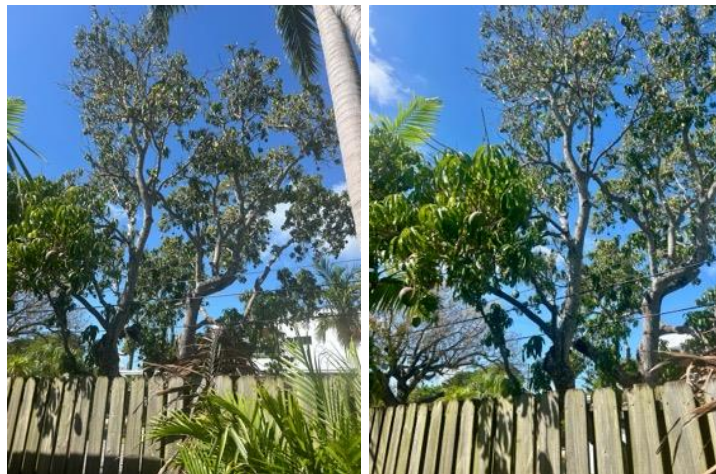
***Mangifera indica*, Mango** – this tree is located on the property to the west. Its trunk is not clearly visible but there is one limb extending approximately 4' over the property line. This tree will require very careful protection if any work activities take place within its TPZ. Canopy pruning and root pruning specifications below apply.

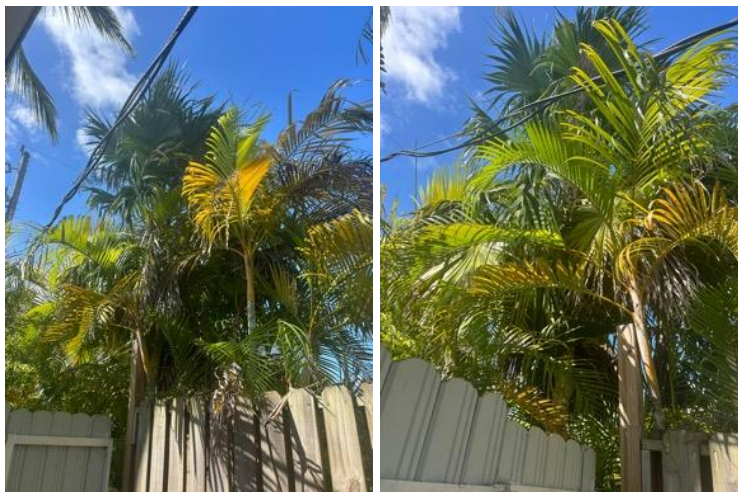
***Dypsis lutescens*, Areca Palm** – this palm cluster is growing outside of the southwest fence line adjacent to Tree #32. It is chlorotic and under regulation size. Its TPZ extends less than 1' over the property line, so it is not expected to be impacted, but protection measures below apply.

***Thrinax radiata*, Thatch Palm** – this palm is growing in the cluster of Areca Palms on the southwest side of this residence. Its TPZ does not extend over the property line and it should not be impacted.
