ALVEY TREE CONSULTING LLC

Arborist Report

7410 Collins Avenue
Miami Beach

6/22/2023

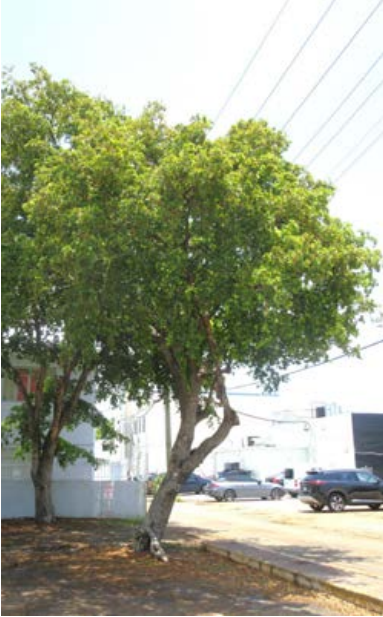
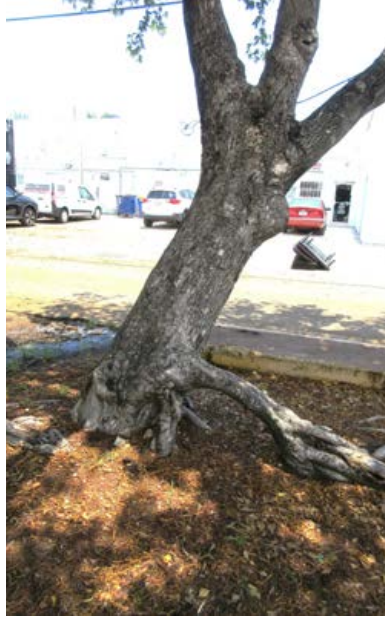
Tree #1

Tree # 1 is a Black Olive in poor condition. The tree has a poor root system and large surface roots are present. There is an injury at the base of the trunk. The tree has low vigor and old pruning cuts are not closing over. Prune to remove deadwood and to maintain clearance over the parking lot.

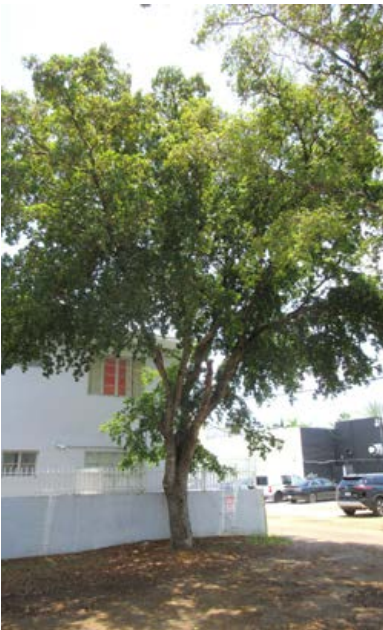
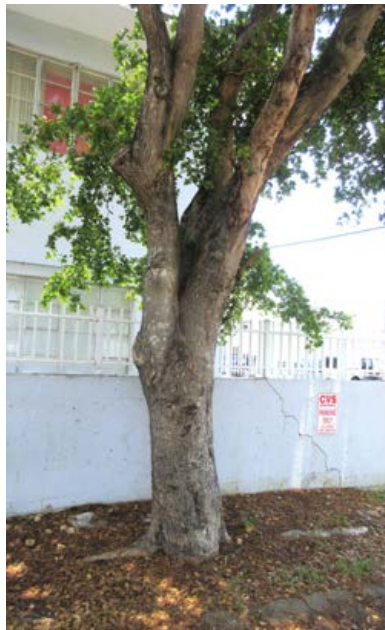
Tree #2 is a Black Olive in fair condition. A large, dead limb is present. There is included bark between the limbs. Large surface roots are present. Prune to remove deadwood and to maintain clearance over the parking lot.

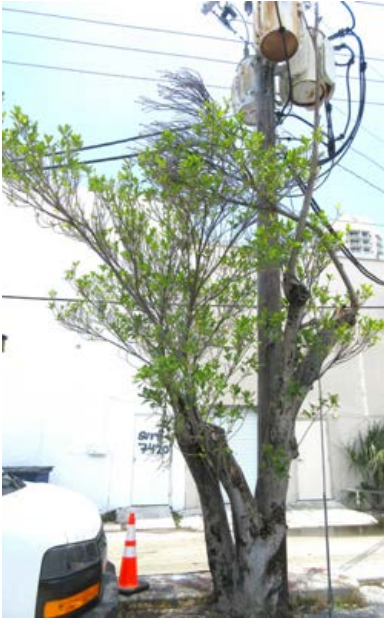
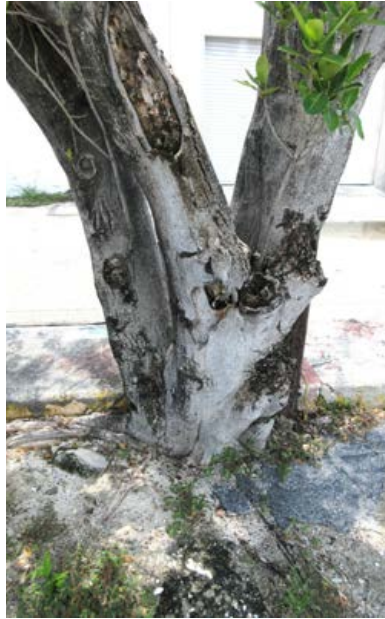
Tree #3 is an Indian-Laurel in poor condition. The canopy has been hatracked and there is little foliage that remains. Overhead wires are above. The tree has very limited rooting space. This species is highly invasive in South Florida and this tree will therefore need to be removed.

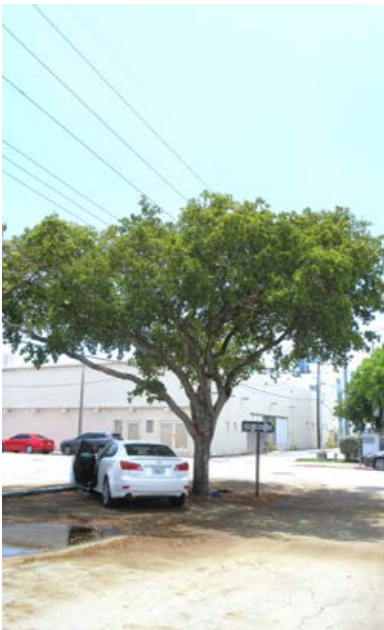
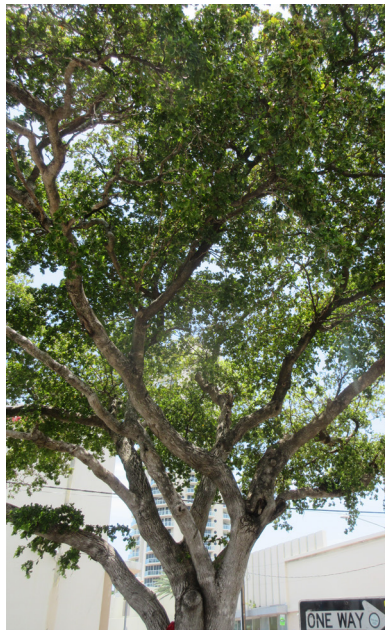
Tree #4 is a Black Olive in good condition. There are crossing limbs and included bark between limbs. Large surface roots are present. Prune to remove deadwood and to increase clearance over the parking lot, sidewalk, and street.

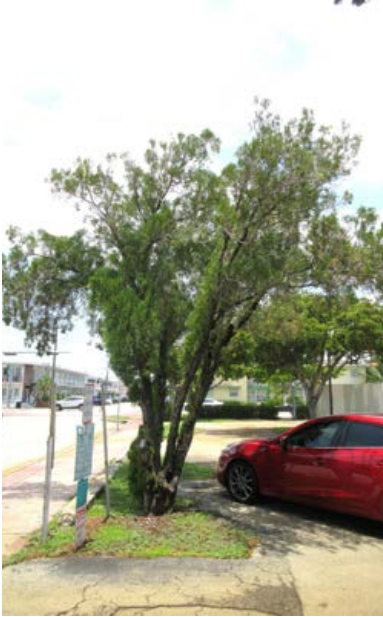
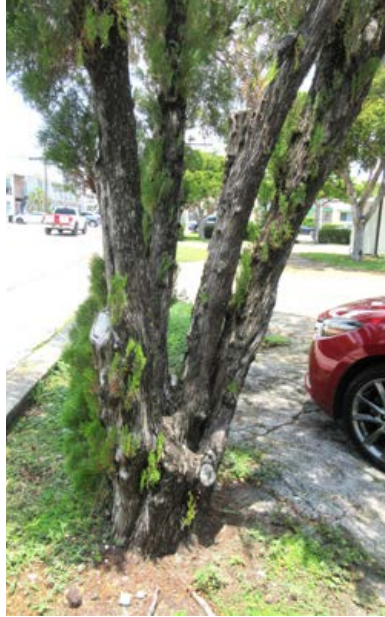
Tree #5 is an Arborvitae in fair condition. The tree is multi-trunked and has twig dieback. The tree has low vigor and no woundwood has formed on old pruning cuts. Prune to remove deadwood and to increase clearance over the parking lot and sidewalk.

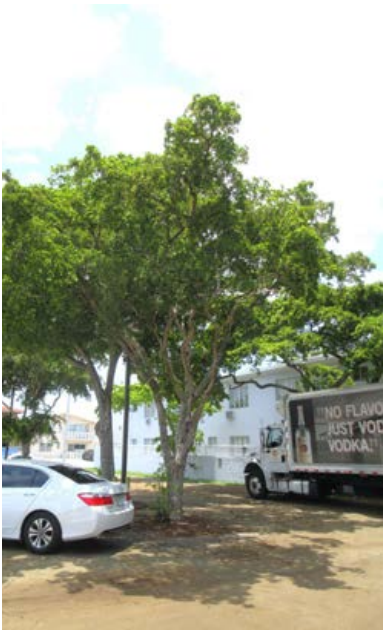
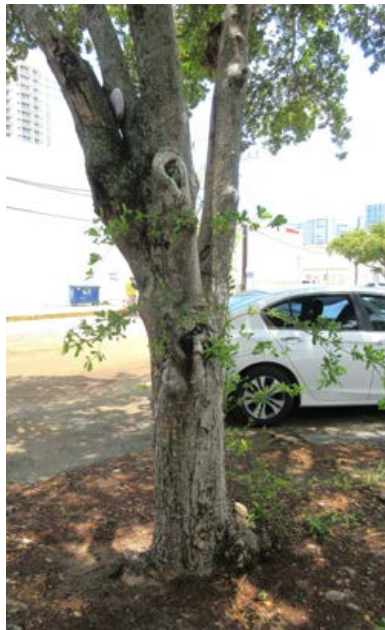
Tree #6 is a Black Olive in fair condition. Included bark and wetwood are present. A number of limbs have been injured by passing large vehicles. There is a burl at the base of the trunk. Cavities have formed at old pruning cuts. Prune to remove deadwood and to increase clearance over the parking lot.

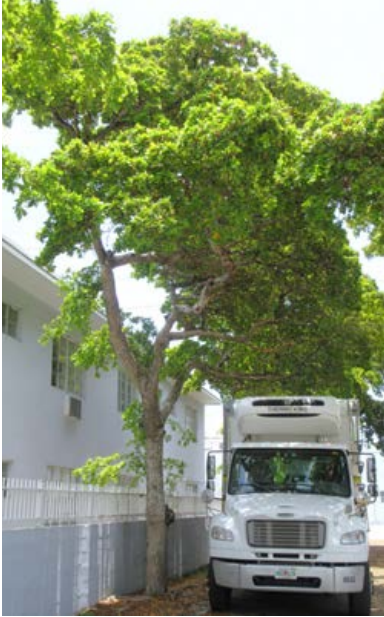
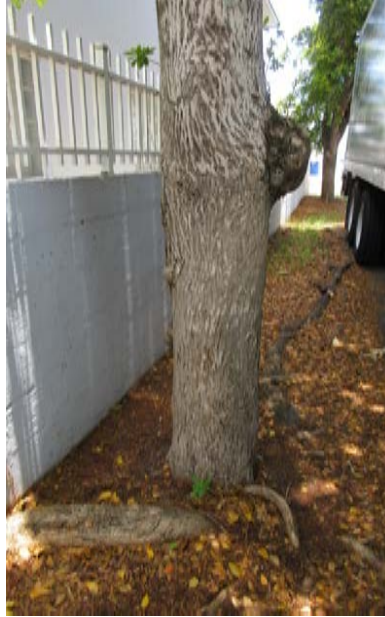
Tree #7 is a Black Olive in fair condition. The canopy is asymmetrical and has been pruned away from the neighboring building. There is a burl on the main trunk and a cavity on one of the main limbs. Large surface roots are present.

Prune to remove deadwood and to maintain clearance over the parking lot.

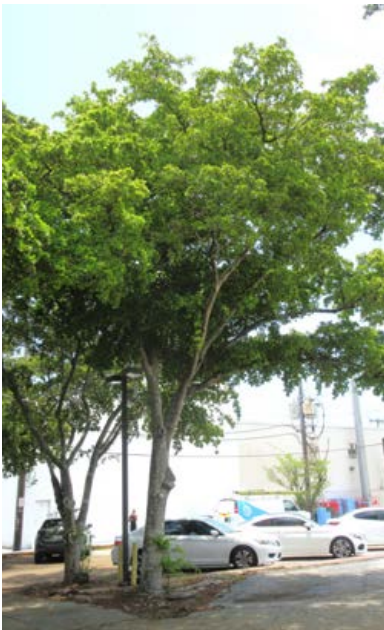
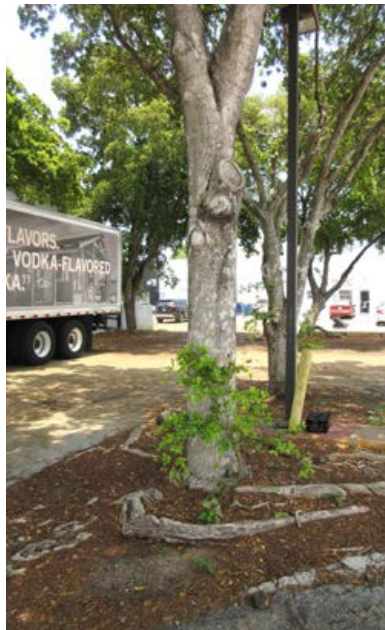
Tree #8 is a Black Olive in fair condition. There is included bark between the limbs. Large surface roots are present. There is sapsucker damage to the trunk.

Prune to remove deadwood and to maintain clearance over the parking lot.

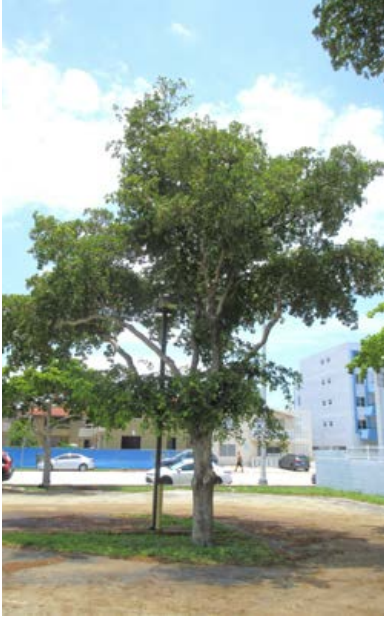
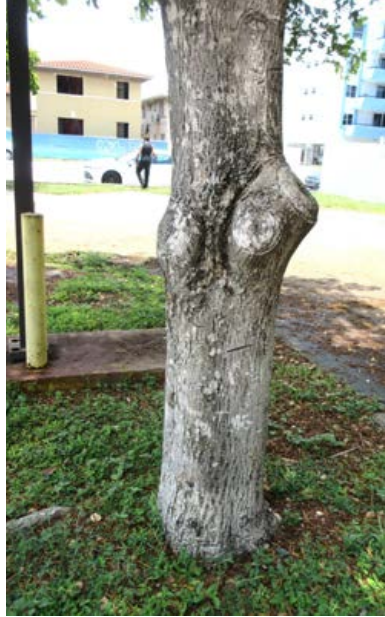
Tree #9 is a Black Olive in fair condition. There is included bark between the limbs. Burls on the trunk have formed from old pruning cuts. Large surface roots are present. Wetwood is also present. Prune to remove deadwood and to maintain clearance over the parking lot.

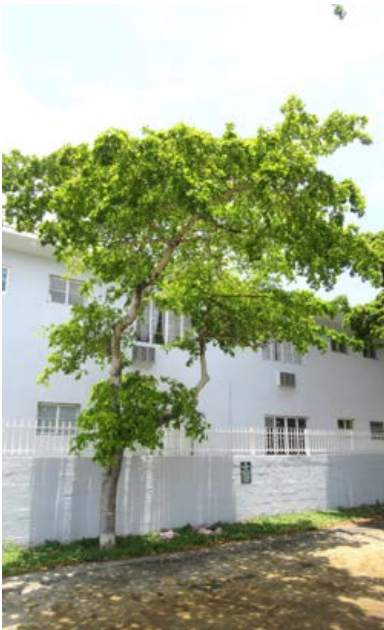
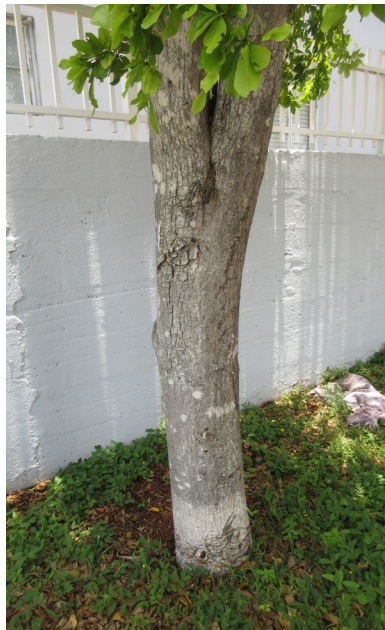
Tree #10 is a Black Olive in fair condition. The foliage is very chlorotic and there is included bark. Large surface roots are present. Prune to remove deadwood and to maintain clearance over the parking lot.

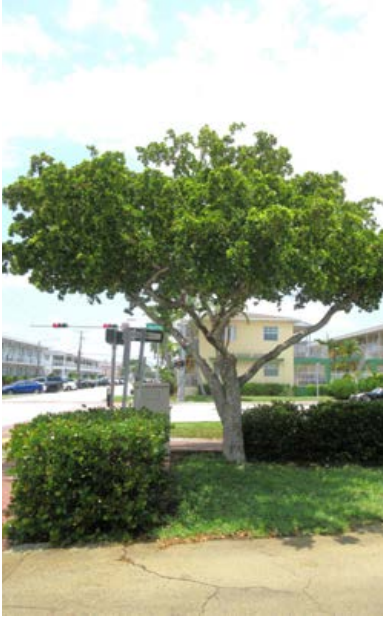
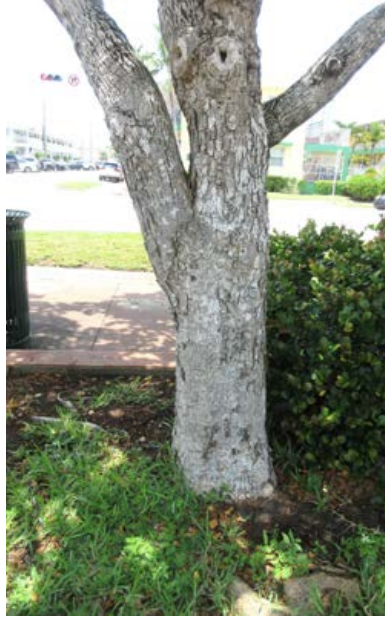
Tree #11 is a Black Olive in fair condition. Included bark is present and large surface roots are present. Prune to remove deadwood and to maintain clearance over the sidewalk.

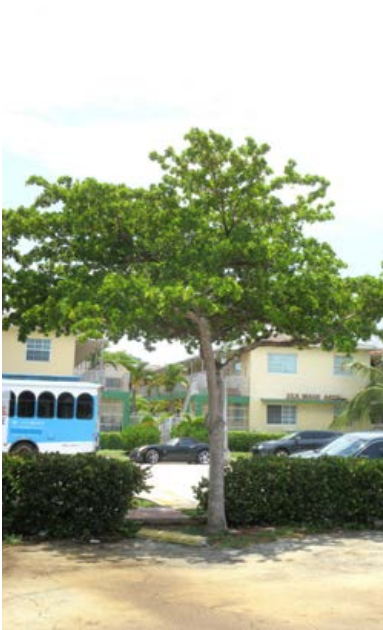
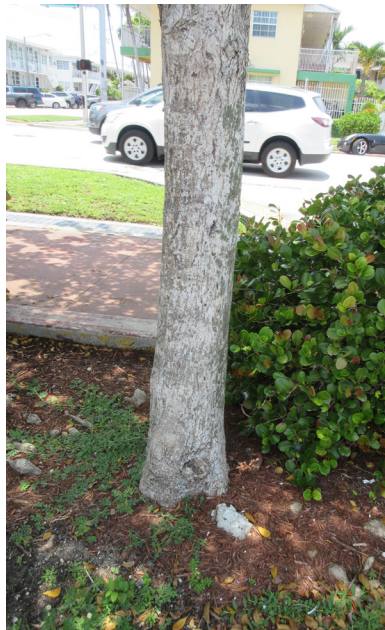
Tree #12 is a Black Olive in fair condition. Large surface roots and small deadwood are present. Prune to remove deadwood and to maintain clearance over the sidewalk.

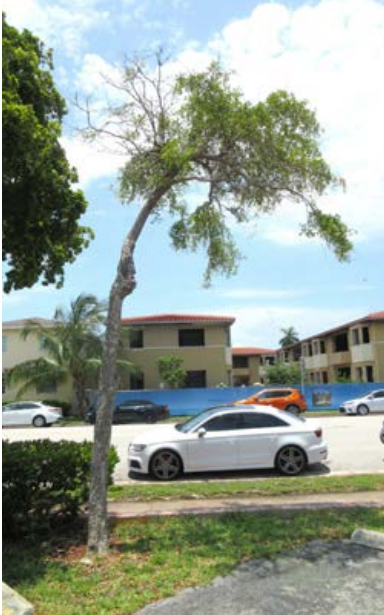
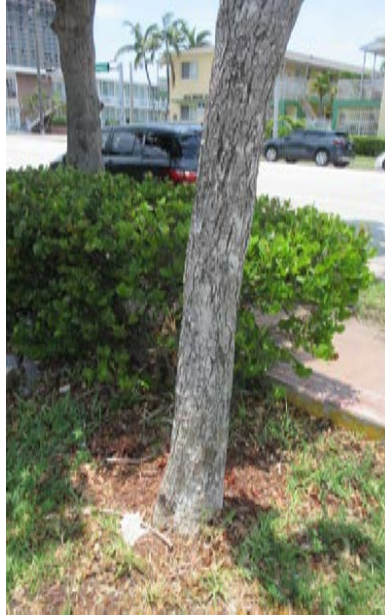
Tree #13 is a Black Olive in very poor condition. There are multiple large wounds on the trunk. There is dieback in the canopy. The leaves are small and distorted. This tree will need to be removed.

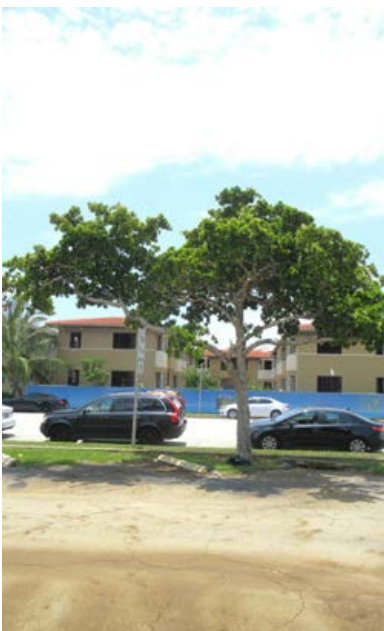
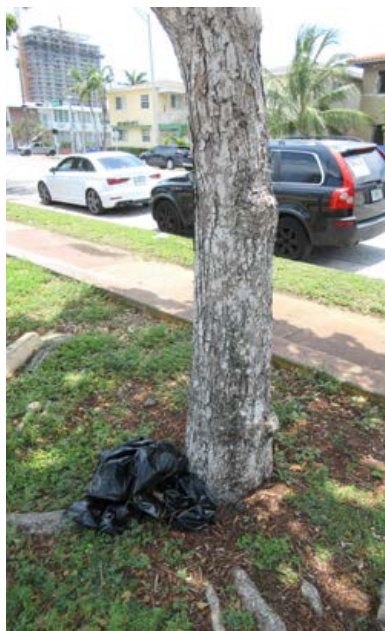
Tree #14 is a Black Olive in fair condition. The tree has low vigor and large surface roots. Prune to remove deadwood and to maintain clearance over the sidewalk.

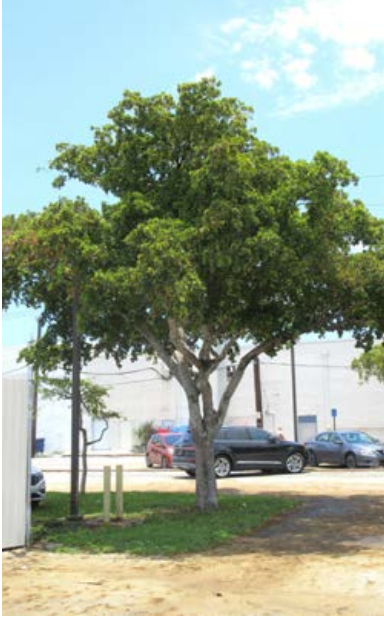
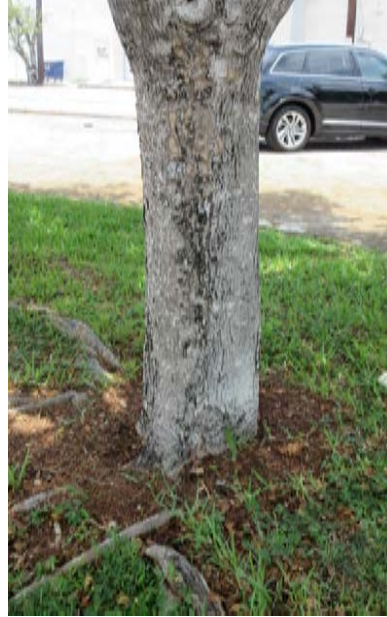
Tree #15 is a Black Olive in good condition. Included bark is present as well as large surface roots. Prune to remove deadwood and to maintain clearance over the sidewalk.

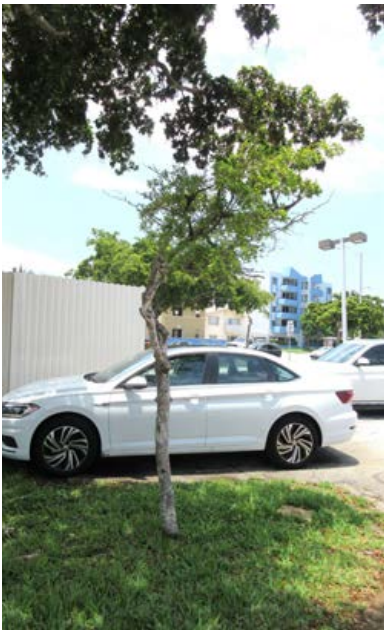
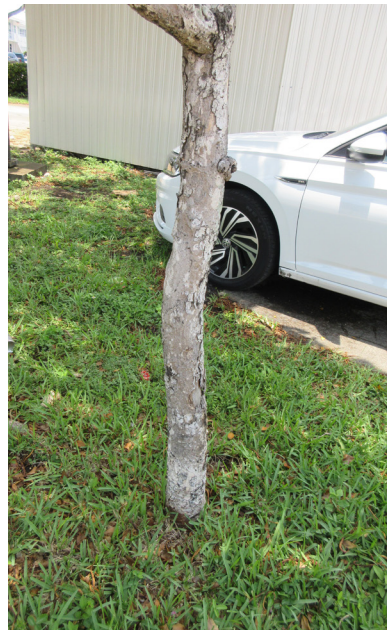
Tree #16 is a Black Olive in very poor condition. There are multiple injuries on the trunk. There is dieback in the canopy. The leaves are small and distorted. This tree will need to be removed.

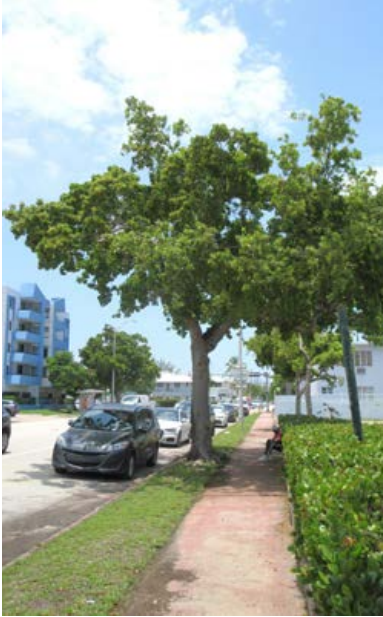
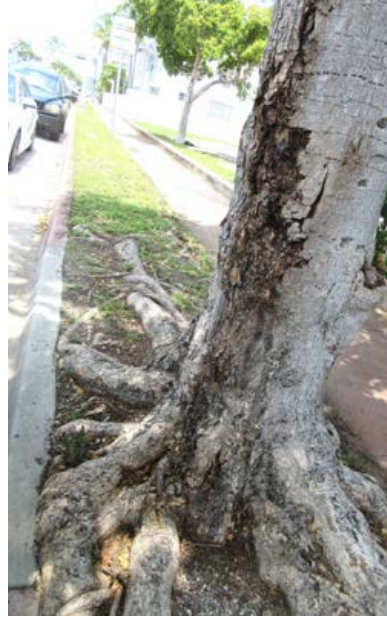
Tree #17 is a Black Olive street tree located along Harding Avenue. It is growing in a narrow, 4ft wide planting strip and has limited rooting space. The tree is in fair condition. Large surface roots are present. There are multiple injuries to the trunk. Sapsucker damage is present.

Prune to remove deadwood and to maintain clearance over the street and sidewalk.

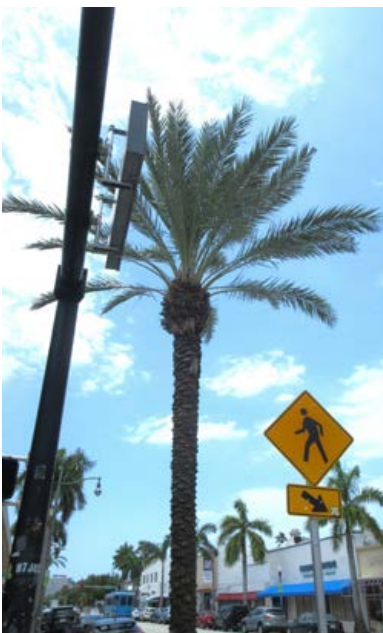
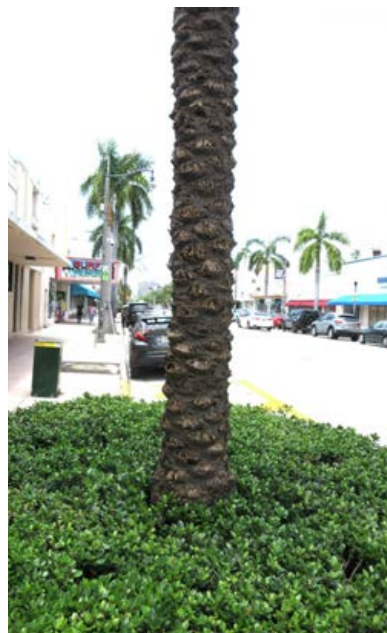
Tree #18 is a Date Palm street tree located along Collins Avenue. It is in good condition.

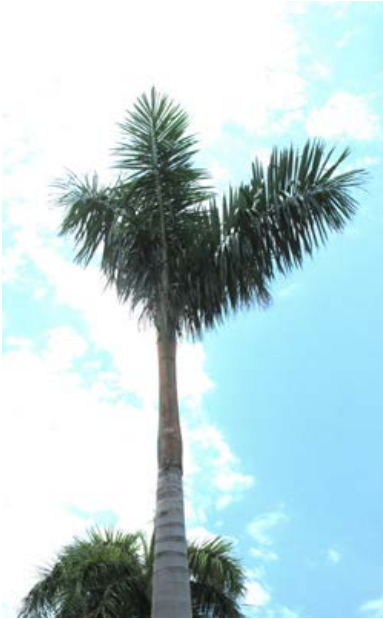
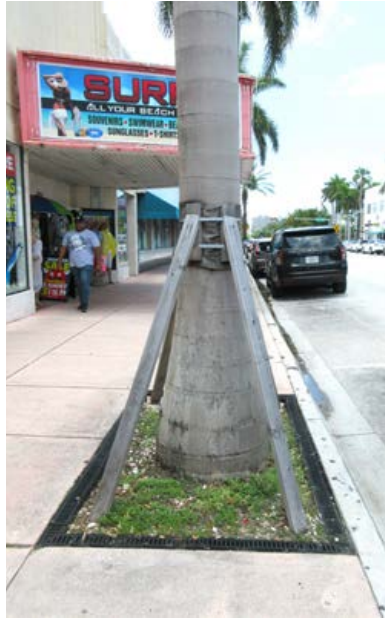
Tree #19 is a Royal Palm street tree located along Collins Avenue. It is growing in a 5ft by 8ft wide sidewalk cut-out. The tree is in fair condition. Braces are on the trunk and the trunk is pencilling. Remove the braces before they injure the trunk.
