# HPB24-0638

## 1210 Michigan Avenue

Certificate of Appropriateness  
for Demolition and Design

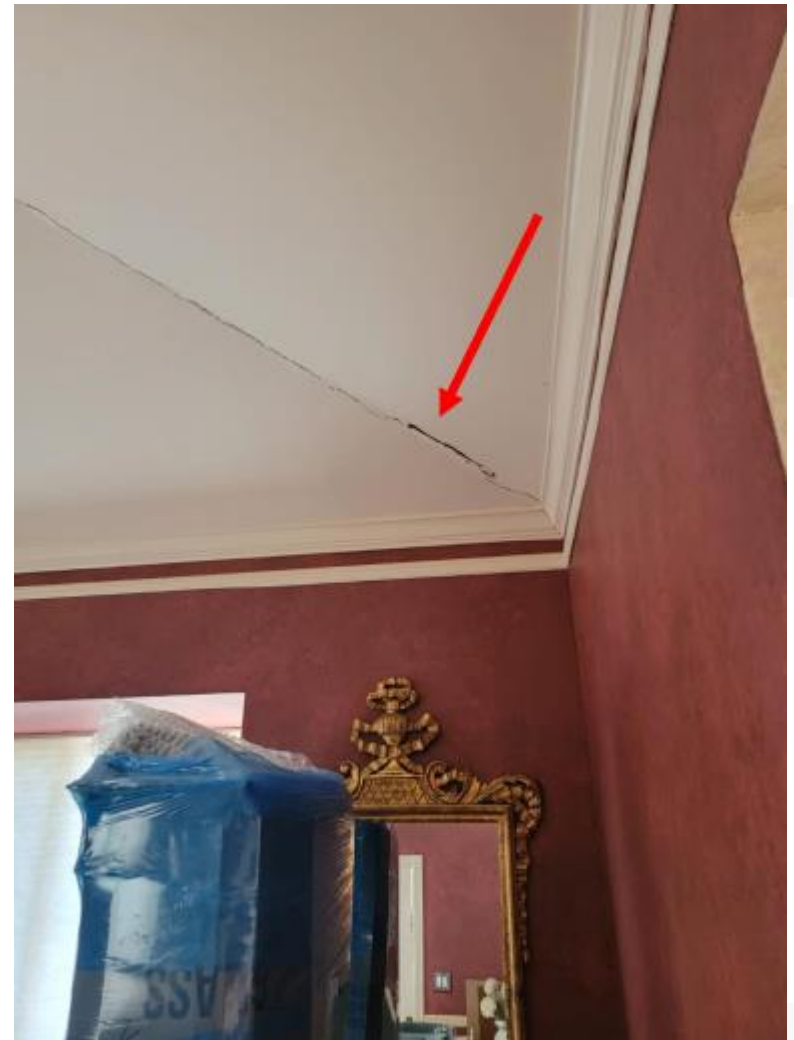
# Structural Integrity Issues With Roof

- The roof has failed in multiple locations
- Moisture intrusion has caused severe and extensive damage to all the wood members of the building

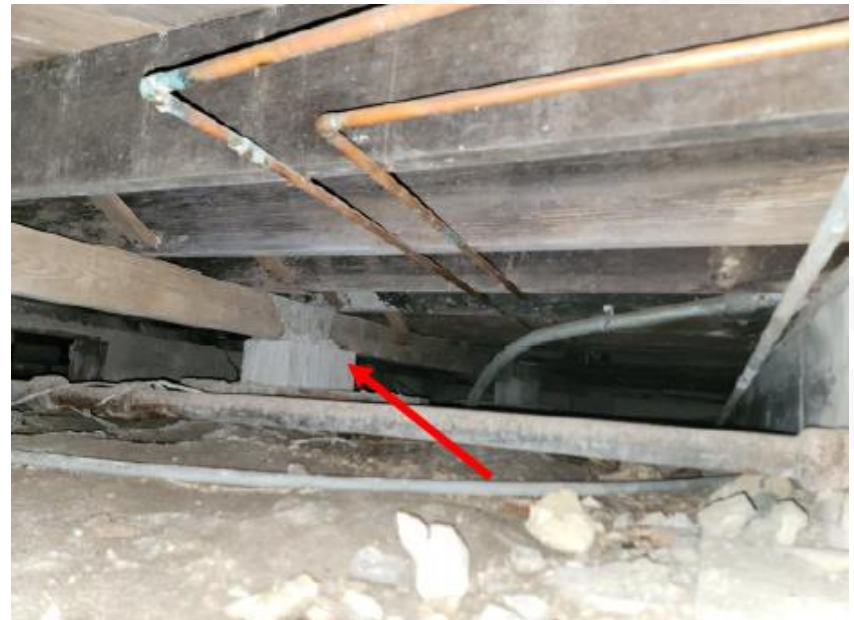
# Structural Integrity Issues With Foundations

- Foundations are severely deteriorated
- Reinforcing rebars are corroded
- Damage accelerated by continuous flooding
- Floor joists have been supported in a rudimentary fashion due to floor sagging and settlement

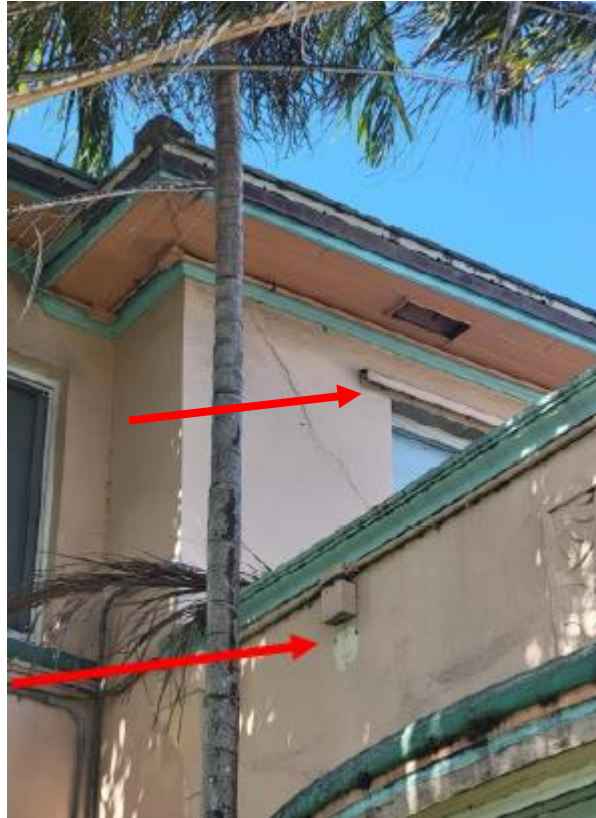
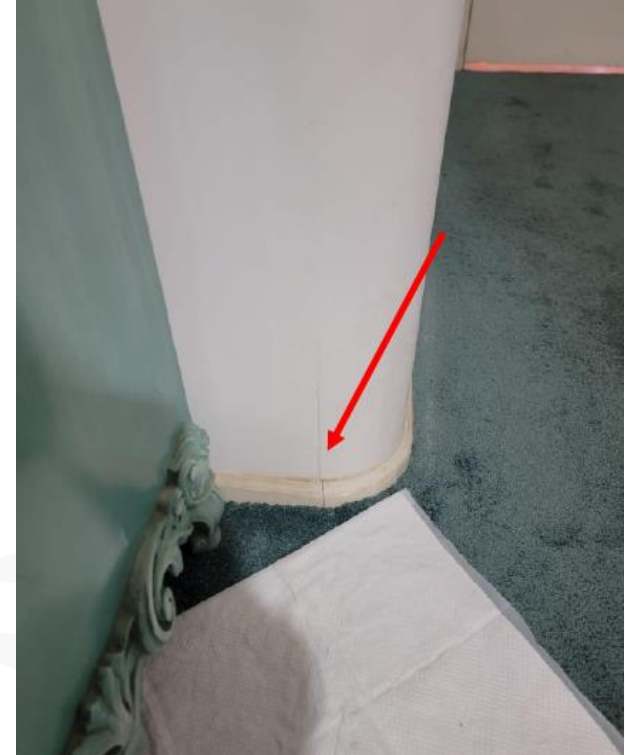
# Structural Integrity Issues With Foundations

- Floor joists have been supported in a rudimentary fashion due to floor sagging and settlement
- Distressed signs are cracking, spalling, water damage, decayed wood and termite damage
