# 1020 Pennsylvania Avenue

Miami Beach

PROJECT DESCRIPTION: PENNSYLVANIA PROPERTY

PROPERTY LOCATION: 1020 PENNSYLVANIA AVENUE, MIAMI BEACH, FLORIDA

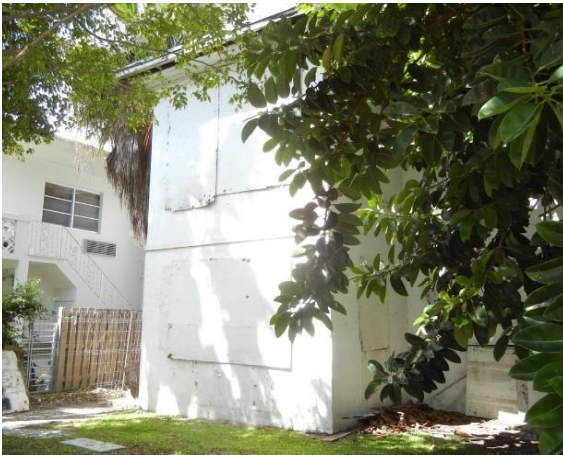
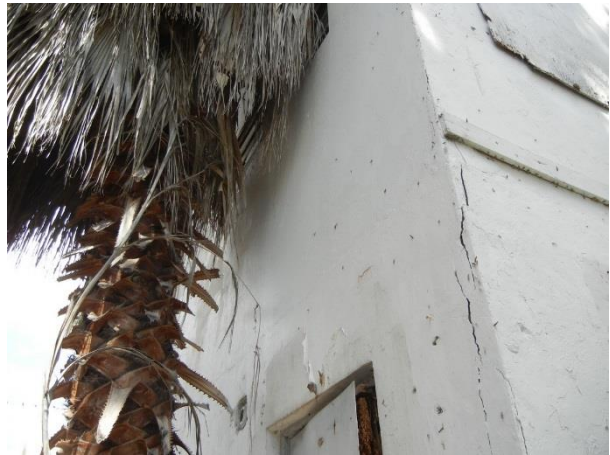
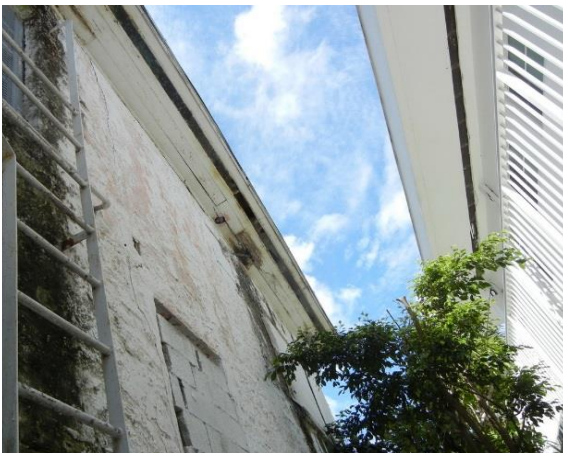
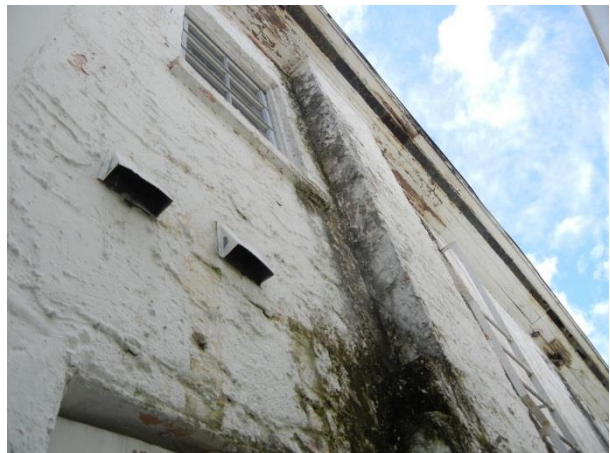
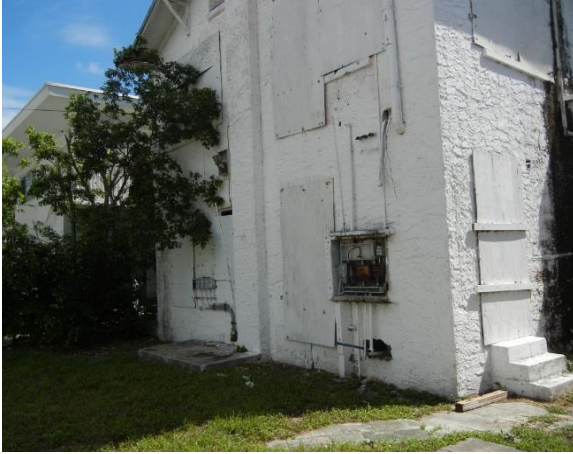
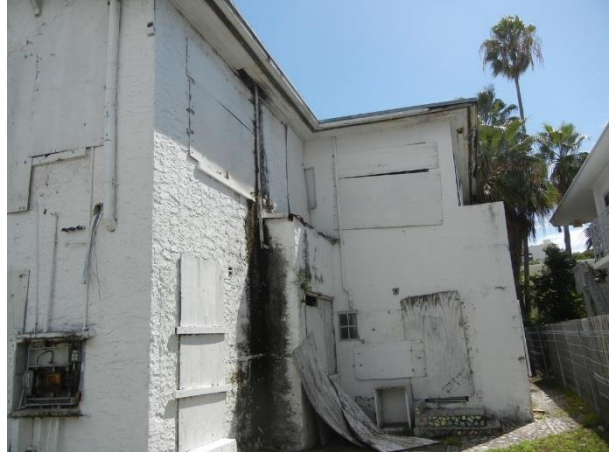
- The perimeter masonry bearing wall present several areas of patching or repairs. Is visible masonry cracks, opening masonry in-fills

At the time of the inspection the CMU block walls were safely standing in place. We did not note settlement of the structure based upon cursory observation of the soil/structure interface and corners of the structure. However, existing condition of floor framing in the first and second floor is clear indication that the structure is not in serviceable condition for human occupancy. The floor framings shall be replaced and repaired where acceptable. New floor sheathing shall be installed. The floor framing shall be connected to the masonry bearing wall. The existing bearing walls do not have concrete tie beam; appropriate shoring shall be designed and provided to allow implementation and construction of new concrete tie beam. The concrete tie beam shall be placed

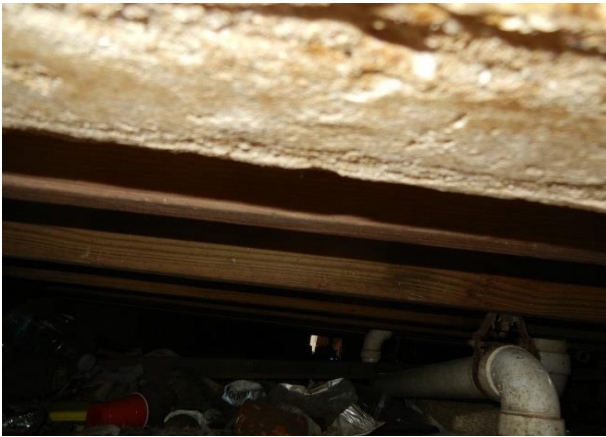
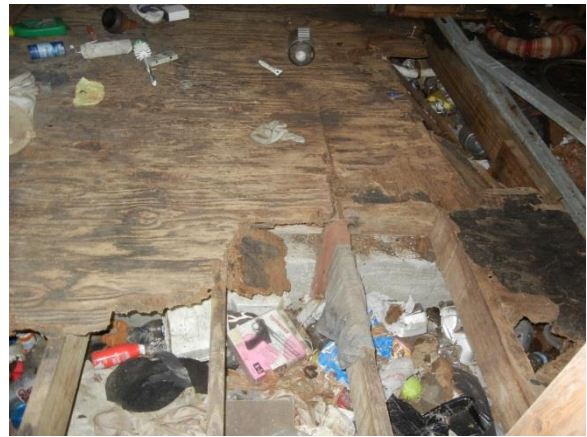
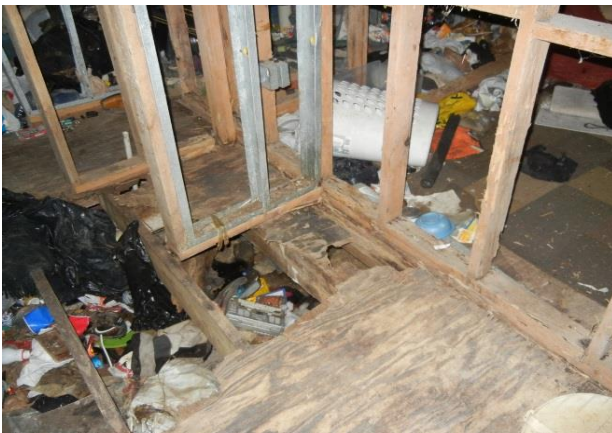
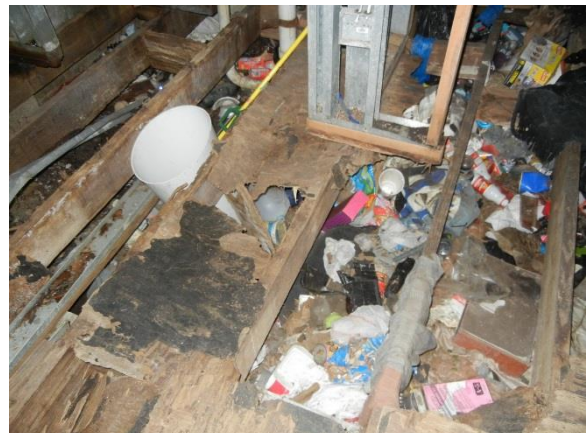
- Floor joists and floor sheathing are deteriorated by termites and humidity. The floor framing is placed raised over a crawl space which does not have proper ventilation.

- Roof sheathing and roofing; these items shall be replaced according to FBC 2010, section 606.3.2
- Second floor framing replacement or retrofitted accordingly and floor sheathing replacement, first floor framing and sheathing shall be replaced; these item shall be constructed or implemented in compliance with existing structures FBC 2010, section 707.4
- Wall openings shall be addressed and filled with impact resisting windows. In addition, the openings shall be reinforced and retrofitted structurally to transfer wind pressure loads to floor and roof diaphragms. These items shall be implemented in compliance with existing structures FBC 2010, section 606.4
- Concrete tie beams at floor and roof diaphragm line. Rational analysis shall be performed by a registered professional engineer

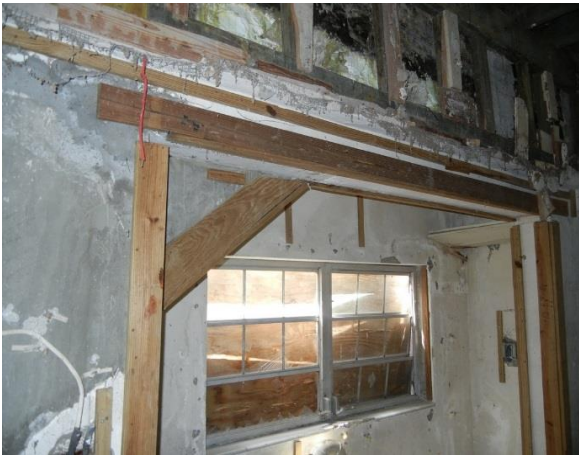
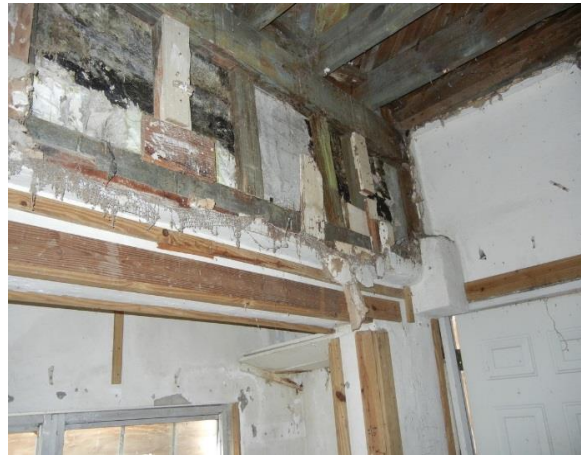
- Some openings in the masonry wall show unstable condition caused by lack of reinforcement. No proper or adequate retrofit procedure were provided at the time the openings were created. Interior CMU walls depict an original structural layout which in some degree were altered on its role as part of the building envelope. Besides, the portion of the building structure located at the east and south of the structure that we considered was an addition at certain time of the life of the structure, uses the area under the stairs that access to the second floor. To extend the area of the addition a portion of the perimeter bearing wall was demolished and reached the exterior face of the stair wall. That opening shows no reinforcement or retrofit to count for gravity loads from second and roof levels.

The building openings will require new impact windows. The existing openings do not present adequate construction condition to accept new window frames and transmit forces to the building diaphragms. The existing masonry openings shall be reinforced and retrofitted accordingly. The new reinforcement of the opening jambs shall frame to a new concrete tie beam.

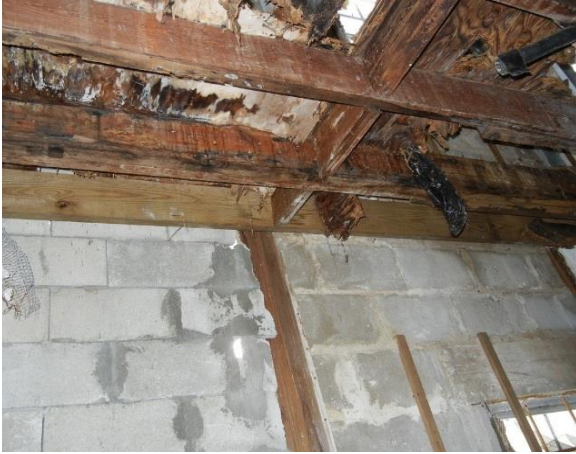
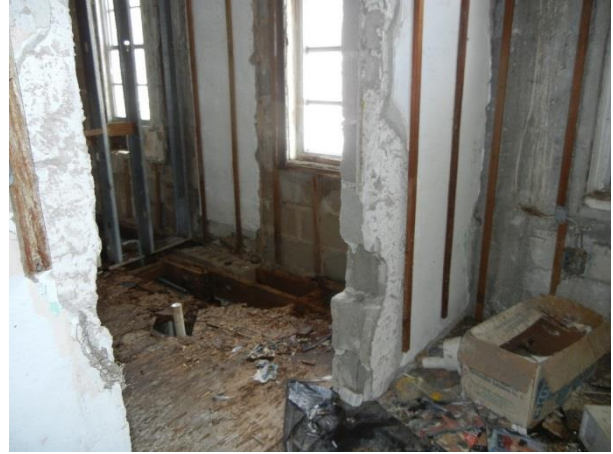
- A substantial number of floor joists in the second floor present sign of deterioration caused by termites and humidity. Also the floor sheathing is severely damaged or deteriorated by the same source of joist damage.

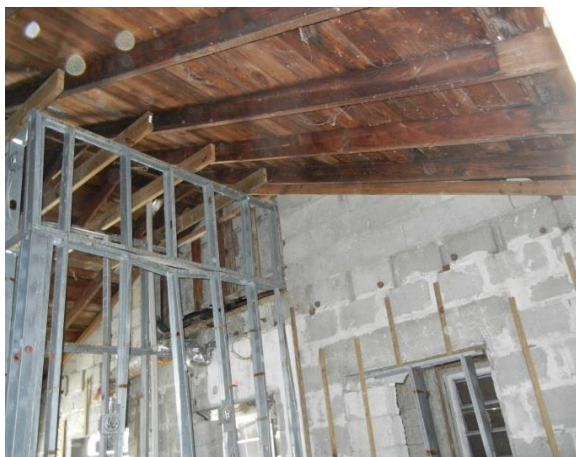
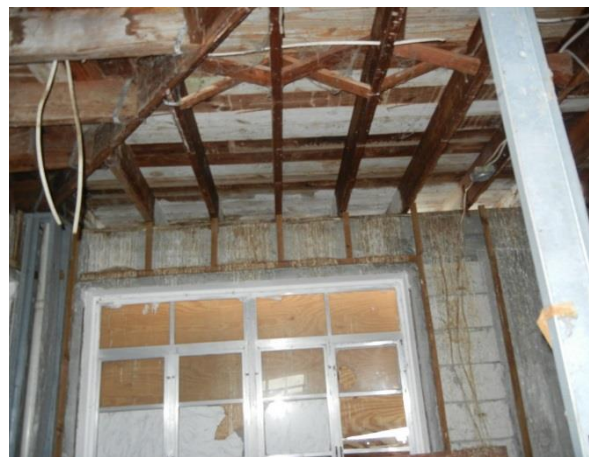
- The roof rafters are in fair condition for the most part. However, the roof sheathing evidence progressive deterioration.

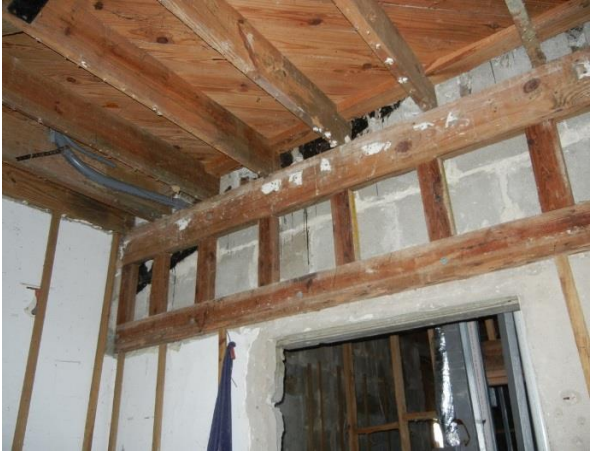
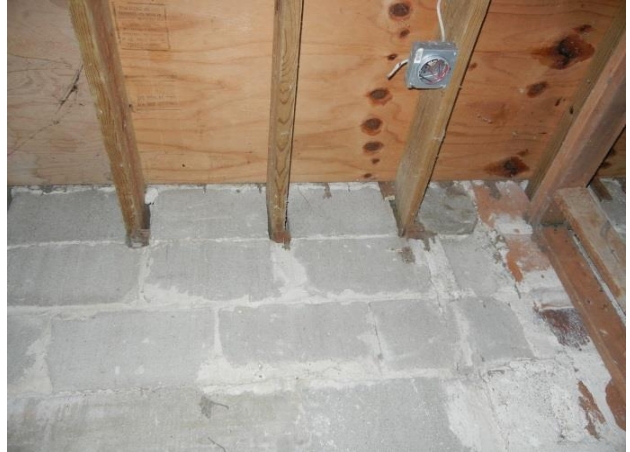
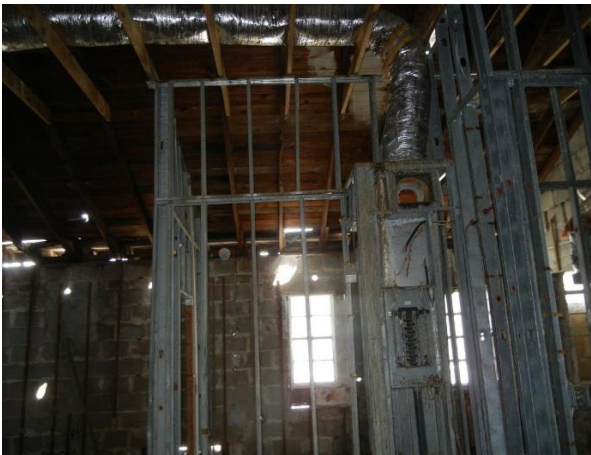
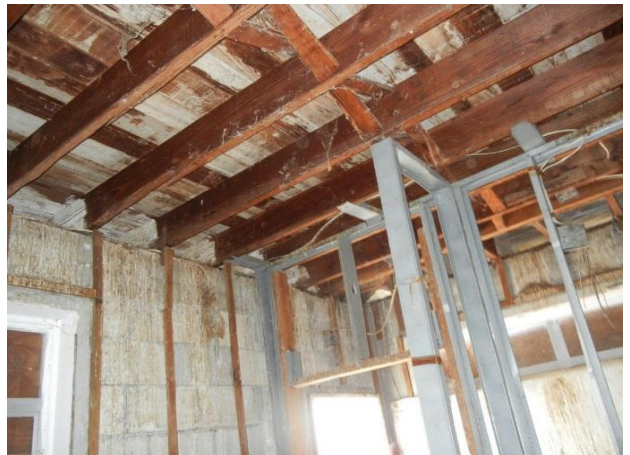
- The masonry walls throughout the structure layout do not have concrete tie beams. The floor joists have been placed in pockets created into the masonry built-up. The roof rafters have been placed on top of the masonry wall final grout.

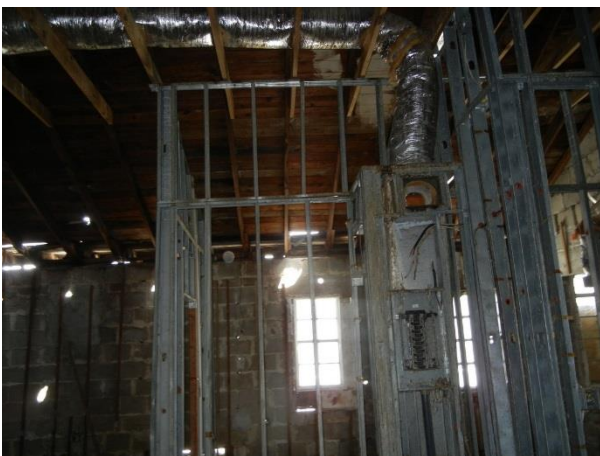
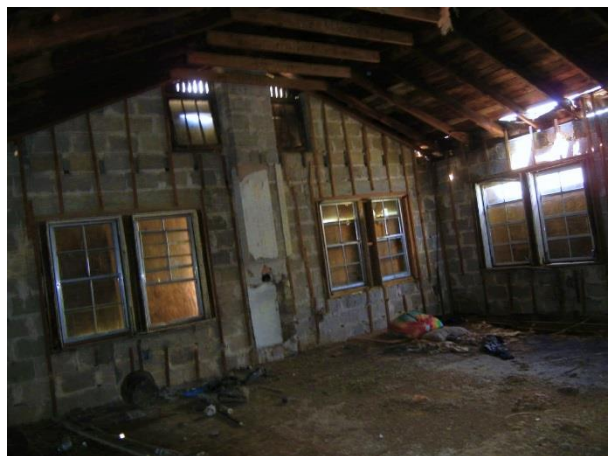
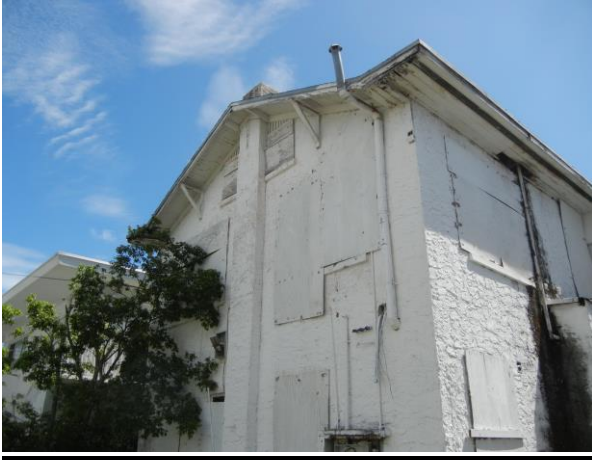
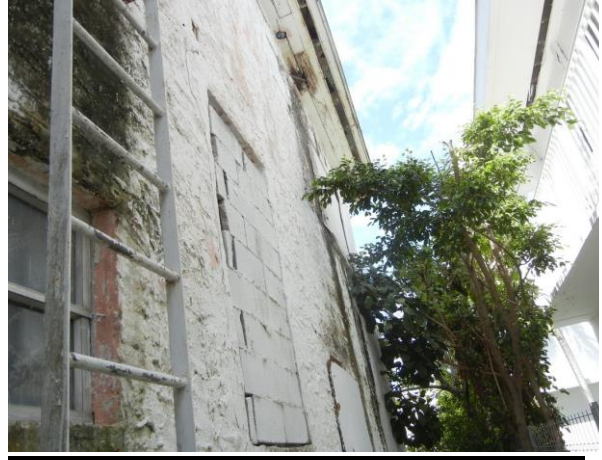
- Second floor walls at the west and north side walls are considered high walls. We assumed those walls are unreinforced. Cracks are evident in the exterior side of the wall.

In many areas of the perimeter masonry walls we consider that the piers between openings are unreinforced. Those piers shall be fastened to a substrate structure to accept out of plane forces induced by wind pressures. Consequently, the masonry piers shall be considered as cladding elements that would require special analysis and condition for proper structural attachment.
