STRUCTURAL CONDITION ASSESSMENT  
1800 Michigan Ave  
Miami Beach, Florida

February 14, 2025

Youssef Hachem Consulting Engineering

STRUCTURAL CONDITION ASSESSMENT for  
1800 Michigan Ave  
Miami Beach, Florida

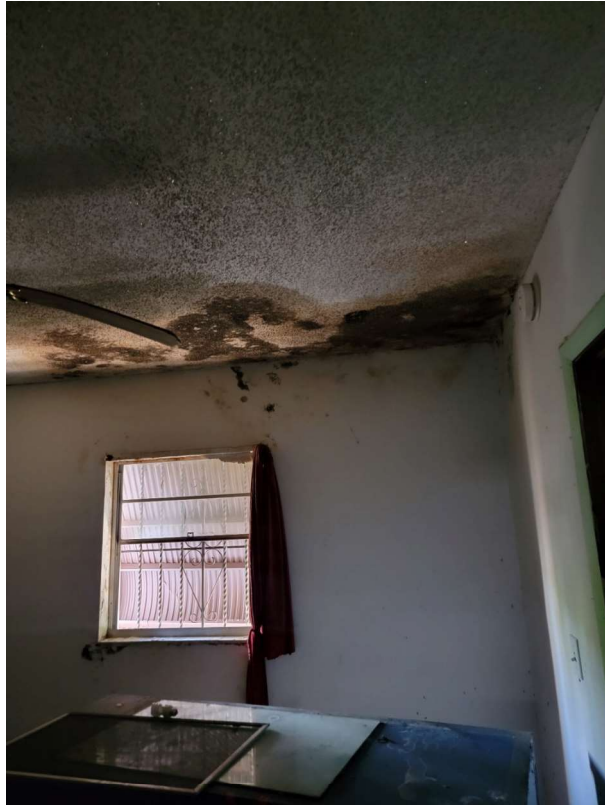
Mold is present on the interior finishes

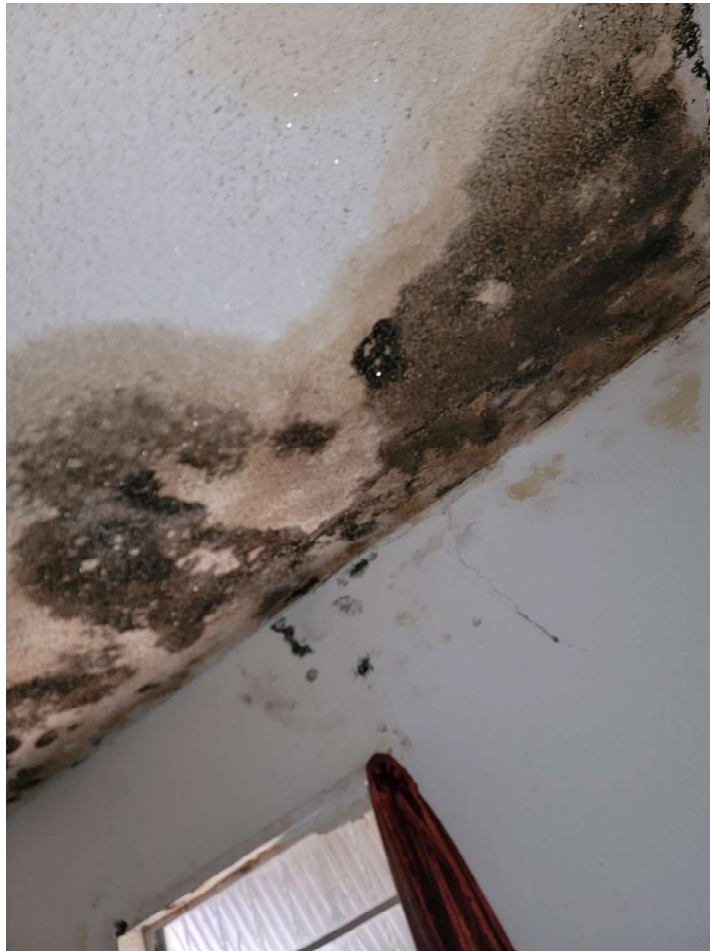
Mold and water intrusion is present

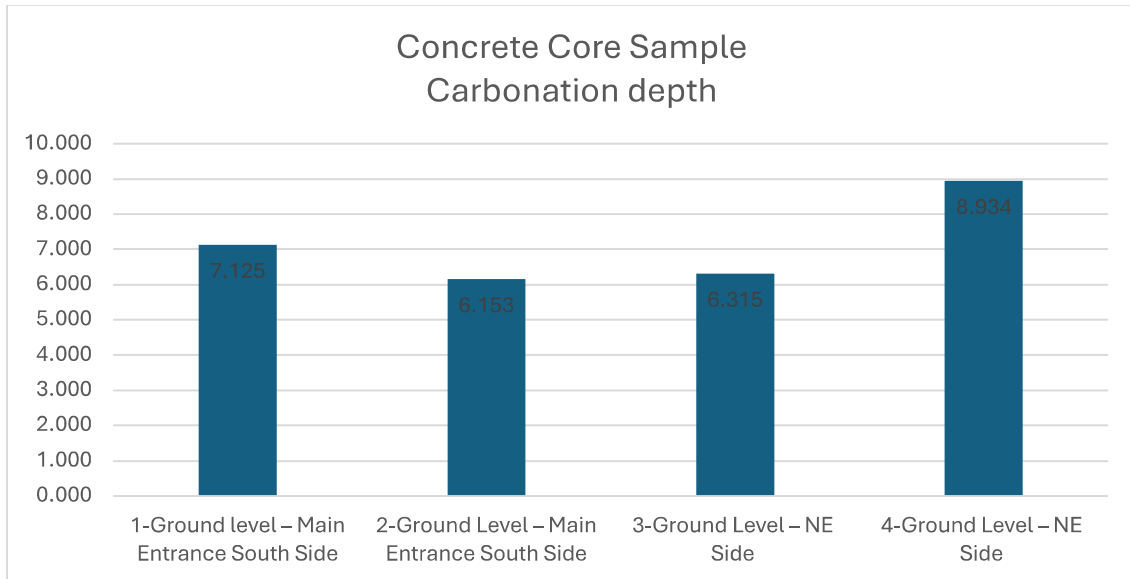
The carbonation found in the samples ranged between 6.153" – 8.934"

The carbonation is extensive and exposes the reinforcing rebars to corrosion
