# 1020 Pennsylvania Avenue

Miami Beach

PROJECT DESCRIPTION: PENNSYLVANIA PROPERTY

PROPERTY LOCATION: 1020 PENNSYLVANIA AVENUE, MIAMI BEACH, FLORIDA

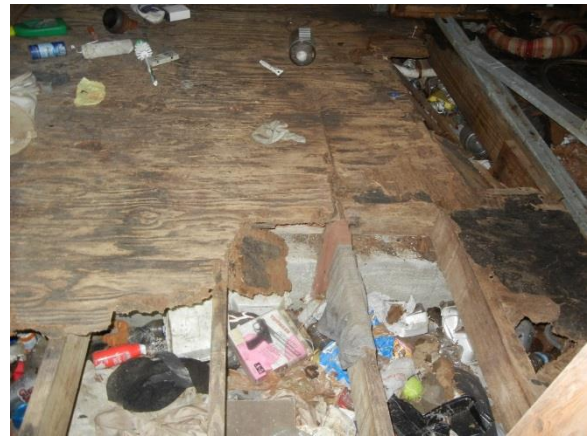
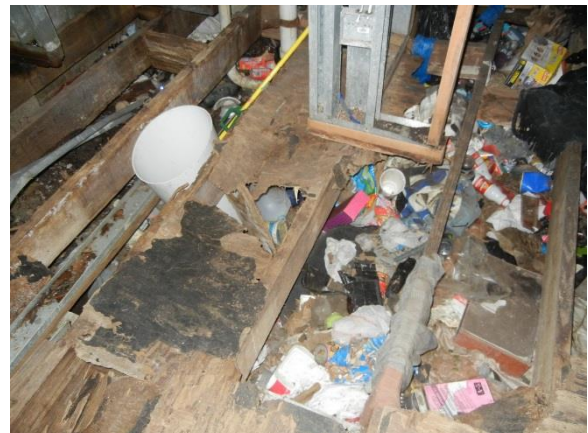
- Floor joists and floor sheathing are deteriorated by termites and humidity. The floor framing is placed raised over a crawl space which does not have proper ventilation.

- Roof sheathing and roofing; these items shall be replaced according to FBC 2010, section 606.3.2
- Second floor framing replacement or retrofitted accordingly and floor sheathing replacement, first floor framing and sheathing shall be replaced; these item shall be constructed or implemented in compliance with existing structures FBC 2010, section 707.4
- Wall openings shall be addressed and filled with impact resisting windows. In addition, the openings shall be reinforced and retrofitted structurally to transfer wind pressure loads to floor and roof diaphragms. These items shall be implemented in compliance with existing structures FBC 2010, section 606.4
- Concrete tie beams at floor and roof diaphragm line. Rational analysis shall be performed by a registered professional engineer

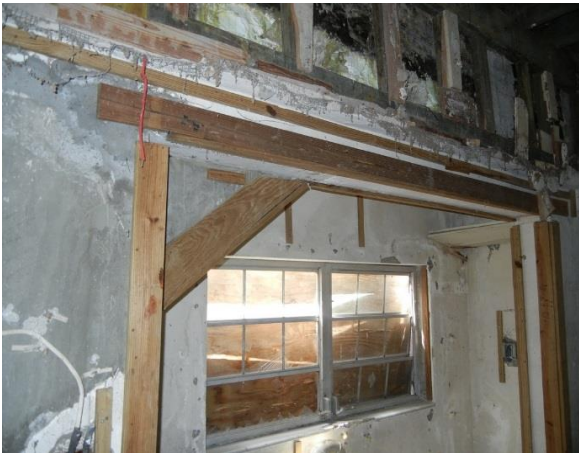
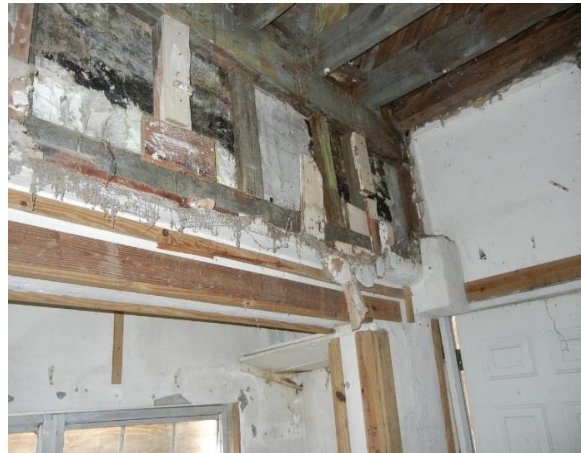
- Some openings in the masonry wall show unstable condition caused by lack of reinforcement. No proper or adequate retrofit procedure were provided at the time the openings were created. Interior CMU walls depict an original structural layout which in some degree were altered on its role as part of the building envelope. Besides, the portion of the building structure located at the east and south of the structure that we considered was an addition at certain time of the life of the structure, uses the area under the stairs that access to the second floor. To extend the area of the addition a portion of the perimeter bearing wall was demolished and reached the exterior face of the stair wall. That opening shows no reinforcement or retrofit to count for gravity loads from second and roof levels.

The building openings will require new impact windows. The existing openings do not present adequate construction condition to accept new window frames and transmit forces to the building diaphragms. The existing masonry openings shall be reinforced and retrofitted accordingly. The new reinforcement of the opening jambs shall frame to a new concrete tie beam.
