STRUCTURAL CONDITION ASSESSMENT  
1800 Michigan Ave  
Miami Beach, Florida

February 14, 2025

Youssef Hachem Consulting Engineering

STRUCTURAL CONDITION ASSESSMENT for  
1800 Michigan Ave  
Miami Beach, Florida

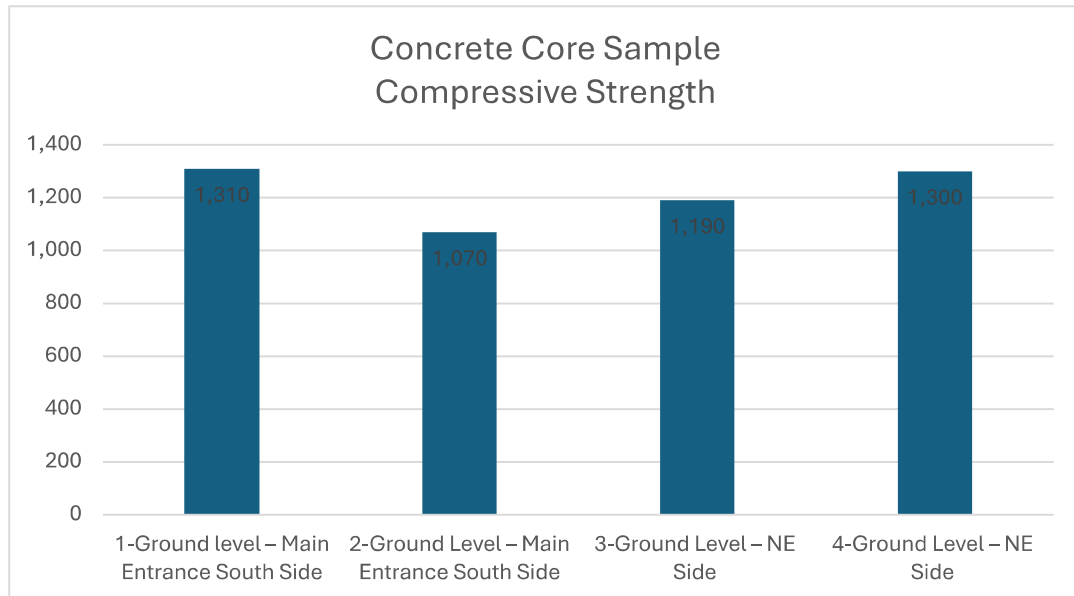
The Concrete compressive strength ranged from 1,070 to 1,310 PSI. Per Florida Building Code the concrete strength should be 5,000 PSI.

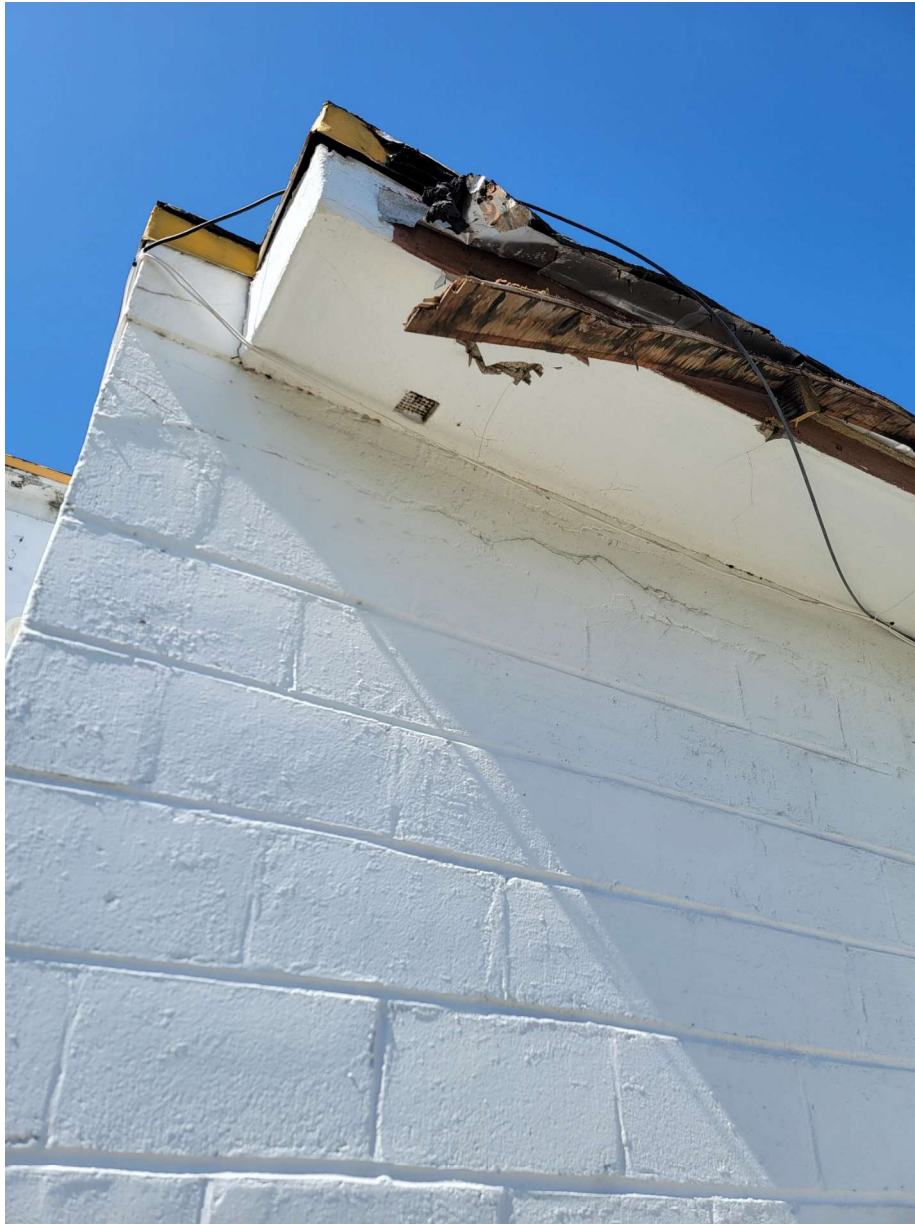
Rotted wood present on fascia

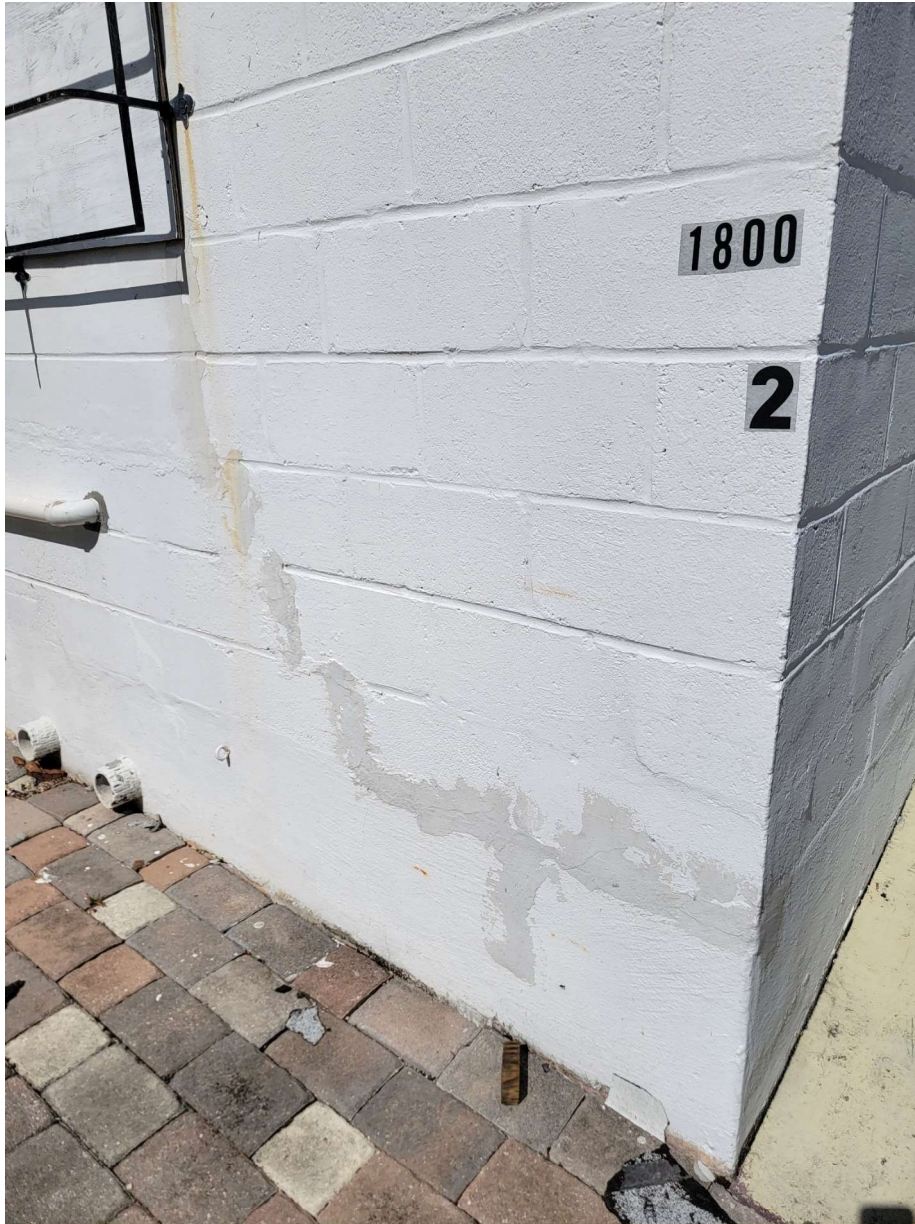
Cracks noted leading to foundations

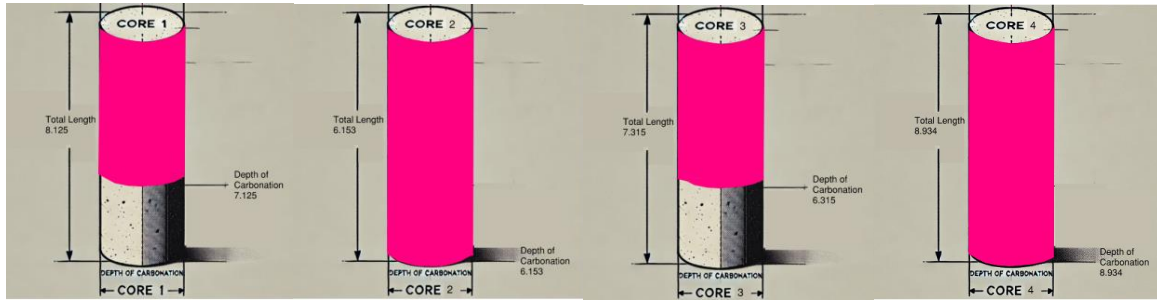
Figure 1- Depth of Carbonation (Core 1)    Figure 2- Depth of Carbonation (Core 2)    Figure 3- Depth of Carbonation (Core 3)    Figure 4- Depth of Carbonation (Core 4)

The depth of carbonation ranged between approximately 6.153 and 8.934. A summary of the test results is summarized below in table 2 and illustrated in Figure 1 through 4.
