STRUCTURAL CONDITION ASSESSMENT
1800 Michigan Ave
Miami Beach, Florida

Prepared for
J. Luis Quintana

February 14, 2025

Youssef Hachem Consulting Engineering

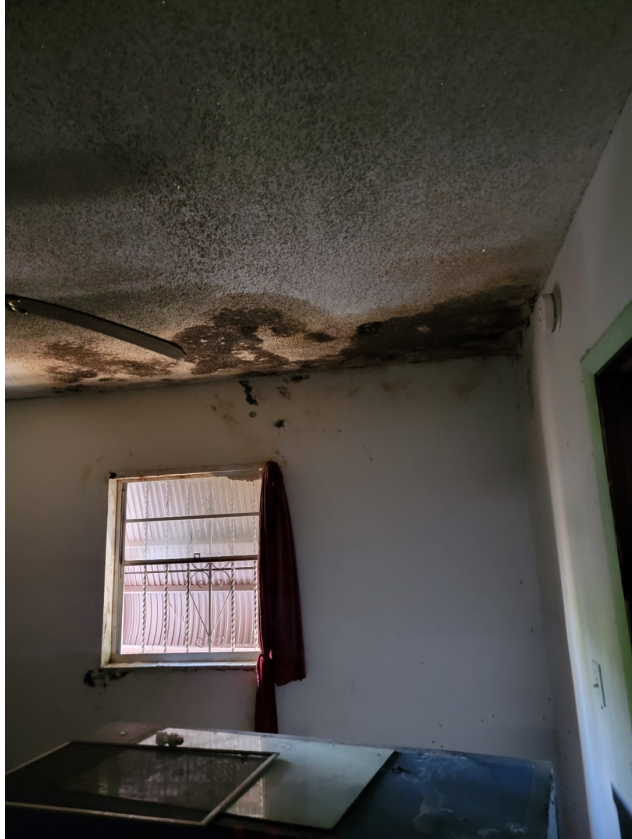
Mold is present on the interior finishes

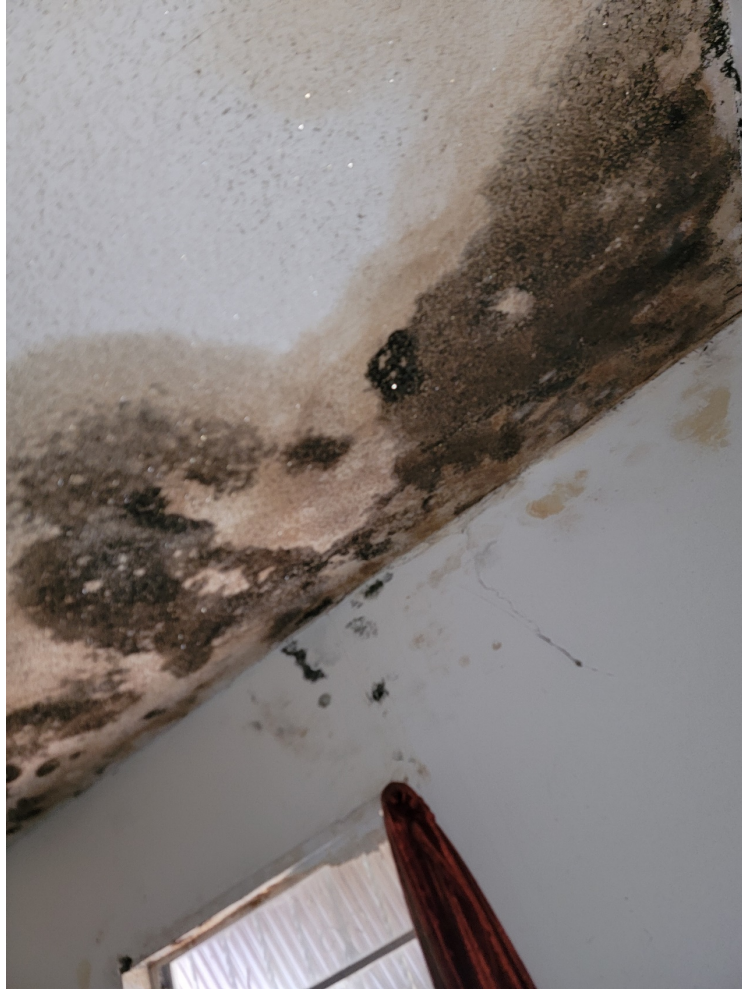
Mold and water intrusion is present

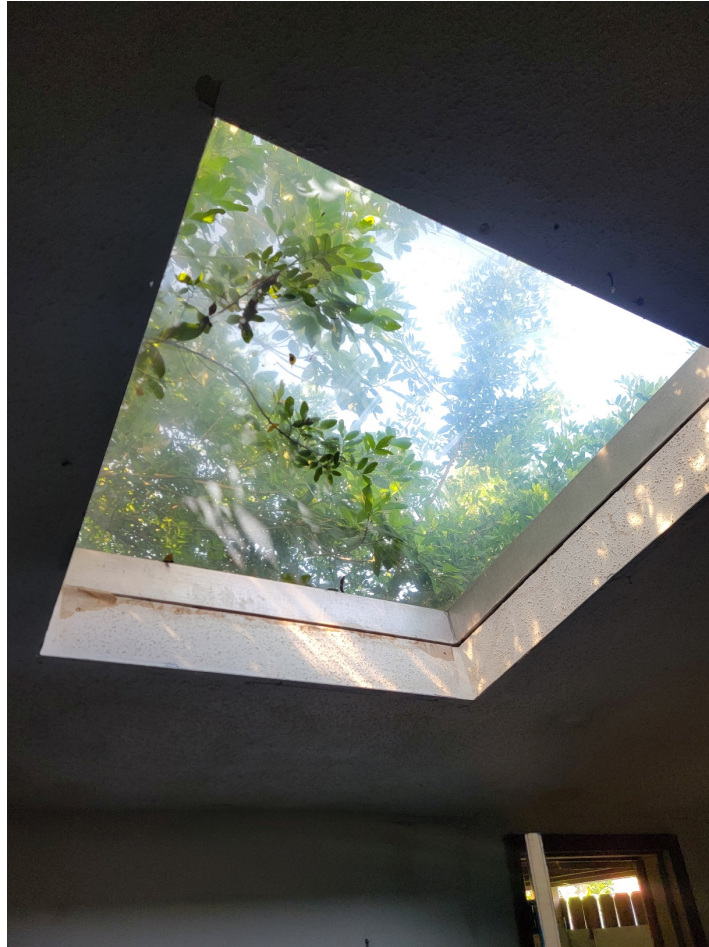
Skylights present show water intrusion.

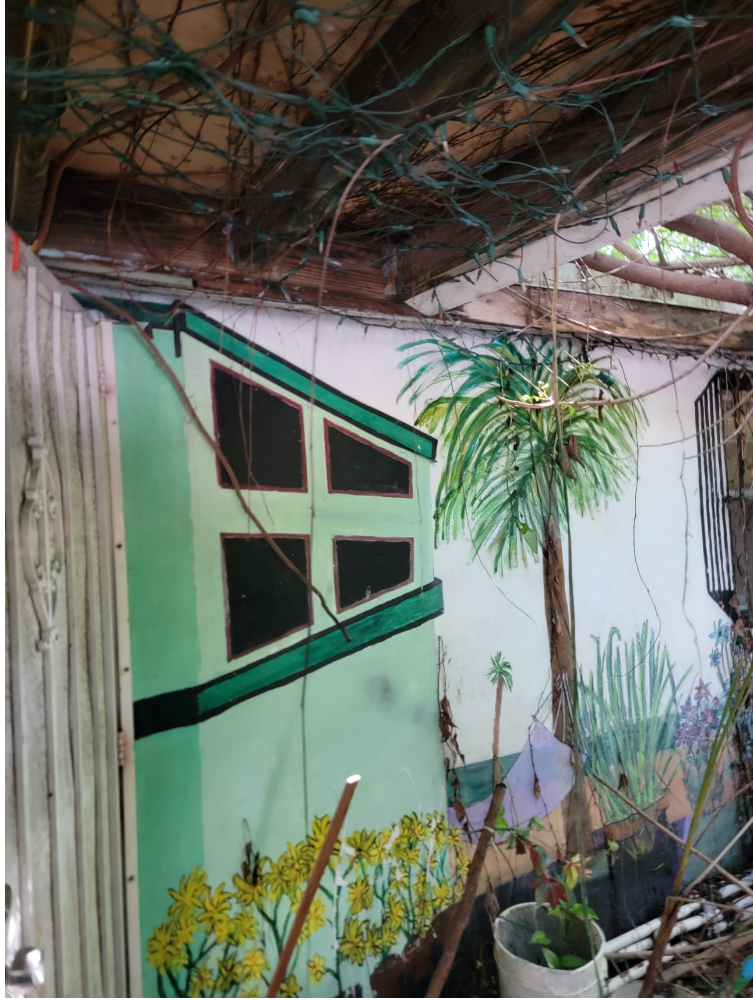
Failures noted in the exterior wood canopy

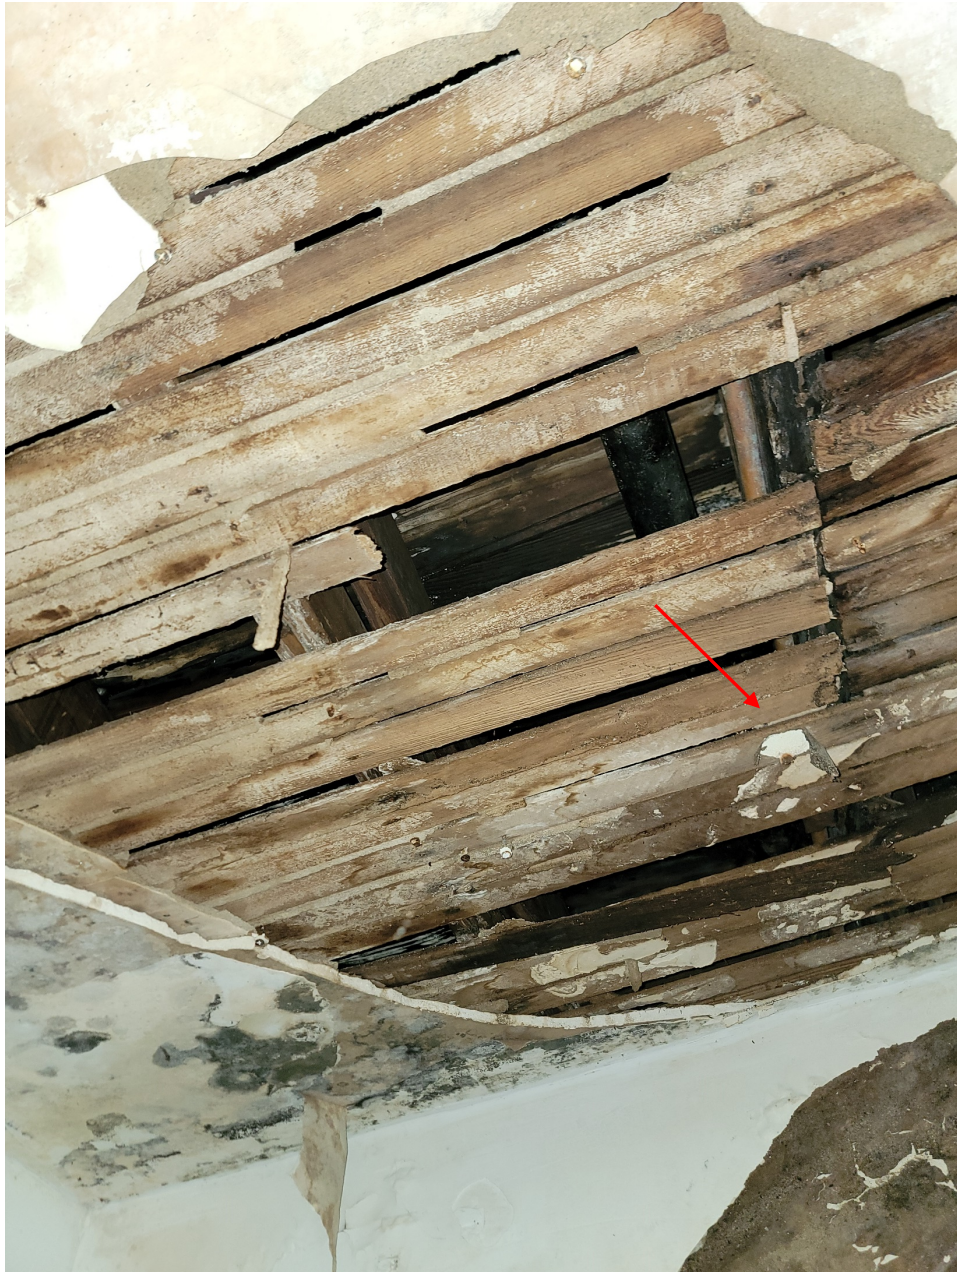
Rotted wood is noticed on the wood joist that make up the second floor of the property

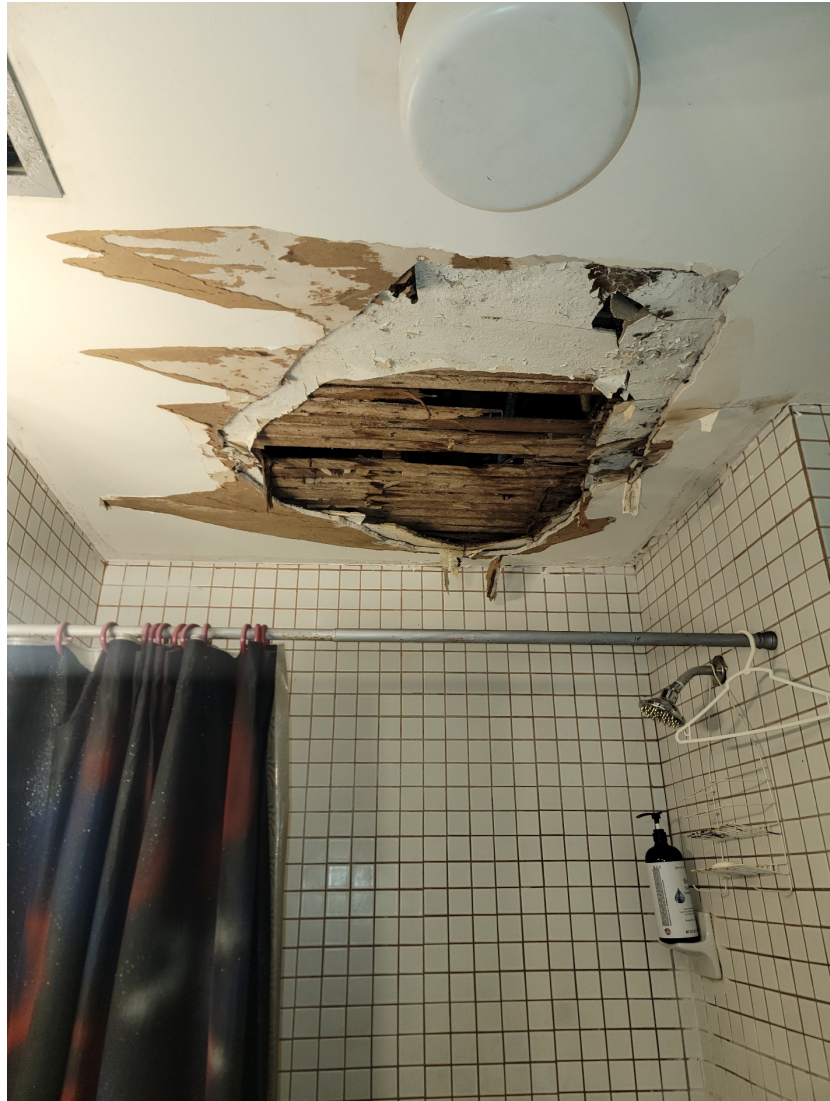
Water intrusion is present throughout the entire property

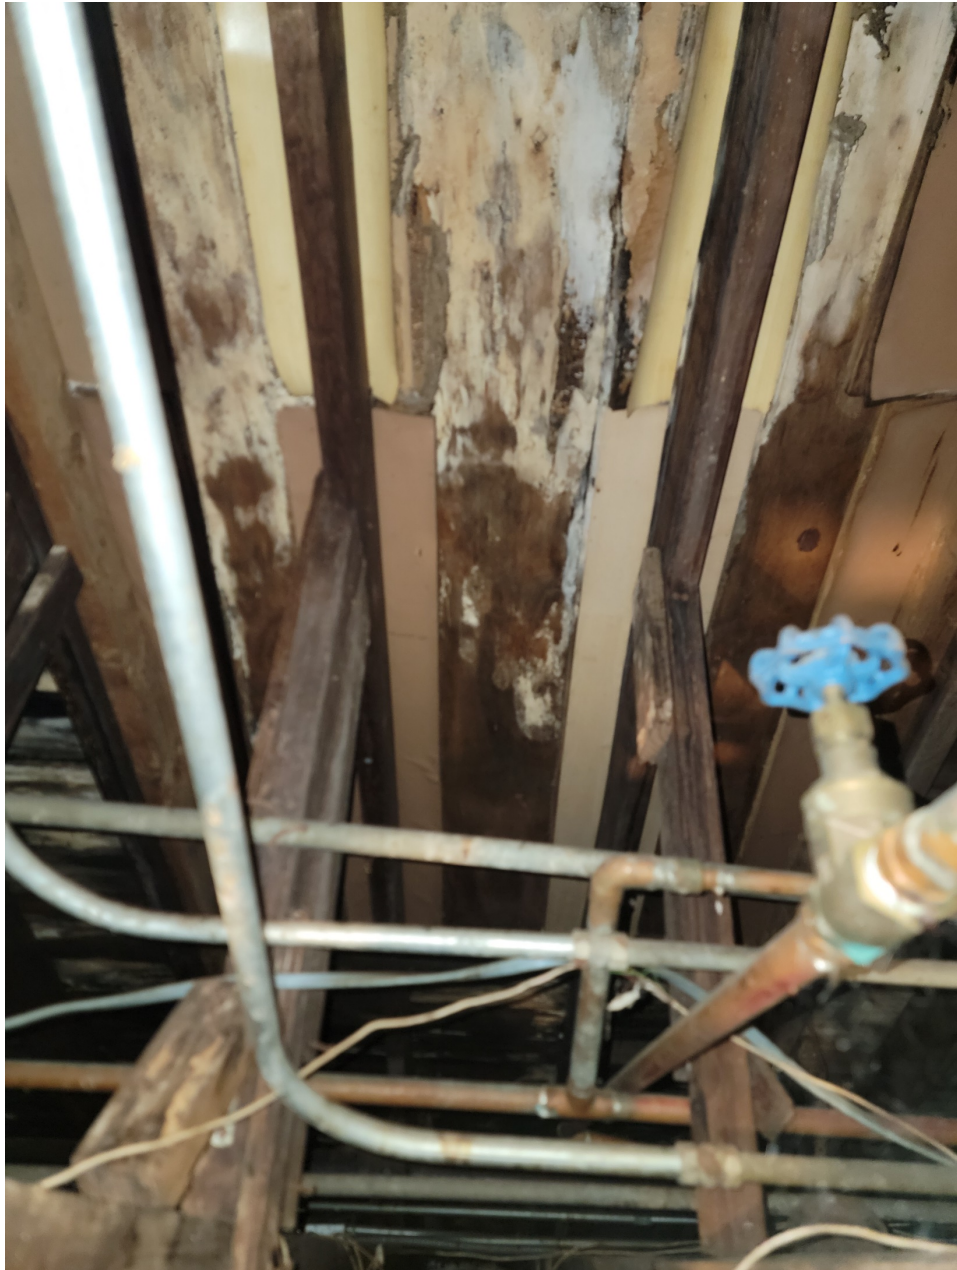
Water intrusion is present throughout the entire property

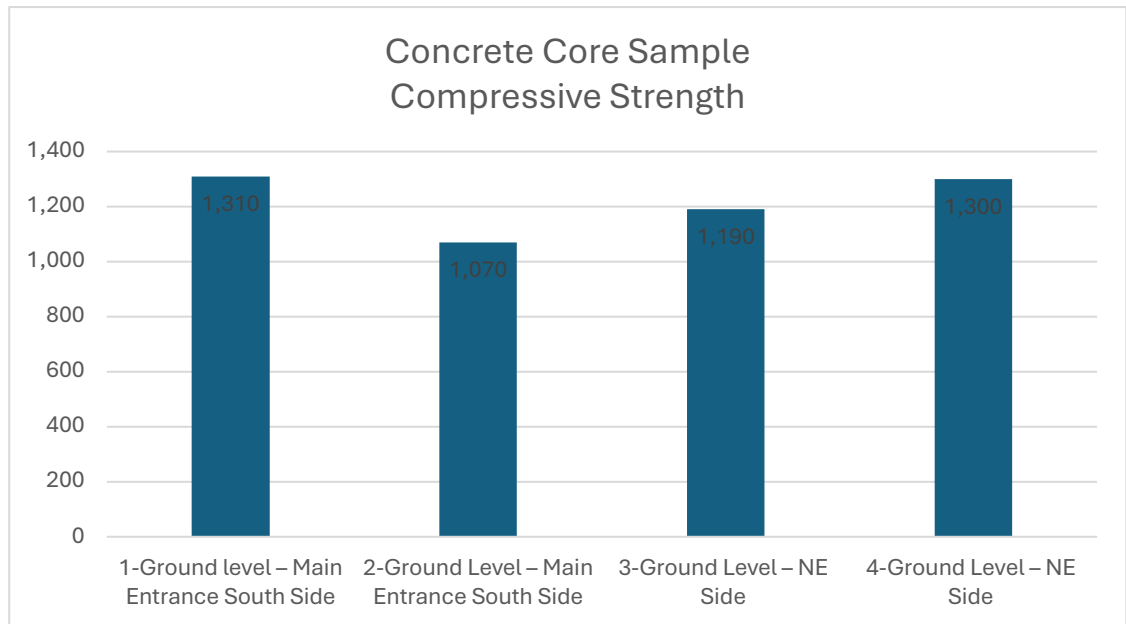
The Concrete compressive strength ranged from 1,070 to 1,310 PSI. Per Florida Building Code the concrete strength should be 5,000 PSI.

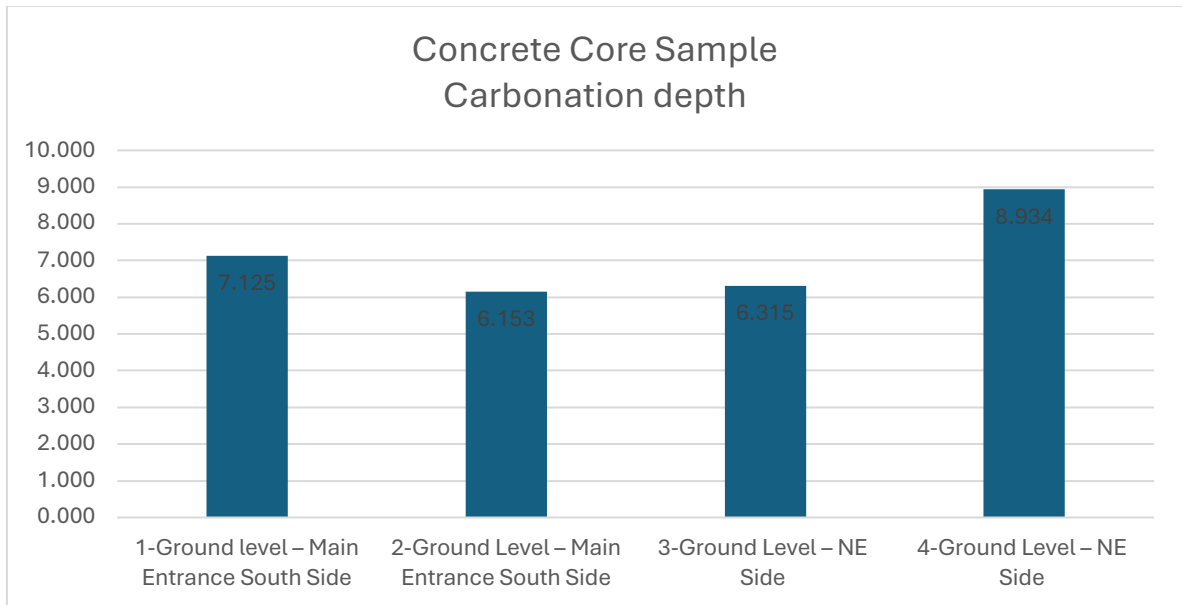
The carbonation found in the samples ranged between 6.153" – 8.934"

The carbonation is extensive and exposes the reinforcing rebars to corrosion

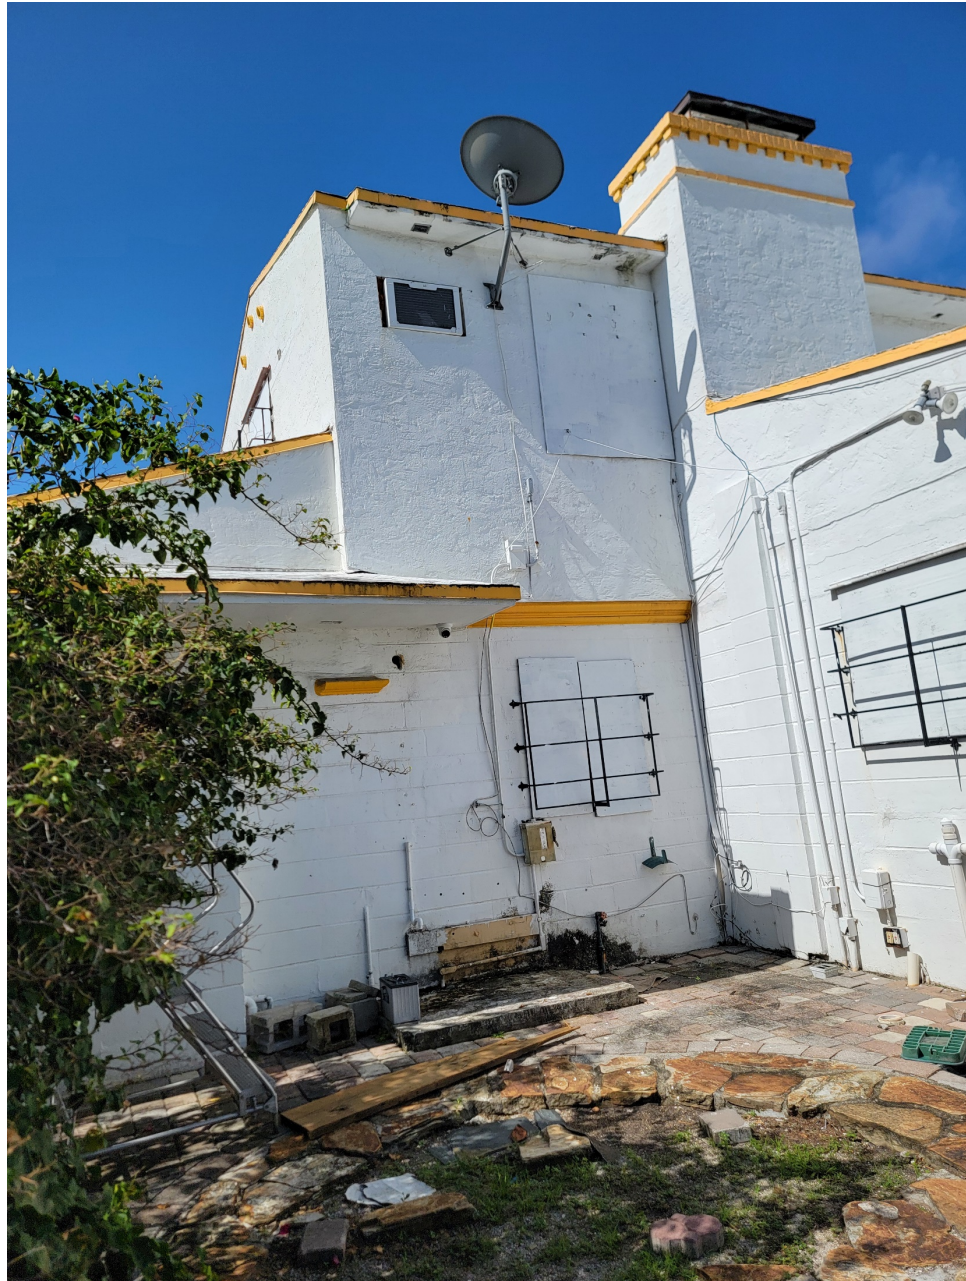
Spall and delaminated stucco present

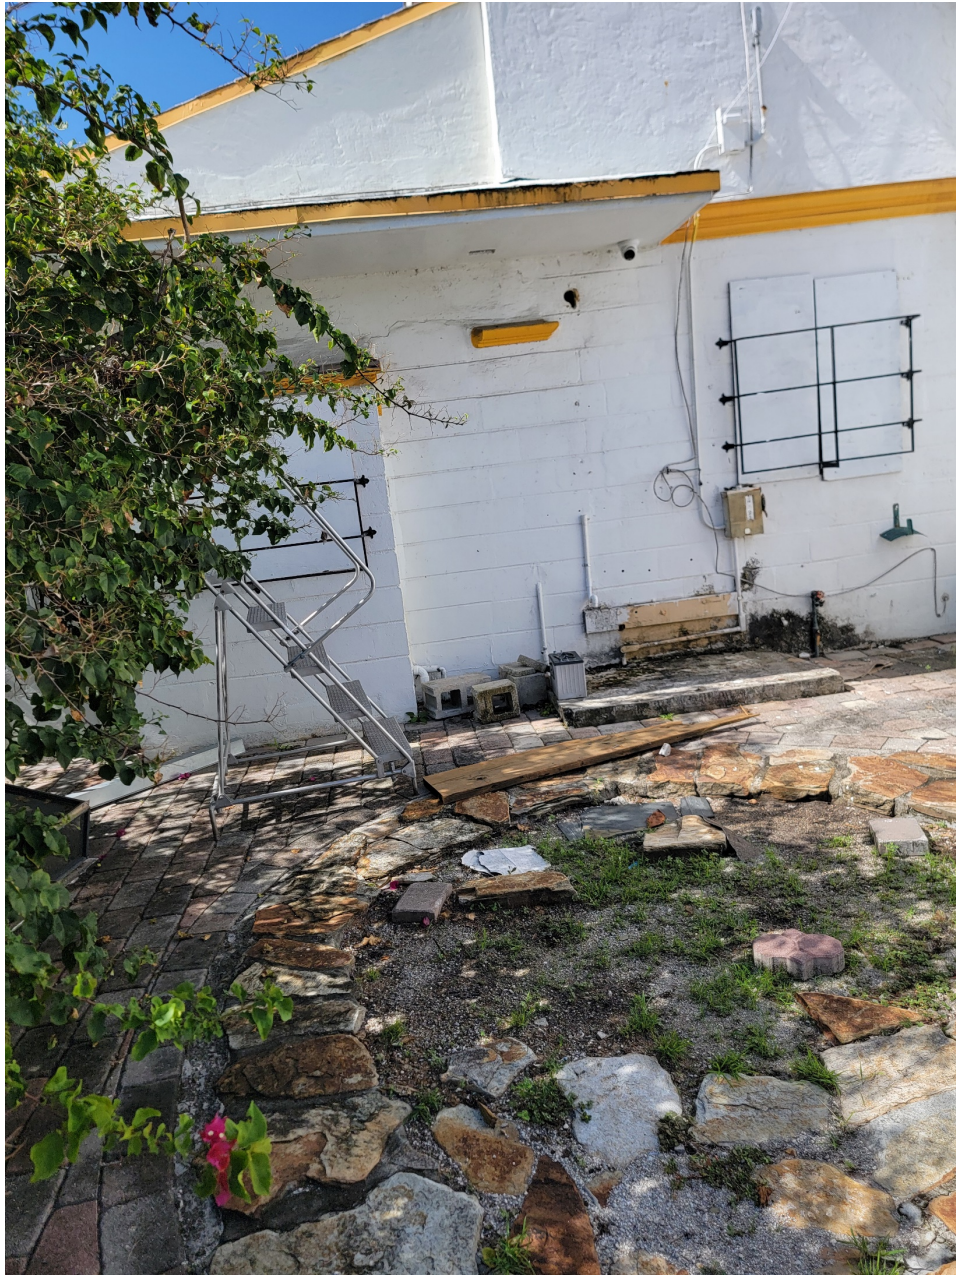
Spall and delaminated stucco present

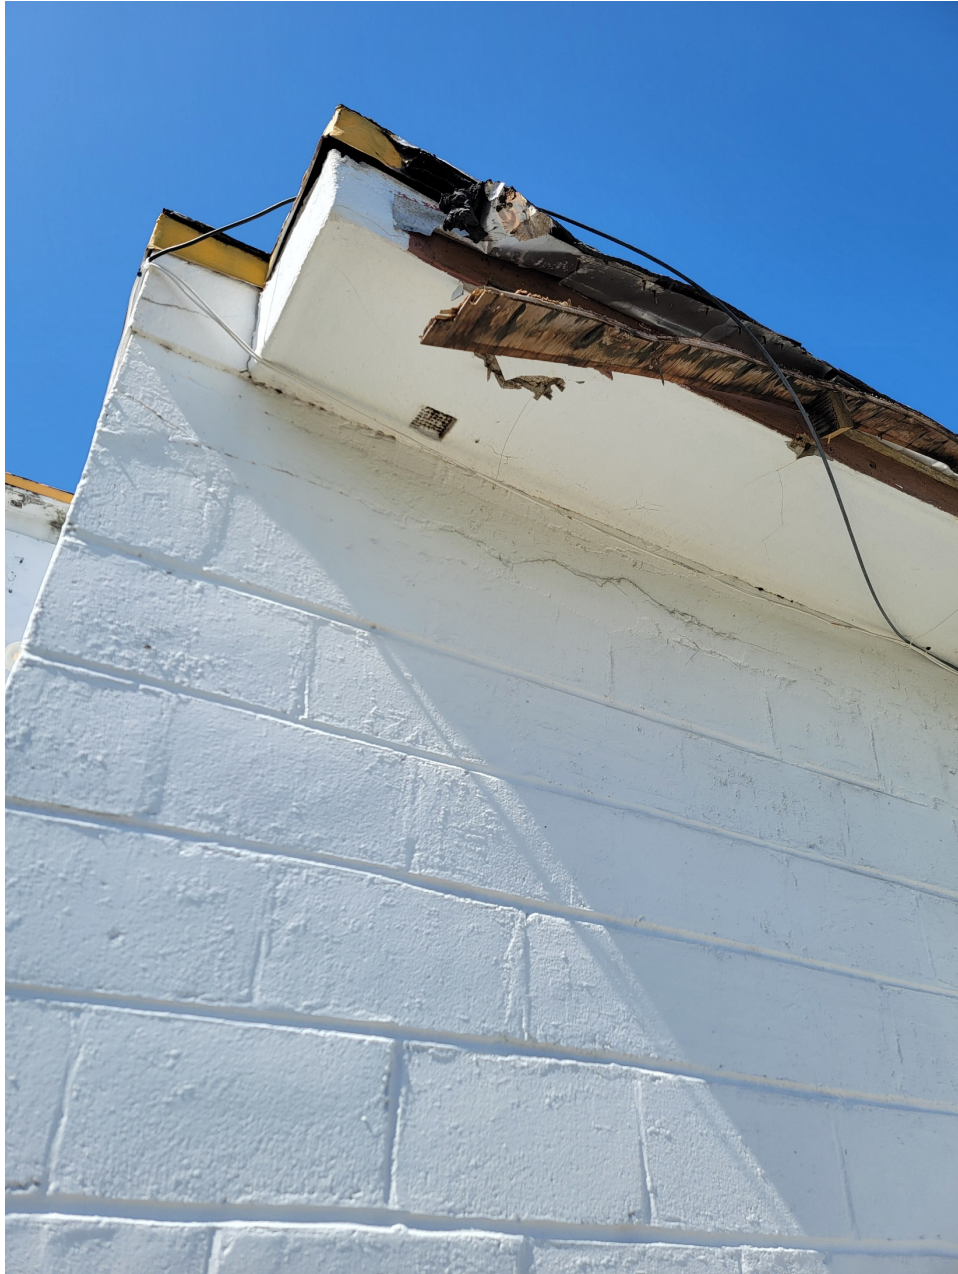
Rotted wood present on fascia

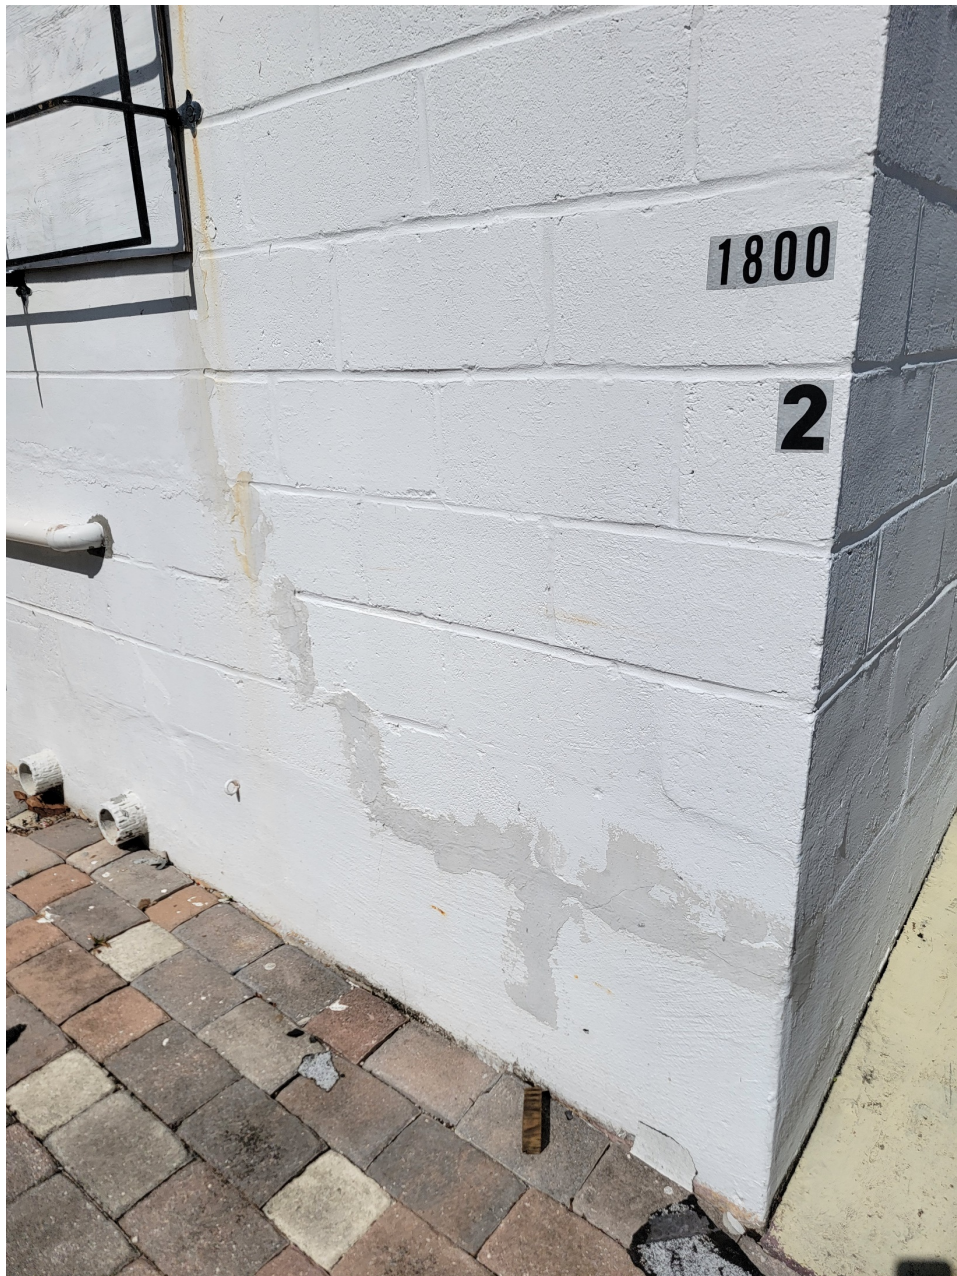
Cracks noted leading to foundations

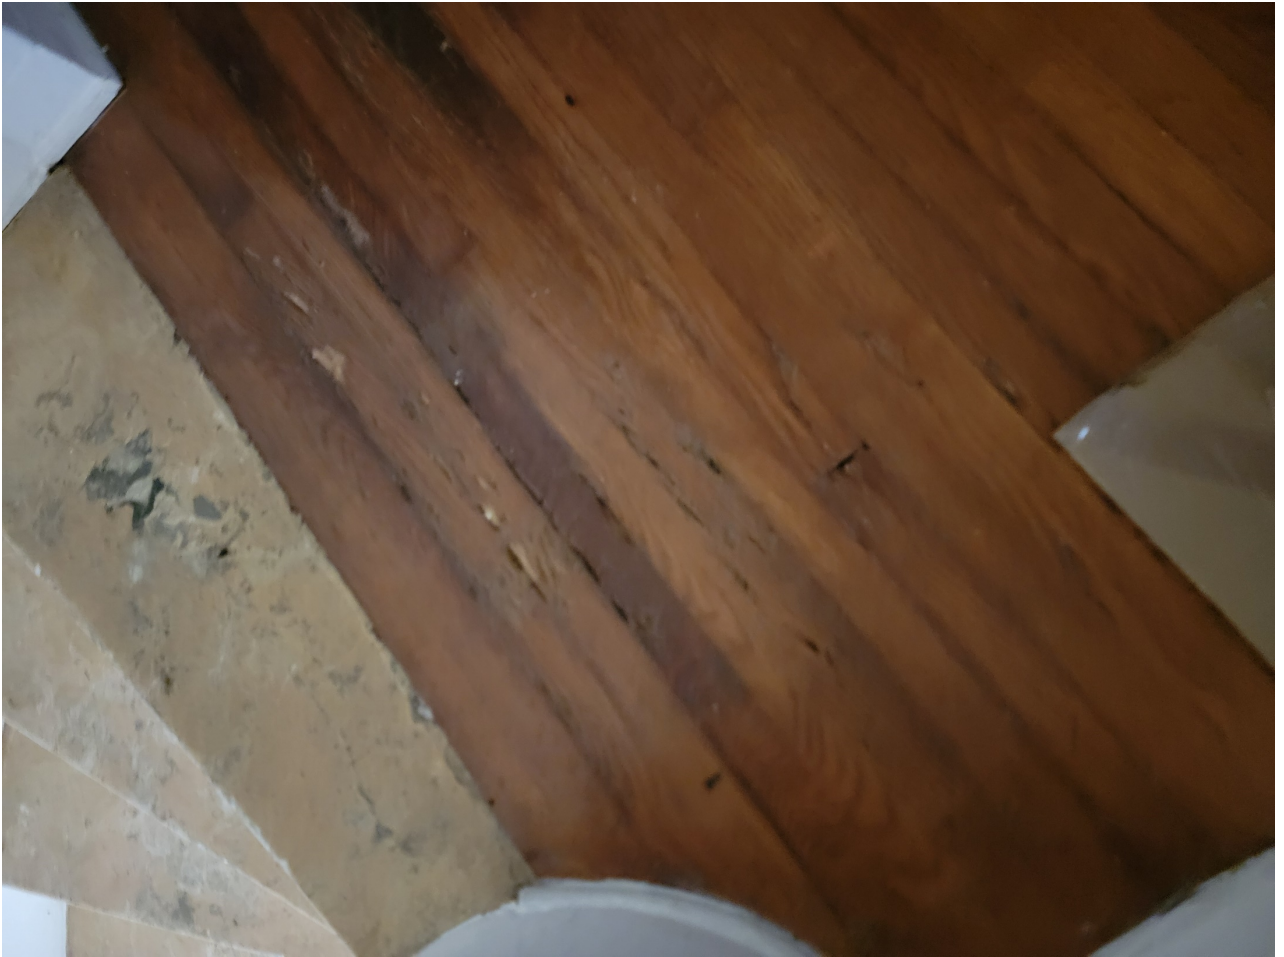
Termite damages noticed on wood floors

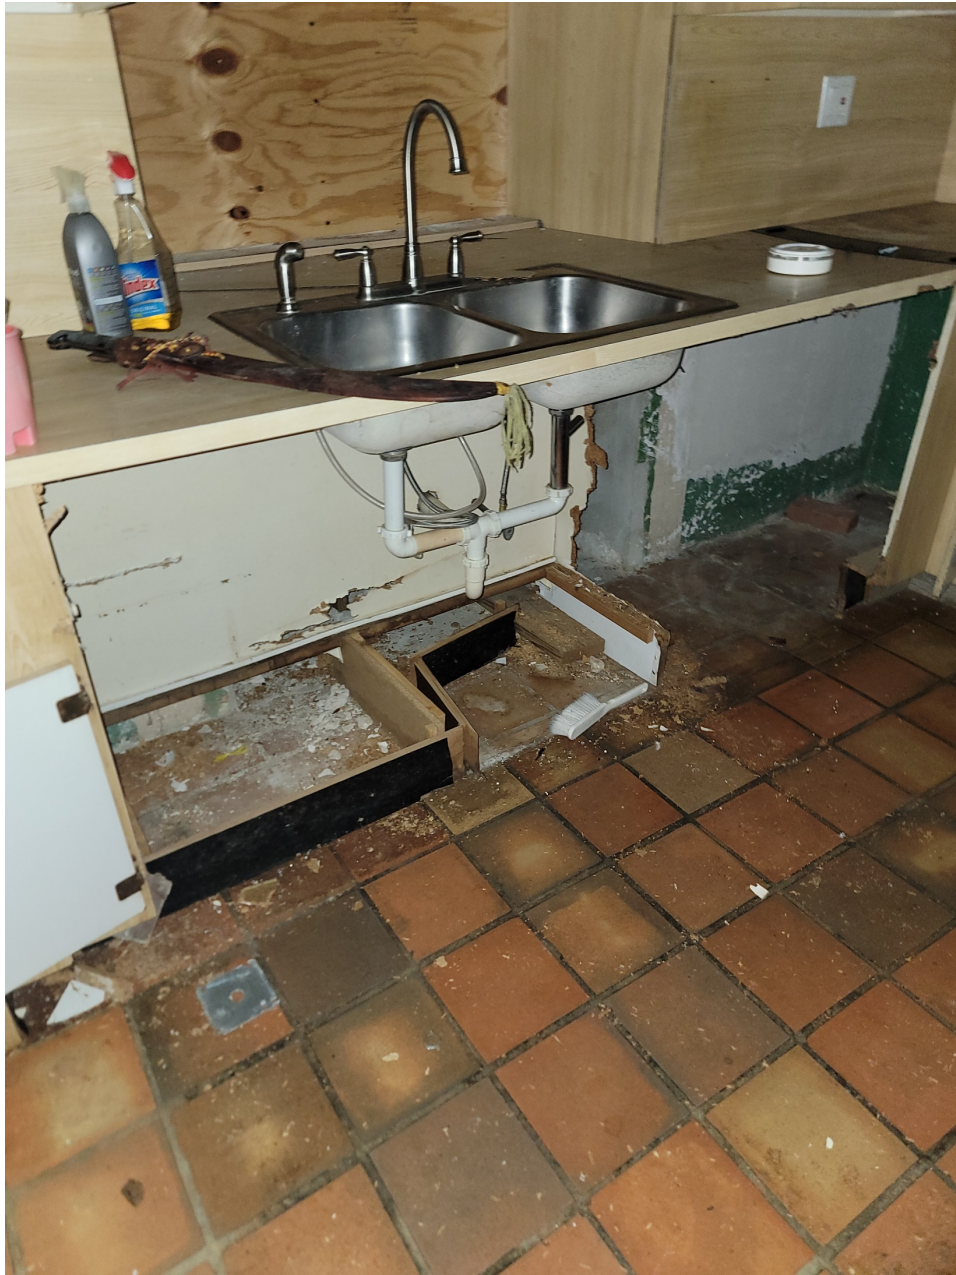
Water intrusion damages noted

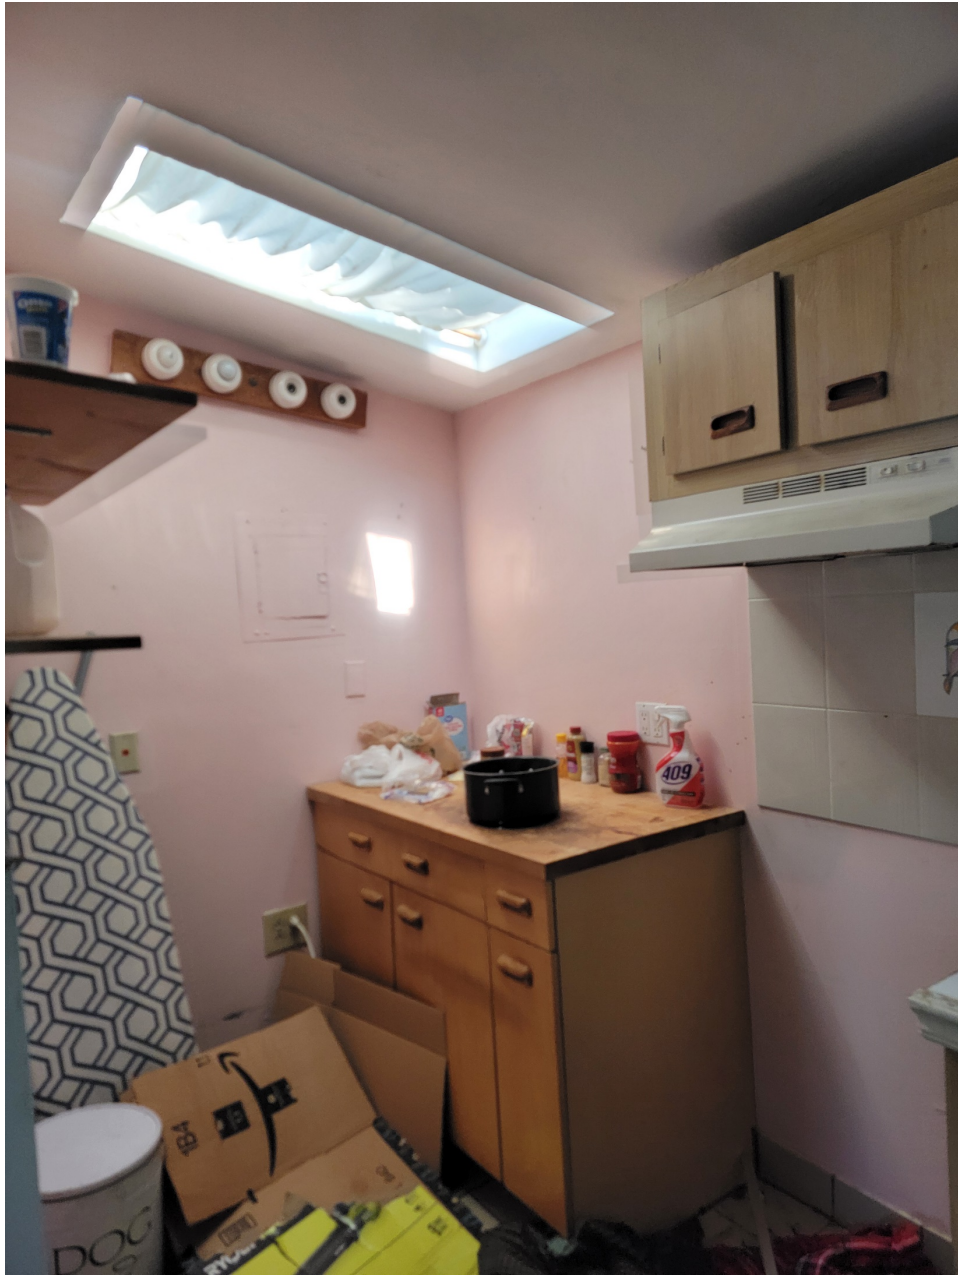
Skylights failure noticed

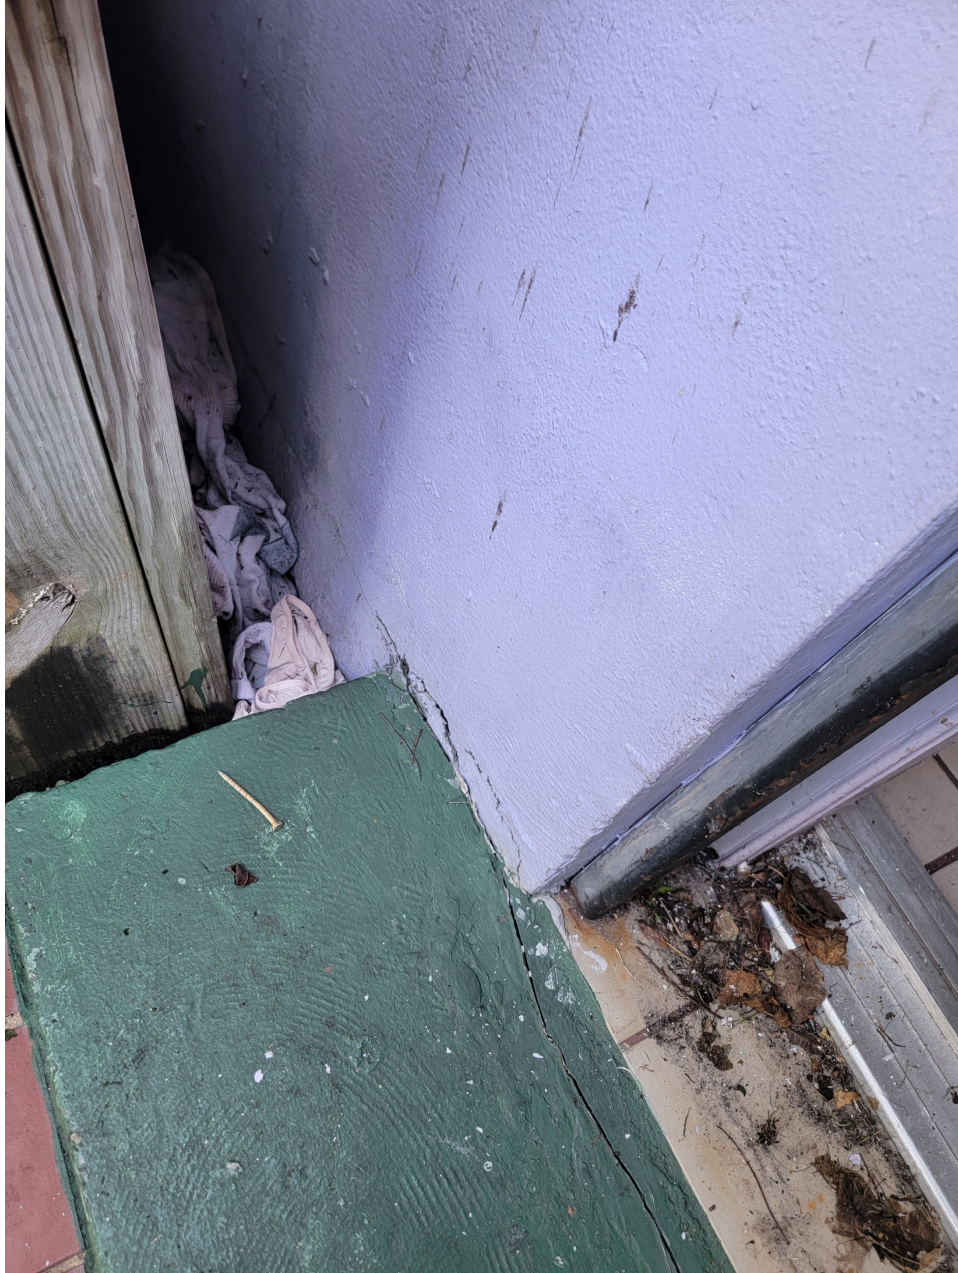
Deflections noticed on foundations

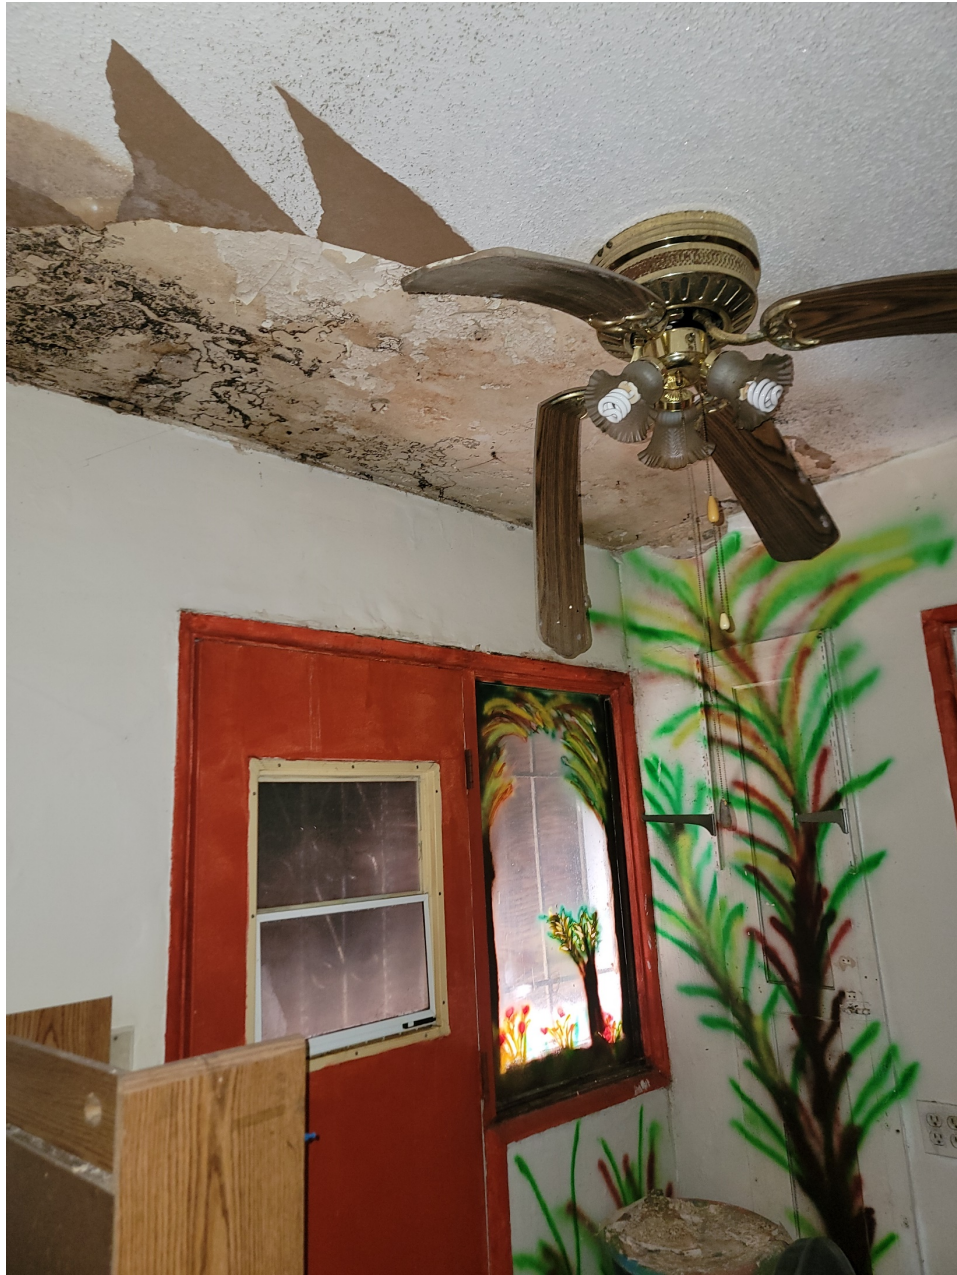
Mold present in interior finishes due to water intrusion

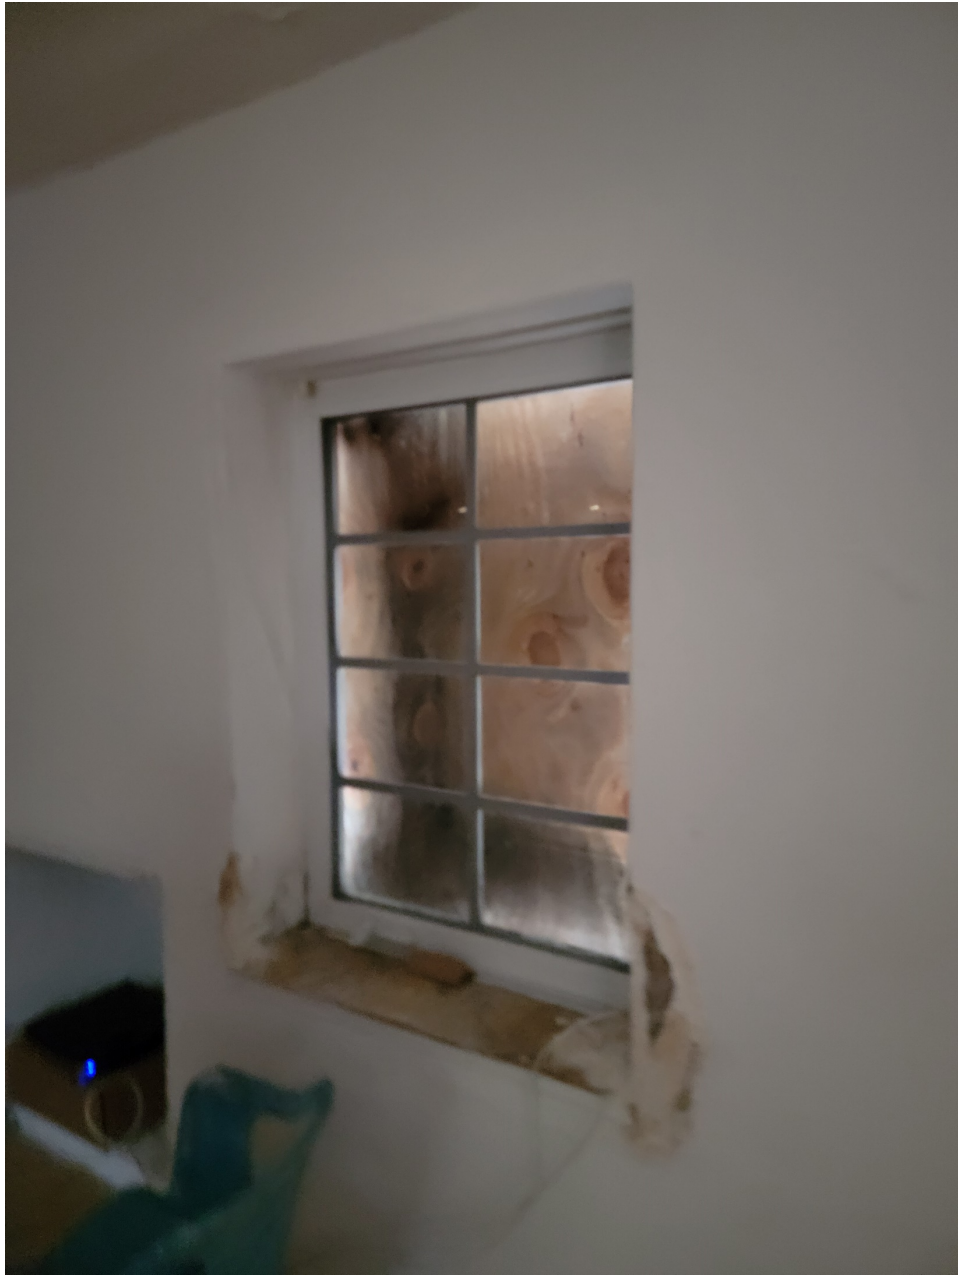
Water intrusion thru windows

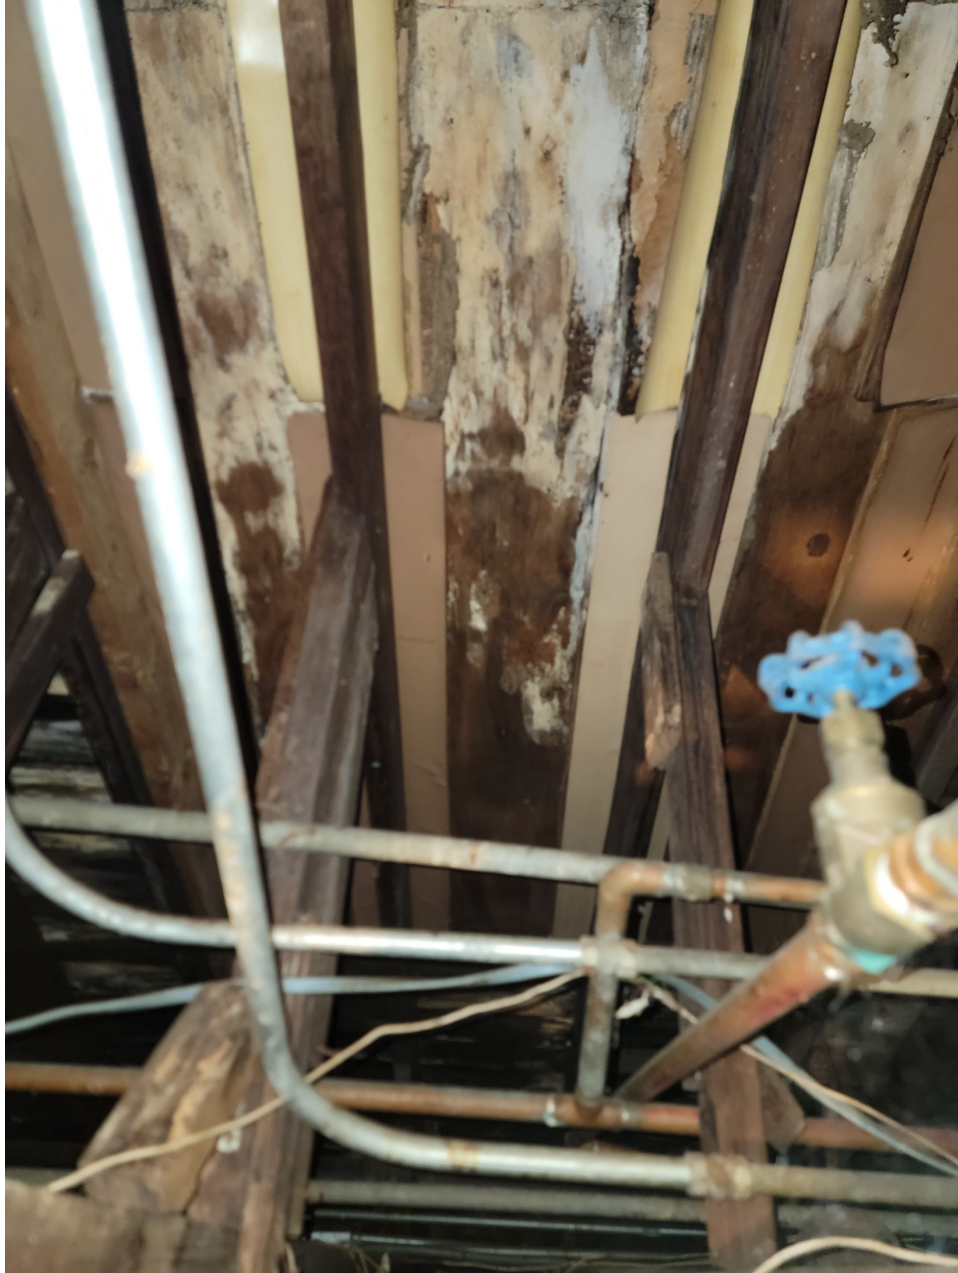
Water intrusion noticed coming from roof

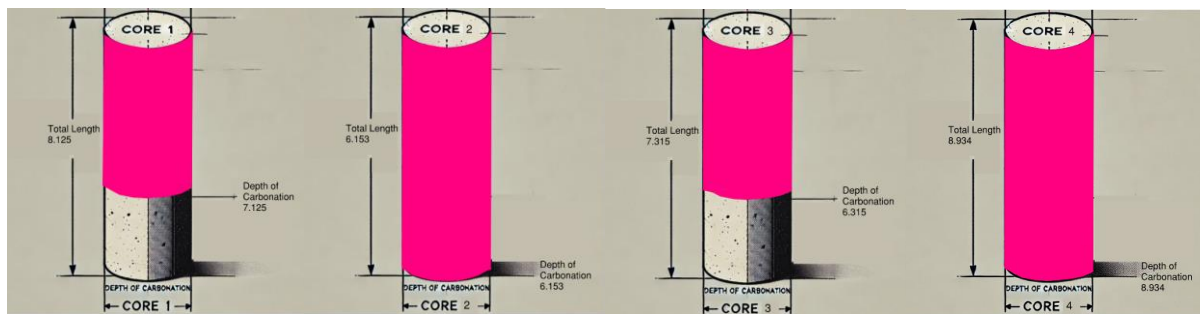
Figure 1- Depth of Carbonation (Core 1) Figure 2- Depth of Carbonation (Core 2) Figure 3- Depth of Carbonation (Core 3) Figure 4- Depth of Carbonation (Core 4)

The depth of carbonation ranged between approximately 6.153 and 8.934. A summary of the test results is summarized below in table 2 and illustrated in Figure 1 through 4.
