July 15, 2025

Attn: Rene Gonzalez
RENE GONZALEZ ARCHITECTS
T. 305.762.5895
www.renegonzalezarchitects.com

**RE: Existing Building at 336 Meridian,
Miami Beach, Florida 33139**

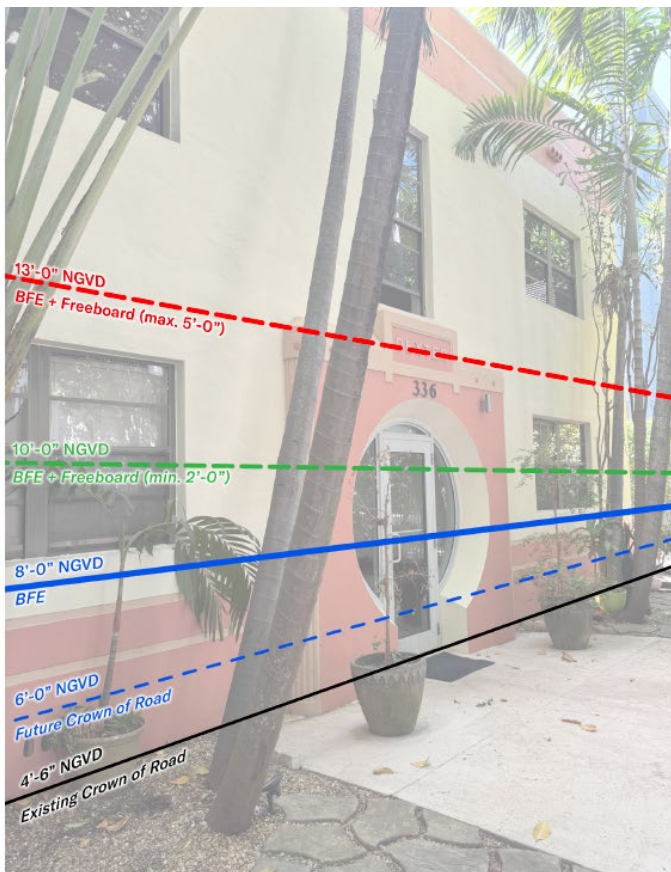
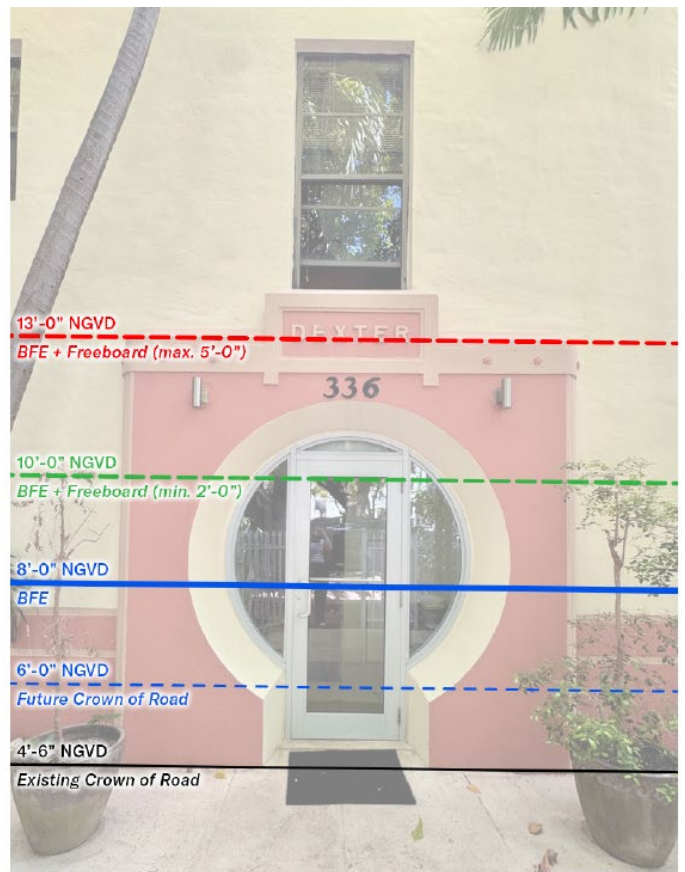
The ground level and second level framing is covered with finishes such as wood floors, tiles, etc. In some areas wood floors and wood joist framing at ground level and second level had severe damage due to wood rot, water intrusion and age of the building. It was also observed that the ground level elevation in the original construction areas is well below the current flood elevation by approximately 4 to 7 feet, and almost at the elevation of the future crown of road elevation. Below is the graphical presentation of the base flood elevation versus the existing elevation of ground level, which potentially can be exposed to several feet of water when flooding conditions occur in the future. It must be noted that the existing structure has not been designed to withstand potential flooding conditions with water level being several feet above the top of level 1. The potential flooding will have detrimental effect on the existing building from the structural stand point, and also will make it inhabitable during the flood event due to life safety concerns.

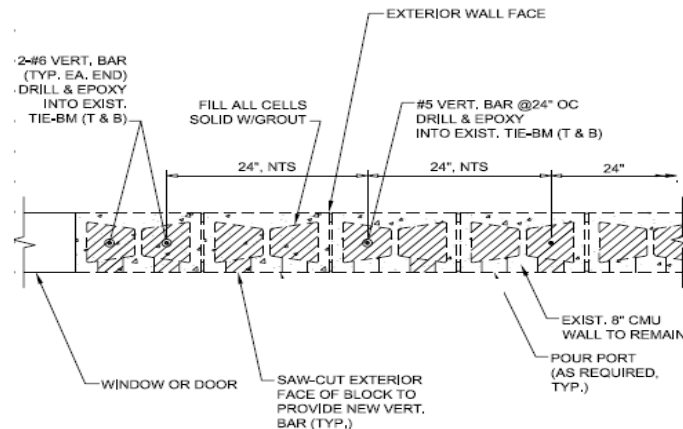
The exterior walls were observed to be CMU construction, with tie beam at second level and tie columns at the corners. The CMU walls do not have vertical reinforcement, reinforcement at window and door openings, etc. These walls also do not have horizontal joint reinforcement which is a code requirement for the current construction, and is placed at every other course. Thus the exterior CMU walls will require structural retrofit which will consist of reinforcement of the wall cells with new reinforcement, placed in trenched cells.

- The existing exterior CMU walls will require reinforcement installed at 24” minimum with additional reinforcement at all corners, intersections and at each window and door opening. All cells will require to be grouted from inside or outside of the wall. Existing window openings will required to be reinforced by installation of two bars in grouted cells at each side of each opening. Some larger openings may require new concrete tie columns. The typical CMU wall retrofit detail is below for reference.
