# ARBORIST REPORT

1265 N. Biscayne Point Rd.  
Miami Beach, FL 33141

Treage LLC was contacted by Andres Montero of AMLA Studio to conduct a Certified Arborist Report at 1265 N. Biscayne Point Rd., Miami Beach, FL

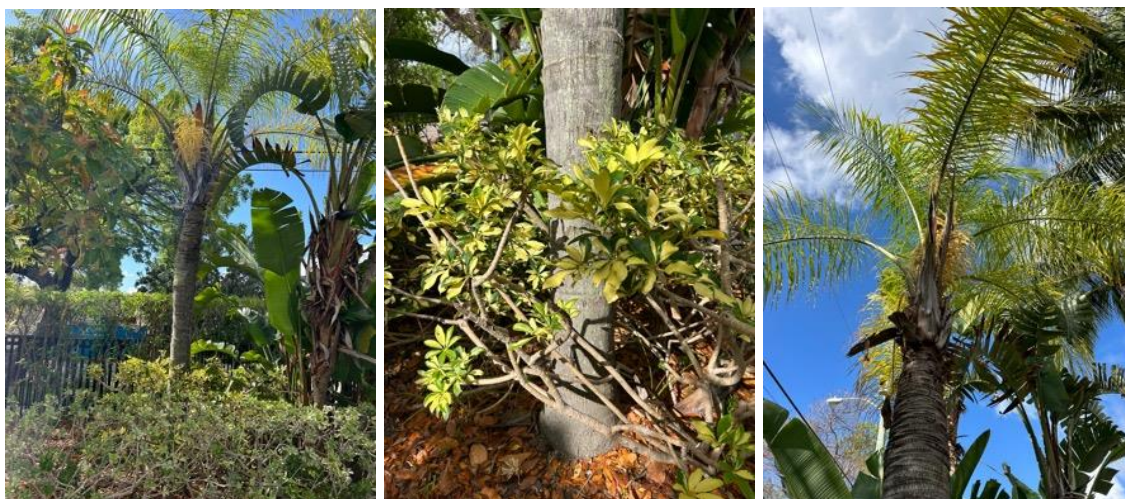
**Tree #2 – *Syagrus romanzoffiana*, Queen Palm** – this palm is located slightly southwest of Tree #1 in the circular driveway cutout. It shows signs of nutrient deficiency and is in borderline fair condition. It is just under regulation size, so it should be eligible for removal without regulation if necessary. It is also a possible, although not ideal, candidate for relocation onsite per specifications below; it is recommended for fertilization per BMP's if it remains or is relocated.

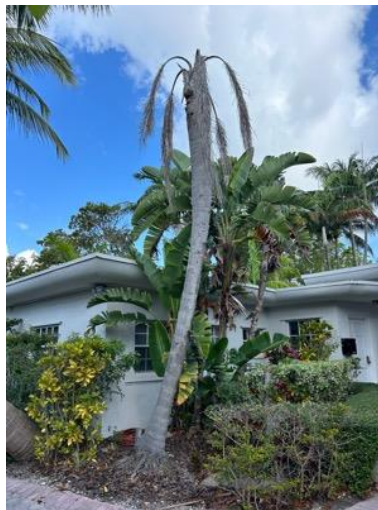
**Tree #9 – *Syagrus romanzoffiana*, Queen Palm** – this palm is located just northeast of Tree #8 on the west side of the front walkway/entrance. It is dead with no remaining live fronds. It should be eligible for removal without regulation, to be confirmed by the City.

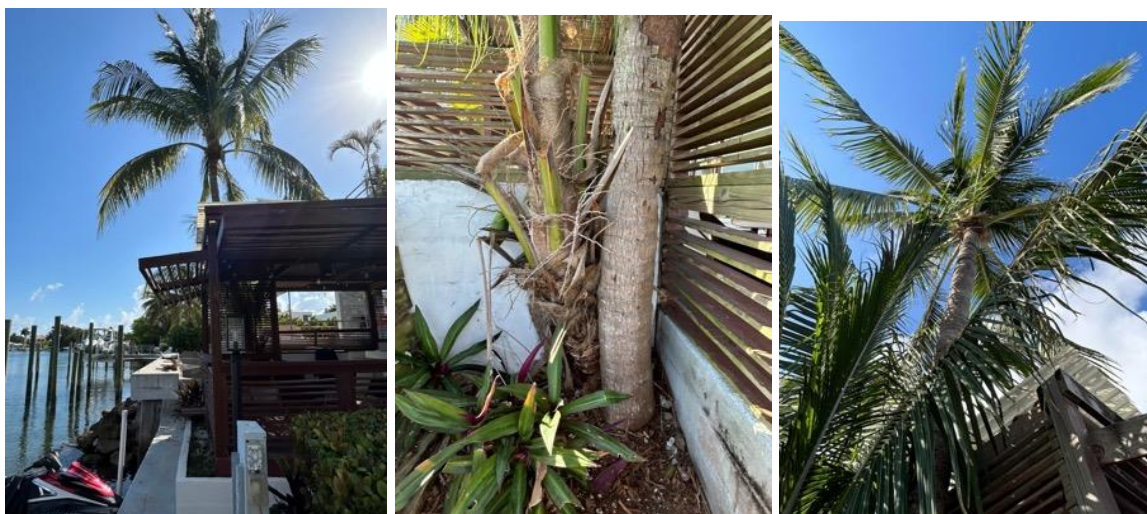
**Tree #13 – *Cocos nucifera*, Coconut** – this palm is growing in the northeast corner of the property near the seawall. It is growing next to a pergola and is within less than 1' of a CBS wall. It has moderate trunk damage but otherwise is in fair condition. It will require a permit and mitigation if it is removed. Otherwise, it will require very careful protection per measures below during all work activities, including demolition. There is a small seedling Coconut next to it with no clear trunk; it is under regulation size and should be eligible for removal without regulation.

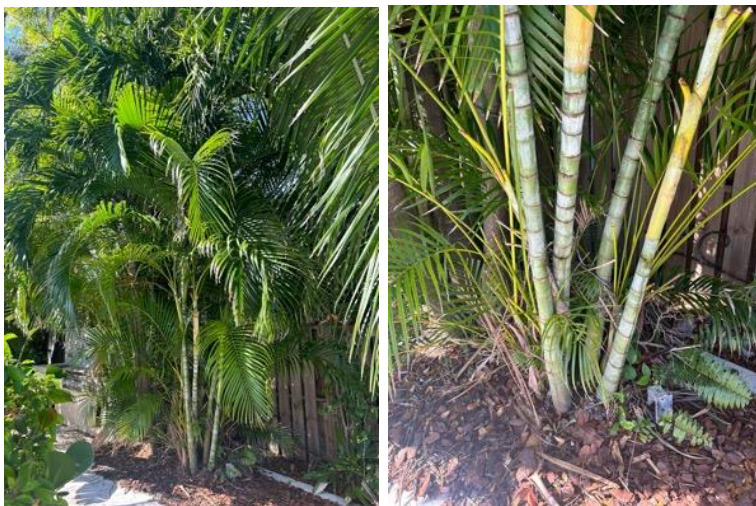
**Tree #16 – *Dypsis lutescens*, Areca Palm** – this palm is growing next to the property line in the northwest corner of the property. It is very crowded but otherwise in fair condition. It is under regulation height, so it should be eligible for removal without regulation if necessary. Otherwise, it is recommended for protection per measures below if it remains.

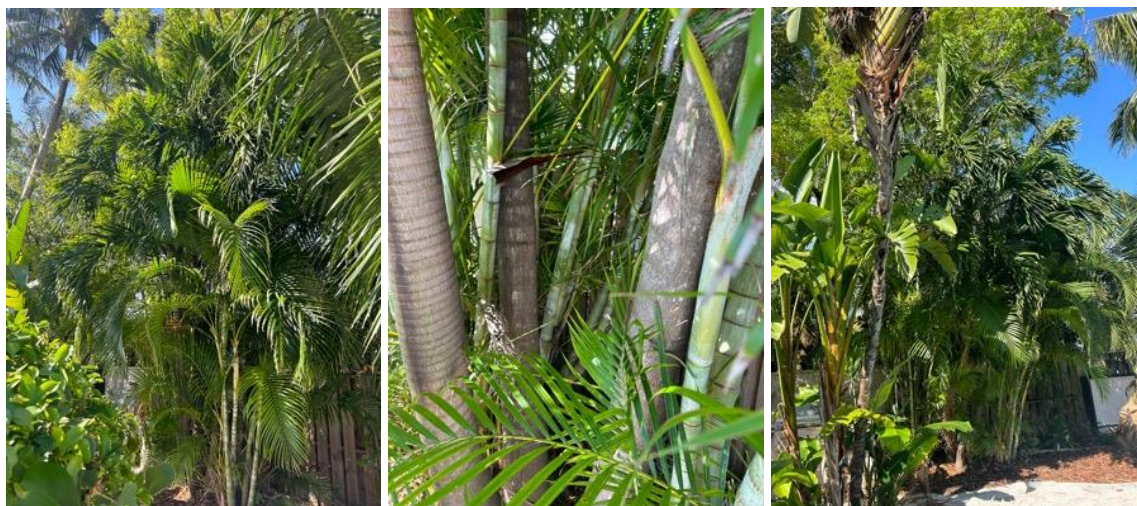
**Tree #17 – *Adonidia merrillii*, Christmas Palm** – this refers to a triple palm growing next to Tree #16. It is very crowded but otherwise in fair condition. It will require a permit and mitigation if it is removed, or protection per measures below if it remains.

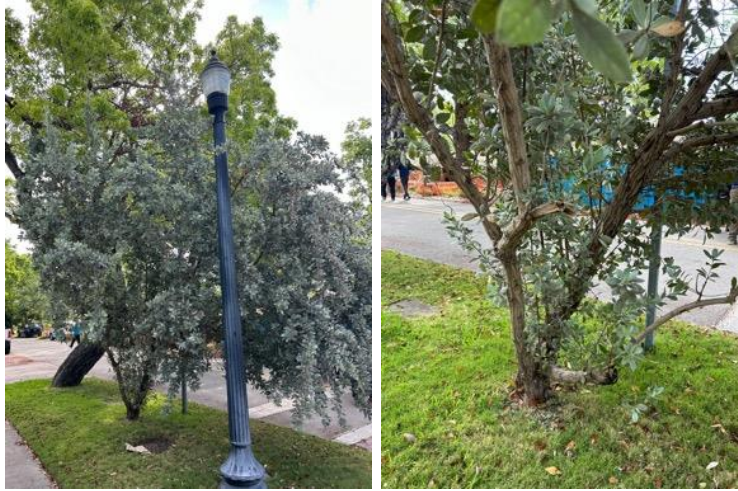
**Tree #34 – *Conocarpus erectus* var. *sericeus*, Silver Buttonwood** – this tree is growing just southwest of Tree #1 in the ROW. It splits into multiple small diameter trunks near ground level with some small tears present along the trunk and lower limbs. It is slightly crowded but otherwise is in fair condition. It is under regulation height, but it is recommended for protection per measures below during all staging/access activities.

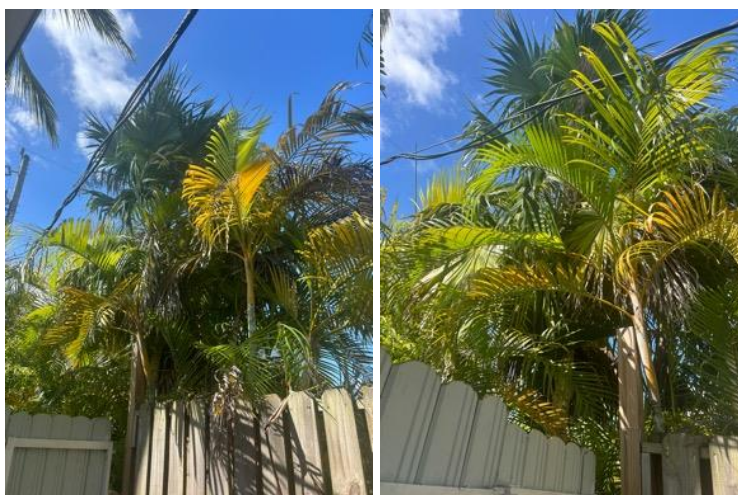
***Dypsis lutescens*, Areca Palm** – this palm cluster is growing outside of the southwest fence line adjacent to Tree #32. It is chlorotic and under regulation size. Its TPZ extends less than 1' over the property line, so it is not expected to be impacted, but protection measures below apply.

***Thrinax radiata*, Thatch Palm** – this palm is growing in the cluster of Areca Palms on the southwest side of this residence. Its TPZ does not extend over the property line and it should not be impacted.
