# ARBORIST REPORT

1265 N. Biscayne Point Rd.  
Miami Beach, FL 33141

Treage LLC was contacted by Andres Montero of AMLA Studio to conduct a Certified Arborist Report at 1265 N. Biscayne Point Rd., Miami Beach, FL

The site consists of an existing single-family home proposed for demolition and new construction of a single-family home. There are 34 trees located onsite, as well as 5 trees located offsite, that are referenced below.

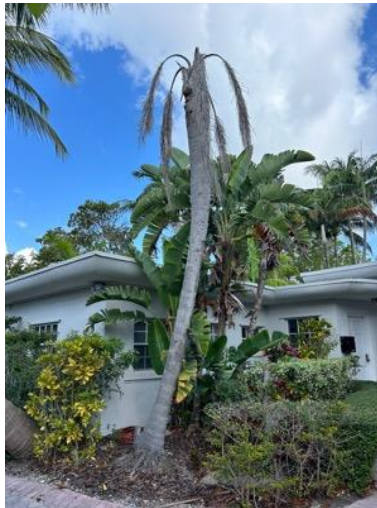
**Tree #9 – *Syagrus romanzoffiana*, Queen Palm** – this palm is located just northeast of Tree #8 on the west side of the front walkway/entrance. It is dead with no remaining live fronds. It should be eligible for removal without regulation, to be confirmed by the City.

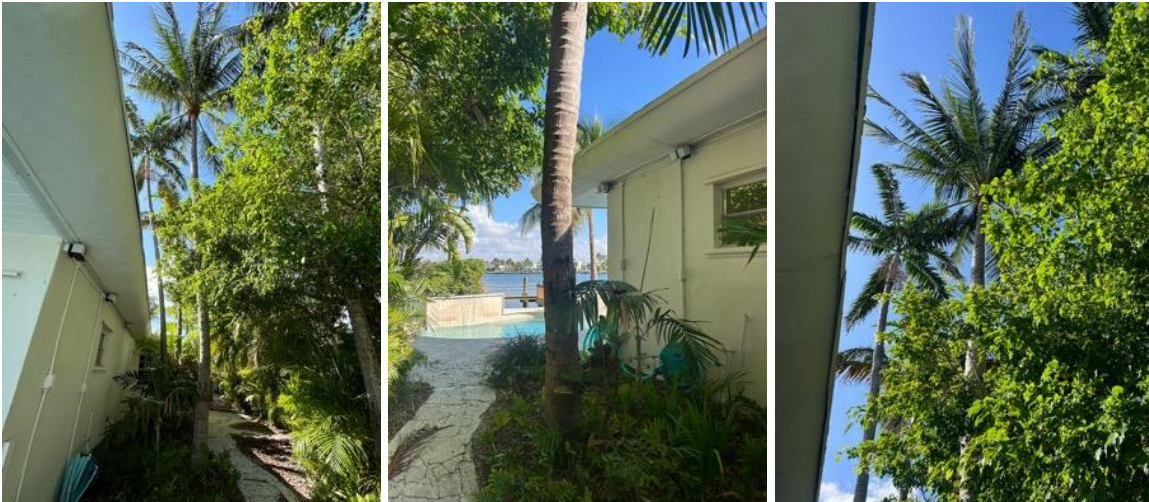
**Tree #21 – *Cocos nucifera*, Coconut** – this palm is growing on the opposite side of the walkway just southeast of Tree #20; it is within 2' of the path and 6' of the existing residence. It has minor to moderate trunk damage present but otherwise is in fair condition. It will require a permit and mitigation if it is removed. Otherwise, it will require very careful protection per measures below during all work activities, including demolition.

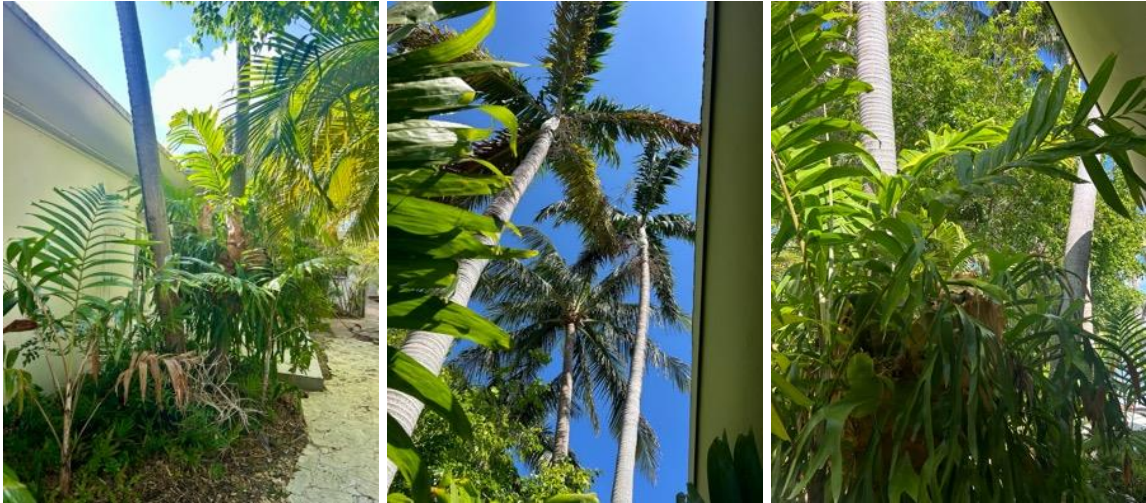
**Trees #22-23 – *Veitchia arecina*, Montgomery Palm** – this refers to 2 palms growing within less than 2' of each other southeast of Tree #21 between the side walkway and the residence. They are both slightly crowded with some epiphytes growing up their trunks, but otherwise they are in fair condition. They will require careful protection per measures below during all work activities if they remain, or a permit and mitigation if they are removed. They are also possible candidates for relocation onsite per measures below as an alternative to removal; see Relocation Specifications below.

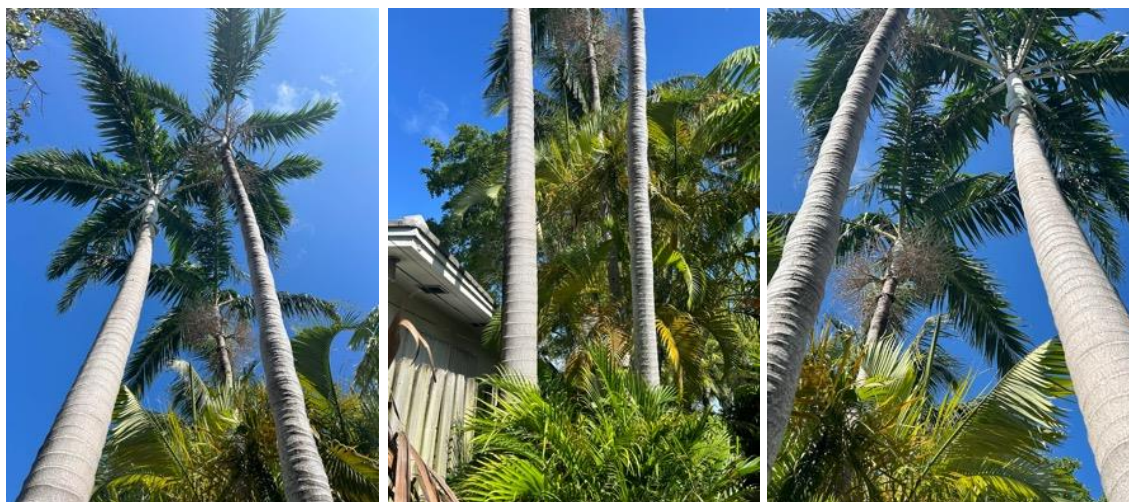
**Trees #28-30 – *Veitchia arecina*, Montgomery Palm** - this refers to 3 palms growing within approximately 3' of each other on the southeast side of Tree #27. They are all somewhat crowded but otherwise in fair to good condition. They are possible candidates to remain with protection during construction per measures below due to their compact root zones and location on the perimeter of the property. If they are removed, they will require a permit and mitigation. They are also possible candidates for relocation onsite as an alternative to removal; see Relocation Specifications below.

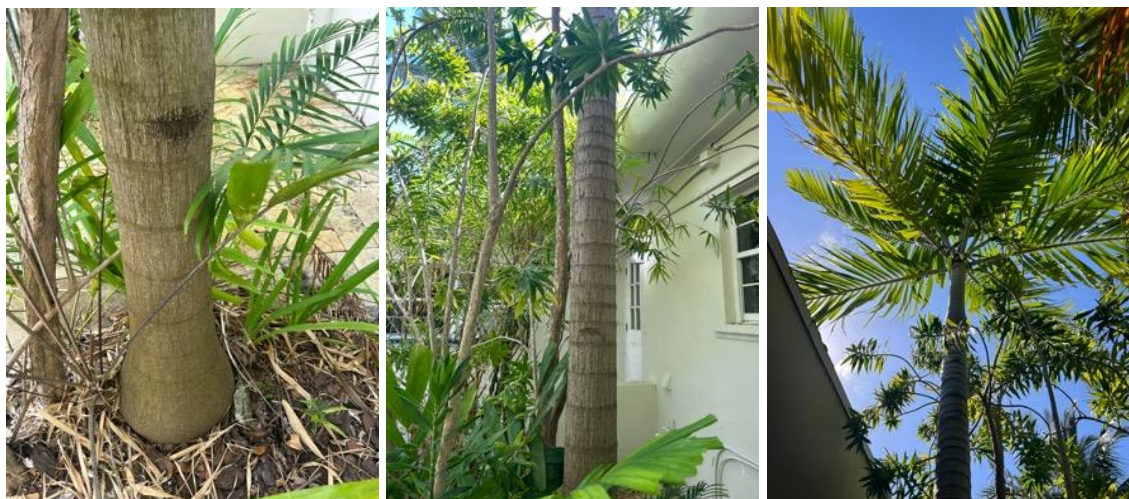
**Tree #31 – *Veitchia arecina*, Montgomery Palm** – this palm is growing on the south side of the AC unit on the east side of the path. It is slightly crowded and slightly chlorotic, but overall it is in fair condition. It is just under regulation height, so it may be eligible for removal without a permit or mitigation.
