June 24<sup>th</sup>, 2024

## **Arboricultural Consulting Services at 8-10 Century Lane, Miami Beach, Florida**

## ALL TREES LOCATED WITHIN THE PROJECT AREA

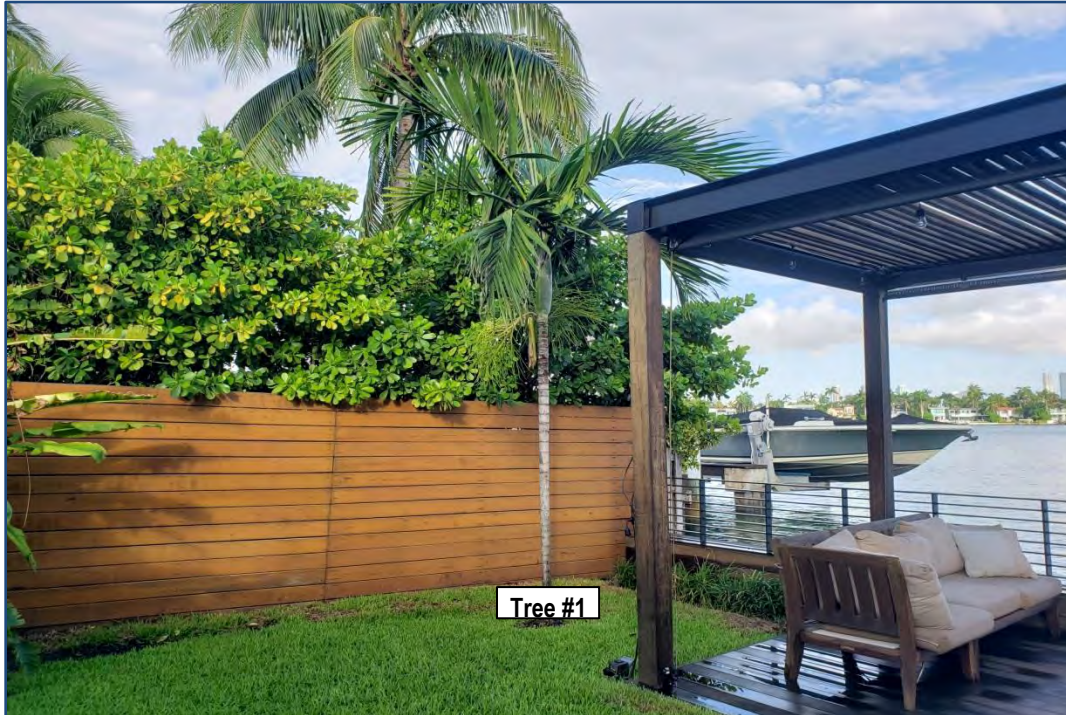
Looking northwest at Non-Regulated Tree No. 1.

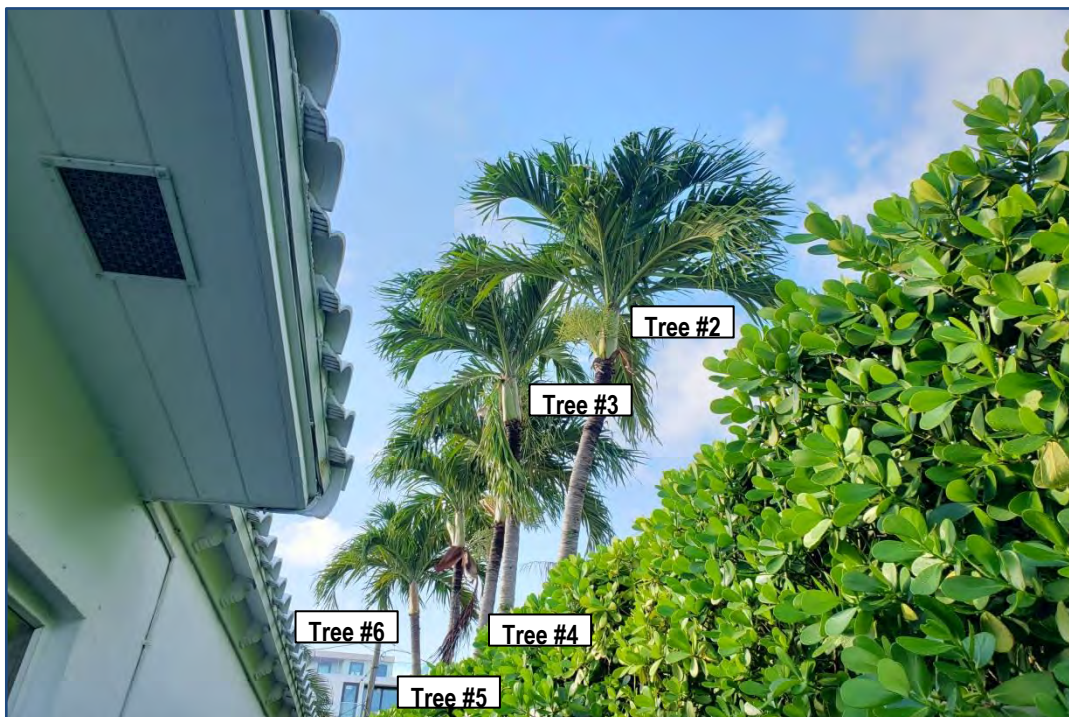
Looking southeast at Non-Regulated Tree No. 2 and Regulated Tree Nos. 3, 4, 5 and 6.

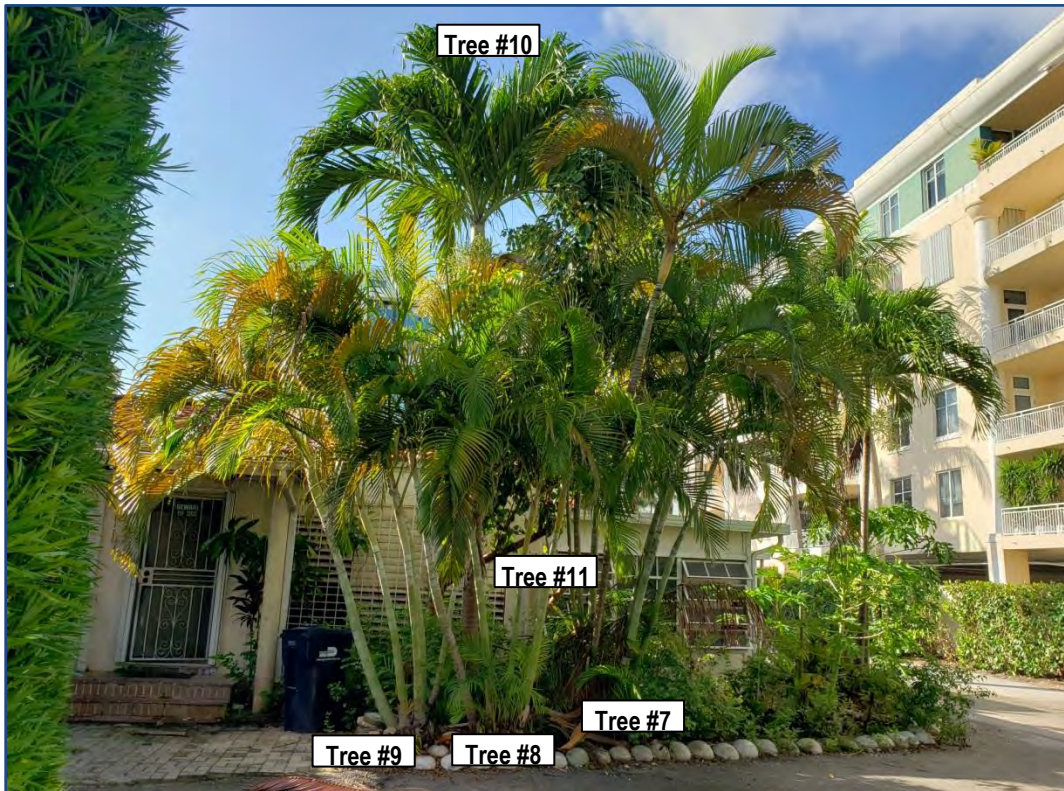
Looking southeast at Non-Regulated Tree Nos. 7, 8 and 9 and Regulated Tree Nos. 10 and 11.

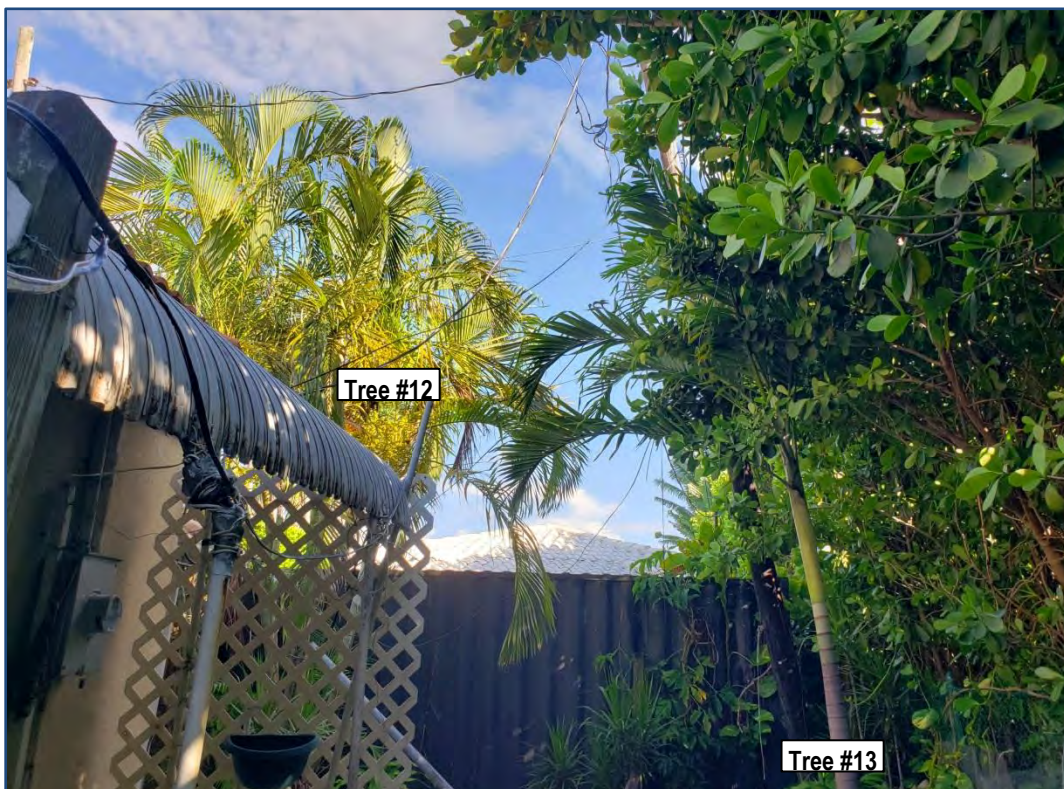
Looking northwest at Non-Regulated Tree Nos. 12 and 13.

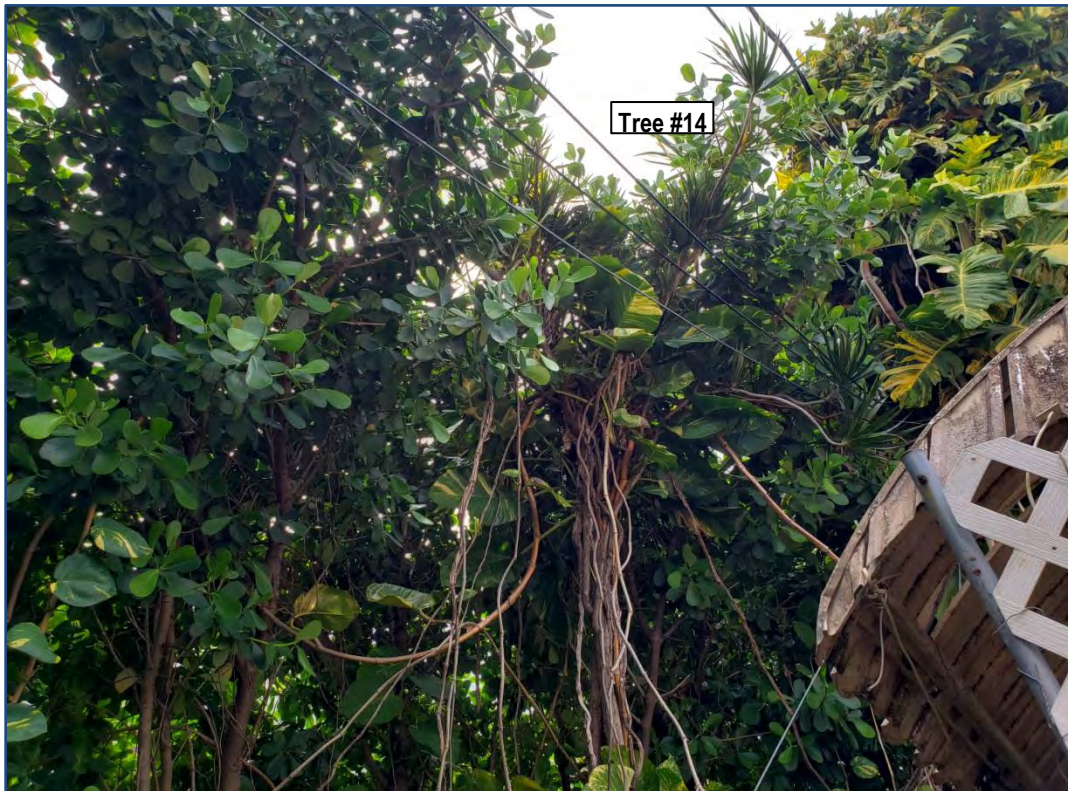
Looking southeast at Non-Regulated Tree No. 14.

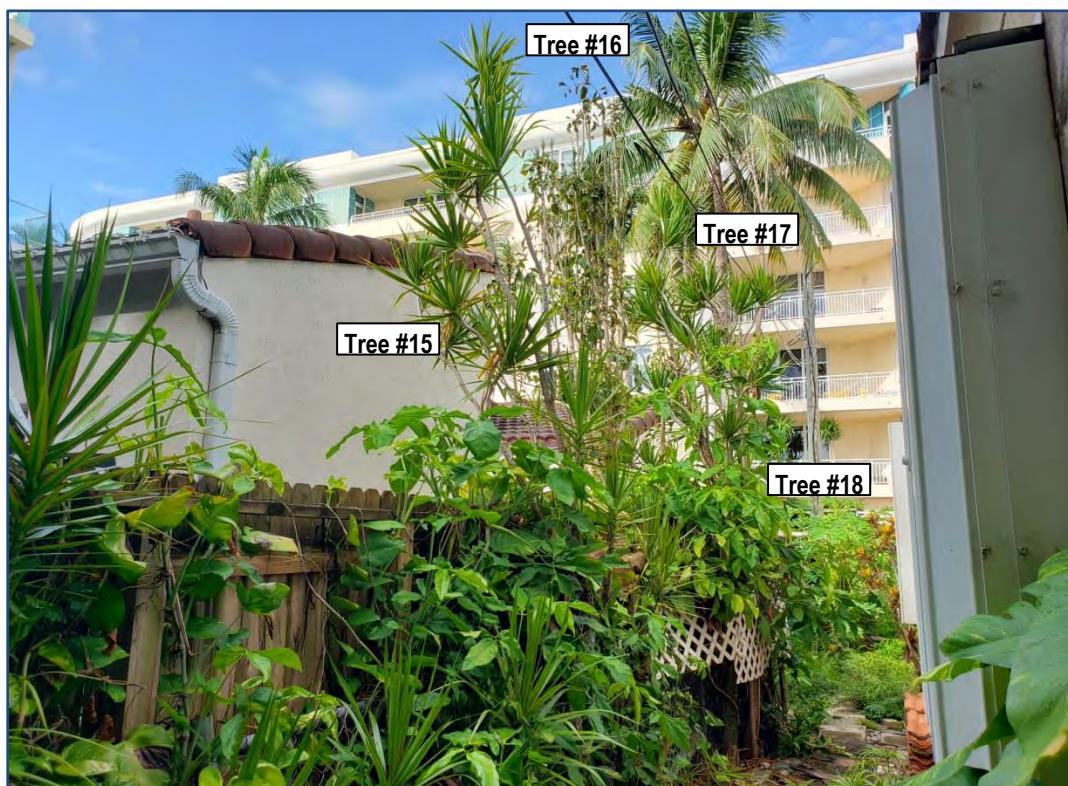
Looking southwest at Non-Regulated Tree Nos. 15, 17 and 18 and Regulated Tree No. 16.

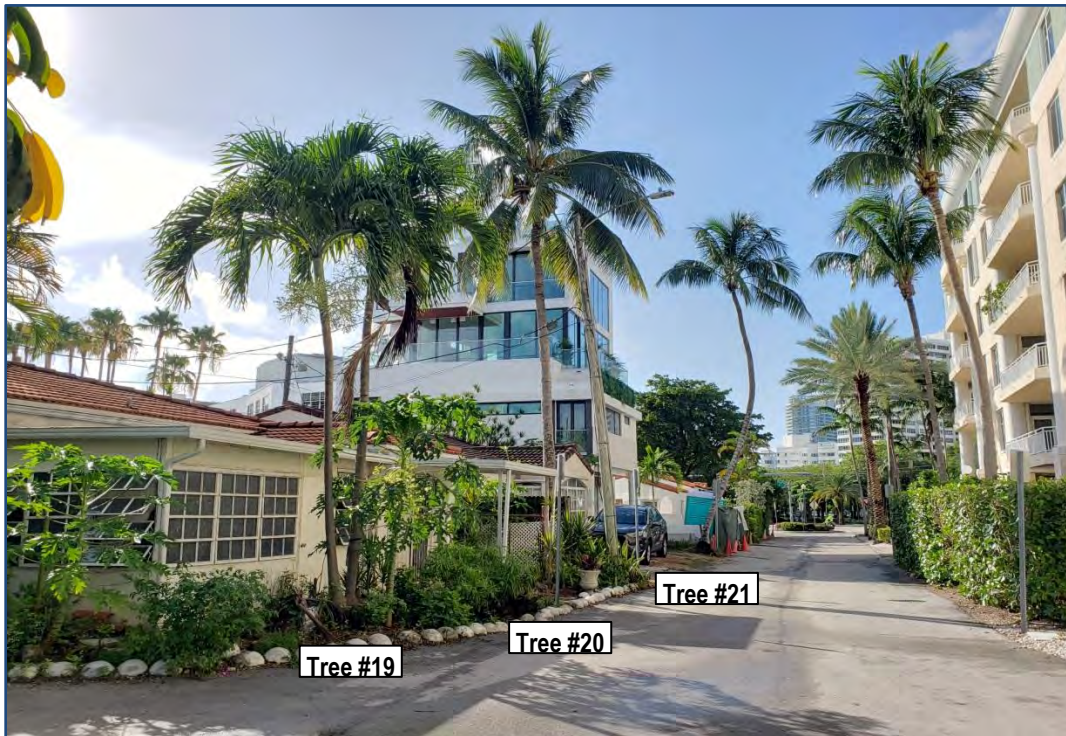
Looking southeast at Regulated Tree Nos. 19, 20 (specimen) and 21.

**Tree number 20**, Coconut palm, *Cocos nucifera*, is 48 feet tall with a canopy width of 22 feet and a DBH of 12 inches. The health condition percentage for the tree is 80%, good. The palm tree has minor line and pole conflicts.

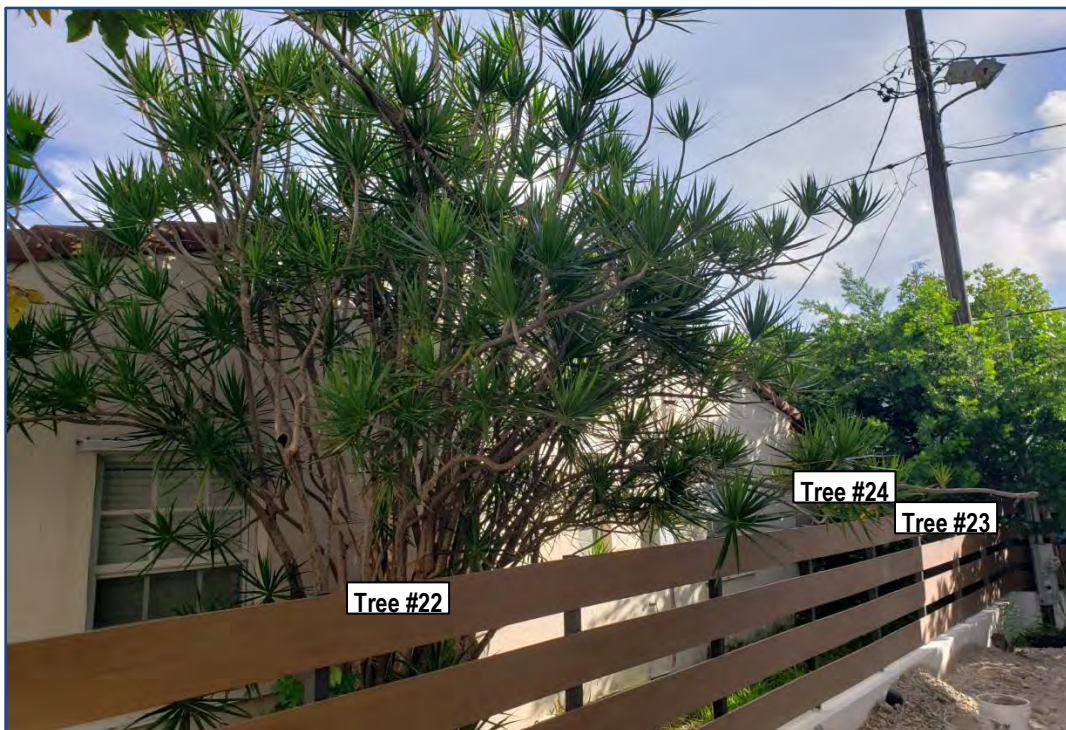
Looking northeast at Non-Regulated Tree No. 22 and Regulated Tree Nos. 23 and 24.
