## Arborist Report

Miller Legg Project No.  
25-00062

## City of Miami Beach North Beach Log Cabin

**North Beach Oceanside Park Log Cabin**  
**Arborist Review**

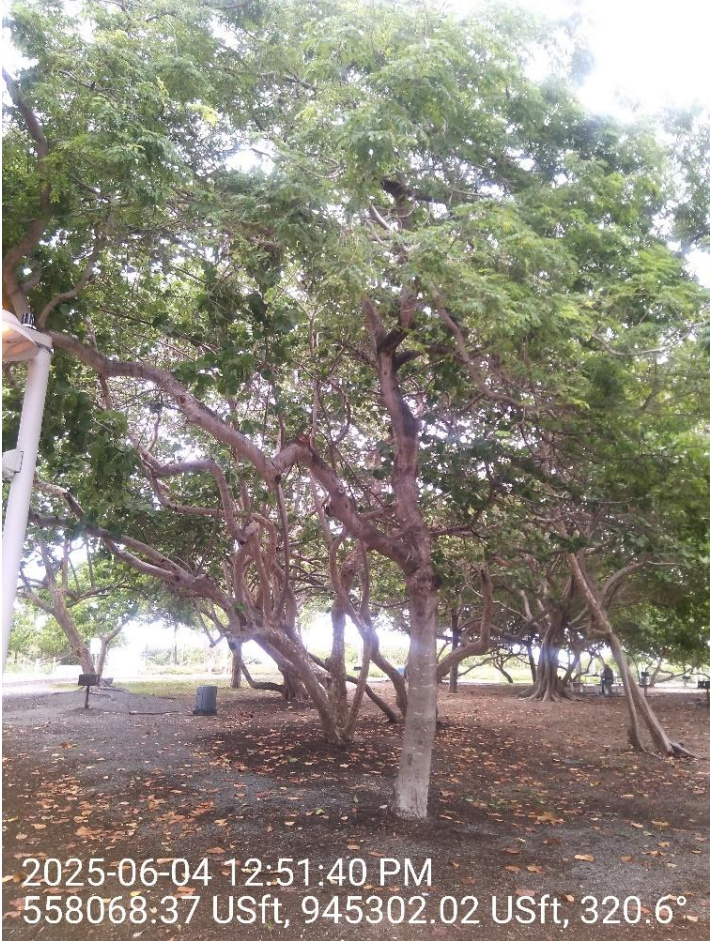
| Tree Details | | Photos |
|---|---|---|
| Tree ID | 1 | |

| Tree Details | | Photos |
|---|---|---|
| Observed Conditions | Bent Trunk, Limb Damage – Minor, Lopsided | |
| Overall Condition | Fair | |
| Condition % | 50% | |

| Tree Details | | Photos |
|---|---|---|
| Disposition | Remain | |

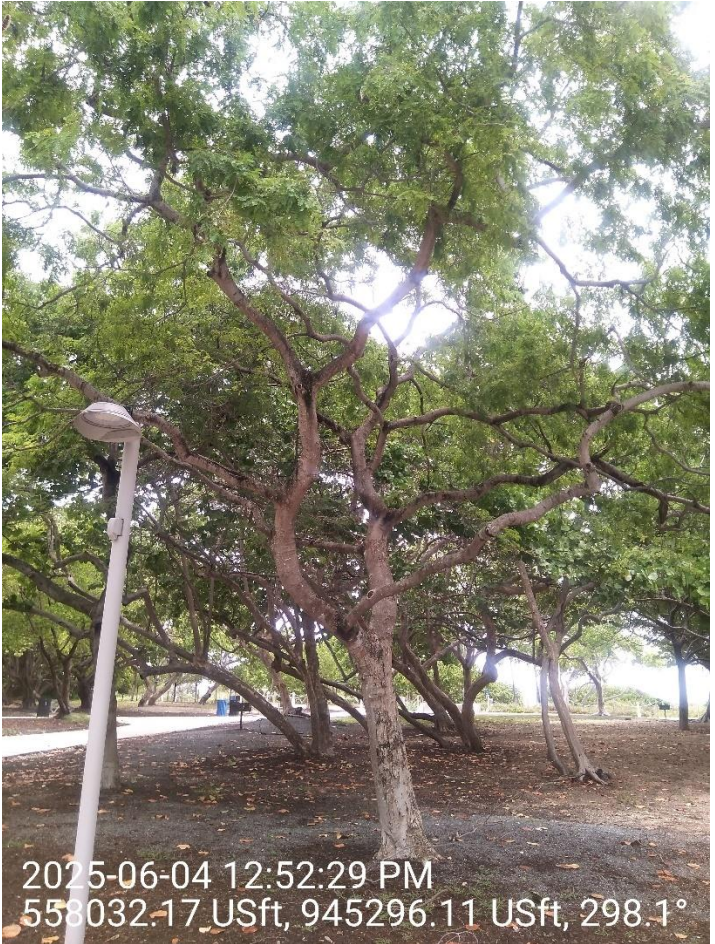
| Tree Details | | Photos |
|---|---|---|
| Tree ID | 2 | |

| Tree Details | | Photos |
|---|---|---|
| Observed Conditions | Bent Trunk,<br>Limb Damage - Minor | |
| Overall Condition | Fair | |
| Condition % | 55% | |

| Tree Details | | Photos |
|---|---|---|
| Disposition | Relocate | |

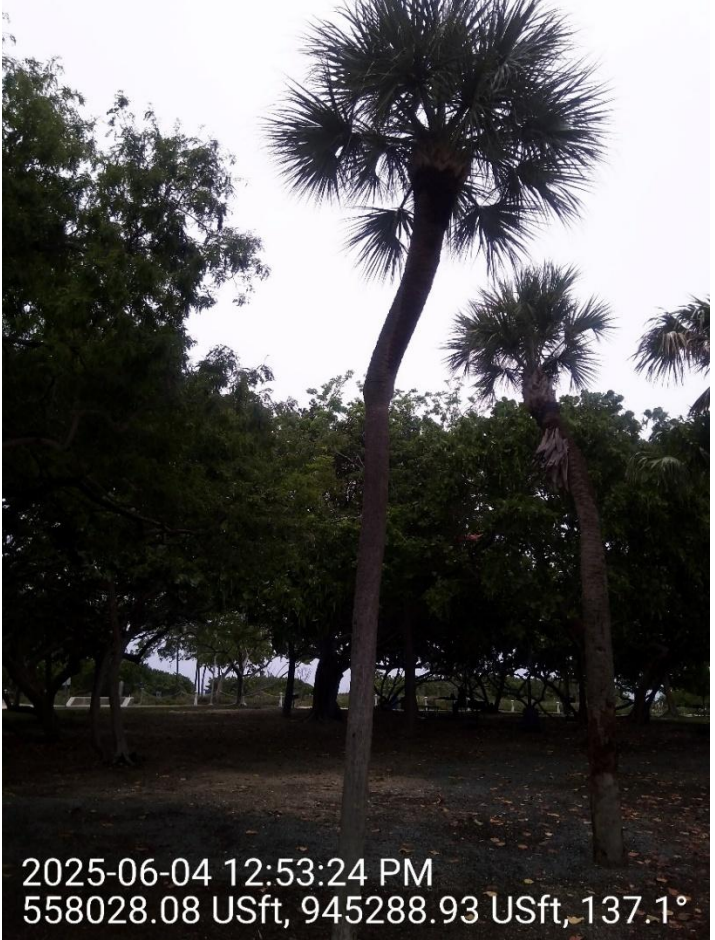
| Tree Details | | Photos |
|---|---|---|
| Tree ID | 3 | |

| Tree Details | | Photos |
|---|---|---|
| Overall Condition | Fair | |
| Condition % | 55% | |

| Tree Details | | Photos |
|---|---|---|
| Disposition | Remain | |

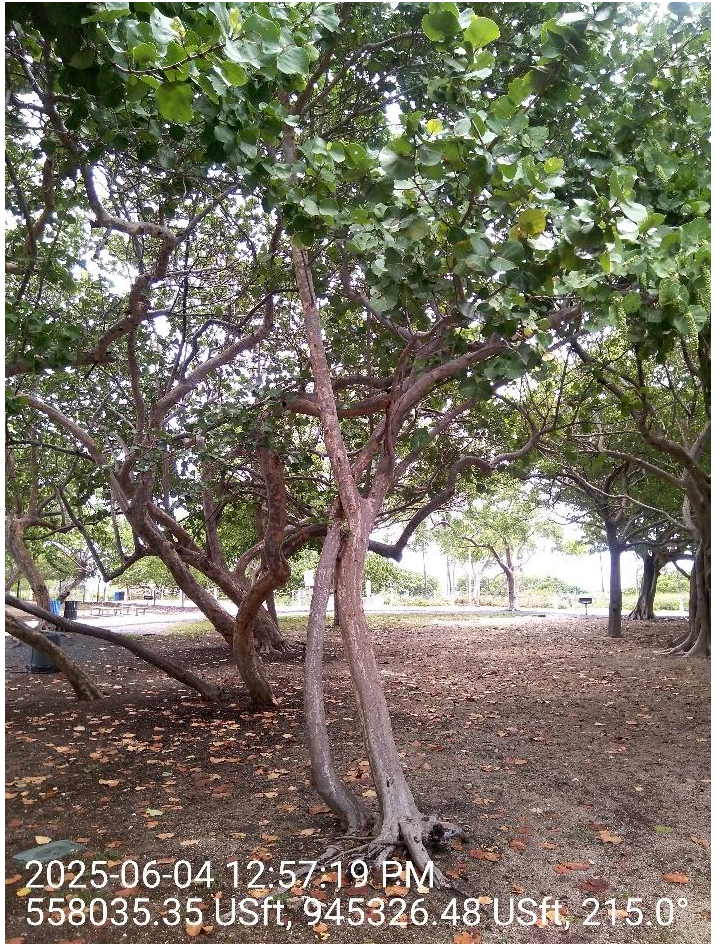
| Tree Details | | Photos |
|---|---|---|
| Tree ID | 8 | |

| Tree Details | | Photos |
|---|---|---|
| Observed Conditions | Bent Trunk, Co-Dominant Leaders | |
| Overall Condition | Fair | |
| Condition % | 50% | |

| Tree Details | | Photos |
|---|---|---|
| Disposition | Relocate | |

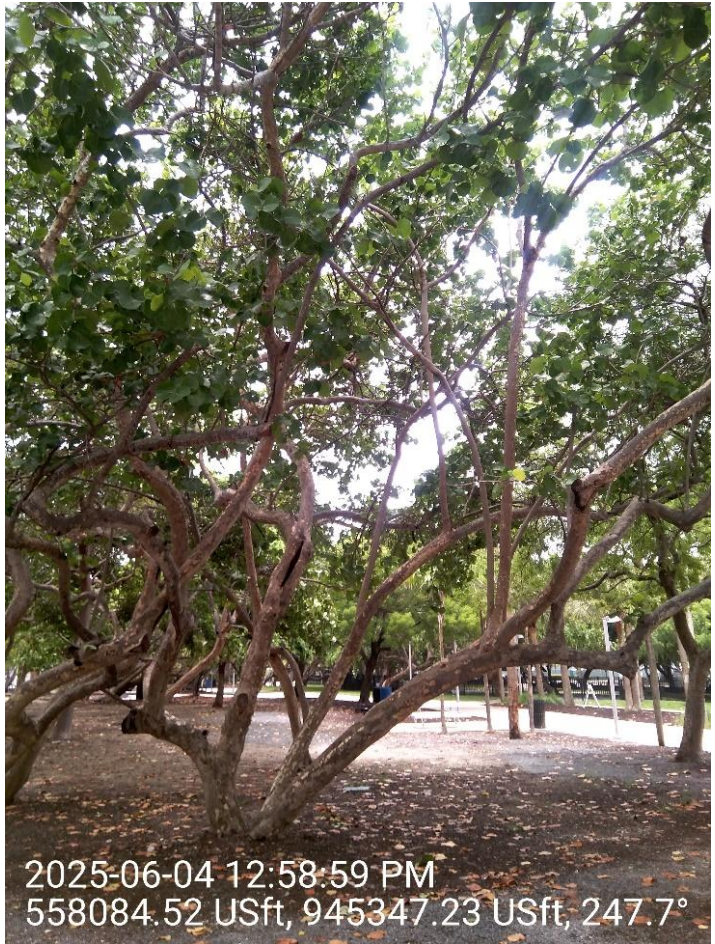
| Tree Details | | Photos |
|---|---|---|
| Tree ID | 10 | |

| Tree Details | | Photos |
|---|---|---|
| Observed Conditions | Bent Trunk, Co-Dominant Leaders | |
| Overall Condition | Fair | |
| Condition % | 50% | |

| Tree Details | | Photos |
|---|---|---|
| Disposition | Relocate | |

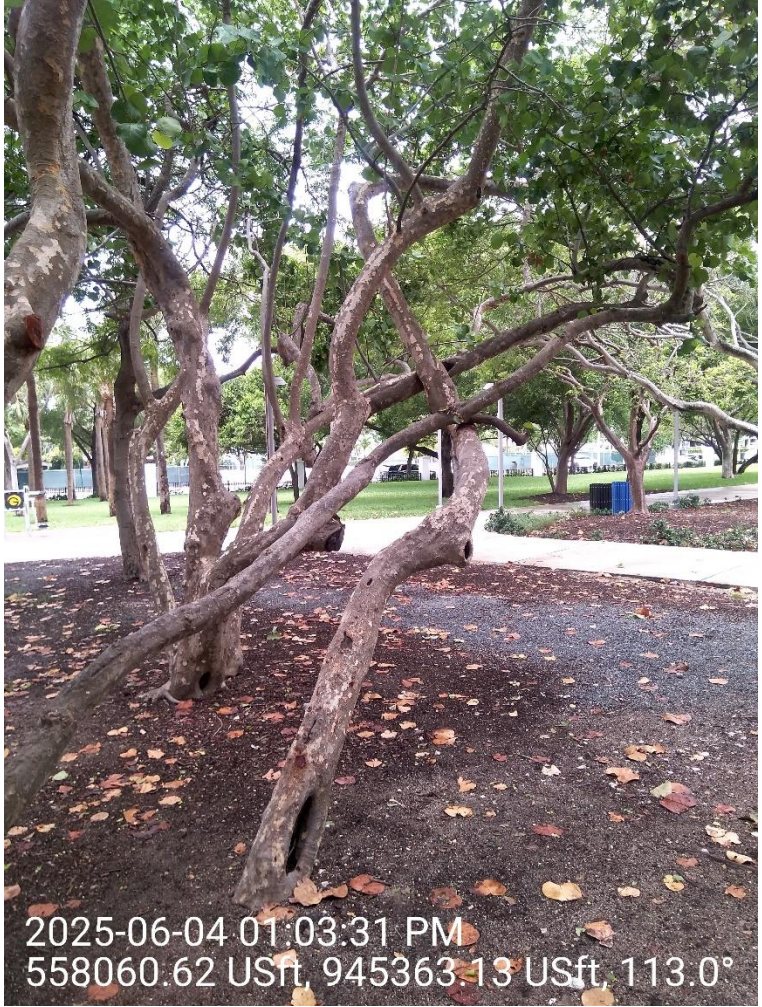
| Tree Details | | Photos |
|---|---|---|
| Tree ID | 14 | |

| Tree Details | | Photos |
|---|---|---|
| Observed Conditions | Bent Trunk, Limb Damage - Minor | |
| Overall Condition | Fair | |
| Condition % | 45% | |

| Tree Details | | Photos |
|---|---|---|
| Disposition | Relocate | |

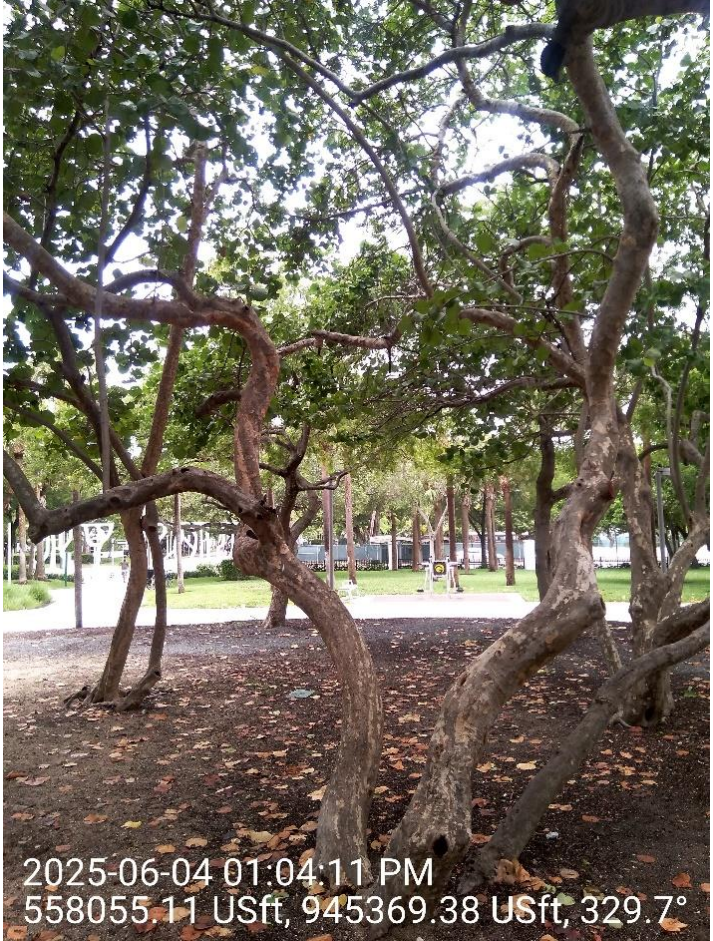
| Tree Details | | Photos |
|---|---|---|
| Tree ID | 15 | |

| Tree Details | | Photos |
|---|---|---|
| Observed Conditions | Bent Trunk, Co-Dominant Leaders, Limb Damage - Minor | |
| Overall Condition | Fair | |
| Condition % | 50% | |

| Tree Details | | Photos |
|---|---|---|
| Disposition | Relocate | |

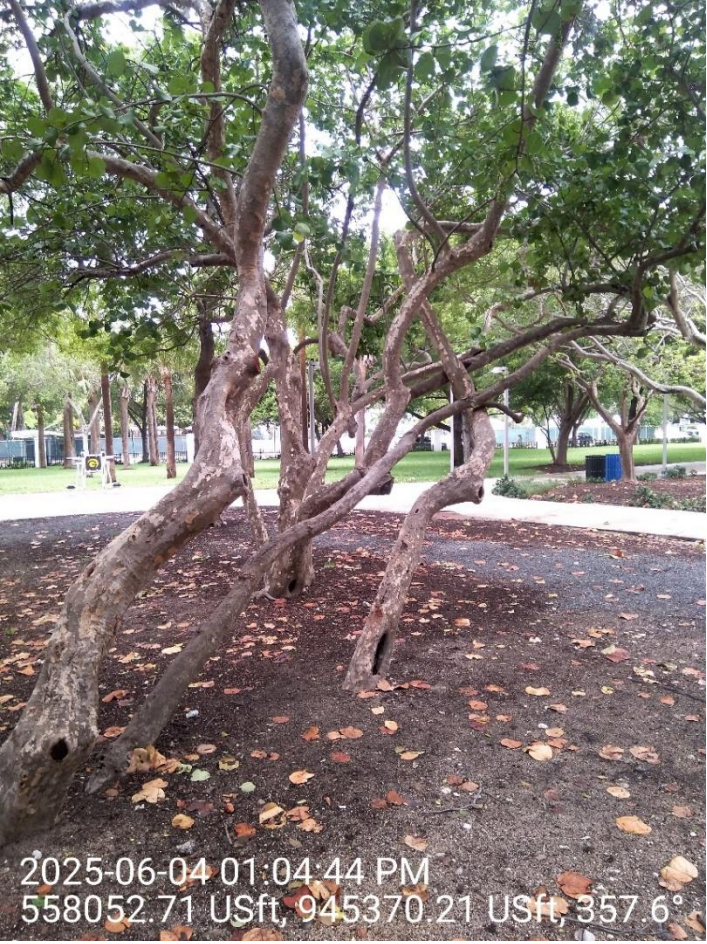
| Tree Details | | Photos |
|---|---|---|
| Tree ID | 16 | |

| Tree Details | | Photos |
|---|---|---|
| Observed Conditions | Bent Trunk, Lopsided | |
| Overall Condition | Fair | |
| Condition % | 50% | |

| Tree Details | | Photos |
|---|---|---|
| Disposition | Relocate | |

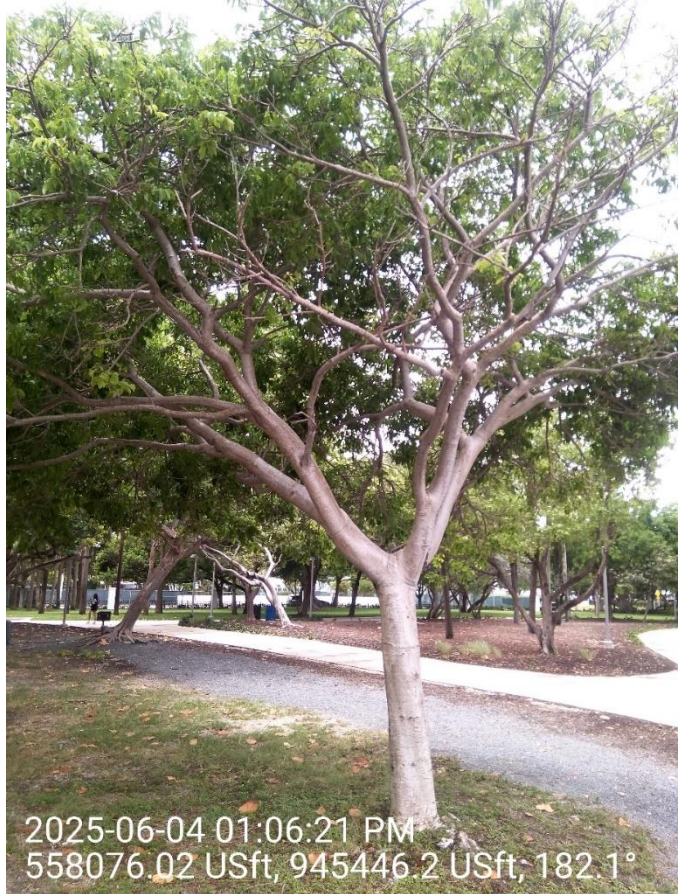
| Tree Details | | Photos |
|---|---|---|
| Tree ID | 17 | |

| Tree Details | | Photos |
|---|---|---|
| Overall Condition | Good | |
| Condition % | 70% | |

| Tree Details | | Photos |
|---|---|---|
| Disposition | Remain | |

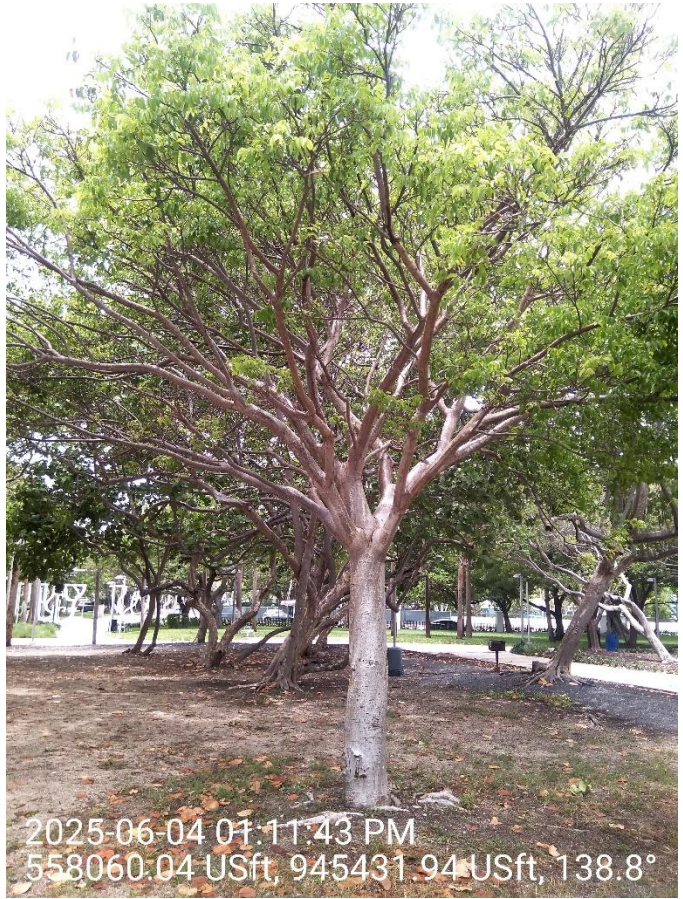
| Tree Details | | Photos |
|---|---|---|
| Tree ID | 19 | |

| Tree Details | | Photos |
|---|---|---|
| Overall Condition | Good | |
| Condition % | 80% | |

| Tree Details | | Photos |
|---|---|---|
| Disposition | Remain | |

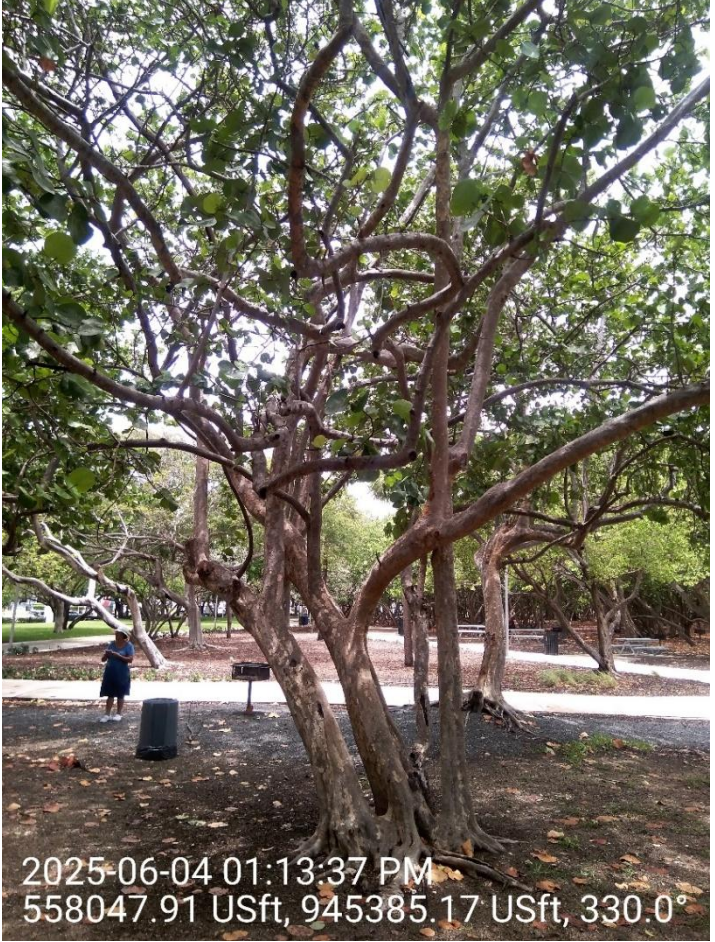
| Tree Details | | Photos |
|---|---|---|
| Tree ID | 20 | |

| Tree Details | | Photos |
|---|---|---|
| Observed Conditions | Bent Trunk, Co-Dominant Leaders, Limb Damage | |
| Overall Condition | Fair | |
| Condition % | 50% | |

| Tree Details | | Photos |
|---|---|---|
| Disposition | Relocate | |

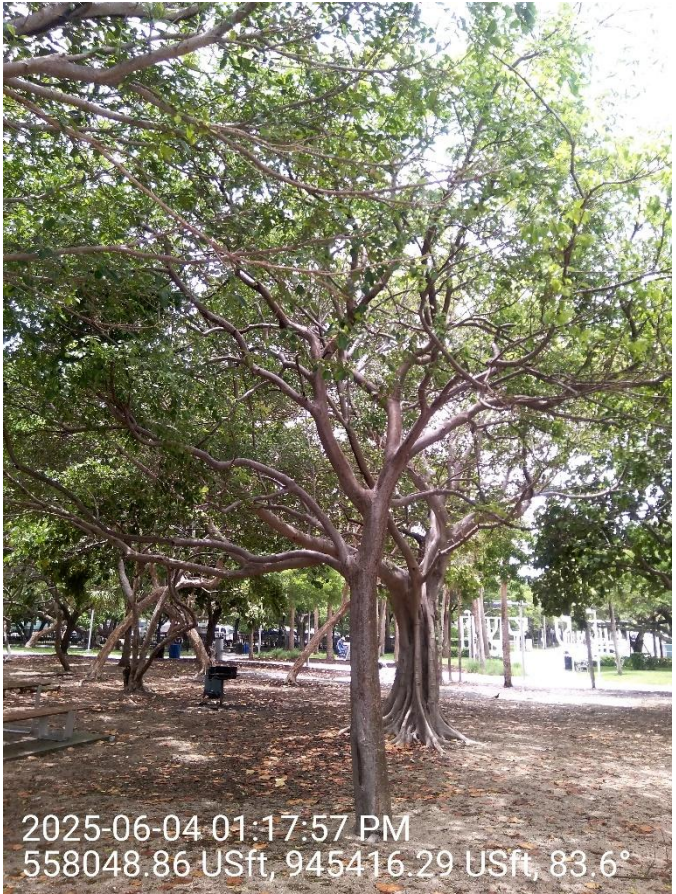
| Tree Details | | Photos |
|---|---|---|
| Tree ID | 24 | |

| Tree Details | | Photos |
|---|---|---|
| Observed Conditions | Trunk Damage – Minor | |
| Overall Condition | Good | |
| Condition % | 70% | |

| Tree Details | | Photos |
|---|---|---|
| Disposition | Remain | |

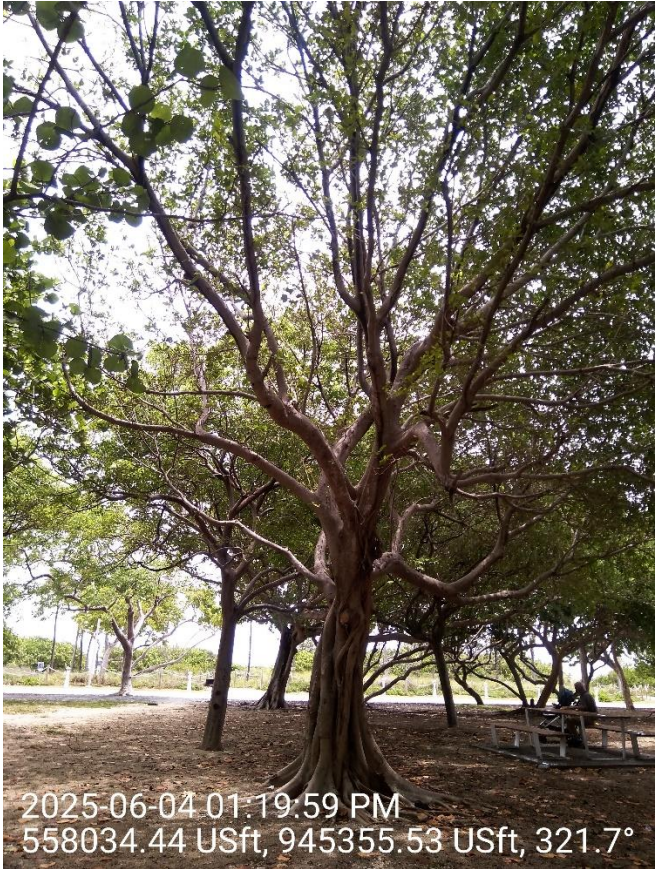
| Tree Details | | Photos |
|---|---|---|
| Tree ID | 25 | |

| Tree Details | | Photos |
|---|---|---|
| Observed Conditions | Limb Damage – Minor | |
| Overall Condition | Good | |
| Condition % | 70% | |

| Tree Details | | Photos |
|---|---|---|
| Disposition | Relocate | |

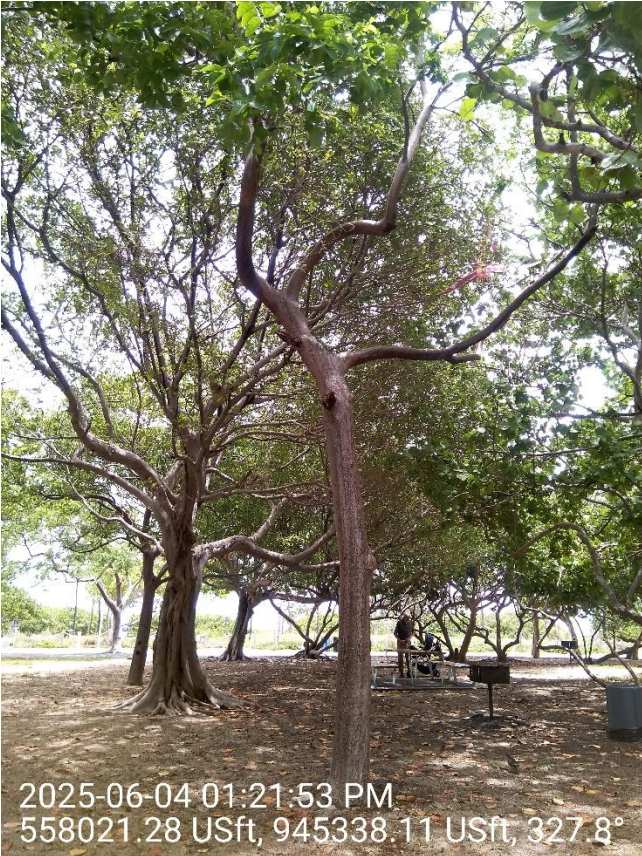
| Tree Details | | Photos |
|---|---|---|
| Tree ID | 26 | |

| Tree Details | | Photos |
|---|---|---|
| Observed Conditions | Bent Trunk, Limb Damage – Minor, Lopsided | |
| Overall Condition | Fair | |
| Condition % | 60% | |

| Tree Details | | Photos |
|---|---|---|
| Disposition | Relocate | |

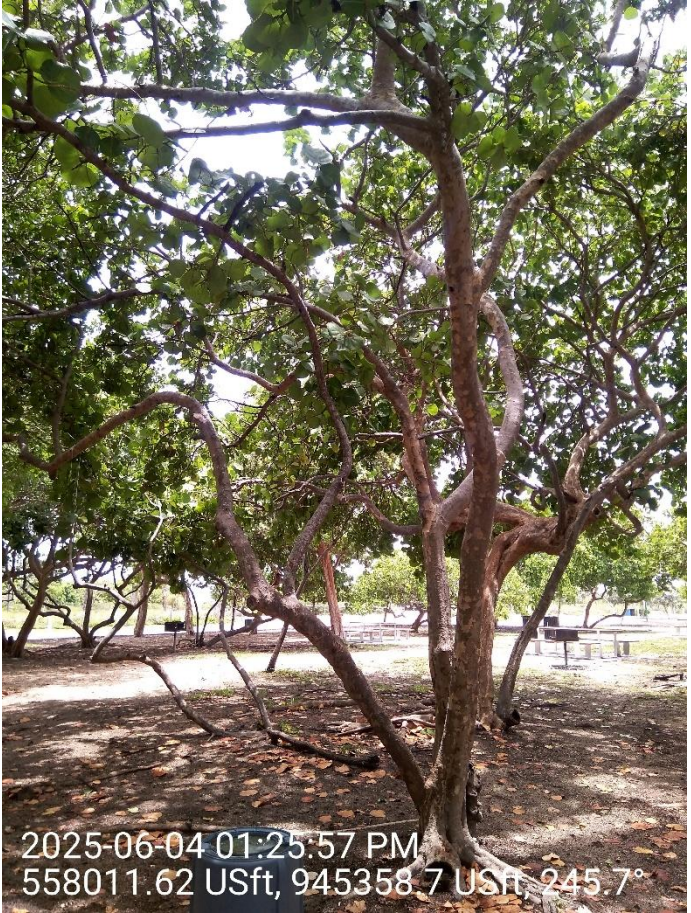
| Tree Details | | Photos |
|---|---|---|
| Tree ID | 31 | |

| Tree Details | | Photos |
|---|---|---|
| Observed Conditions | Codominant leaders, bent trunk | |
| Overall Condition | Fair | |
| Condition % | 50% | |
