*EVALUATION REPORT*

*For Project located at: 7801 ATLANTIC WAY. MIAMI BEACH, FLORIDA. 33141*

# **EXHIBIT 1**

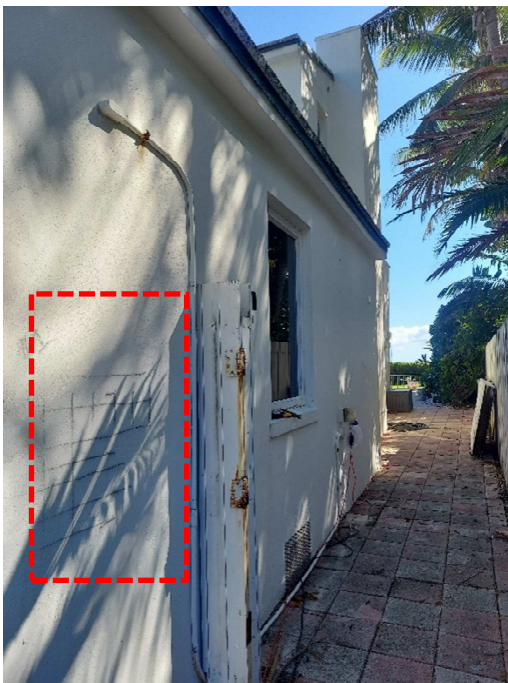
West facade

### Stucco repair areas at facades

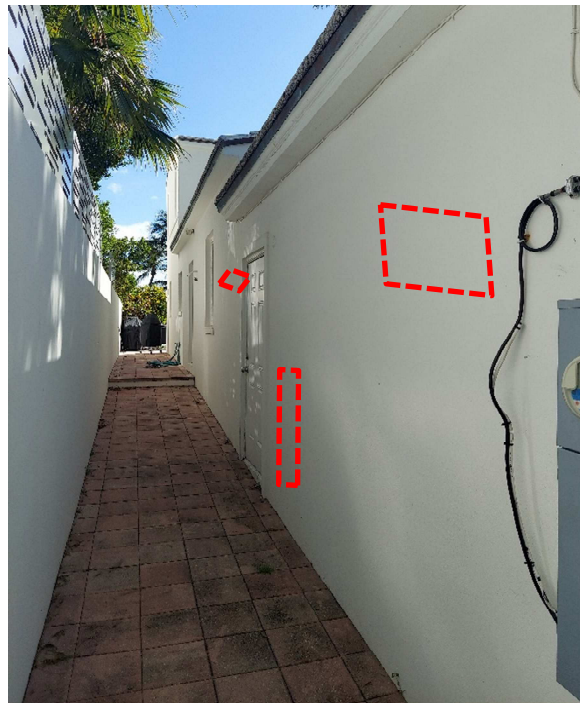
Hairline crack.

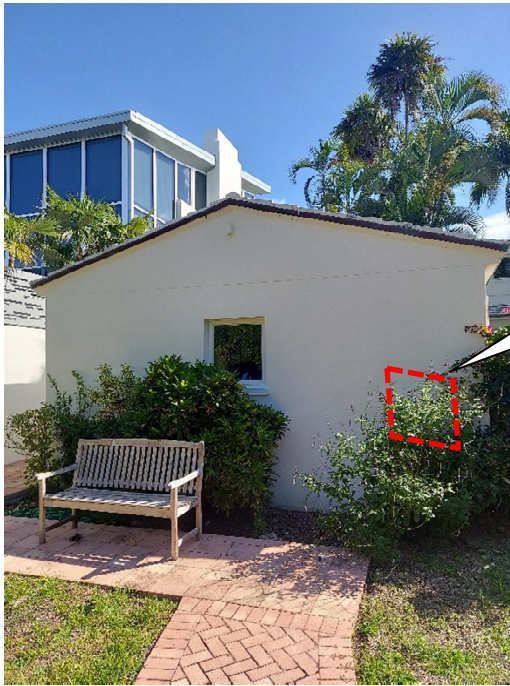
Stucco in  
poor  
condition

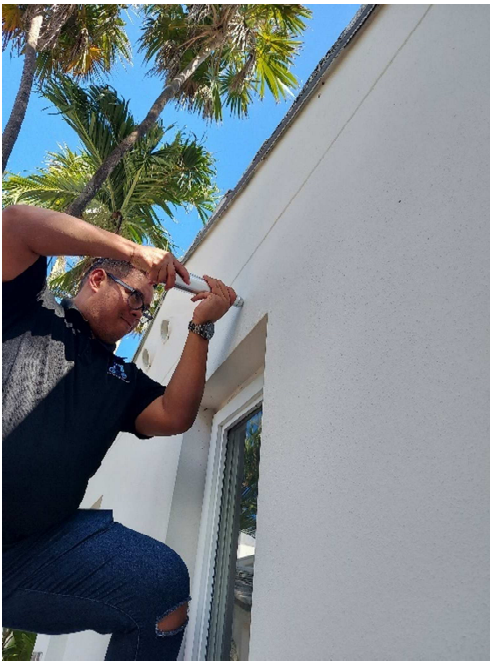
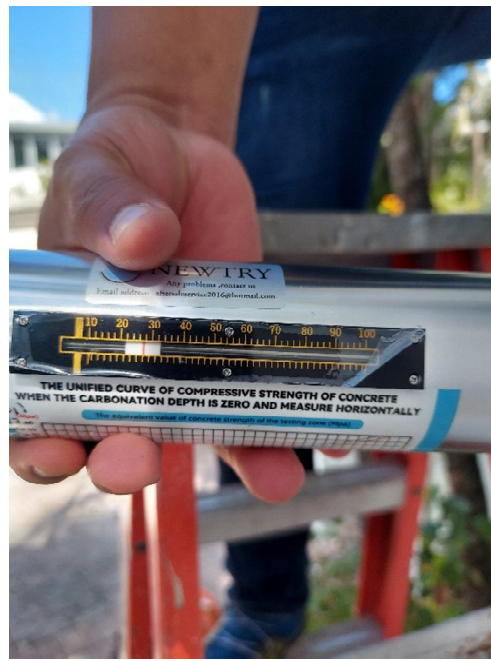
# Sclerometer test

The capacity of the structural elements taking into account their current state (product of a visual inspection) and their compression capacity obtained from the test carried out (around 3000-3500 psi) is compromised to resist future loads, safely and without danger of collapse. Moreover, with the water-cement ratio used to produce a concrete with an f'c of 3000 psi, it is not possible to achieve a w/c ratio equal to 0.40 required by ACI, to ensure the durability of the structure.
