*EVALUATION REPORT*

*For Project located at: 7801 ATLANTIC WAY. MIAMI BEACH, FLORIDA. 33141*

The inspection of the building in reference (See Exhibit 1 for graphical representation), located at 7801 Atlantic Way, Miami Beach FL 33141, took place on Wednesday February 22nd, 2023 and was performed by Mr. Alioskar Ganem P.E. The main objective of the inspection was to identify general areas and critical details of the building components that may compromise the integrity of the Structure and represent a hazard to the users of this property and to ensure that all its components were built following the minimum standards of the Florida Building Code current at the time of construction, including a proper evaluation for the City of Miami Beach Building Department for the construction plans and construction inspections.

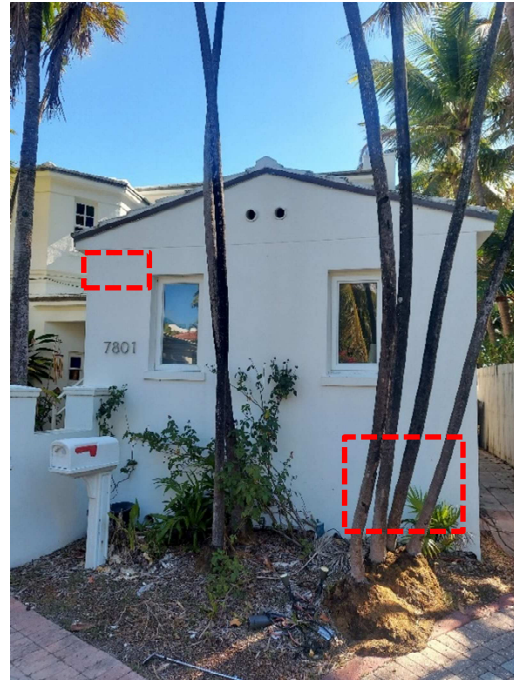
West facade

### Stucco repair areas at facades

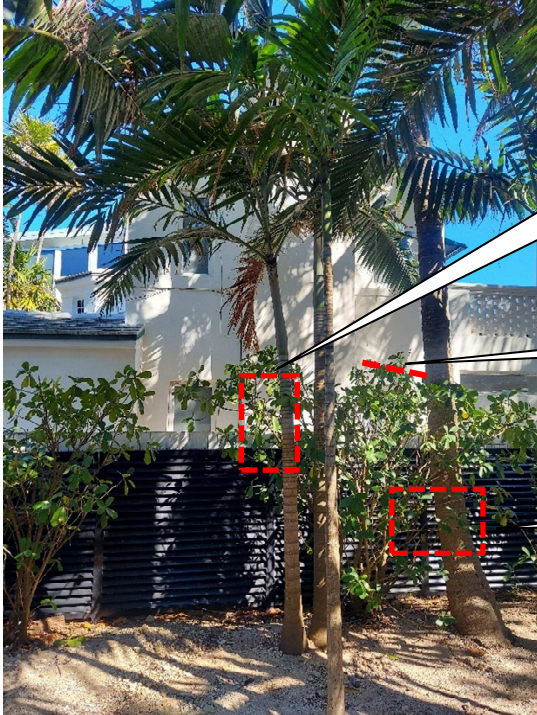
South façade

Stucco in poor condition

Hairline crack.

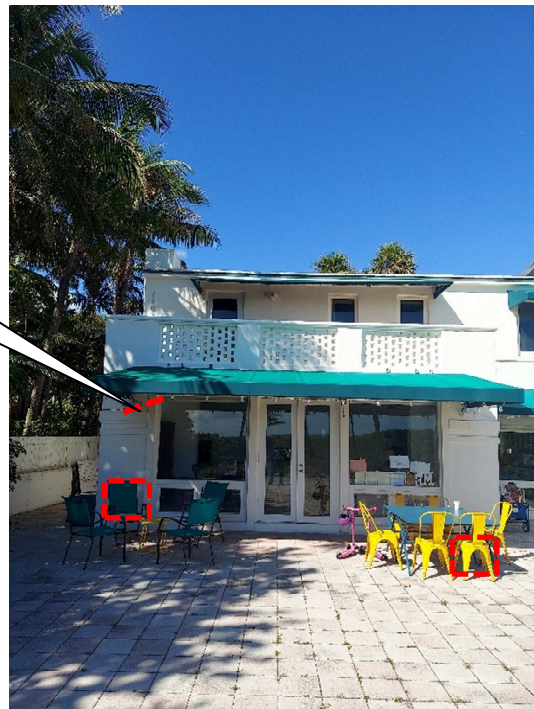
East façade

Stucco in poor condition

Hairline crack.

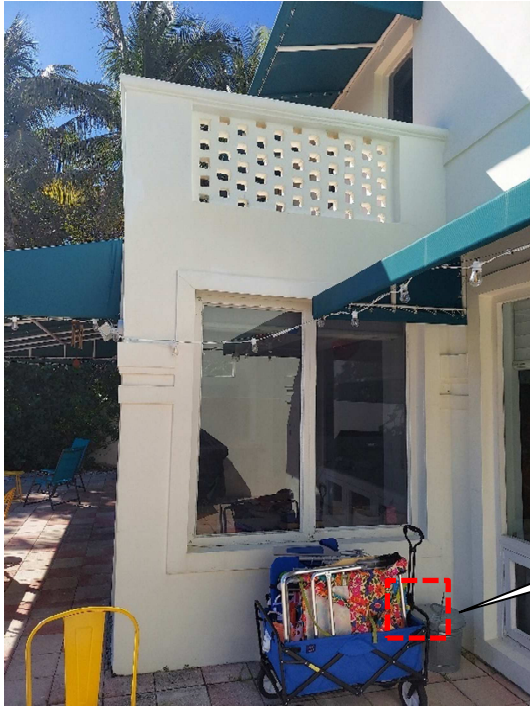
East side

Stucco in poor condition

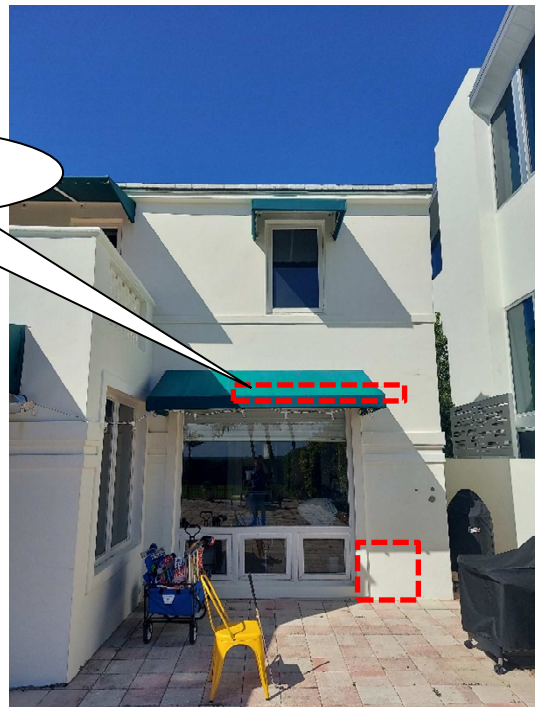
East side

Additionally, as a result of the visual inspection, cracks were observed in bearing elements of reinforced concrete. This is produced as a consequence of the increase in volume of the reinforcing steel produced by an oxidation state. Sulfates attack concrete, forming expansive compounds that cause cracking. Chlorides, if they reach the rebars, cause its corrosion. The cracking caused by sulfates facilitates the penetration of chlorides and the corrosion of the reinforcement. Once the concrete cracks, the integrity and design capacity of the structural element are not guaranteed.

Cracked beam.

It is possible to selectively restore, repair or reconstruct some structural elements in the case of localized failure. However, Failure to meet the required concrete resistance cannot be solved; That is why, based on the results obtained from the tests carried out, a total demolition of the structure is recommended. Future and more exhaustive tests can be carried out to determine additional concealed damages in the different structural elements.

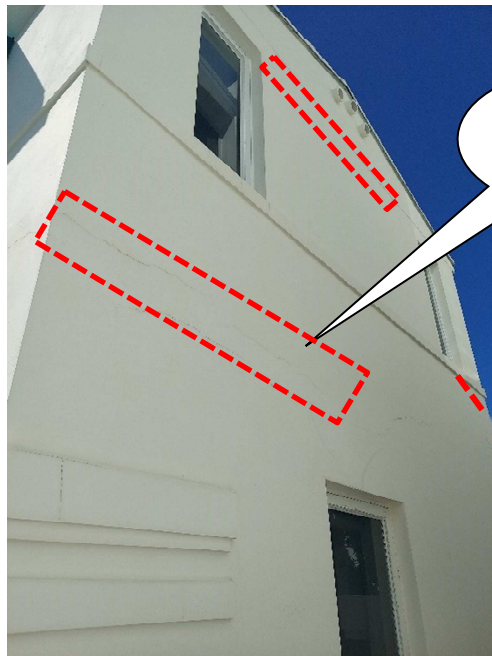
### North façade

Cracked area.

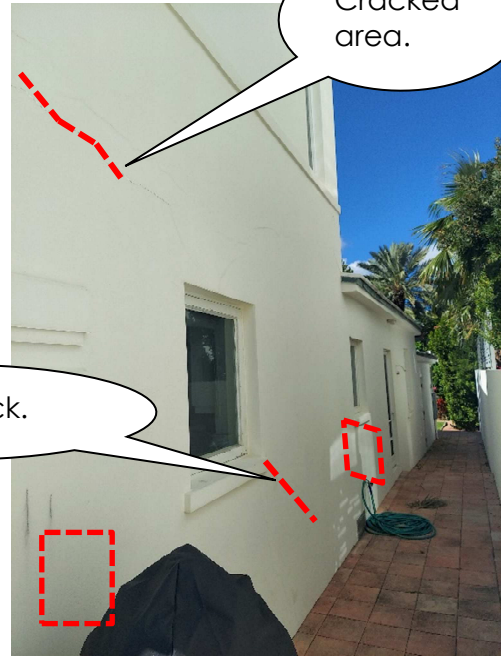
Cracked area.

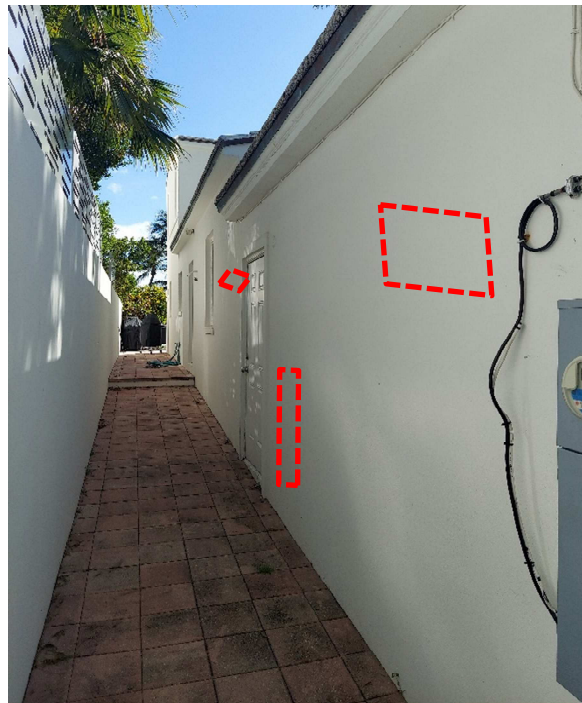
Hairline crack.

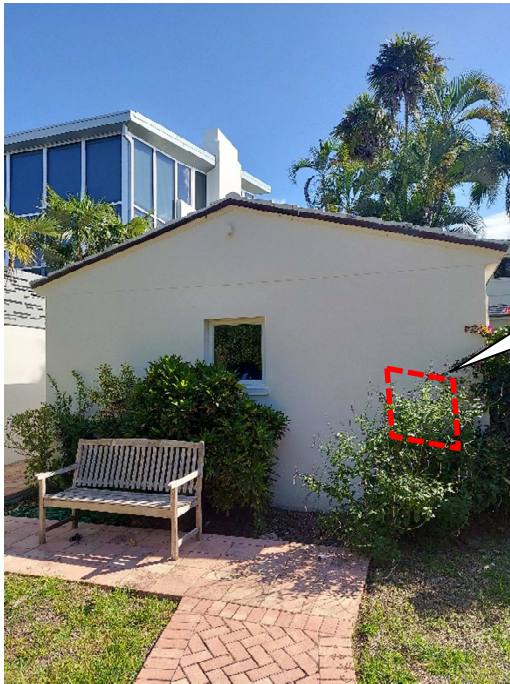
Stucco in  
poor  
condition

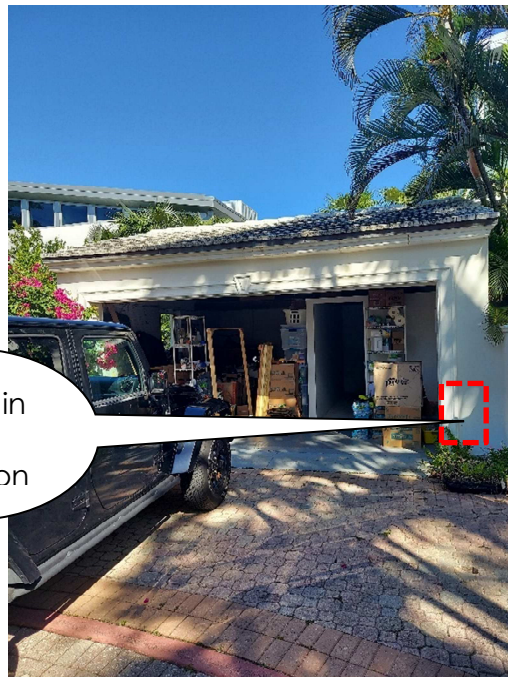
West side

Stucco in  
poor  
condition

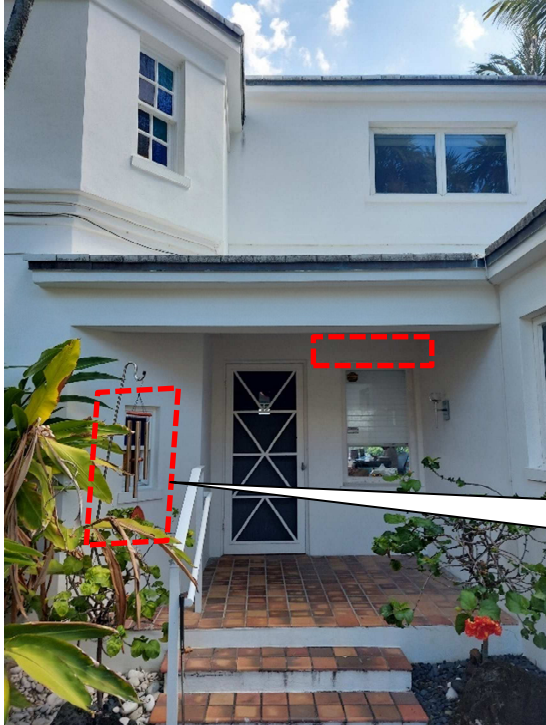
Main entrance

Stucco in  
poor  
condition

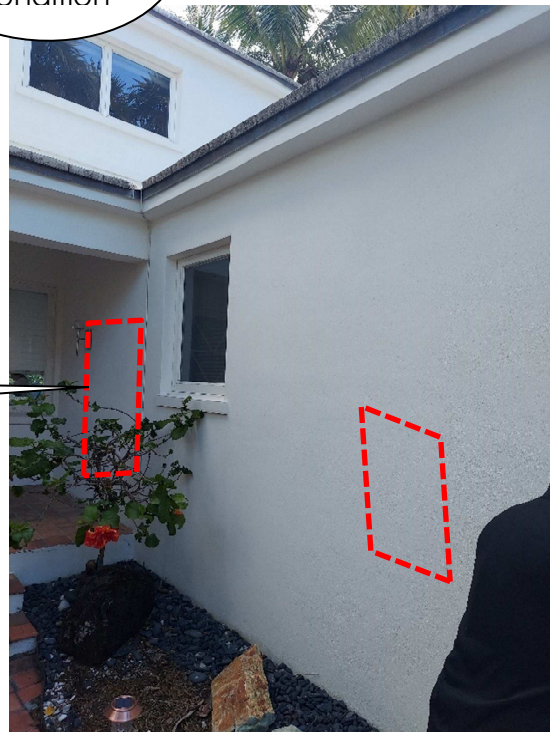
Stucco in  
poor  
condition

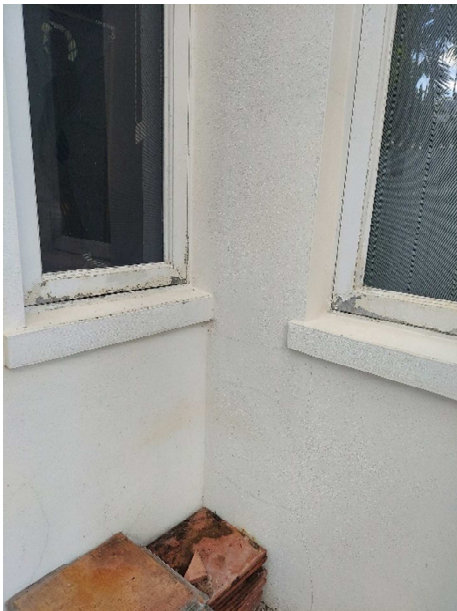
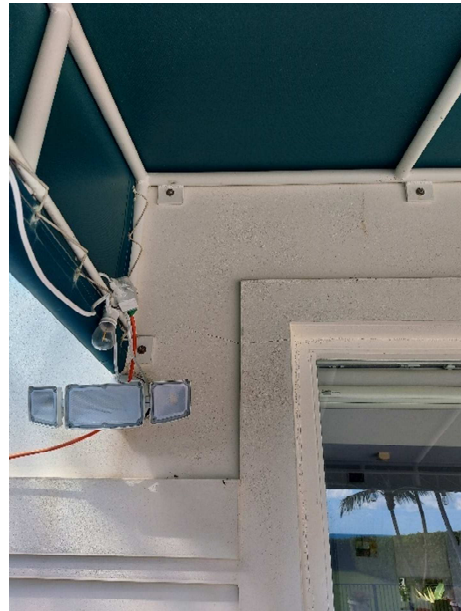
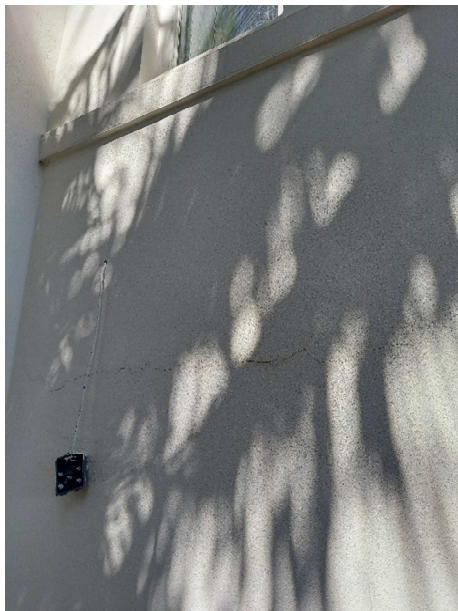
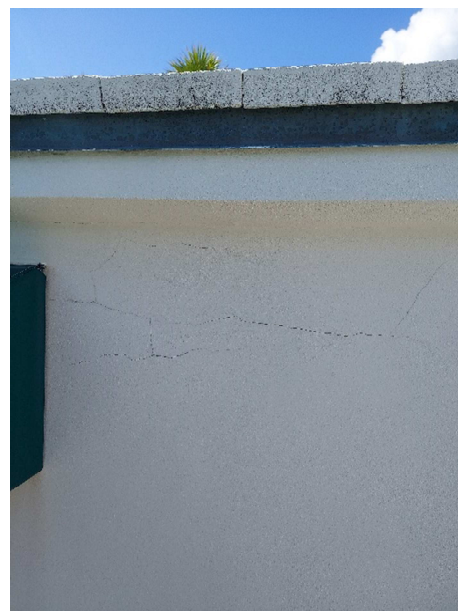
# Façade stucco condition

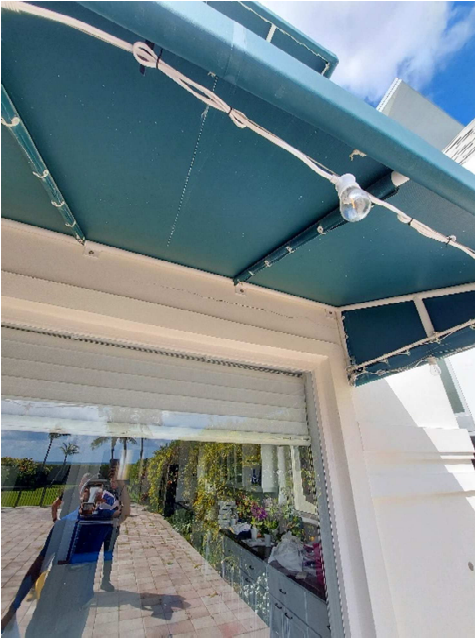
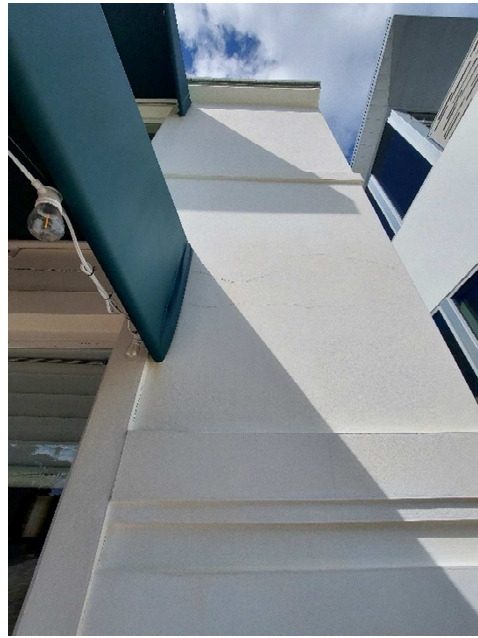
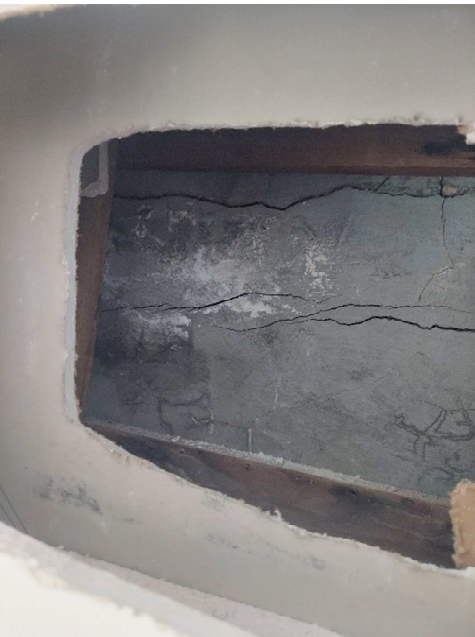
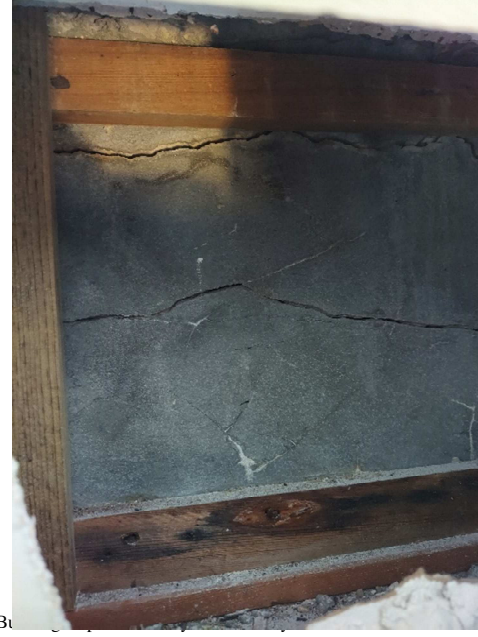
# Cracked beam, east side.
