## GANEM CONSULTING ENGINEERING

### EVALUATION REPORT

*For Project located at: 7801 ATLANTIC WAY. MIAMI BEACH, FLORIDA. 33141*

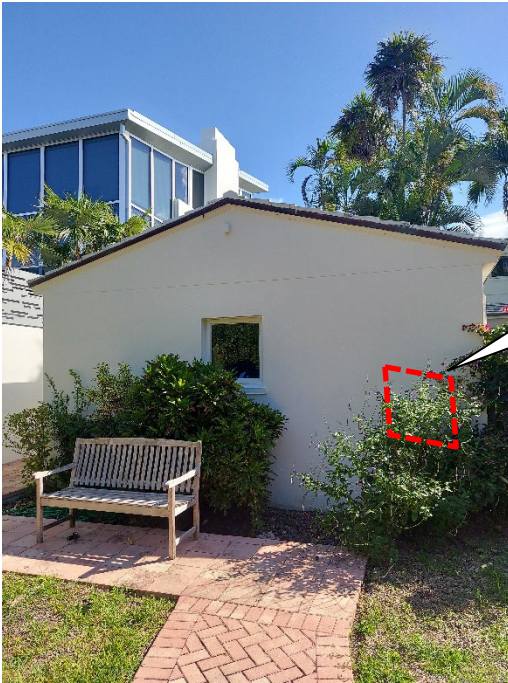
Stucco in  
poor  
condition
