**INTERIM Treatment REPORT I**  
**Jackson Stewart's *Apollo Mural***  
**Conservation of the Mosaic**

**September 14, 2022**

RLA Conservation, Inc.  
852 NW 71<sup>st</sup> Street  
Miami, FL 33150

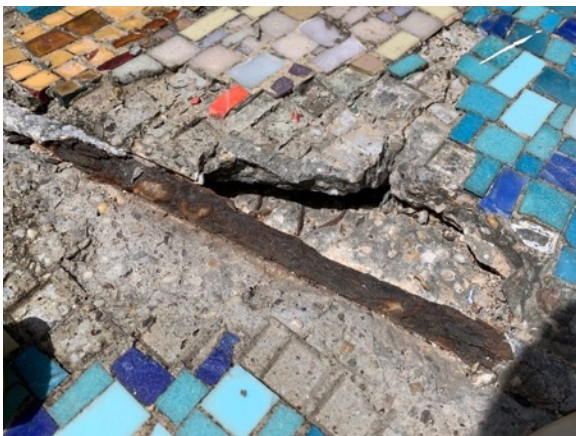
In panel #1, an exposed aluminum tube with internal ferrous support was excavated. The iron was extensively corroded (almost all the way through the rod) and the force of expansion caused the aluminum tube to crack and also expand outwards. The expansion resulted in cracking of the concrete and dislodged embedded tiles. Though the embedded support structure is visible on this panel, it is assumed that this is happening elsewhere, likely due to trapped moisture and galvanic corrosion. As a result, there is extensive tesserae loss throughout most panels anywhere that there is an internal aluminum support bar. This was found to be the case at least in the other two excavated panels #4 and #18. Though the internal mesh is corroded, it does not appear to be causing similar cracking and tesserae loss. However, if it is meant to provide added rigidity to the panels within their backless aluminum frames, this may be compromised based on the extent of the corrosion.

Conservator Christina Varvi sounded select panels and did not detect voids or delamination. However, since the panels are relatively thin, the same sound was detected across the surface, even though a large void/cavity was uncovered at panel #1 at the lower half of the panel. The cause of the void was not readily apparent, but it is possible that there may be additional voids at other panels. This cavity appears to have accelerated the corrosion of the cracked aluminum tube and the exposed internal ferrous bar. More high-pitched rattling usually associated with delamination between tiles bedding mortar and the slab substrate was not detected. Such rattling was detected at individual tiles where they have become delaminated from their bedding mortar, either due to cracking of the slab or biological growth taking hold behind the tile.

Detail of exposed aluminum tube, corroded ferrous bar, corroded wire mesh, and large cavity at panel #1.

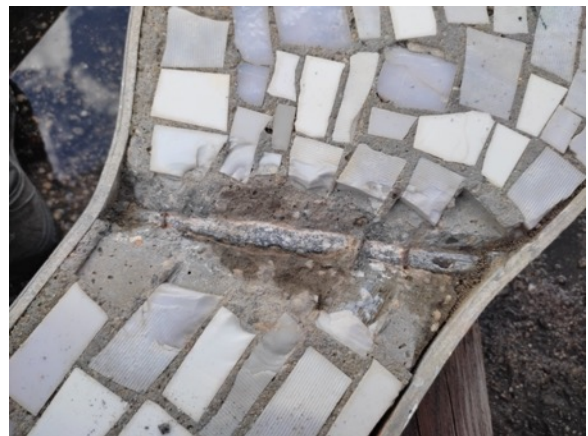
Detail of excavated aluminum tube showing internal corroded ferrous bar, and corroded wires (supposedly attached to mesh) at panel #4.

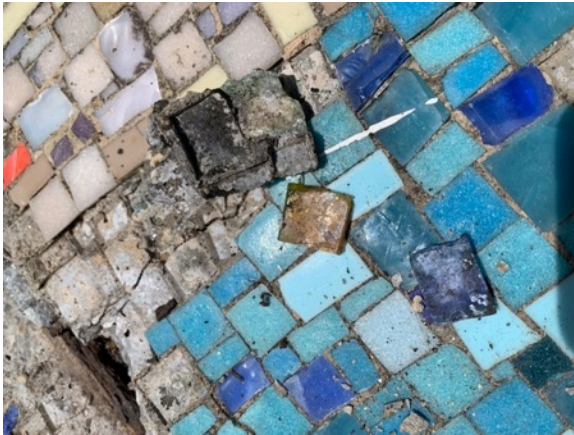
The tile and grout surfaces appeared to be relatively clean except for moderate accumulations of microbiological growths. The growths are tenacious in the grout and at exposed cement surfaces of the "ground" features. Throughout the relocation process and subsequent limited testing and cleaning, many tesserae continued to detach from the mortar bed. Detachment during relocation can be attributed to the flexing of the panels and vibration. While on the pallets, many tiles could be easily dislodged by hand. Those exhibited microbiological growths and/or a layer of what appears to be calcium carbonate efflorescence between the back of the tile and the mortar. The thinner/shallower tiles appear to be the most affected, presumably because it was easier for the growths to migrate from the surface behind these tiles. Thicker tiles were less affected, but some still became dislodged due to biological growths and calcium carbonate. There is concern that the amount of bio growth behind tiles is extensive and that most may have become destabilized as the bio growths and calcium carbonate layer break the bond between the tile and mortar.

*Detail of panel #1, showing dislodged tiles with bio growth visible on both the backs of the tiles as well as on the bedding mortar over which they sat.*
