ALVEY TREE CONSULTING LLC

Arborist Report
Park Avenue Hotel
355 19th Street, Miami Beach

3/7/2019

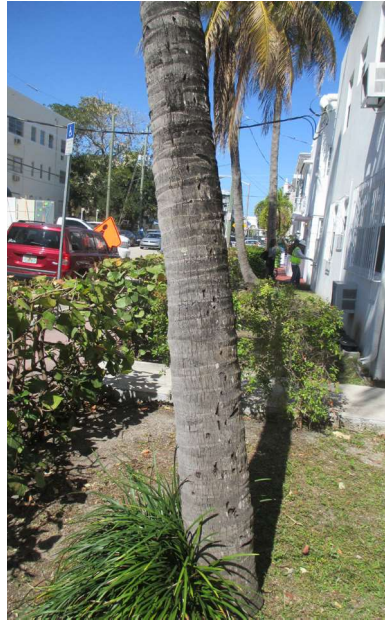
Condition -
Fair

Tree #3 is a Coconut Palm located on the Park Avenue side of the property. It is in fair condition with many yellow or brown fronds and multiple injuries along the trunk. The plans call for this tree to be relocated. If this is to occur, application of a palm fertilizer is recommended prior to relocation. Lower dead fronds and coconuts should be removed.

Disposition -
Relocate

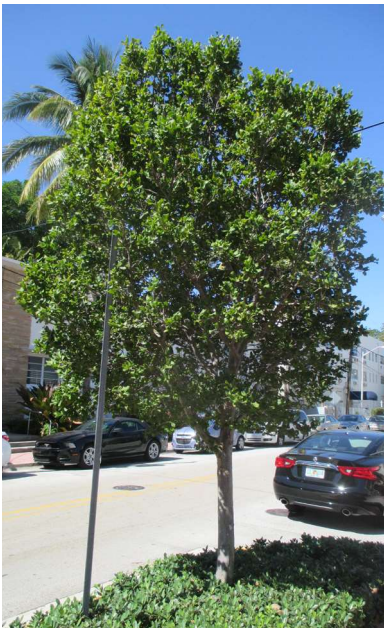
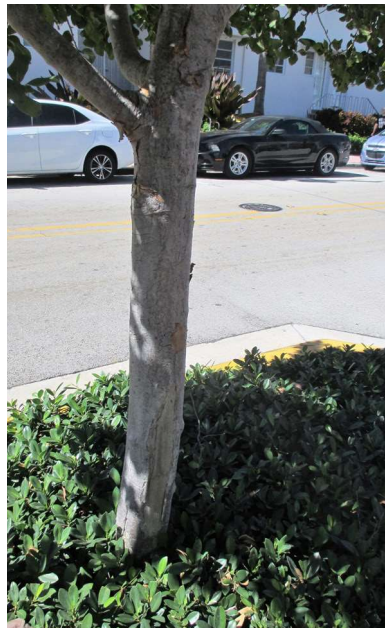
Condition -
Fair

Tree #4 is a Pigeon Plum street tree located along Park Avenue. It is in fair condition - there is some foliar spotting and the tree has good form. This tree has not been incorporated into the landscape plan and will therefore be removed.

Disposition -
Remove

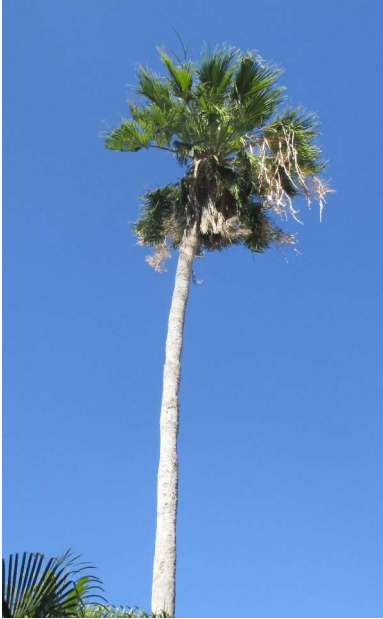
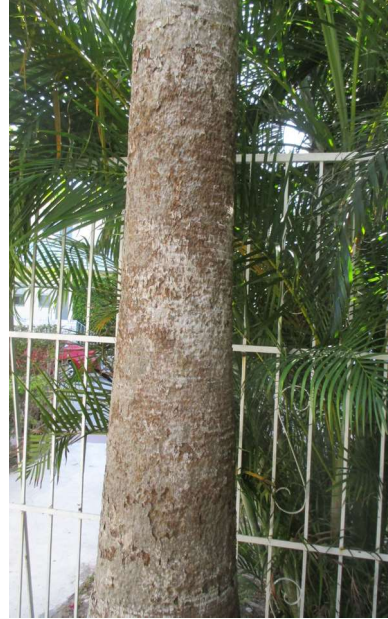
Condition -
Fair

Tree #7 is a Washingtonia Palm located at the front of the courtyard. It is in fair condition - it has a green canopy and some of the pseudo-bark is sloughing off. This tree has not been incorporated into the landscape plan and will therefore be removed.

Disposition -
Remove

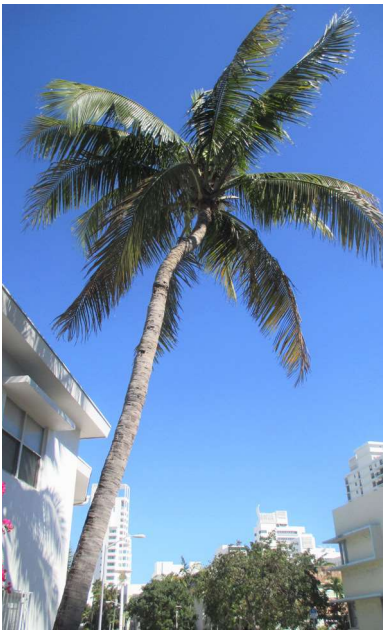
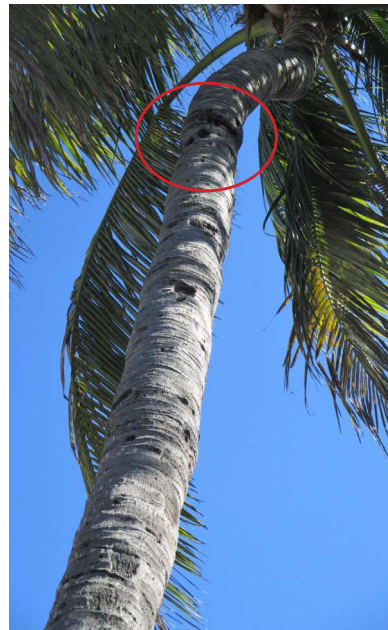
Condition -
Poor

Tree #8 is a Coconut Palm located at the front of the property along 19th Street. It is in poor condition with much yellow and brown on the fronds and multiple injuries along the trunk. One injury in particular is quite deep and occurs around the circumference of the tree (circled in red) near where the trunk kinks. The plans call for this tree to be relocated. If this is to occur, application of a palm fertilizer is recommended prior to relocation. Any lower dead fronds and coconuts should be removed.

Disposition -
Remove / Relocate

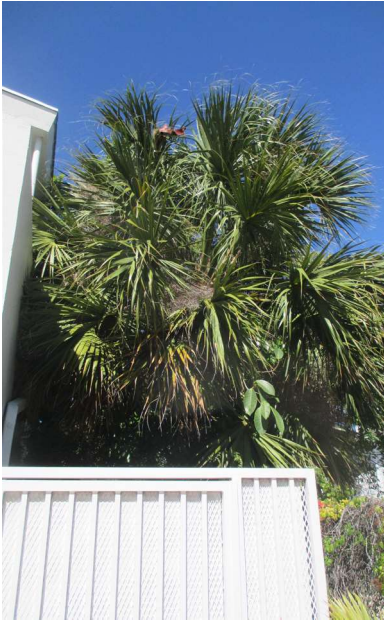
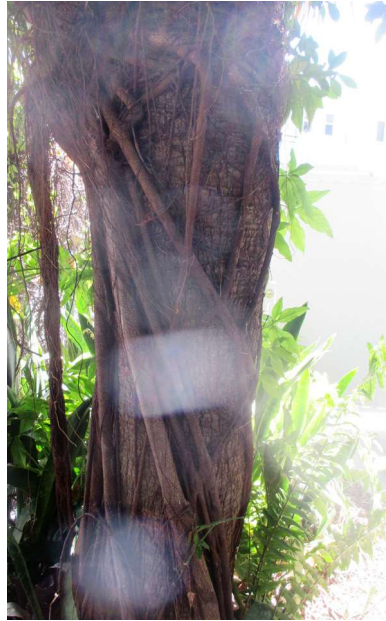
Condition -
Good

Tree #9 is a Sabal Palm located behind the building on the east side of the property. It is in good condition with a full, dense canopy. Vines are growing on the trunk. If this tree is to remain, a 7ft TPZ will need to be established. If this tree is to be relocated elsewhere on the site, care should be taken and irrigation should be focused on, since this species can be fairly difficult to transplant.

Disposition -
Remove / Relocate / Remain

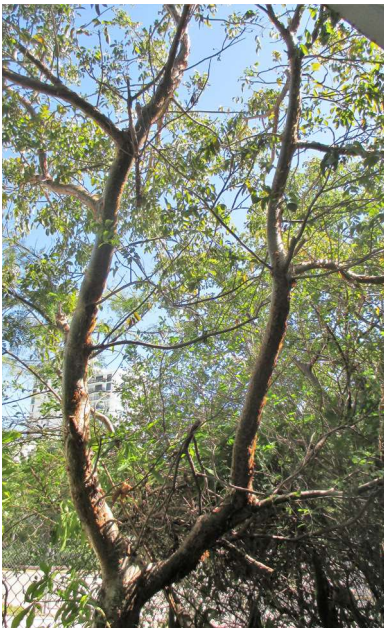
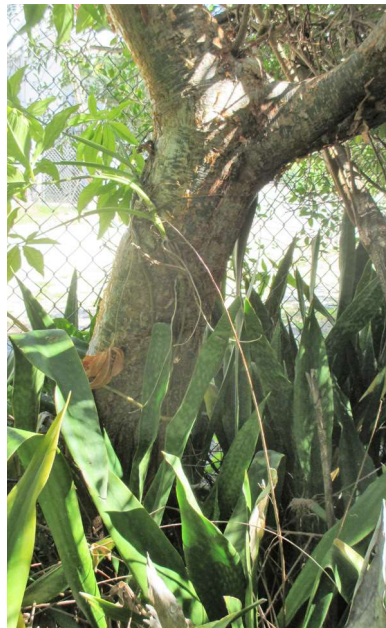
Condition -
Fair

Tree #10 is a Gumbo Limbo located behind the building on the east side of the property. The tree is in fair condition with poor form. This tree is in a location that does not provide adequate growing space, and it should therefore be removed.

Disposition -
Remove
