*EVALUATION REPORT*

*For Project located at: 7801 ATLANTIC WAY. MIAMI BEACH, FLORIDA. 33141*

I, Alioskar Ganem, PE for the state of Florida, license : 74745, was contracted to prepare an evaluation report of the current conditions of the building located at 7801 Atlantic Way, Miami Beach FL 3314. The report will consist of two major components, First component will address FEMA evaluation and the existing home conditions as it pertains to the 100 year flood guidelines. Second component will address the structural integrity of the building based on site visit and studies conducted. The intent of this report is to assess if the conditions of the current home allow for building remodeling.

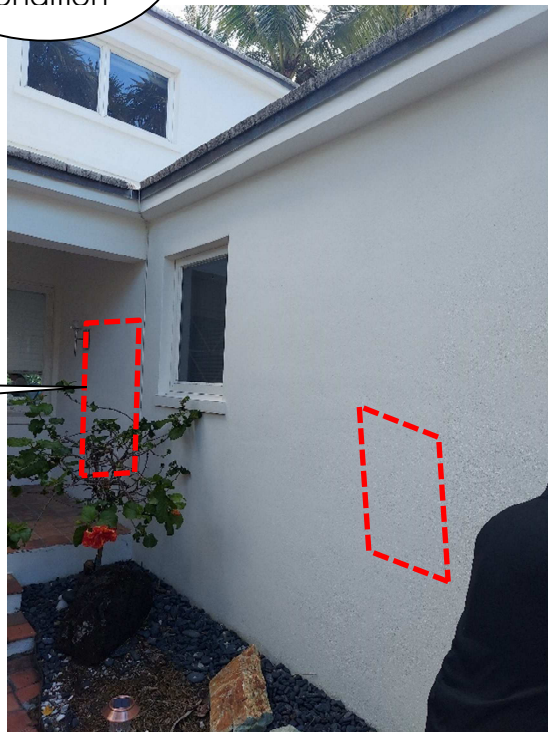
Stucco in  
poor  
condition
