Arborist Report

Miller Legg Project No.  
25-00062

City of Miami Beach  
North Beach Log Cabin

**North Beach Oceanside Park Log Cabin**  
**Arborist Review**

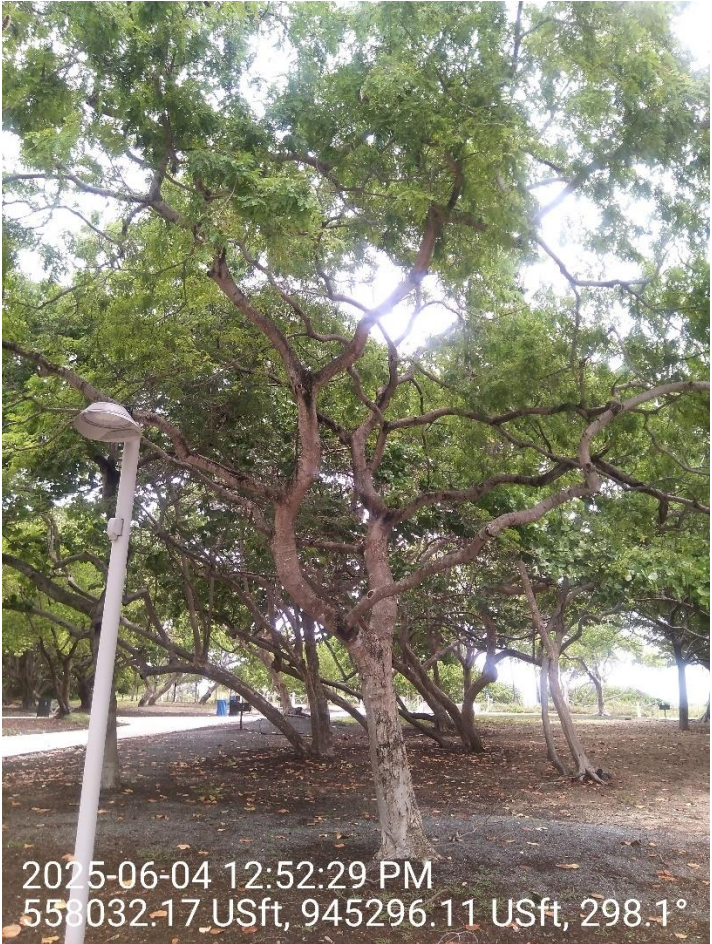
Easting	945319.78	
Tree ID	2	
Latin Name	<i>Tamarindus indica</i>	
Common Name	Tamarind	
DBH (in)	13	
Height (ft)	30	
Canopy Width (ft)	30	
Observed Conditions	Bent Trunk, Limb Damage - Minor	
Overall Condition	Fair	
Condition %	55%	
Disposition	Relocate

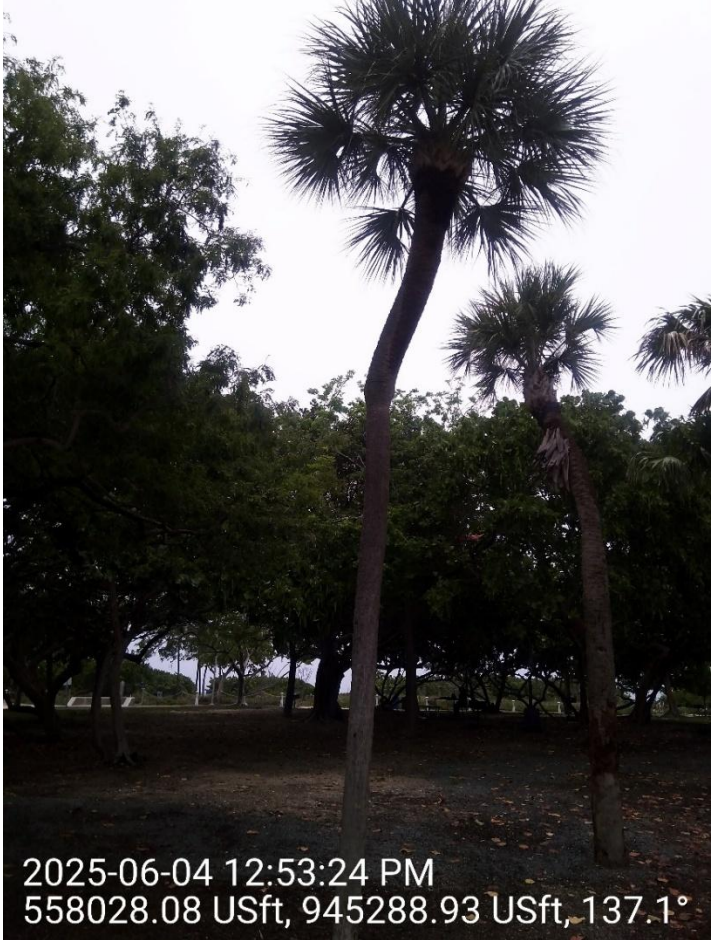
<p>2025-06-04 12:53:24 PM                      558028.08 USft, 945288.93 USft, 137.1°</p>
Easting	945313.58	
Tree ID	3	
Latin Name	<i>Sabal palmetto</i>	
Common Name	Cabbage Palm	
DBH (in)	8	
Height (ft)	26	
Canopy Width (ft)	8	
Observed Conditions		
Overall Condition	Fair	
Condition %	55%	
Disposition	Remain

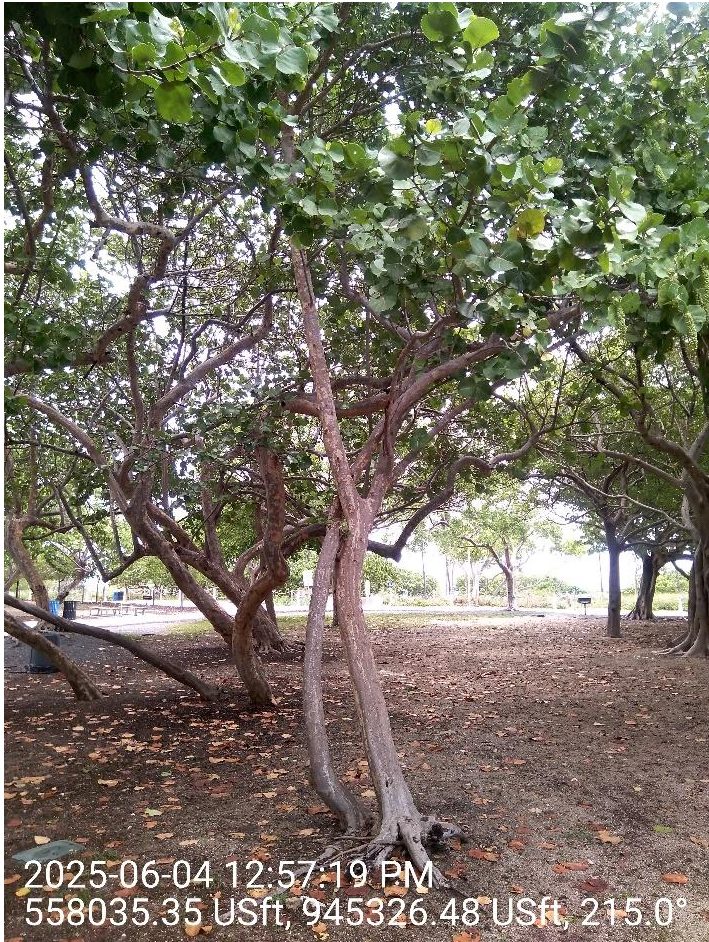
Easting	945342.93	
Tree ID	8	
Latin Name	<i>Cocoloba uvifera</i>	
Common Name	Sea Grape	
DBH (in)	10	
Height (ft)	30	
Canopy Width (ft)	32	
Observed Conditions	Bent Trunk, Co-Dominant Leaders	
Overall Condition	Fair	
Condition %	50%	
Disposition	Relocate

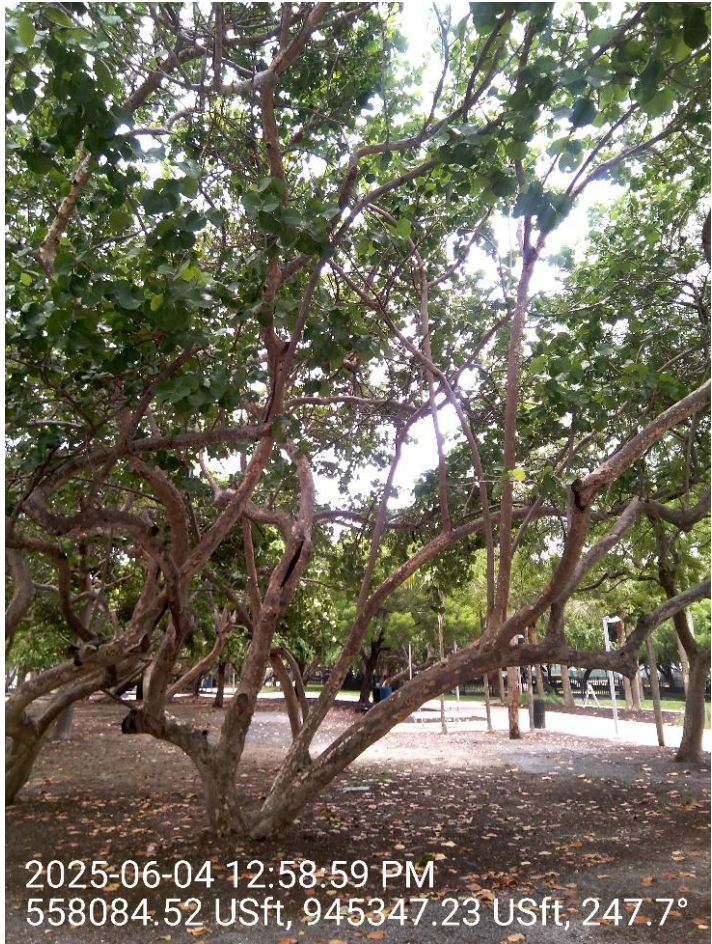
Easting	945348.73	
Tree ID	10	
Latin Name	<i>Cocoloba uvifera</i>	
Common Name	Sea Grape	
DBH (in)	22	
Height (ft)	32	
Canopy Width (ft)	40	
Observed Conditions	Bent Trunk, Co-Dominant Leaders	
Overall Condition	Fair	
Condition %	50%	
Disposition	Relocate

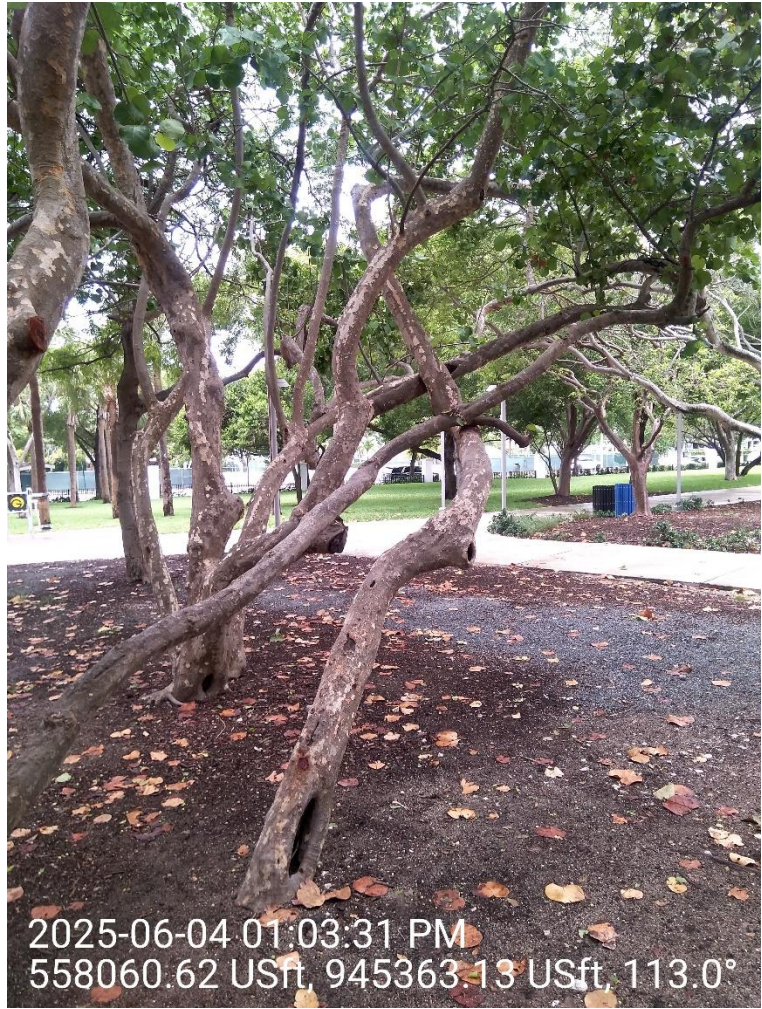
Easting	945361.41	
Tree ID	14	
Latin Name	<i>Cocoloba uvifera</i>	
Common Name	Sea Grape	
DBH (in)	10	
Height (ft)	32	
Canopy Width (ft)	30	
Observed Conditions	Bent Trunk, Limb Damage - Minor	
Overall Condition	Fair	
Condition %	45%	
Disposition	Relocate

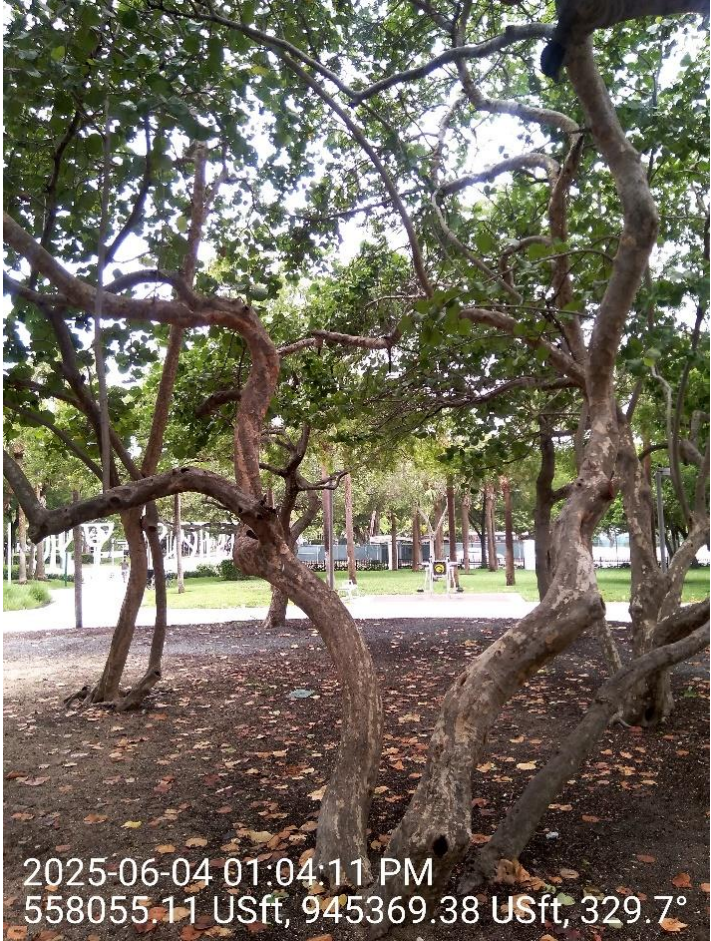
Easting	945360.83	
Tree ID	15	
Latin Name	<i>Cocoloba uvifera</i>	
Common Name	Sea Grape	
DBH (in)	20	
Height (ft)	32	
Canopy Width (ft)	36	
Observed Conditions	Bent Trunk, Co-Dominant Leaders, Limb Damage - Minor	
Overall Condition	Fair	
Condition %	50%	
Disposition	Relocate

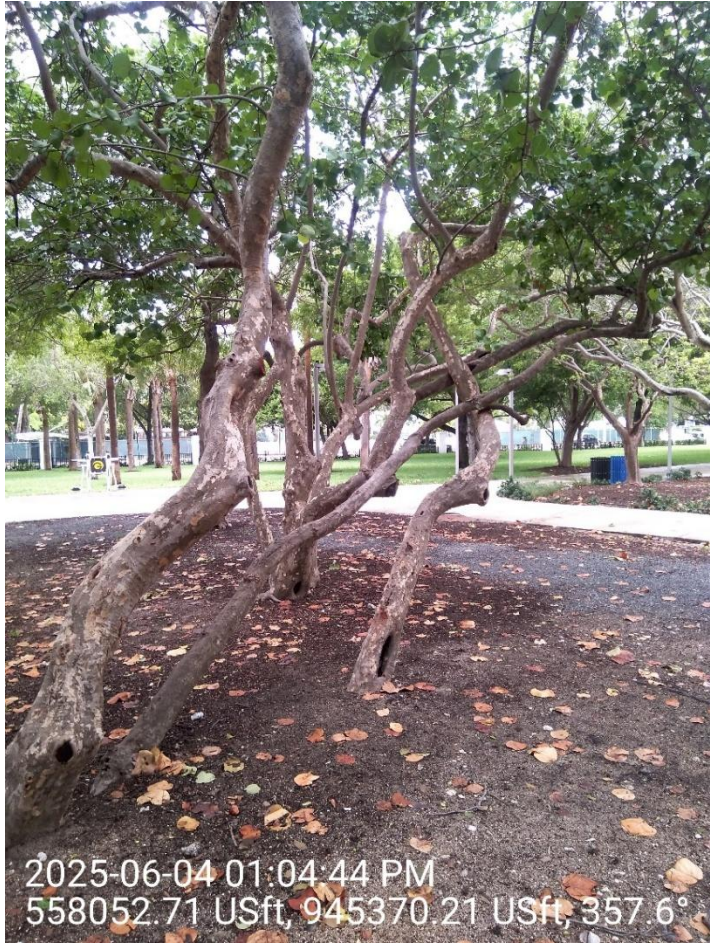
Easting	945362.38	
Tree ID	16	
Latin Name	<i>Cocoloba uvifera</i>	
Common Name	Sea Grape	
DBH (in)	8	
Height (ft)	24	
Canopy Width (ft)	20	
Observed Conditions	Bent Trunk, Lopsided	
Overall Condition	Fair	
Condition %	50%	
Disposition	Relocate

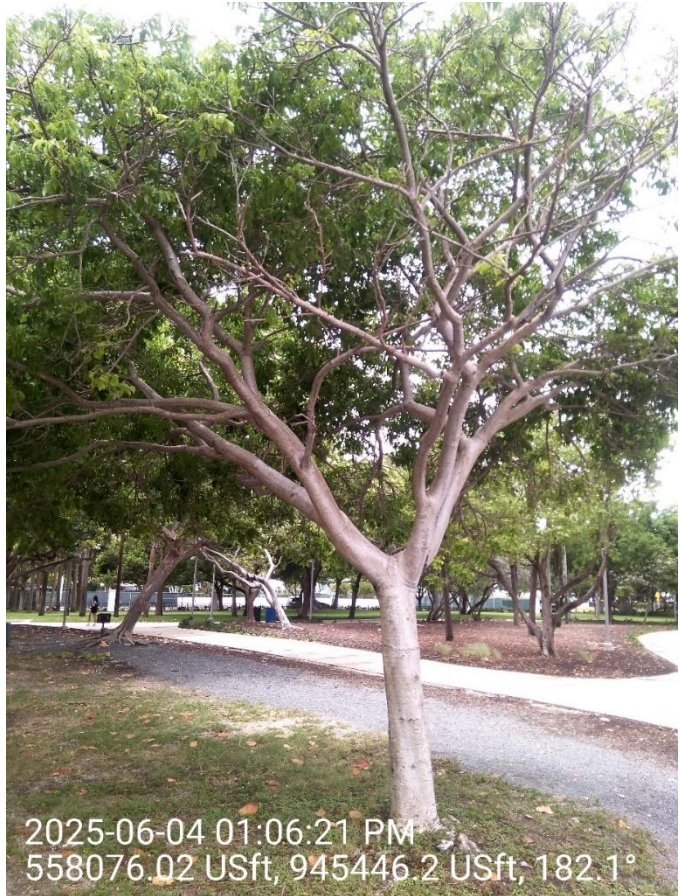
<p>2025-06-04 01:06:21 PM                      558076.02 USft, 945446.2 USft; 182.1°</p>
Easting	945427.02	
Tree ID	17	
Latin Name	<i>Bursera simaruba</i>	
Common Name	Gumbo Limbo	
DBH (in)	13	
Height (ft)	22	
Canopy Width (ft)	30	
Observed Conditions		
Overall Condition	Good	
Condition %	70%	
Disposition	Remain

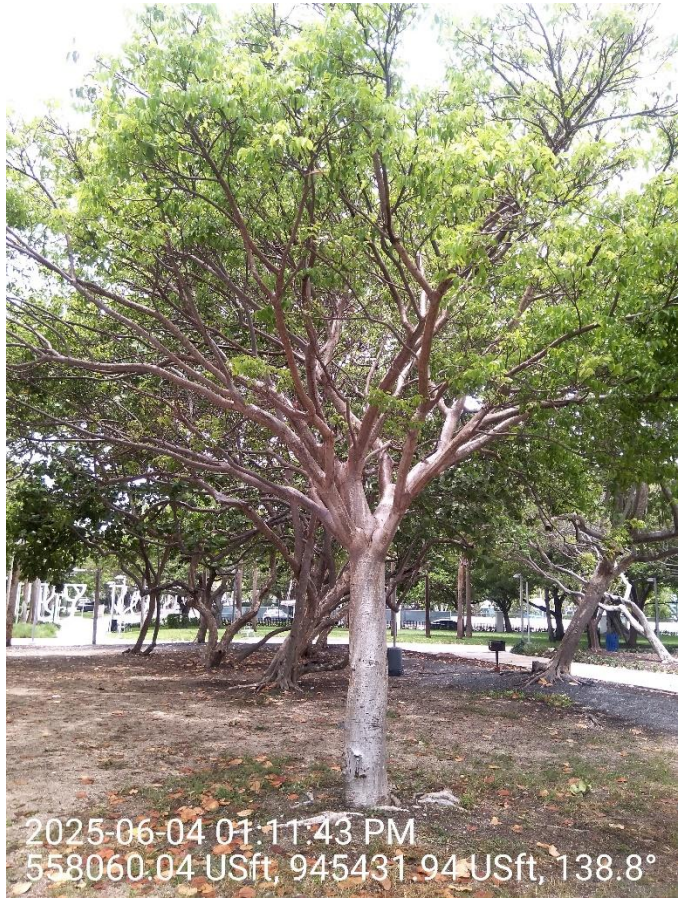
Easting	945409.07	
Tree ID	19	
Latin Name	<i>Bursera simaruba</i>	
Common Name	Gumbo Limbo	
DBH (in)	15	
Height (ft)	24	
Canopy Width (ft)	34	
Observed Conditions		
Overall Condition	Good	
Condition %	80%	
Disposition	Remain

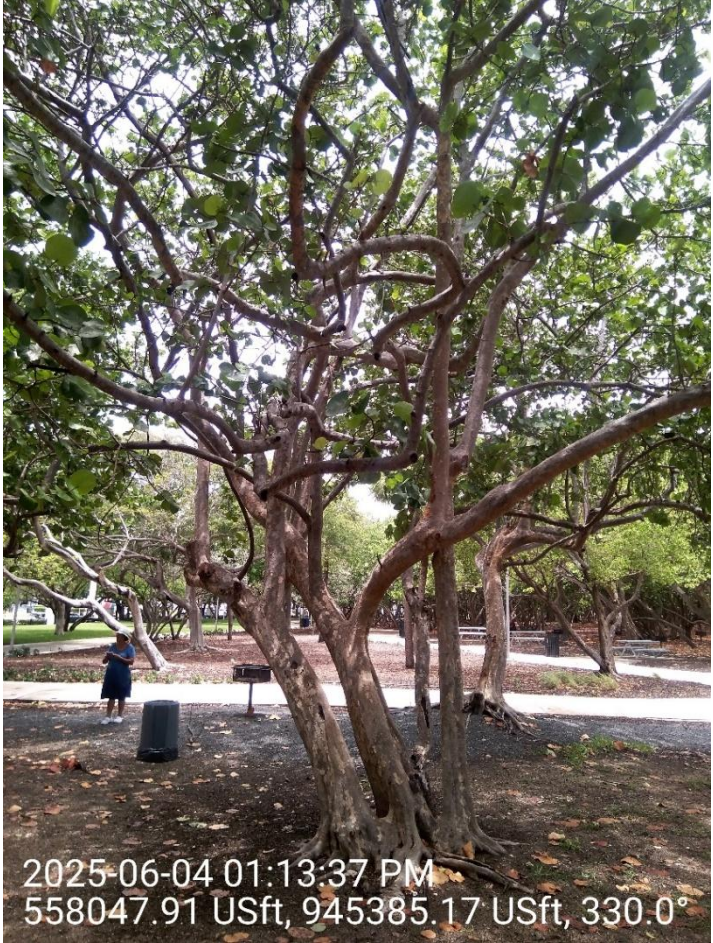
Easting	945382.60	
Tree ID	20	
Latin Name	<i>Cocoloba uvifera</i>	
Common Name	Sea Grape	
DBH (in)	24	
Height (ft)	36	
Canopy Width (ft)	40	
Observed Conditions	Bent Trunk, Co-Dominant Leaders, Limb Damage	
Overall Condition	Fair	
Condition %	50%	
Disposition	Relocate

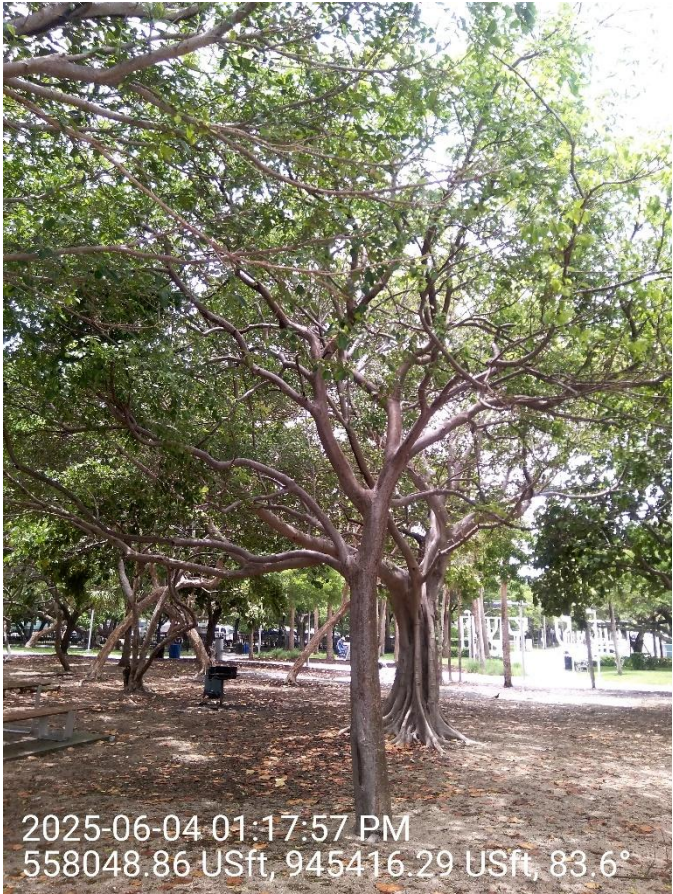
Easting	945402.48	
Tree ID	24	
Latin Name	<i>Bursera simaruba</i>	
Common Name	Gumbo Limbo	
DBH (in)	12	
Height (ft)	28	
Canopy Width (ft)	30	
Observed Conditions	Trunk Damage – Minor	
Overall Condition	Good	
Condition %	70%	
Disposition	Remain

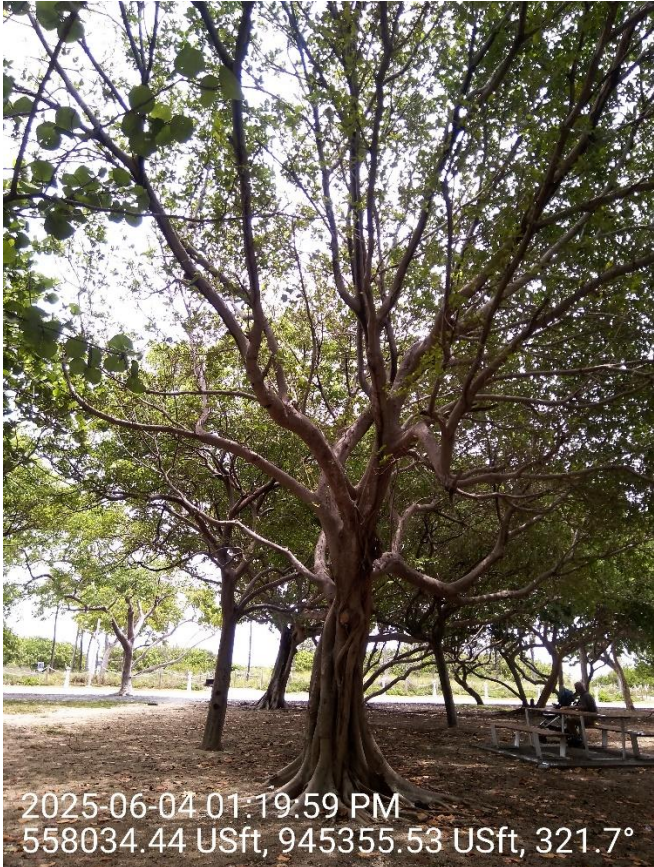
Easting	945387.77	
Tree ID	25	
Latin Name	<i>Ficus aurea</i>	
Common Name	Strangler Fig	
DBH (in)	28	
Height (ft)	36	
Canopy Width (ft)	60	
Observed Conditions	Limb Damage – Minor	
Overall Condition	Good	
Condition %	70%	
Disposition	Relocate

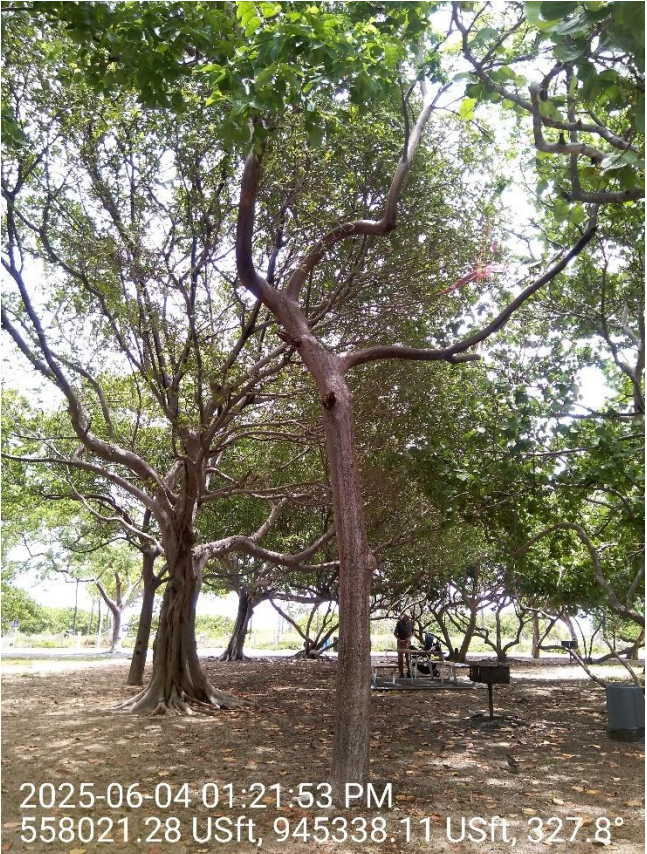
Easting	945364.58	
Tree ID	26	
Latin Name	<i>Bursera simaruba</i>	
Common Name	Gumbo Limbo	
DBH (in)	13	
Height (ft)	34	
Canopy Width (ft)	30	
Observed Conditions	Bent Trunk, Limb Damage – Minor, Lopsided	
Overall Condition	Fair	
Condition %	60%	
Disposition	Relocate

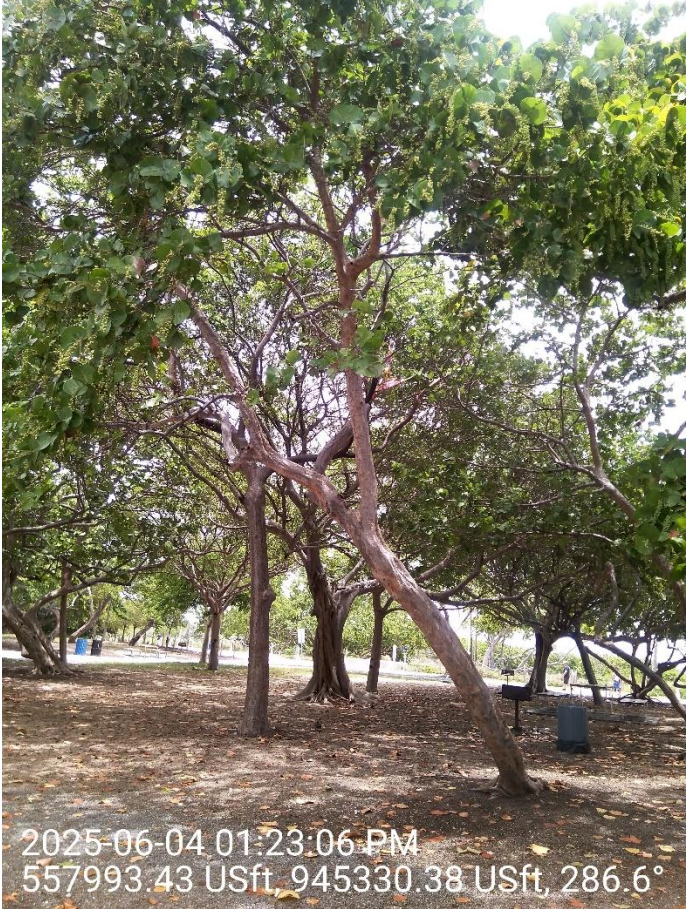
<p>2025-06-04 01:23:06 PM                      557993.43 USft, 945330.38 USft, 286.6°</p>
Easting	945359.55	
Tree ID	27	
Latin Name	<i>Cocoloba uvifera</i>	
Common Name	Sea Grape	
DBH (in)	12	
Height (ft)	26	
Canopy Width (ft)	24	
Observed Conditions		
Overall Condition	Fair	
Condition %	50%	
Disposition	Remain

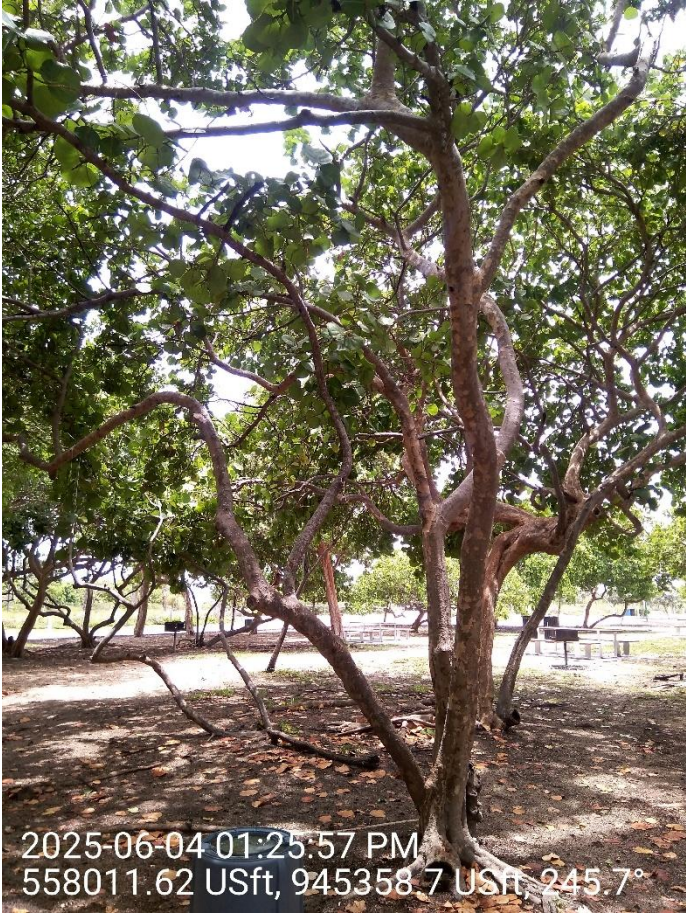
Easting	945376.63	
Tree ID	31	
Latin Name	<i>Cocoloba uvifera</i>	
Common Name	Sea Grape	
DBH (in)	14	
Height (ft)	30	
Canopy Width (ft)	34	
Observed Conditions	Codominant leaders, bent trunk	
Overall Condition	Fair	
Condition %	50%	
Disposition	Remain
