November 8, 2025

**Certified Arborist Assessment  
1250 West Ave, Miami Beach, Florida  
NLE Project No. 0325004**

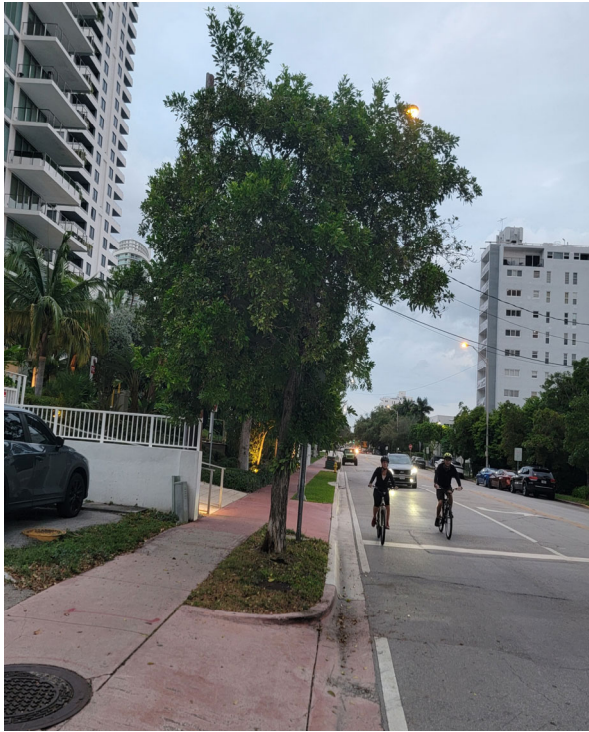
Tree 1 pink trumpet tree  
(*Tabebuia heterophylla*)  
10 inch DBH, Good condition  
20 foot height, 20 foot spread

ROW

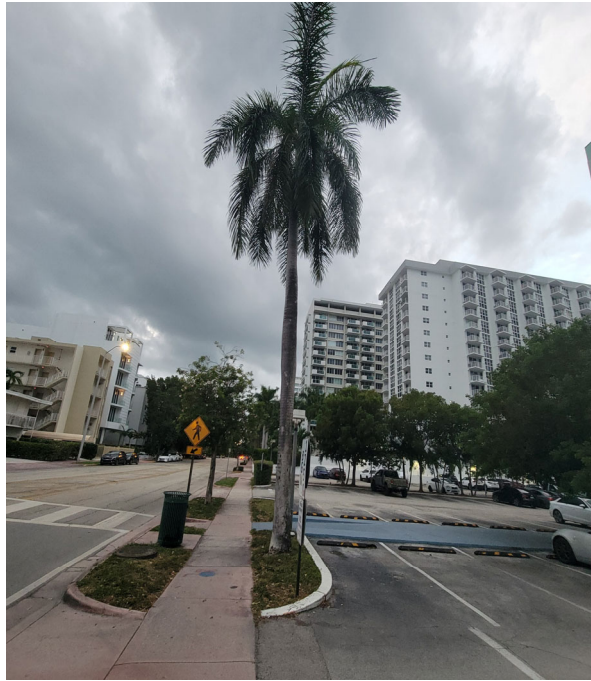
Tree 2 royal palm  
(*Roystonea regia*)  
16 inch DBH Good condition  
38 foot height, 16 foot spread

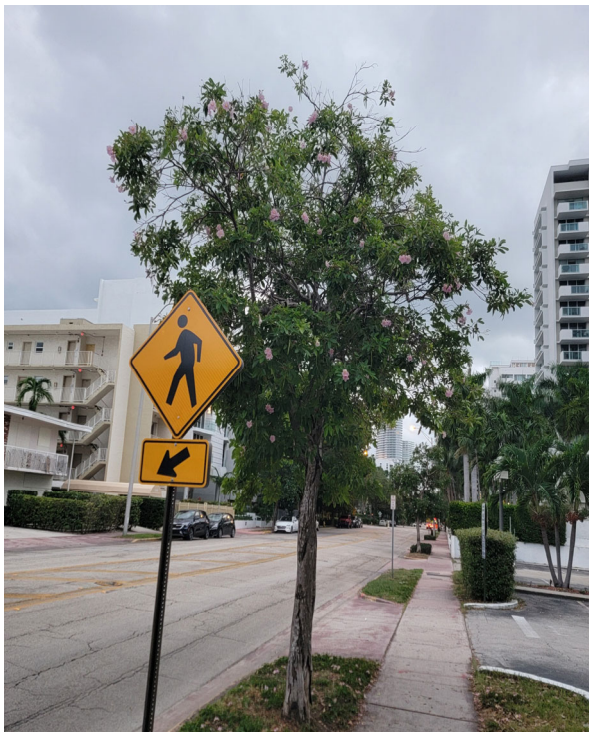
Tree 3 pink trumpet tree  
(*Tabebuia heterophylla*)  
8 inch DBH, Fair condition  
16 foot height, 18 foot spread

ROW

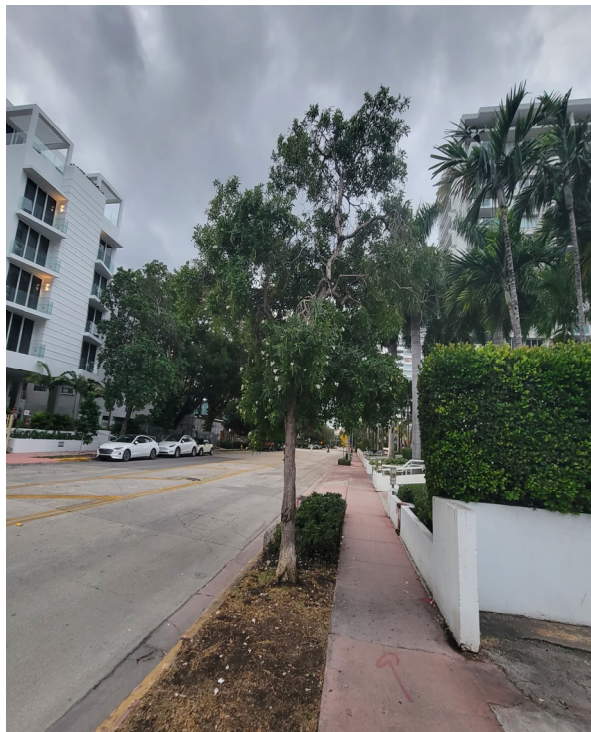
Tree 4 pink trumpet tree  
(*Tabebuia heterophylla*)  
9 inch DBH Good condition  
18 foot height, 18 foot spread

ROW

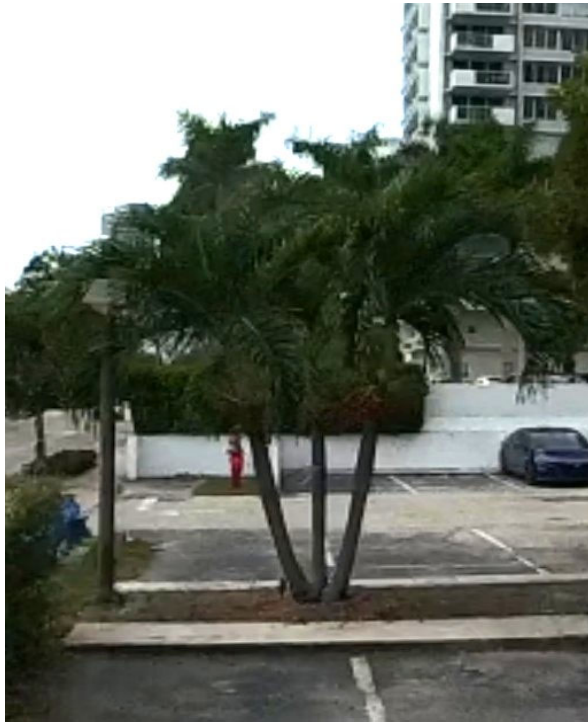
Tree 5 Christmas palm  
(*Adonidia merrellii*)  
6,5,5 inch DBH, Good condition  
12 foot height, 8 foot spread

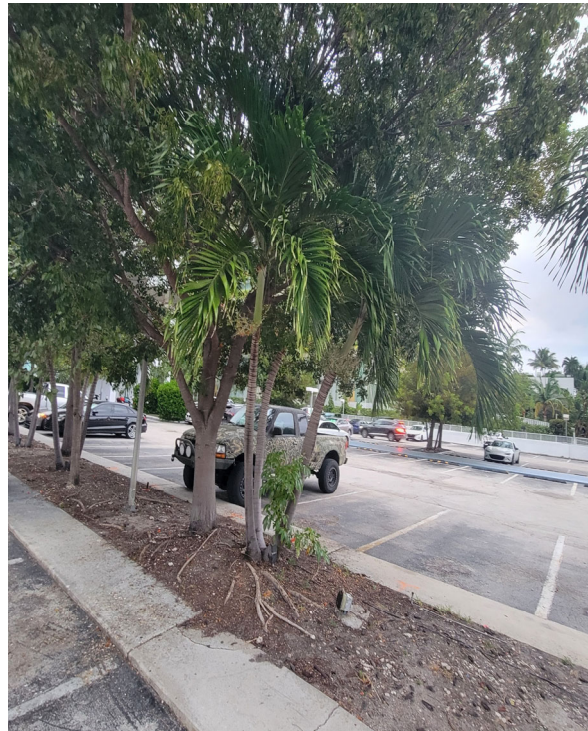
Tree 6 Christmas palm  
(*Adonidia merrellii*)  
5,4,4 inch DBH Good condition  
12 foot height, 8 foot spread

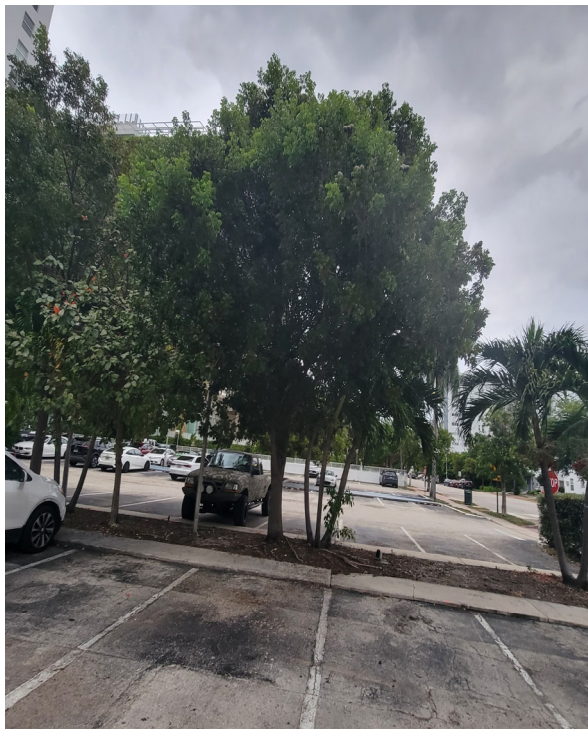
Tree 7 mahogany  
(*Swietenia mahagoni*)  
12 inch DBH, Good condition  
22 foot height, 25 foot spread

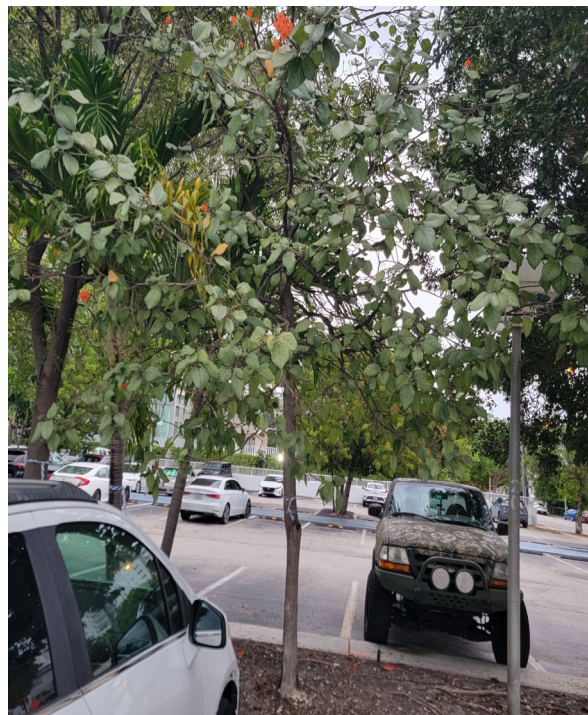
Tree 8 orange geiger  
(*Cordia sebestena*)  
5 inch DBH Good condition  
20 foot height, 16 foot spread

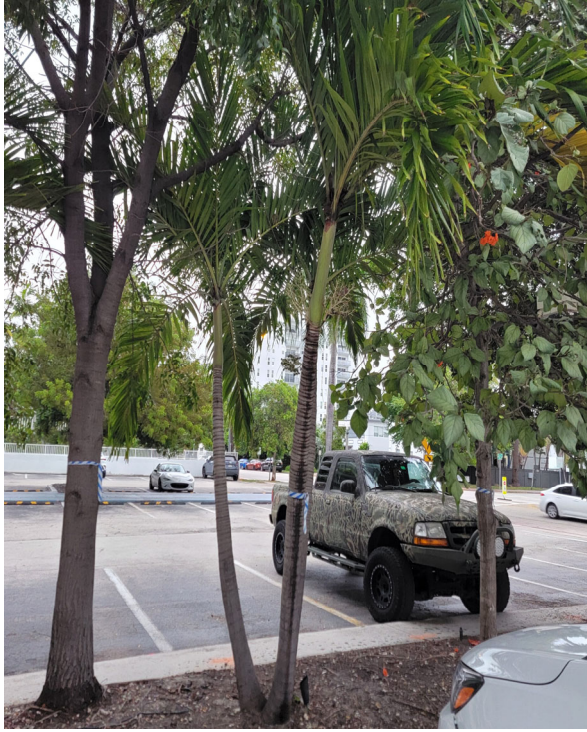
Tree 9 Christmas palm  
(*Adonidia merrellii*)  
5,4,4 inch DBH, Good condition  
12 foot height, 8 foot spread

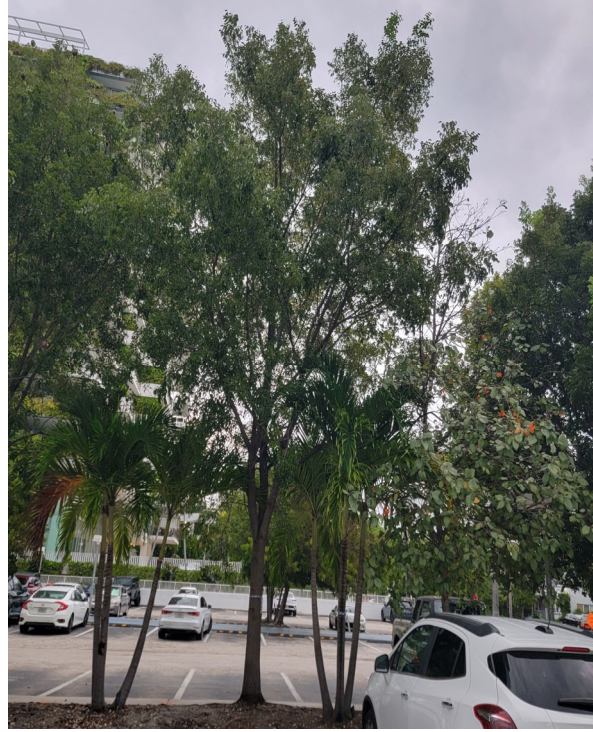
Tree 10 mahogany  
(*Swietenia mahagoni*)  
9 inch DBH Good condition  
35 foot height, 25 foot spread

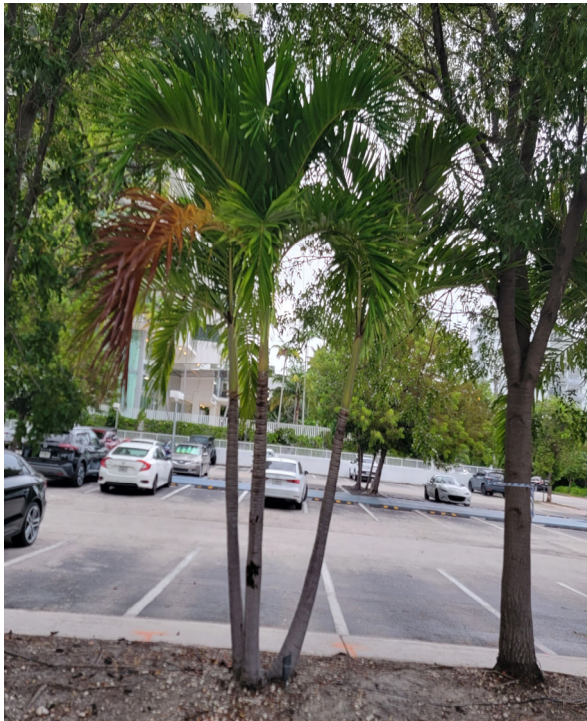
Tree 11 Christmas palm  
(*Adonidia merrellii*)  
4,4,4 inch DBH, Good condition  
10 foot height, 8 foot spread

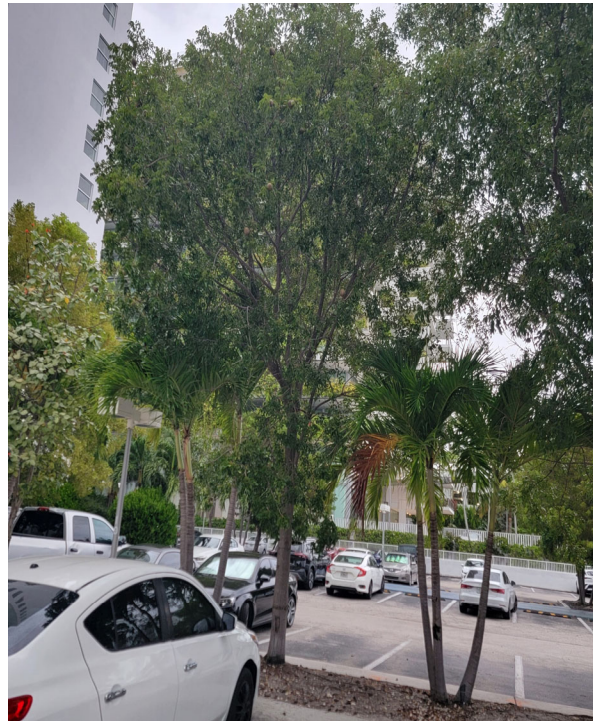
Tree 12 mahogany  
(*Swietenia mahagoni*)  
8 inch DBH Good condition  
35 foot height, 22 foot spread

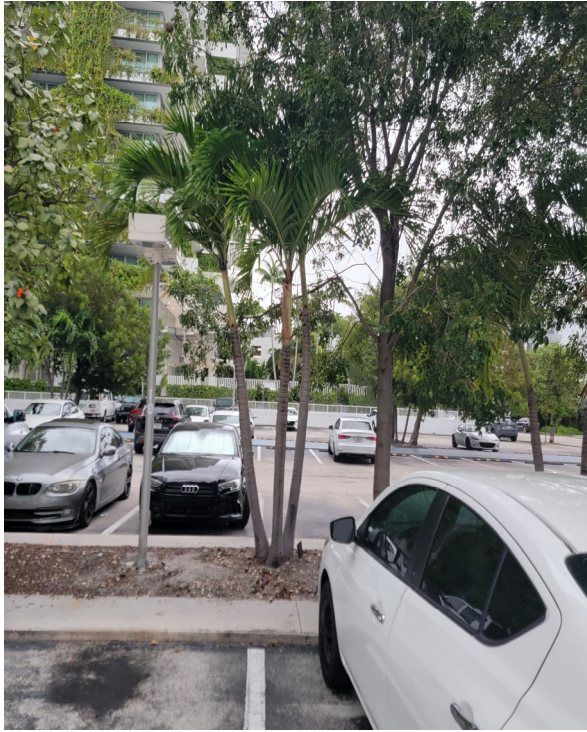
Tree 13 Christmas palm  
(Adonidia merrellii)  
5,5,5 inch DBH, Good condition  
12 foot height, 8 foot spread

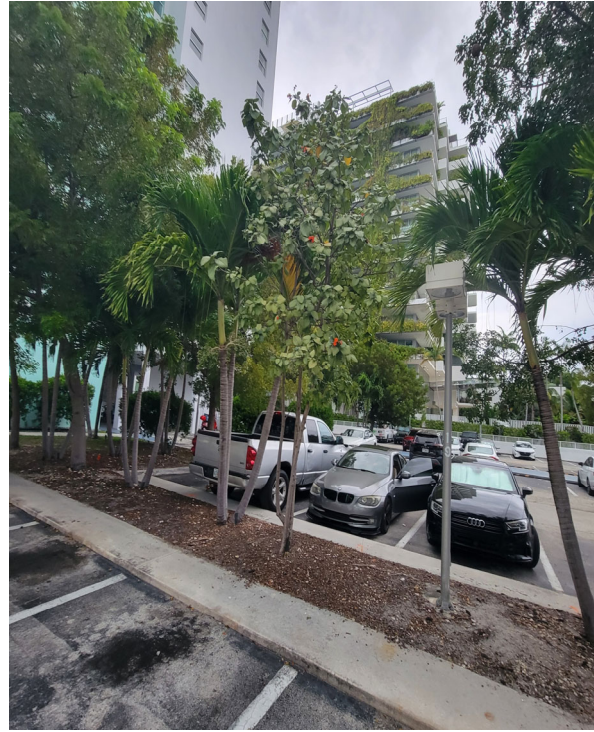
Tree 14 orange geiger  
(Cordia sebestena)  
3 inch DBH Good condition  
14 foot height, 12 foot spread

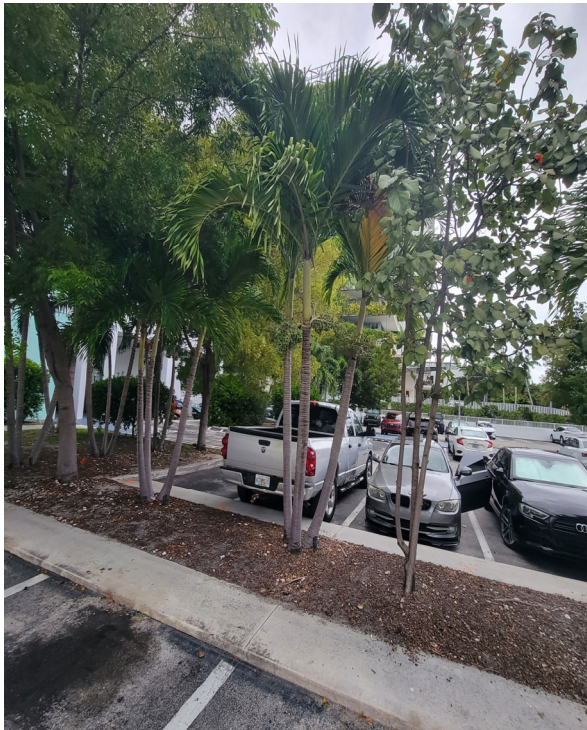
Tree 15 Christmas palm  
(Adonidia merrellii)  
6,5,5 inch DBH, Good condition  
10 foot height, 8 foot spread

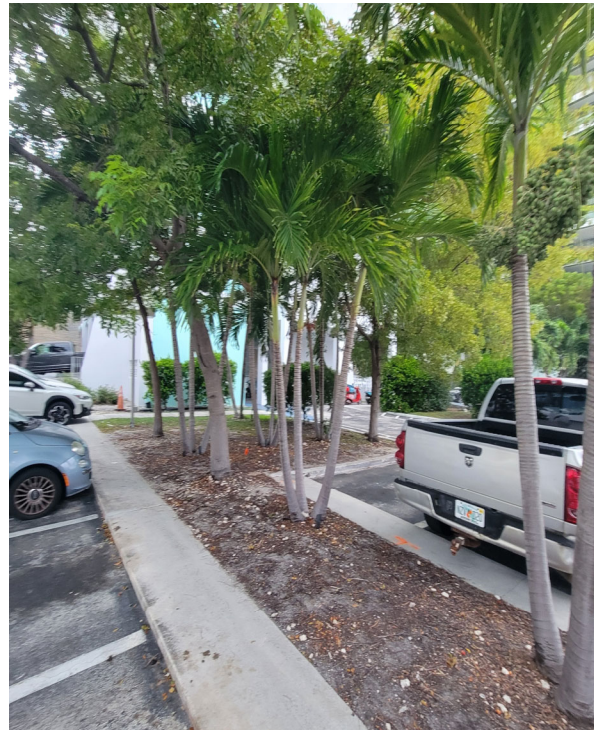
Tree 16 Christmas palm  
(Adonidia merrellii)  
4,4,4 inch DBH Good condition  
12 foot height, 8 foot spread

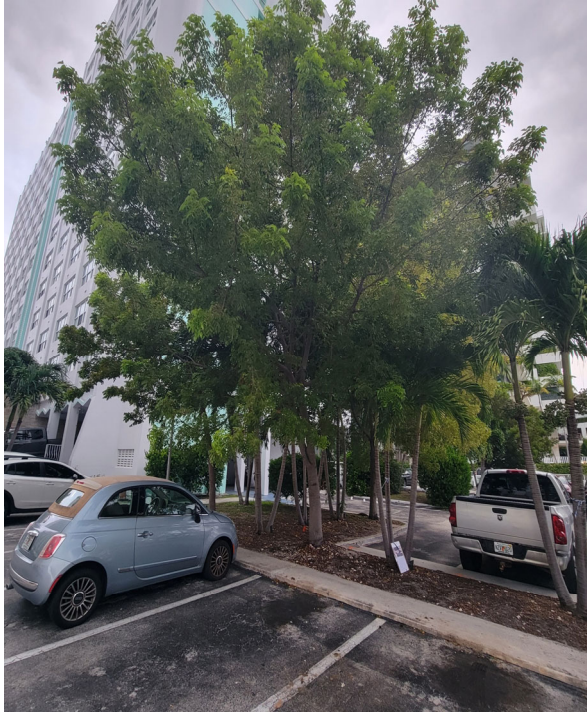
Tree 17 mahogany  
(Swietenia mahagoni)  
9 inch DBH, Good condition  
35 foot height, 35 foot spread

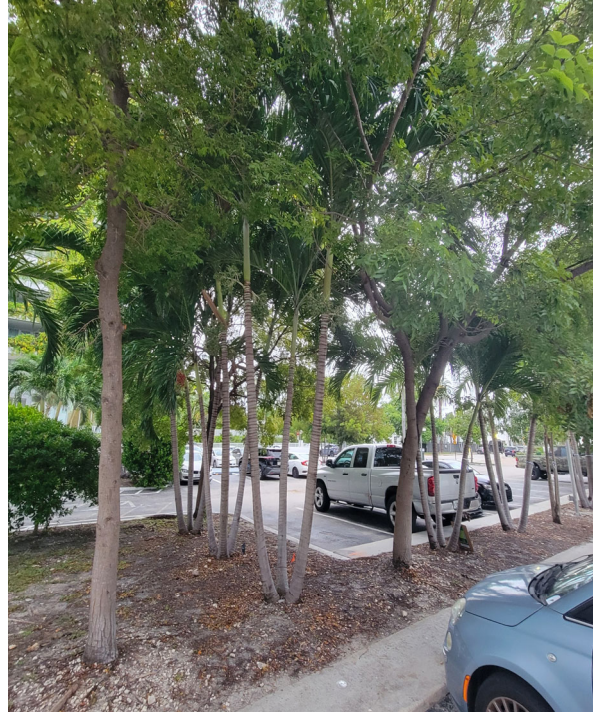
Tree 18 Christmas palm  
(Adonidia merrellii)  
5,4,4 inch DBH Good condition  
16 foot height, 8 foot spread

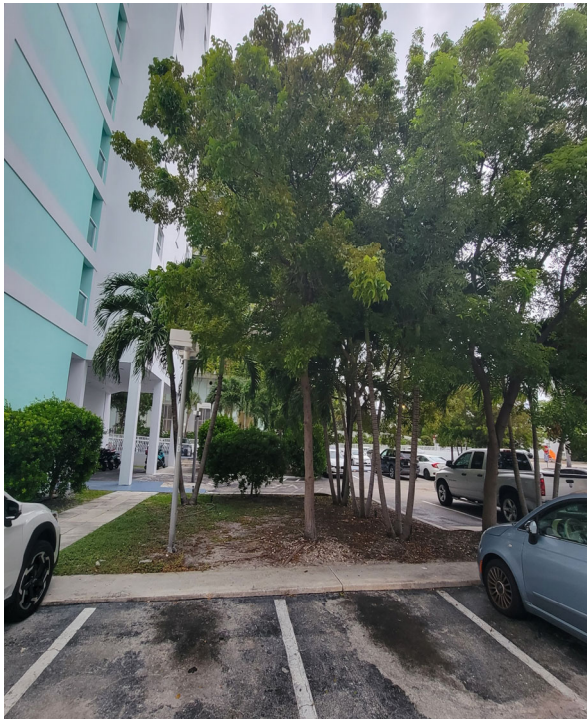
Tree 19 mahogany  
(Swietenia mahagoni)  
7 inch DBH, Good condition  
28 foot height, 25 foot spread

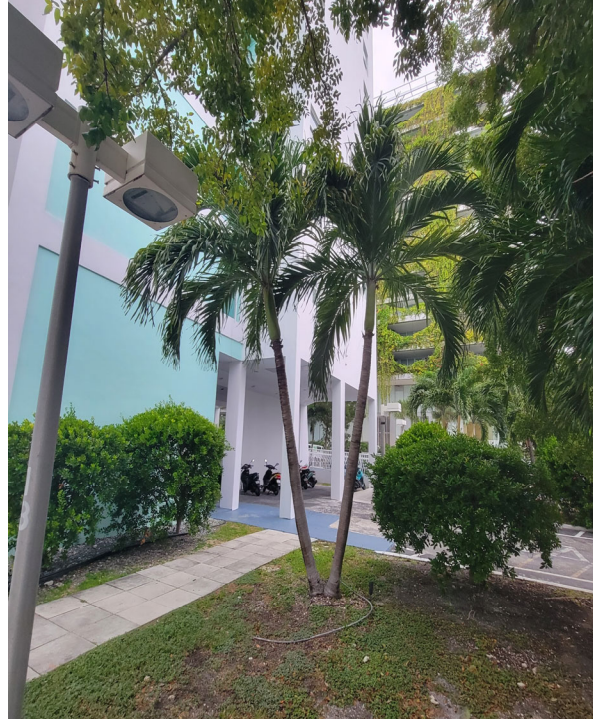
Tree 20 Christmas palm  
(Adonidia merrellii)  
7,7 inch DBH Good condition  
14 foot height, 8 foot spread

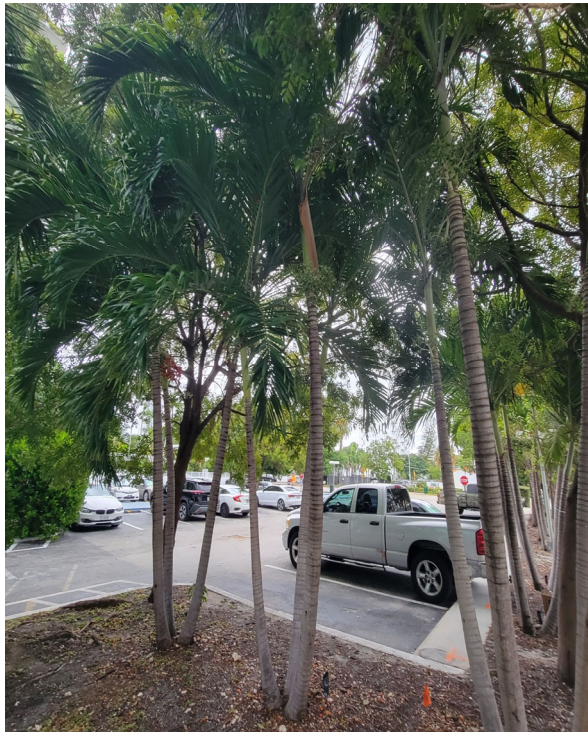
Tree 21 Christmas palm  
(*Adonidia merrellii*)  
6,5,4 inch DBH, Good condition  
16 foot height, 8 foot spread

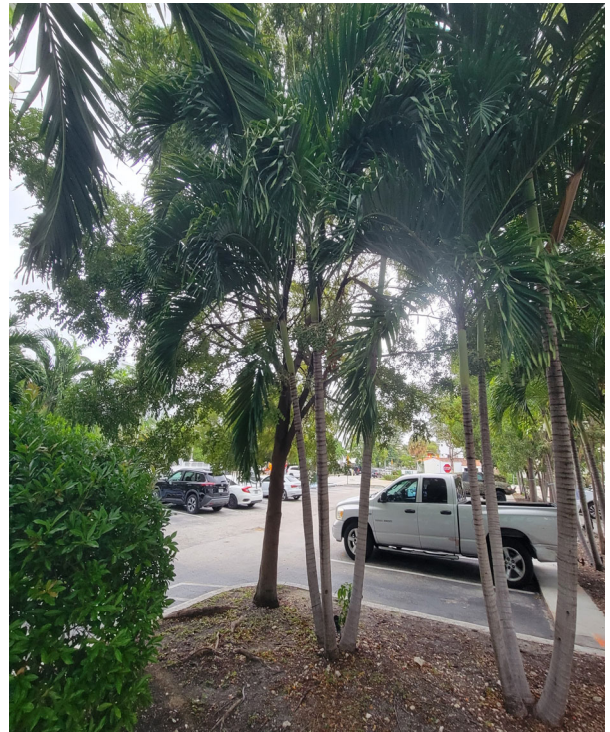
Tree 22 Christmas palm  
(*Adonidia merrellii*)  
6,6,6 inch DBH Good condition  
18 foot height, 8 foot spread

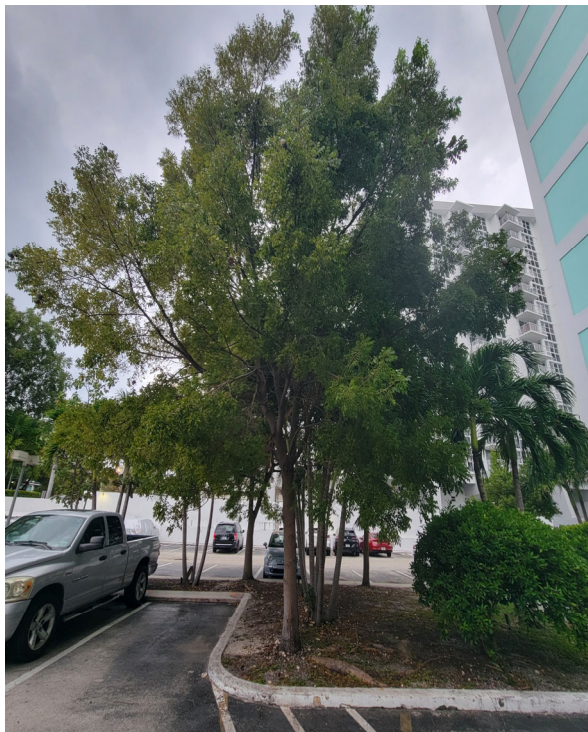
Tree 23 mahogany  
(*Swietenia mahagoni*)  
10 inch DBH, Good condition  
35 foot height, 35 foot spread

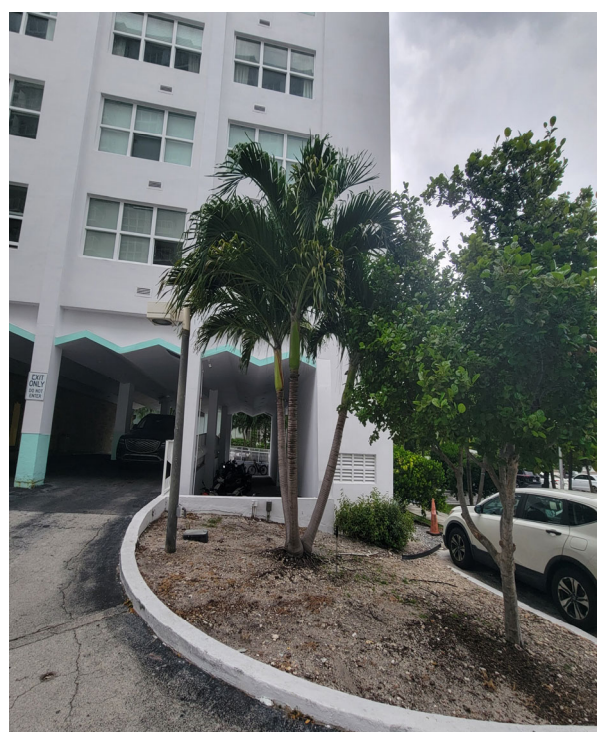
Tree 24 Christmas palm  
(*Adonidia merrellii*)  
7,7,7 inch DBH Good condition  
15 foot height, 8 foot spread

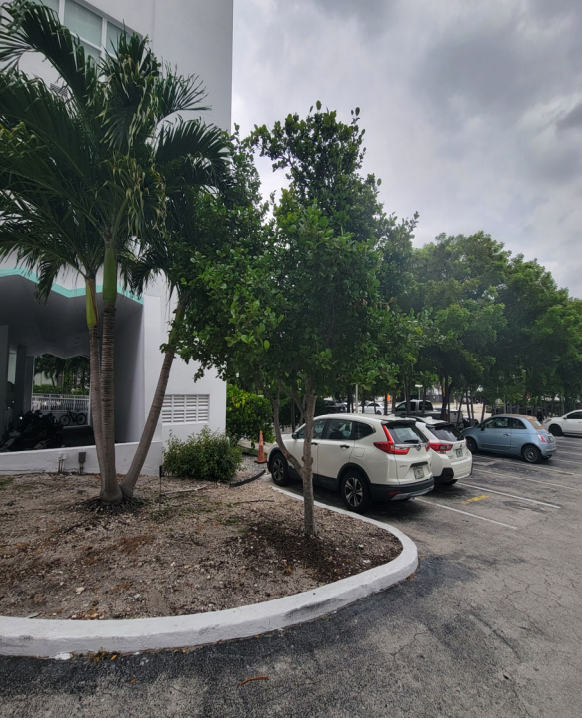
Tree 25 pigeon plum  
(*Coccoloba diversifolia*)  
6 inch DBH, Good condition  
12 foot height, 12 foot spread

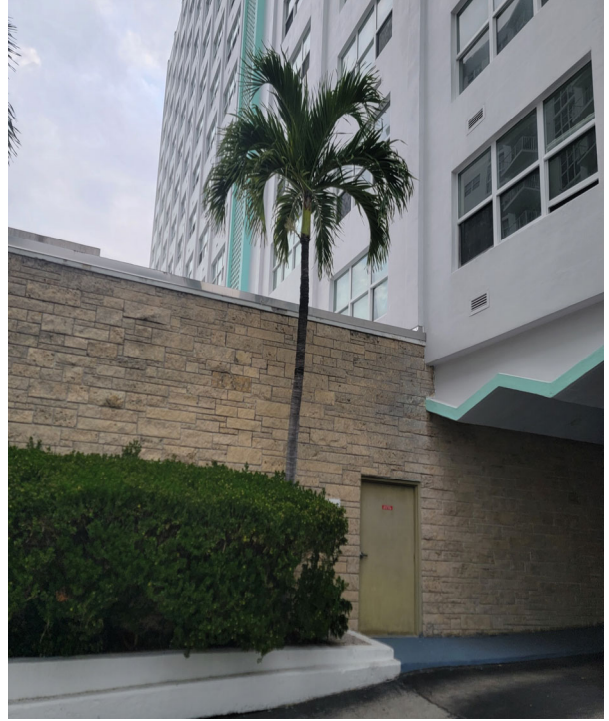
Tree 26 Alexander palm  
(*Archontophoenix alexandrae*)  
8 inch DBH Good condition  
25 foot height, 6 foot spread

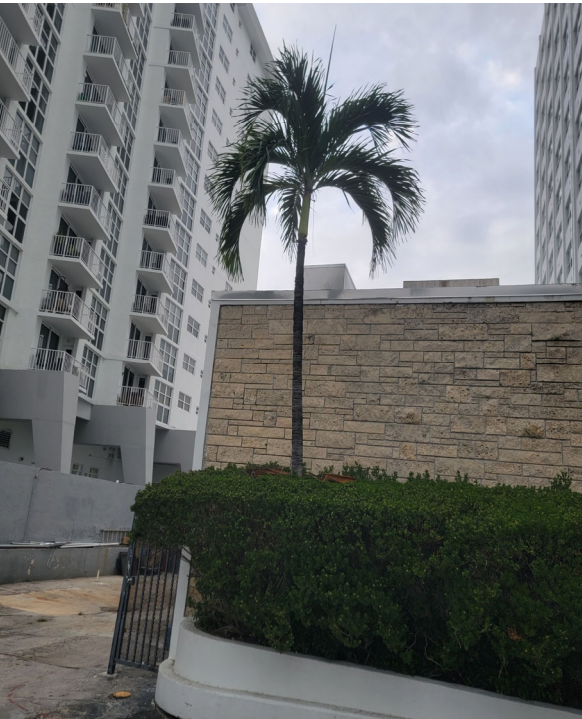
Tree 27 Alexander palm  
(*Archontophoenix alexandrae*)  
8 inch DBH, Good condition  
25 foot height, 6 foot spread

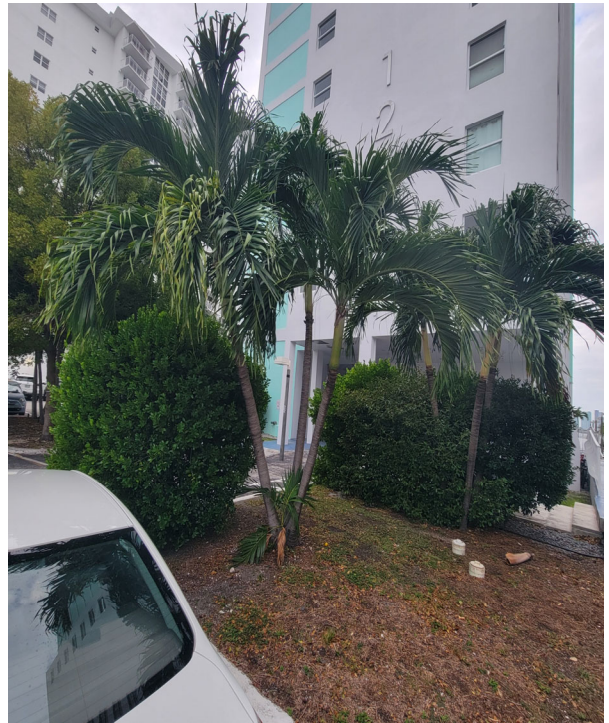
Tree 28 Christmas palm  
(*Adonidia merrellii*)  
5,5,4 inch DBH Good condition  
12 foot height, 6 foot spread

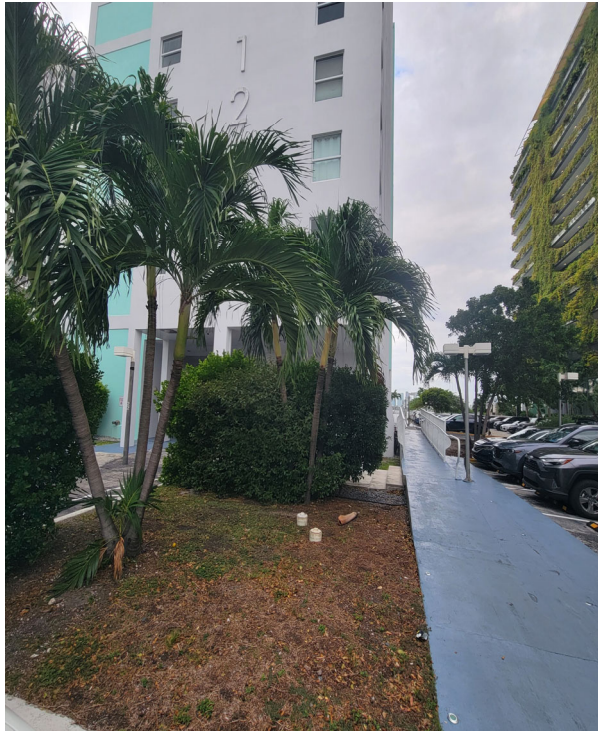
Tree 29 christmas palm  
(Adonidia merrellii)  
5,5,5 inch DBH, Good condition  
12 foot height, 6 foot spread

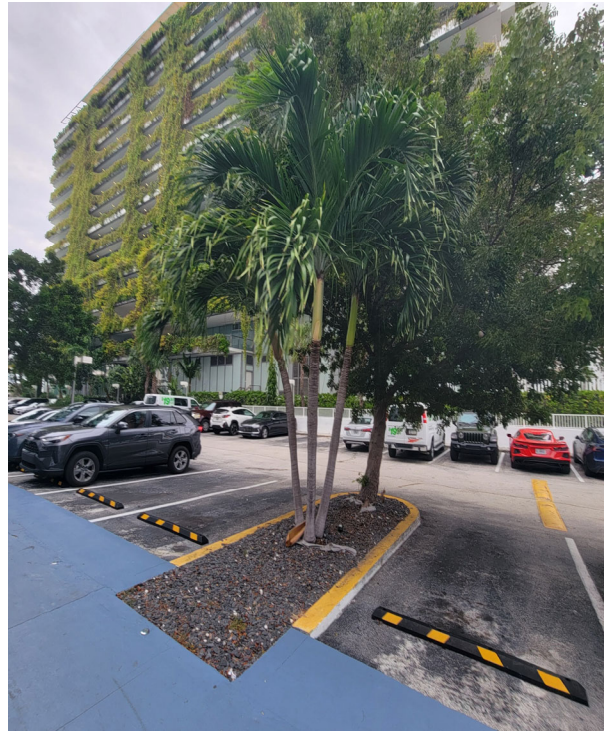
Tree 30 christmas palm  
(Adonidia merrellii)  
5,5,5 inch DBH Good condition  
12 foot height, 6 foot spread

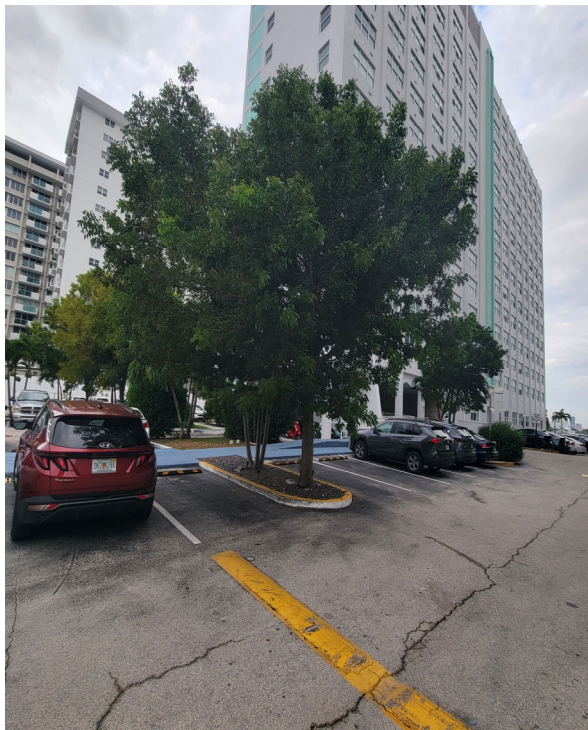
Tree 31 mahogany  
(Swietenia mahagoni)  
12 inch DBH, Good condition  
30 foot height, 30 foot spread

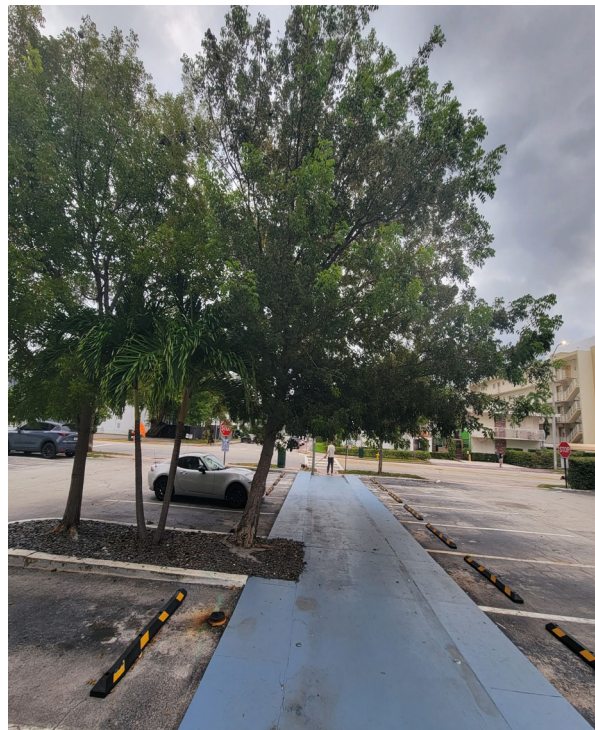
Tree 32 mahogany  
(Swietenia mahagoni)  
10 inch DBH Good condition  
35 foot height, 35 foot spread

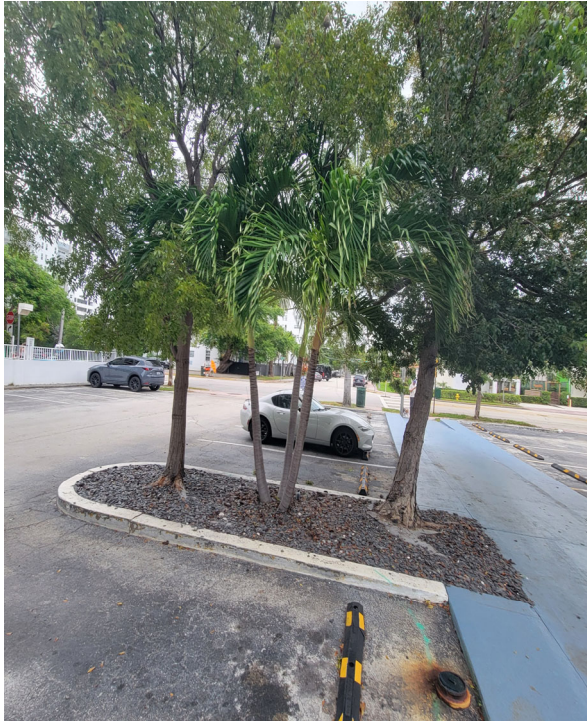
Tree 33 christmas palm  
(Adonidia merrellii)  
5,4,4 inch DBH, Good condition  
12 foot height, 6 foot spread

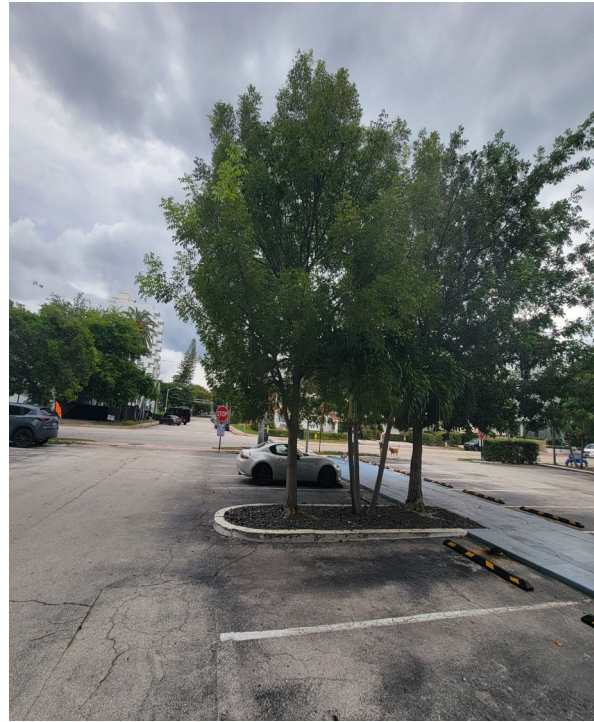
Tree 34 mahogany  
(Swietenia mahagoni)  
10 inch DBH Good condition  
32 foot height, 32 foot spread

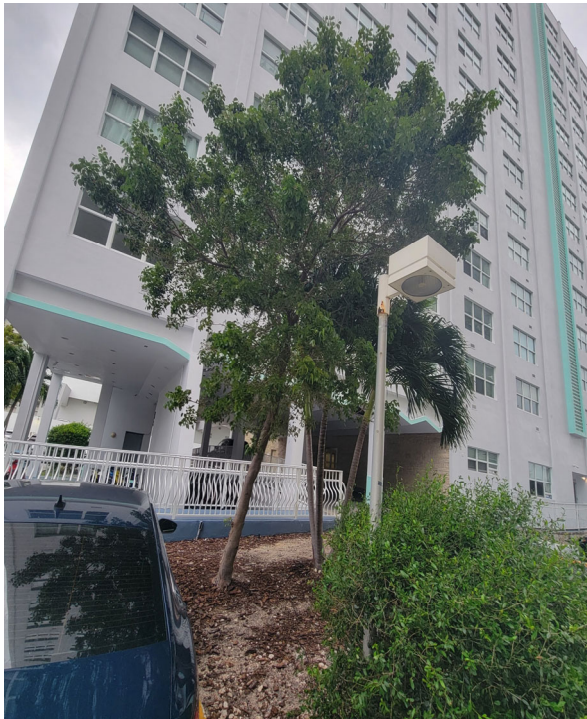
Tree 35 mahogany  
(Swietenia mahagoni)  
6 inch DBH, Good condition  
25 foot height, 25 foot spread

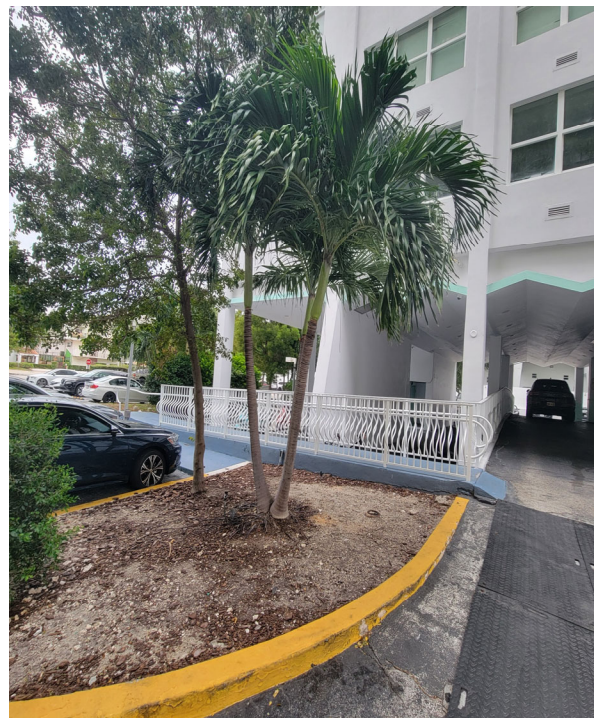
Tree 36 christmas palm  
(Adonidia merrellii)  
6,6,6 inch DBH Good condition  
16 foot height, 6 foot spread

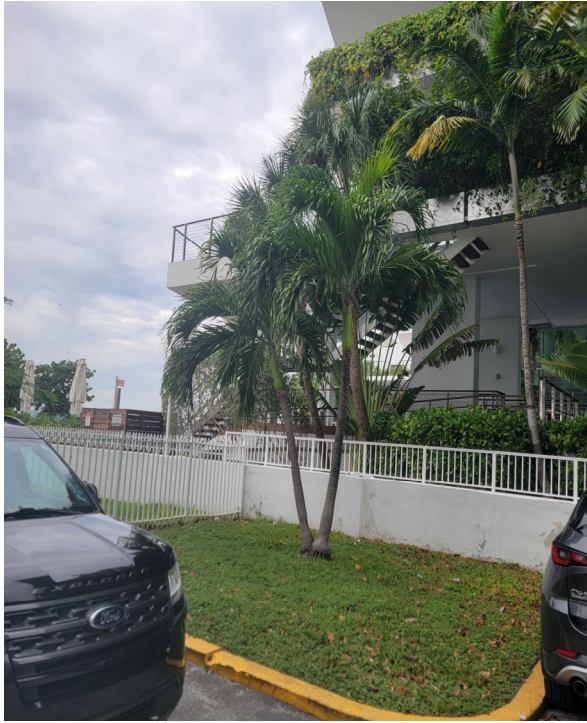
Tree 37 christmas palm  
(*Adonidia merrellii*)  
6,6 inch DBH, Good condition  
16 foot height, 6 foot spread

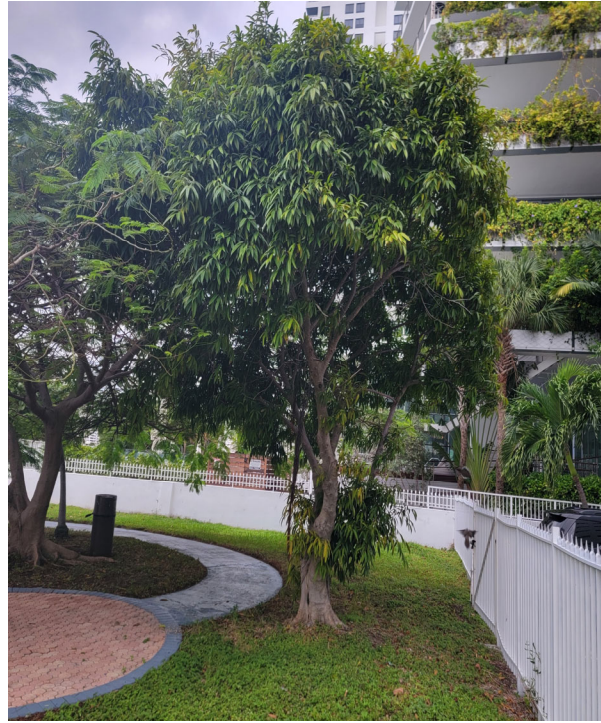
Tree 38 long leaf fig  
(*Ficus maclellandii*)  
12 inch DBH Good condition  
20 foot height, 22 foot spread

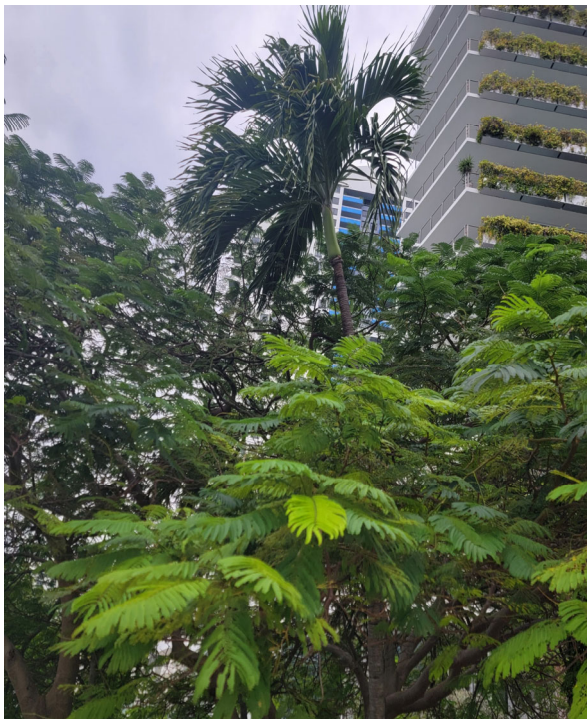
Tree 39 Alexander palm  
(*Archontophoenix alexandrae*)  
5 inch DBH, Good condition  
25 foot height, 6 foot spread

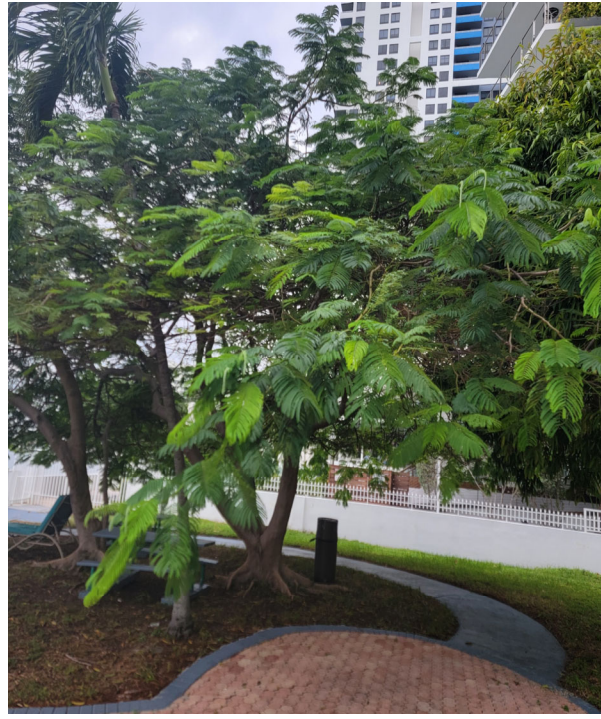
Tree 40 royal poinciana  
(*Delonix regia*)  
18 inch DBH Good condition  
32 foot height, 35 foot spread

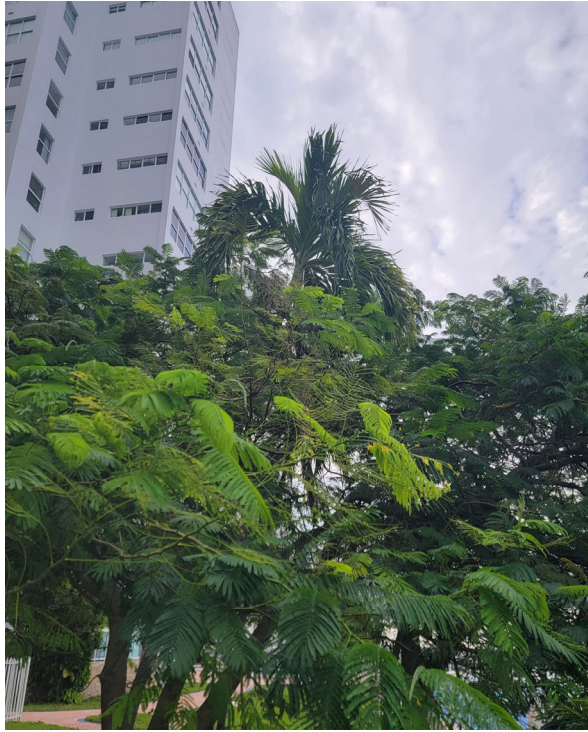
Tree 41 Alexander palm  
(Archontophoenix alexandrae)  
5 inch DBH, Good condition  
25 foot height, 6 foot spread

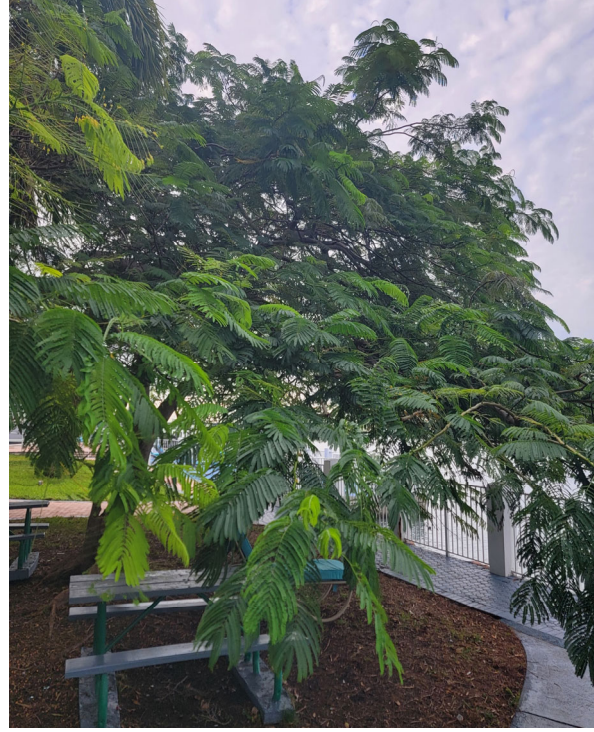
Tree 42 royal poinciana  
(Delonix regia)  
14 inch DBH Good condition  
32 foot height, 32 foot spread

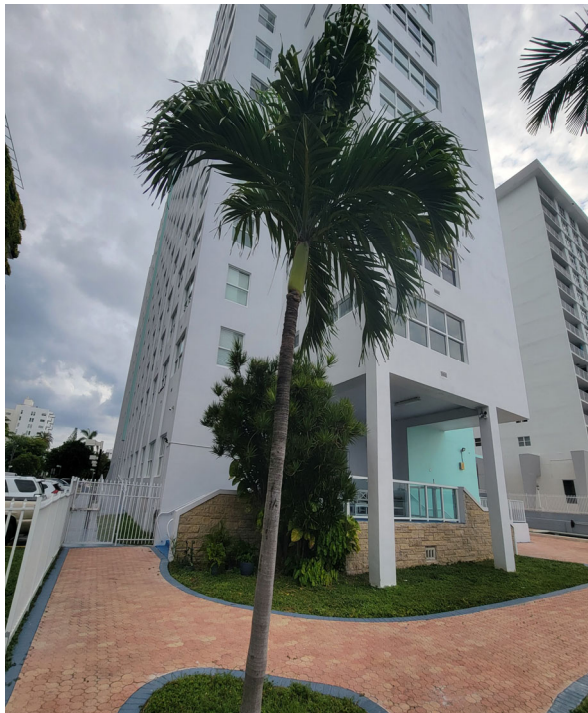
Tree 43 Alexander palm  
(Archontophoenix alexandrae)  
6 inch DBH, Good condition  
18 foot height, 6 foot spread

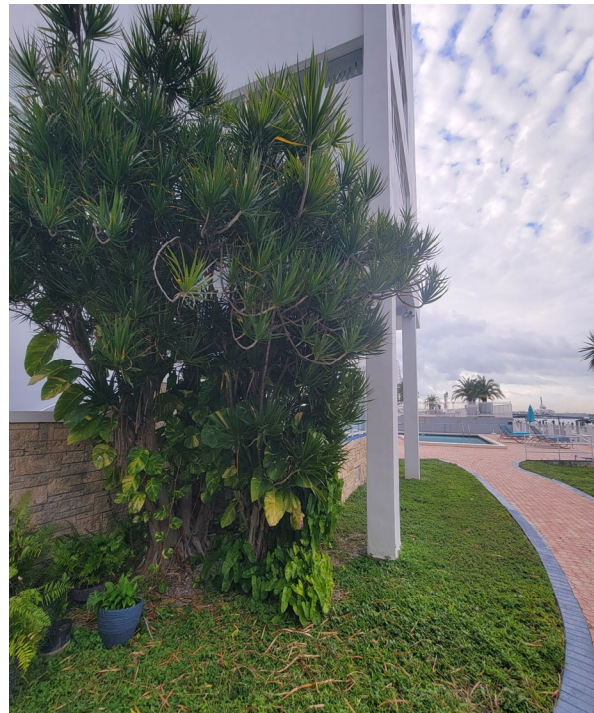
Tree 44 dragon tree  
(Dracaena Marginata)  
8 inch DBH Good condition  
20 foot height, 18 foot spread

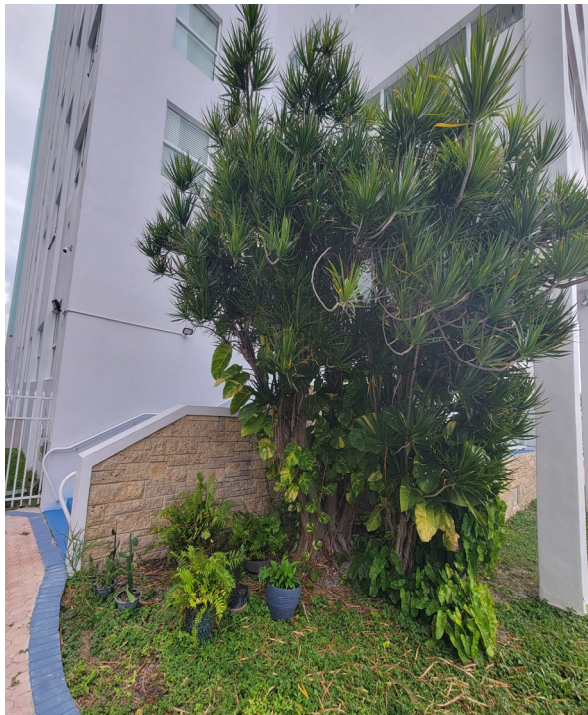
Tree 45 dragon tree  
(*Dracaena Marginata*)  
15 inch DBH, Good condition  
20 foot height, 18 foot spread

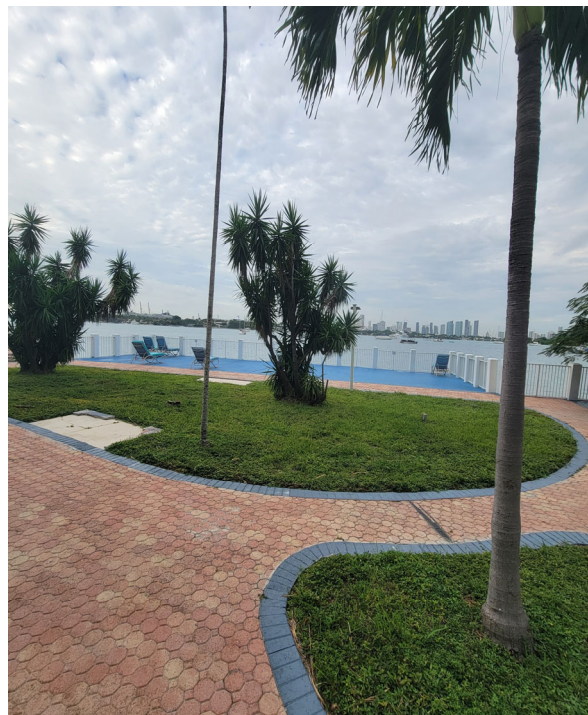
Tree 46 spanish bayonet  
(*Yucca aloifolia*)  
12 inch DBH Good condition  
18 foot height, 16 foot spread

species not considered a tree

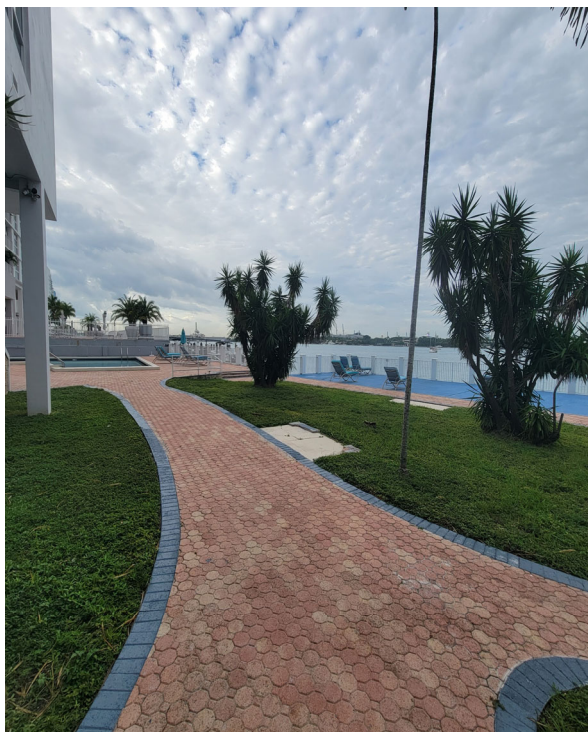
Tree 47 spanish bayonet  
(*Yucca aloifolia*)  
13 inch DBH, Fair condition  
18 foot height, 16 foot spread

species not considered a tree

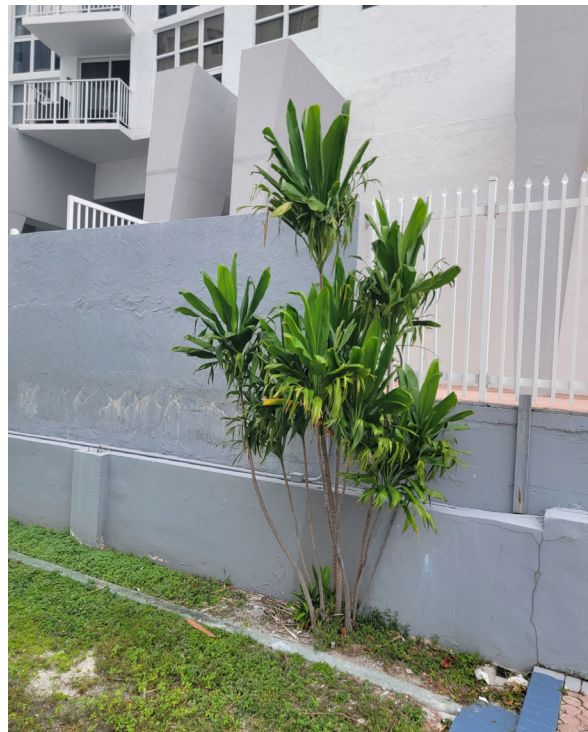
Tree 48 Cordyline hybrid  
(*Cordyline hybrid*)  
3 inch DBH Good condition  
10 foot height, 10 foot spread

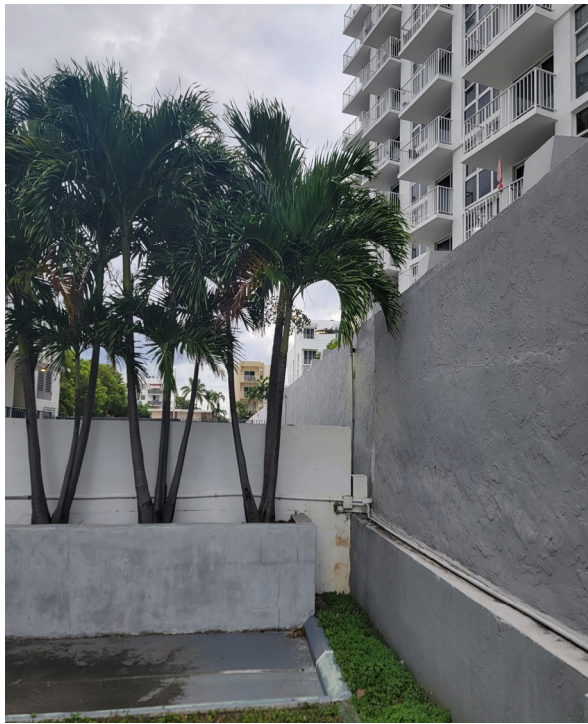
Tree 49 christmas palm  
(Adonidia merrellii)  
3,3,4 inch DBH, Good condition  
12 foot height, 8 foot spread

planter box

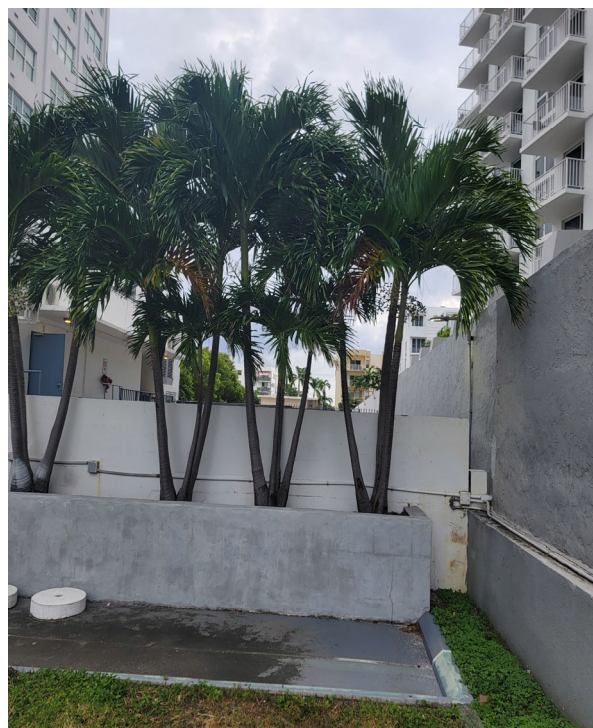
Tree 50 christmas palm  
(Adonidia merrellii)  
4,3,3,2 inch DBH Good condition  
12 foot height, 8 foot spread

planter box
