November 8, 2025

**Certified Arborist Assessment  
1250 West Ave, Miami Beach, Florida  
NLE Project No. 0325004**

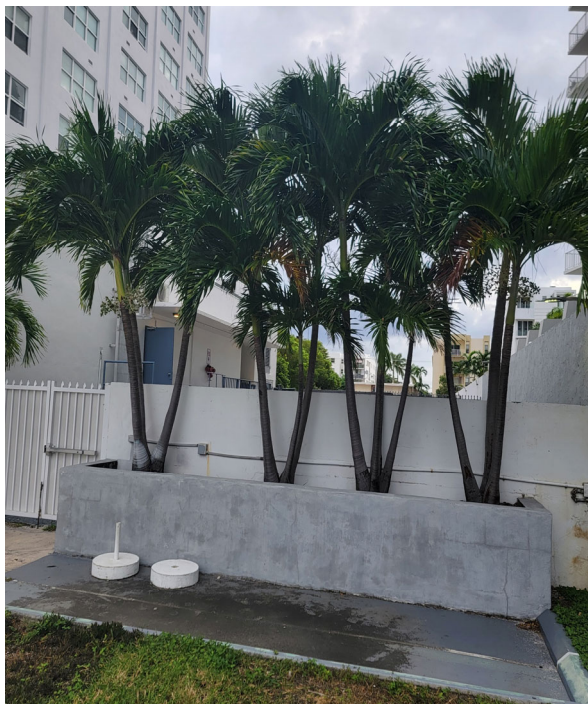
Tree 51 christmas palm  
(Adonidia merrellii)  
4,3,3,2 inch DBH, Good condition  
12 foot height, 8 foot spread

planter box

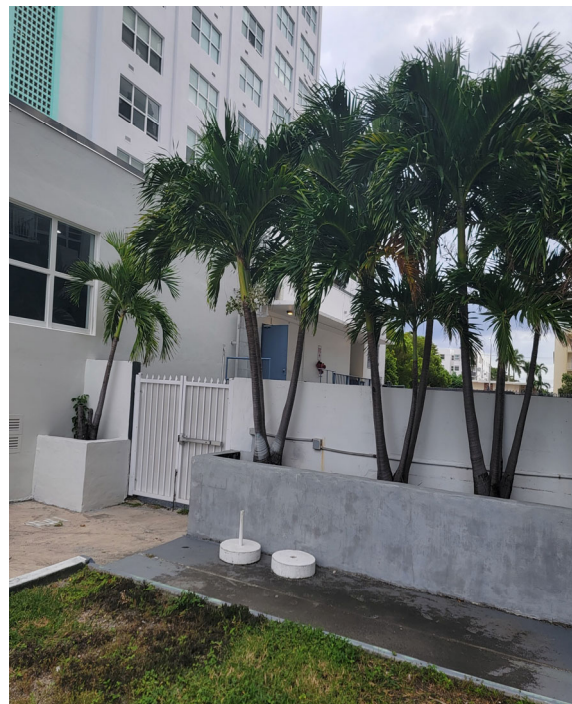
Tree 52 christmas palm  
(Adonidia merrellii)  
5,4,4 inch DBH Good condition  
12 foot height, 8 foot spread

planter box

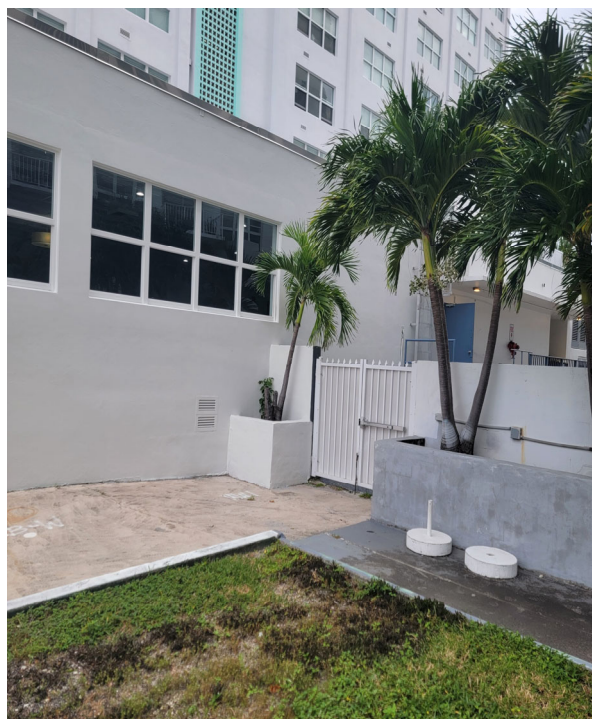
Tree 53 christmas palm  
(*Adonidia merrellii*)  
4 inch DBH, Fair condition  
12 foot height, 8 foot spread

planter box

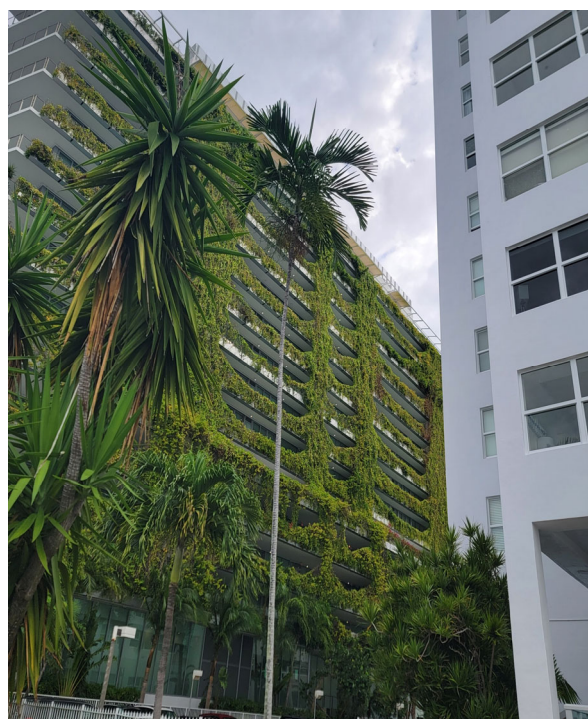
Tree 54 solitaire palm  
(*Ptychosperma elegans*)  
3 inch DBH Good condition  
32 foot height, 6 foot spread
