INTERIM Treatment REPORT I
Jackson Stewart's *Apollo Mural*
Conservation of the Mosaic

September 14, 2022

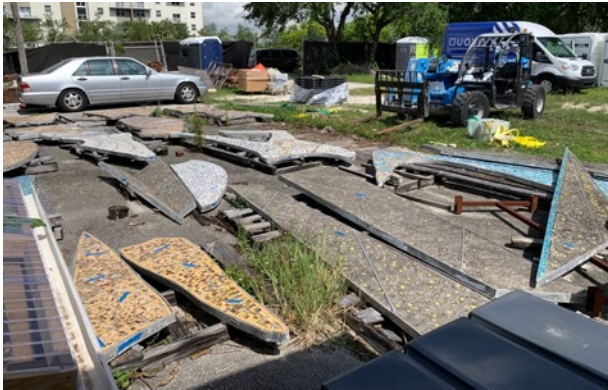
Overall of inventoried elements **before** relocation.

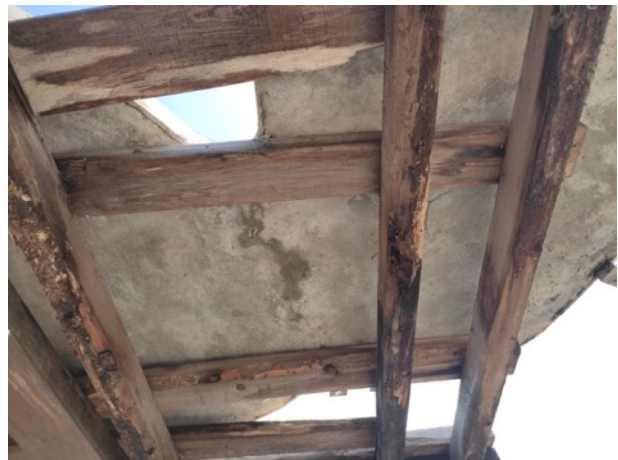
Detail of water infiltration at crack on the back of panel #17 **during** relocation.

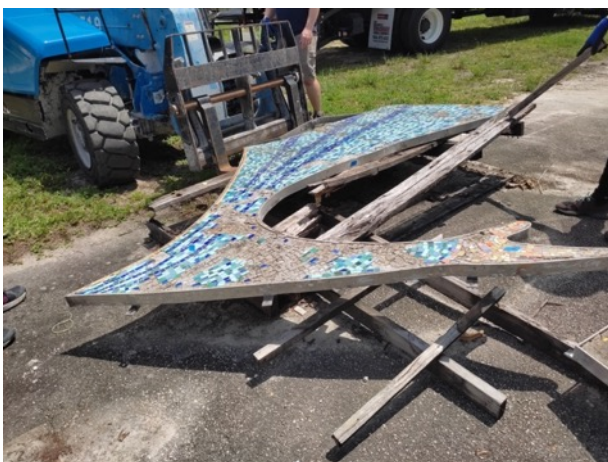
Overall of panel #18 **during** relocation.

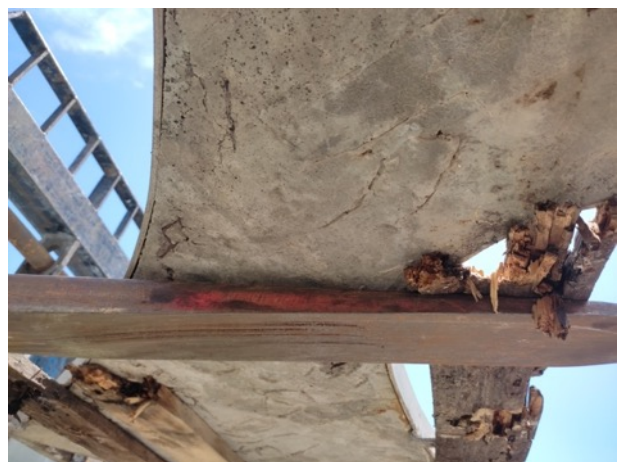
Detail of cracks, distinguishing marks and exposed wire mesh on the back of panel #18 **during** relocation.

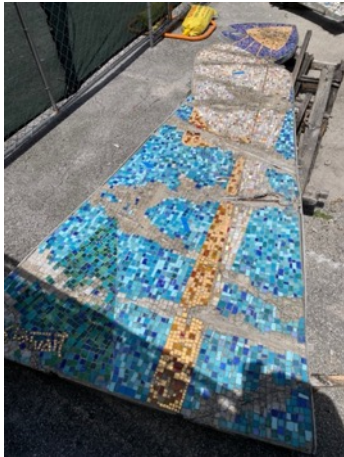
Overall of panel #1 **during** excavation.

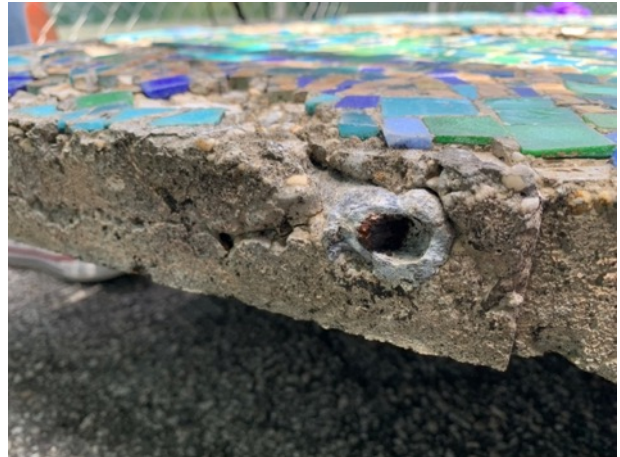
Detail of aluminum tube and corroded ferrous bar exposed due to the detachment of the aluminum frame at panel #1.

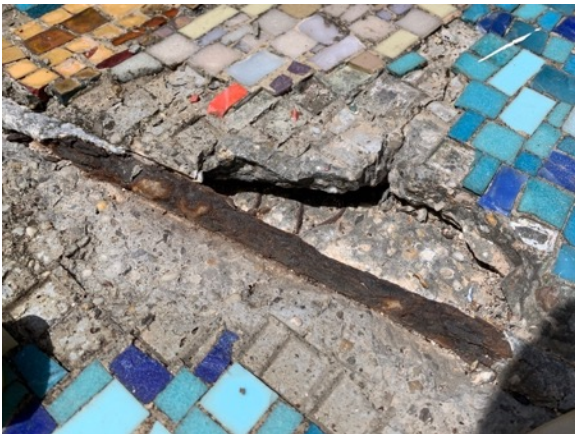
Detail of exposed aluminum tube, corroded ferrous bar, corroded wire mesh, and large cavity at panel #1.

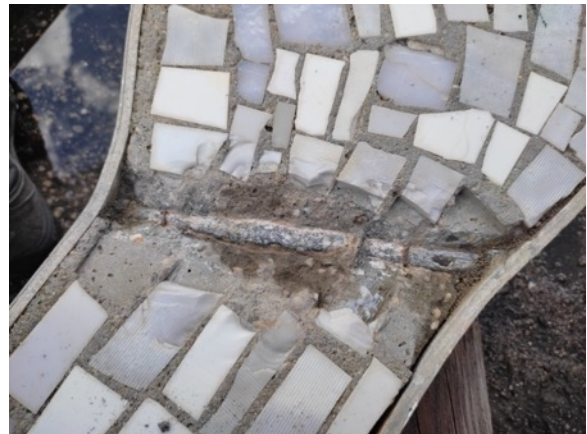
Detail of excavated aluminum tube showing internal corroded ferrous bar, and corroded wires (supposedly attached to mesh) at panel #4.

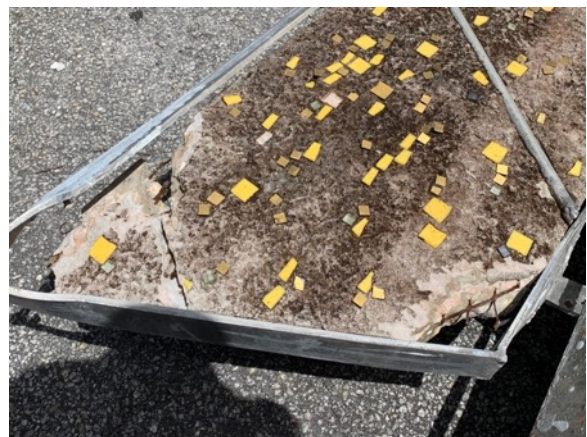
Detail of exposed aluminum tube, cracks, concrete loss and exposed corroded wire mesh on 'ground' panel **during** excavation.

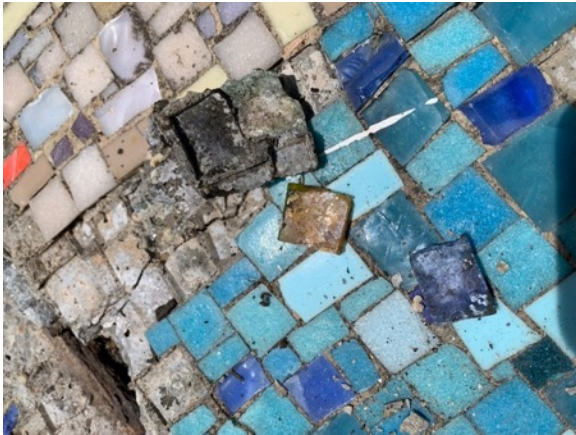
Detail of panel #1, showing dislodged tiles with bio growth visible on both the backs of the tiles as well as on the bedding mortar over which they sat.

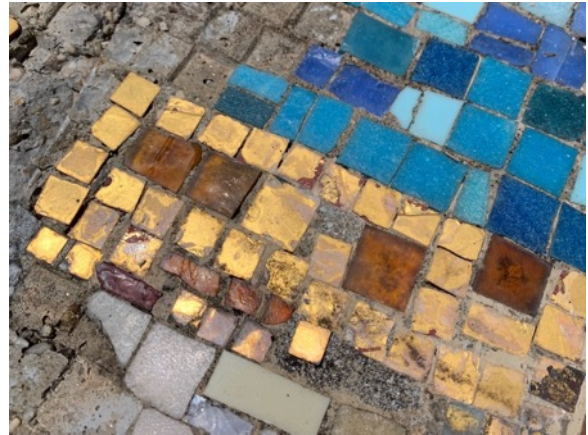
Detail of panel #1, showing translucent square amber tiles with dark/black bio growth visible between the back of the tile and the mortar bed, and gold leaf tiles where thin glass surface has been compromised and spalled, turning light pink.

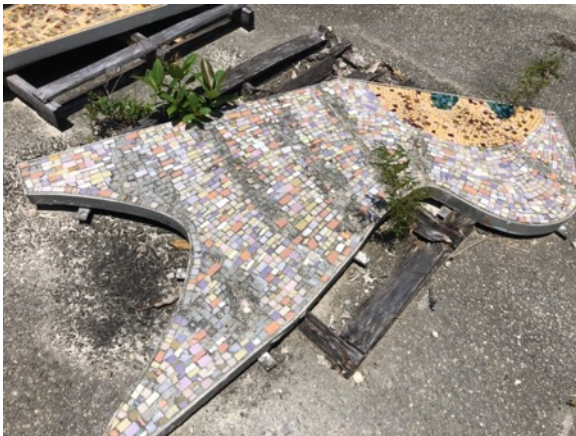
*Overall of panel #20 **before** relocation.*

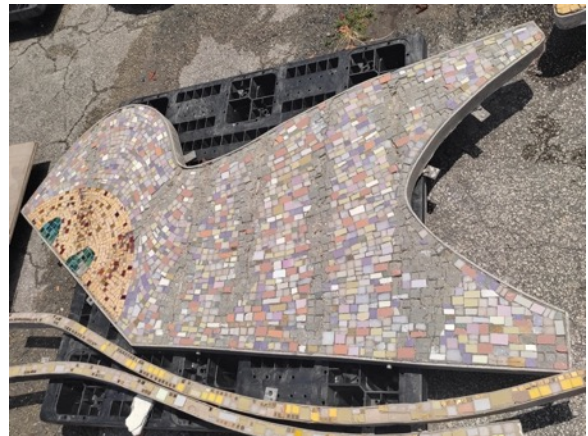
*Overall of panel #20 **after** relocation, cleaning and removal of additional loose tiles.*

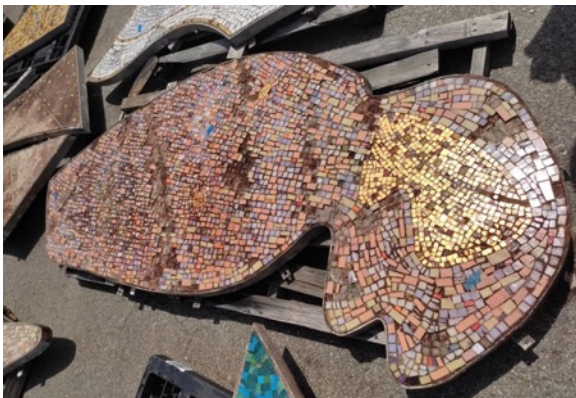
*Overall of panel #17 **during** cleaning with D/2®.*

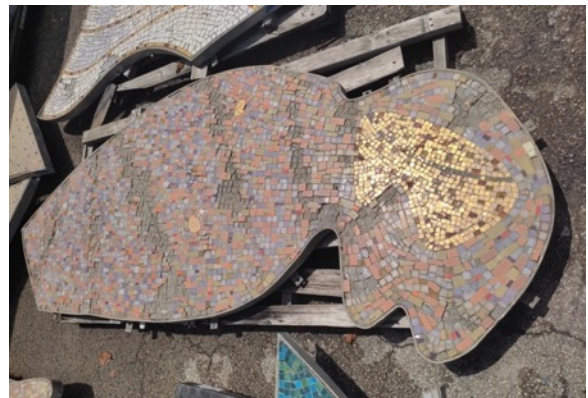
*Overall of panel #17 **after** wet cleaning and removal of additional loose tiles.*

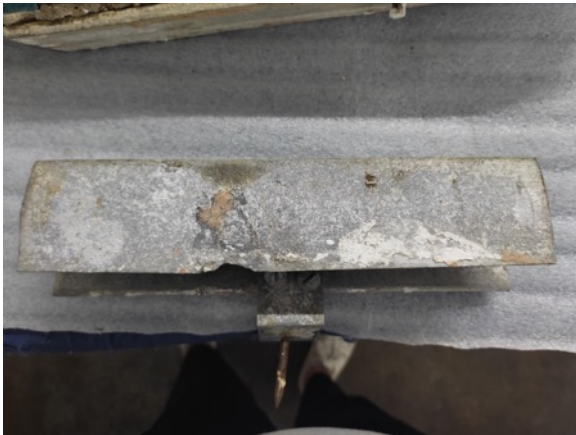
Detail of aluminum edge **before** mechanical and wet cleaning test.
