STRUCTURAL CONDITION ASSESSMENT  
235 Washington Ave  
Miami Beach, Florida

Prepared for  
Bercow Radell Fernandez Larkin + Tapanes  
200 S. Biscayne Boulevard, Suite 300  
Miami, FL 33131

December 19, 2025

STRUCTURAL CONDITION ASSESSMENT for  
235 Washington Ave  
Miami Beach, Florida

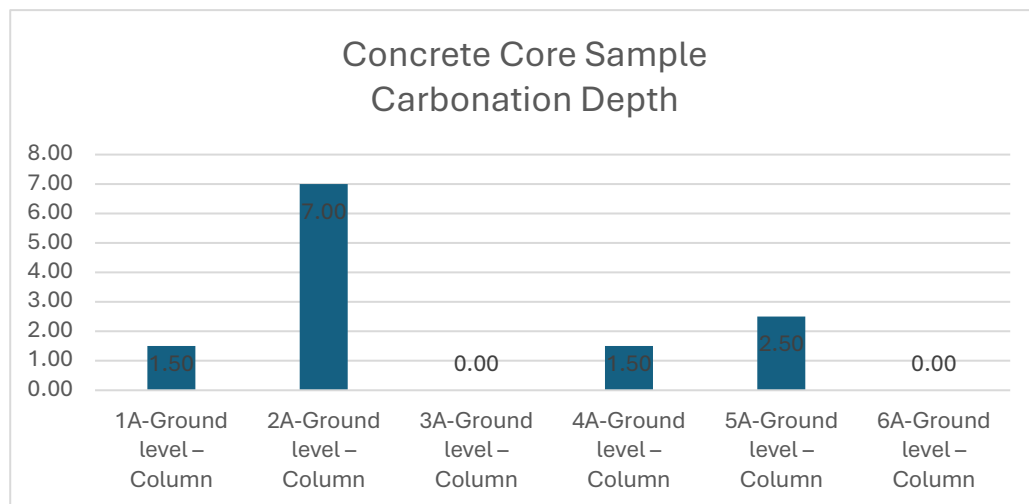
The carbonation found in the samples ranged between 0" – 7"

The carbonation is extensive and exposes the reinforcing rebars to corrosion

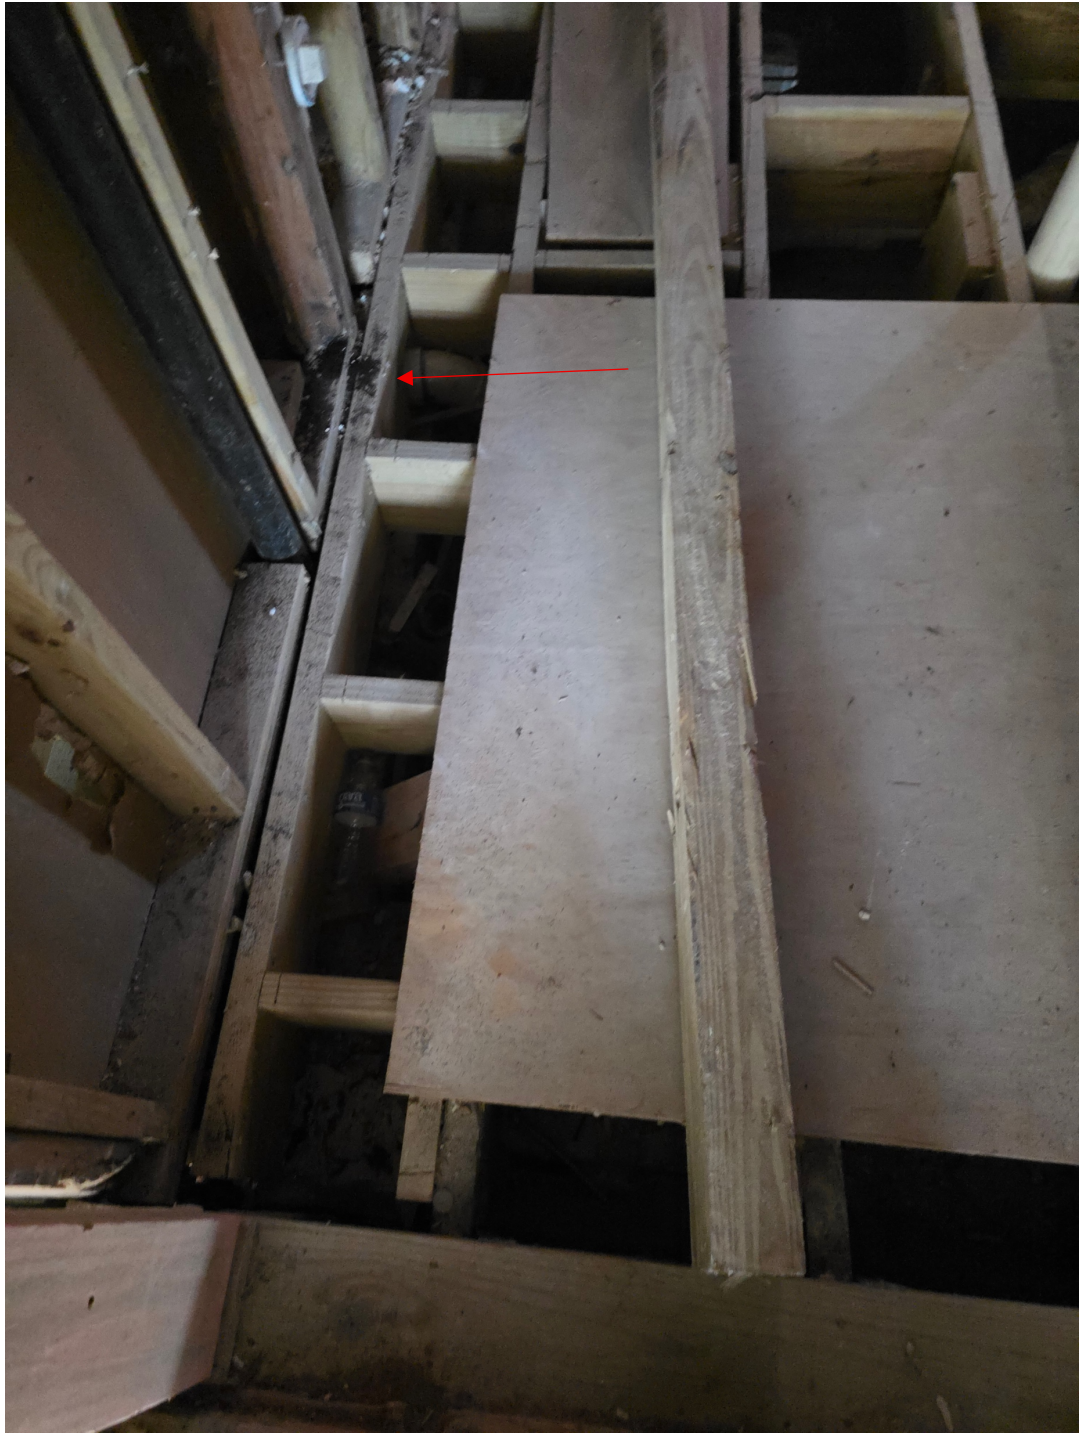
Termite dropping and stud damage

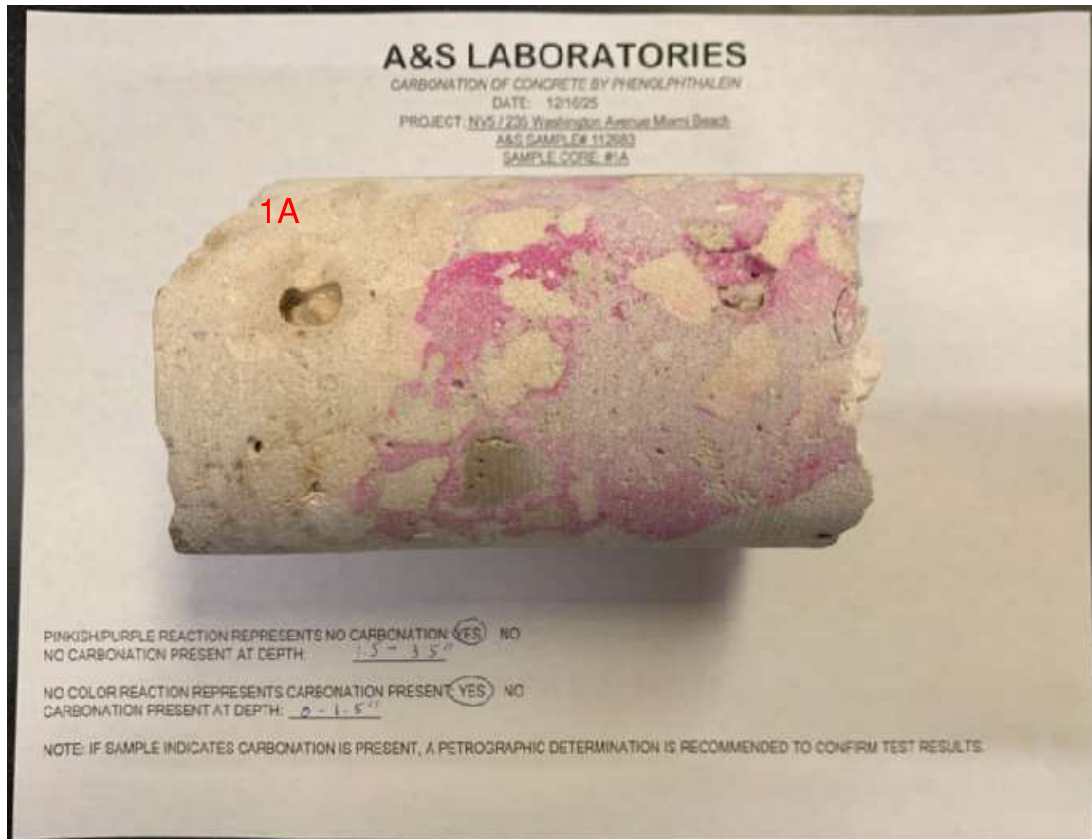
Photograph #3: Concrete Cores #1A Depth of Carbonation Testing

| Core Number | Carbonation Depth [in] |
|---|---|
| 1A-Ground level – Column | 1.50 |

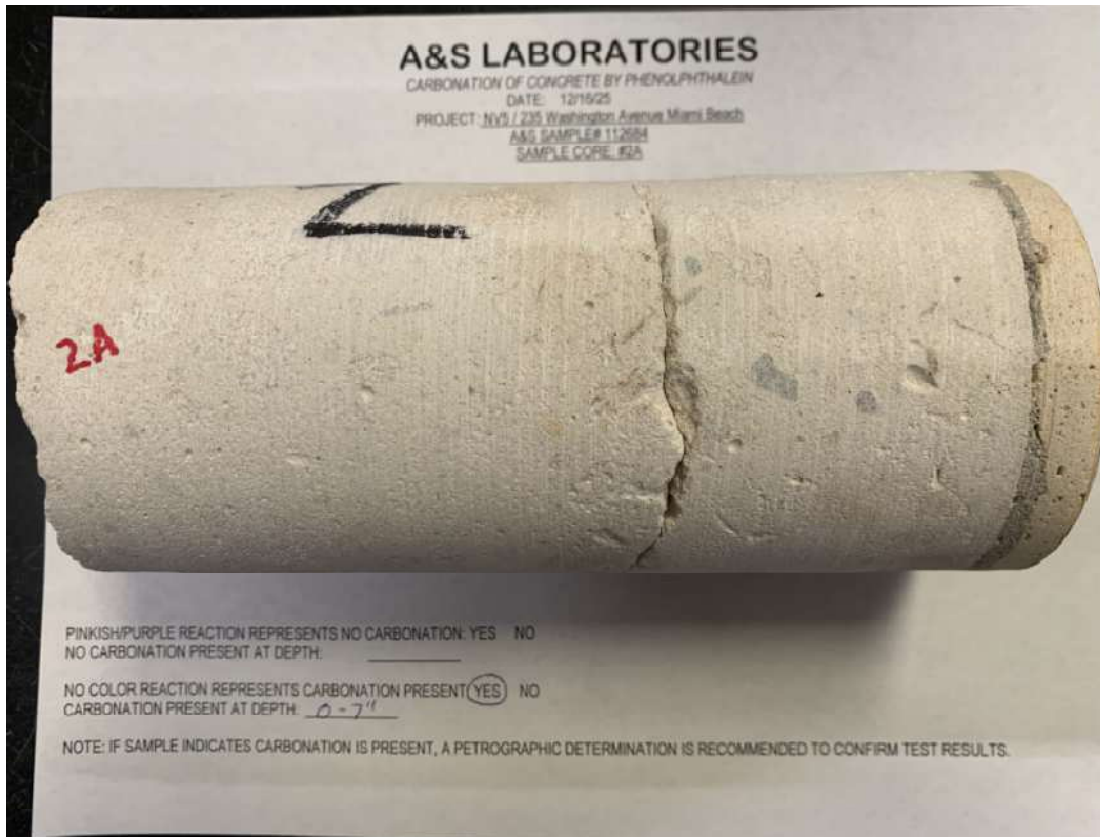
Photograph #4: Concrete Cores #2A Depth of Carbonation Testing

| Core Number | Carbonation Depth [in] |
|---|---|
| 2A-Ground level – Column | 7.00 |

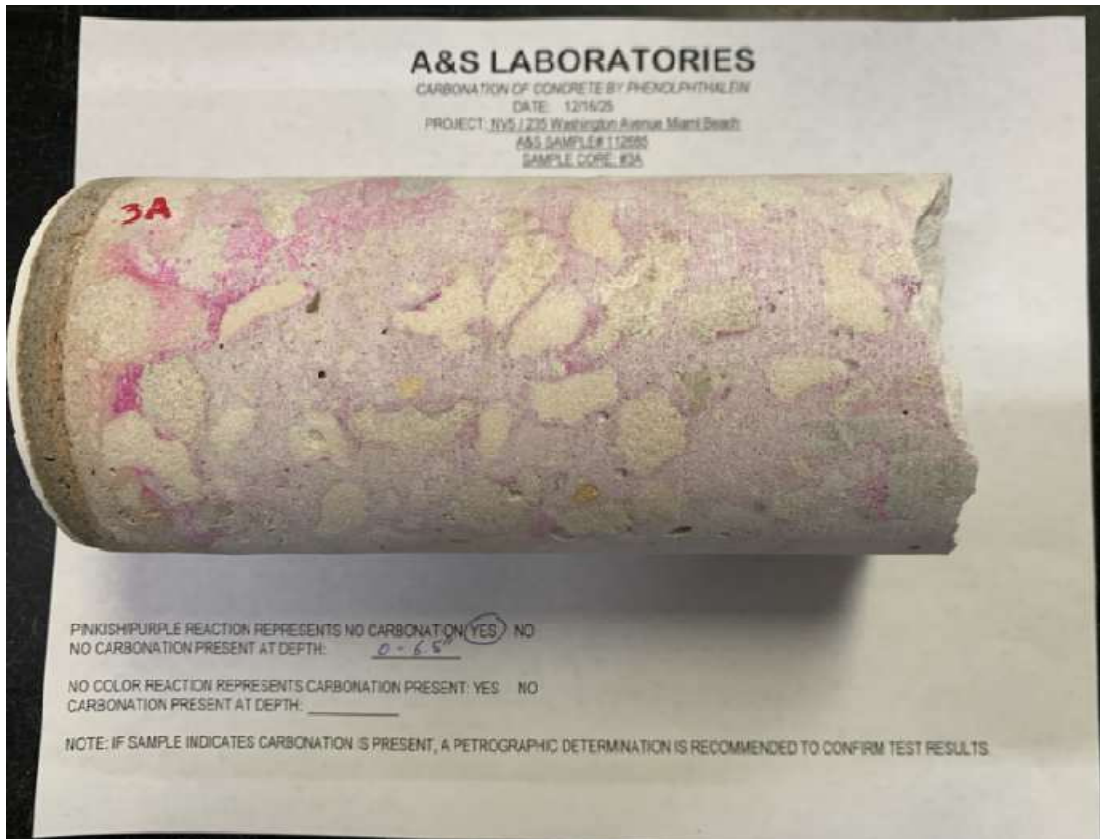
Photograph #5: Concrete Cores #3A Depth of Carbonation Testing

| Core Number | Carbonation Depth [in] |
|---|---|
| 3A-Ground level – Column | 0.00 |

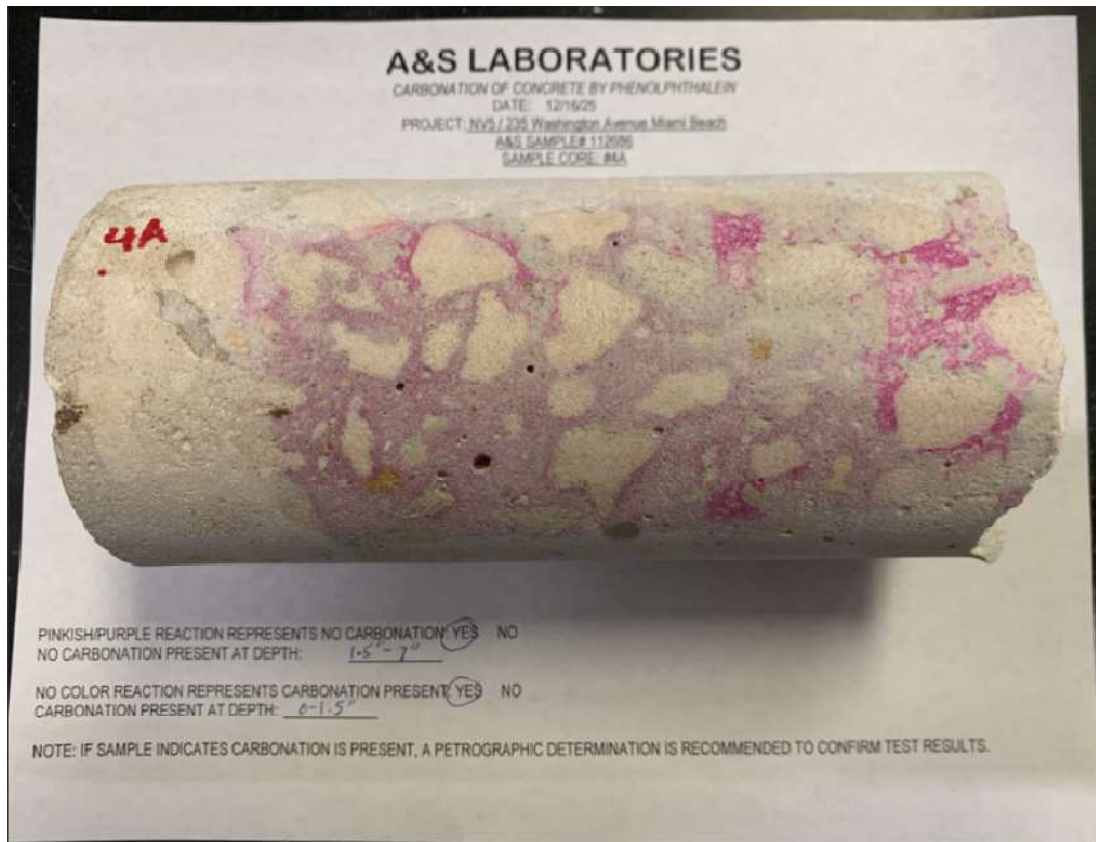
Photograph #6: Concrete Cores #4A Depth of Carbonation Testing

| Core Number | Carbonation Depth [in] |
|---|---|
| 4A-Ground level – Column | 1.50 |

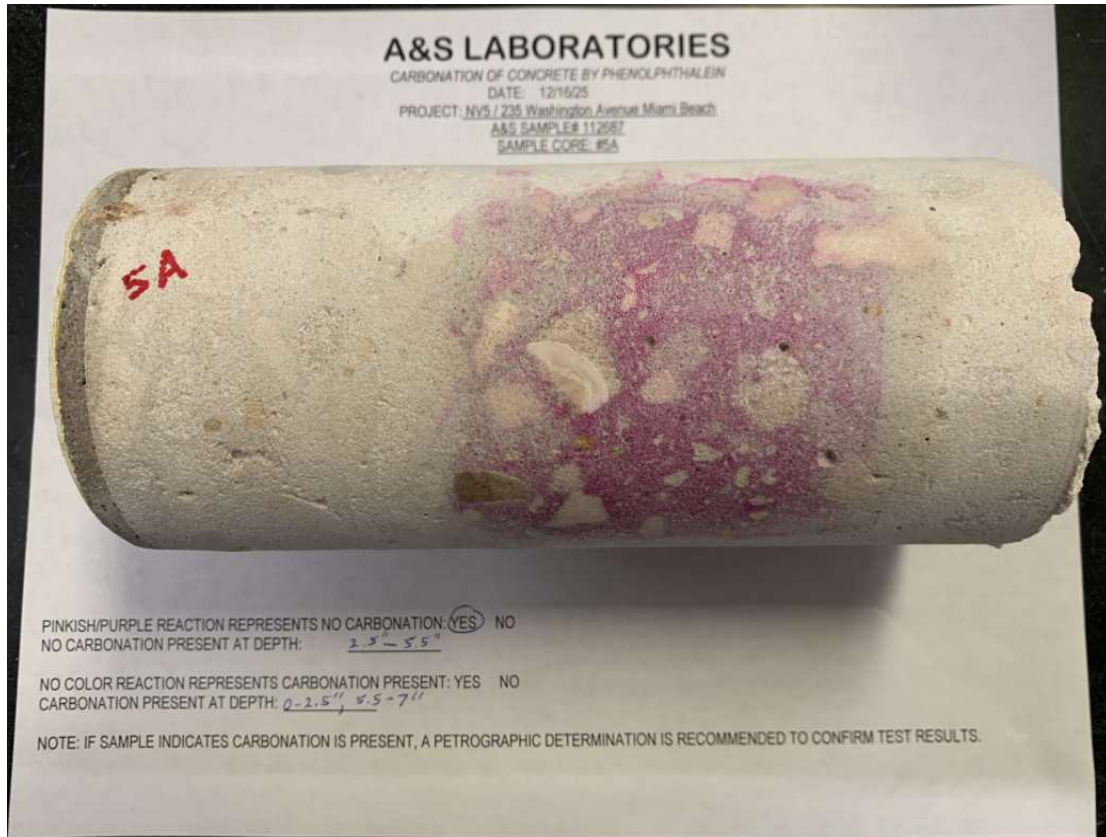
Photograph #7: Concrete Cores #5A Depth of Carbonation Testing

| Core Number | Carbonation Depth [in] |
|---|---|
| 5A-Ground level – Column | 2.50 |

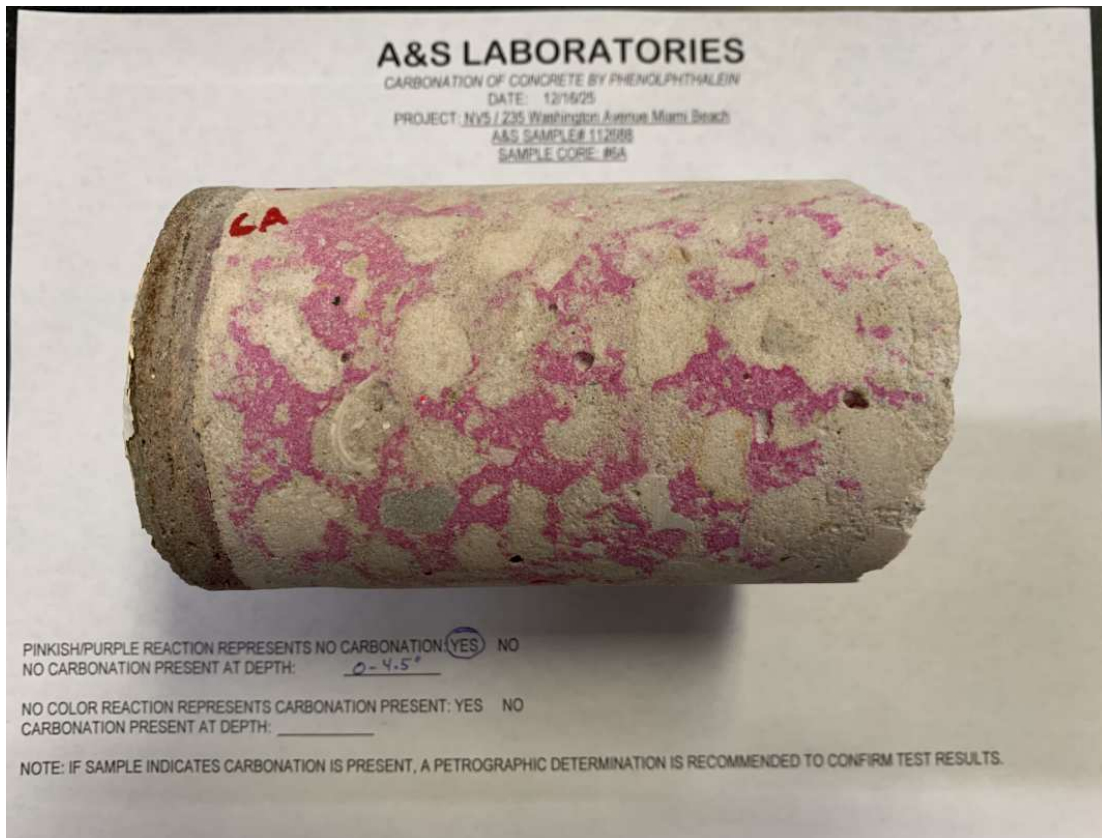
Photograph #8: Concrete Cores #6A Depth of Carbonation Testing

| Core Number | Carbonation Depth [in] |
|---|---|
| 6A-Ground level – Column | 0.00 |
