STRUCTURAL CONDITION ASSESSMENT
235 Washington Ave
Miami Beach, Florida

December 19, 2025

STRUCTURAL CONDITION ASSESSMENT for
235 Washington Ave
Miami Beach, Florida

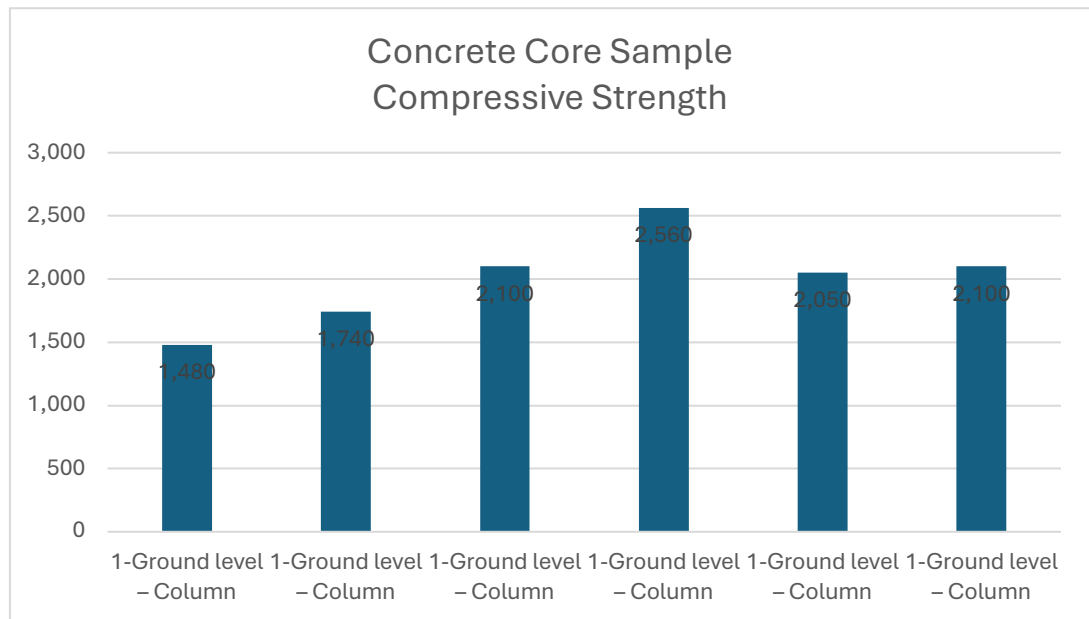
Core	Compressive Strength
Number	[PSI]
1-Ground level – Column	1,480
2-Ground level – Column	1,740
3-Ground level – Column	2,100
4-Ground level – Column	2,560
5-Ground level – Column	2,050
6-Ground level – Column	2,100

The Concrete compressive strength ranged from 1,480 to 2,560 PSI. Per Florida Building Code the concrete strength should be 5,000 PSI.

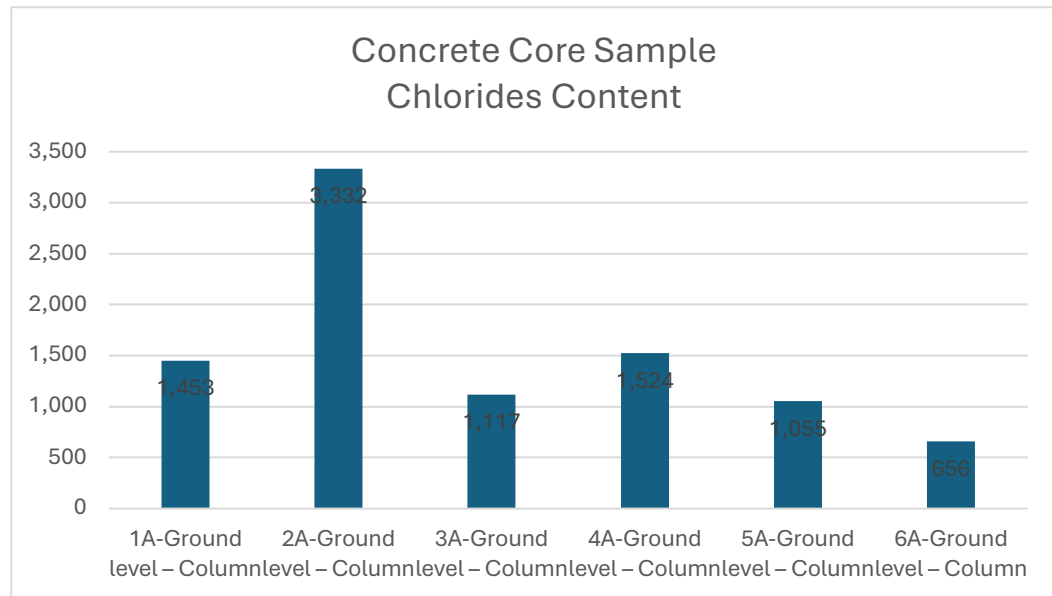
- Chloride Content: Due to the exposure to the salty environment in Miami Beach, the concrete structural frame of the building will get contaminated with chlorides by wind and rain. The chlorides will the ph of the concrete mix and lowers the alkaline protection of the steel reinforcing rebars. This leads to corrosion of the reinforcing rebars, then concrete spalling and cracking due to the increased volume of the corroded rebars.

Core Number	Chlorides Content [ppm]
1A-Ground level – Column	1,453
2A-Ground level – Column	3,332
3A-Ground level – Column	1,117
4A-Ground level – Column	1,524
5A-Ground level – Column	1,055
6A-Ground level – Column	656

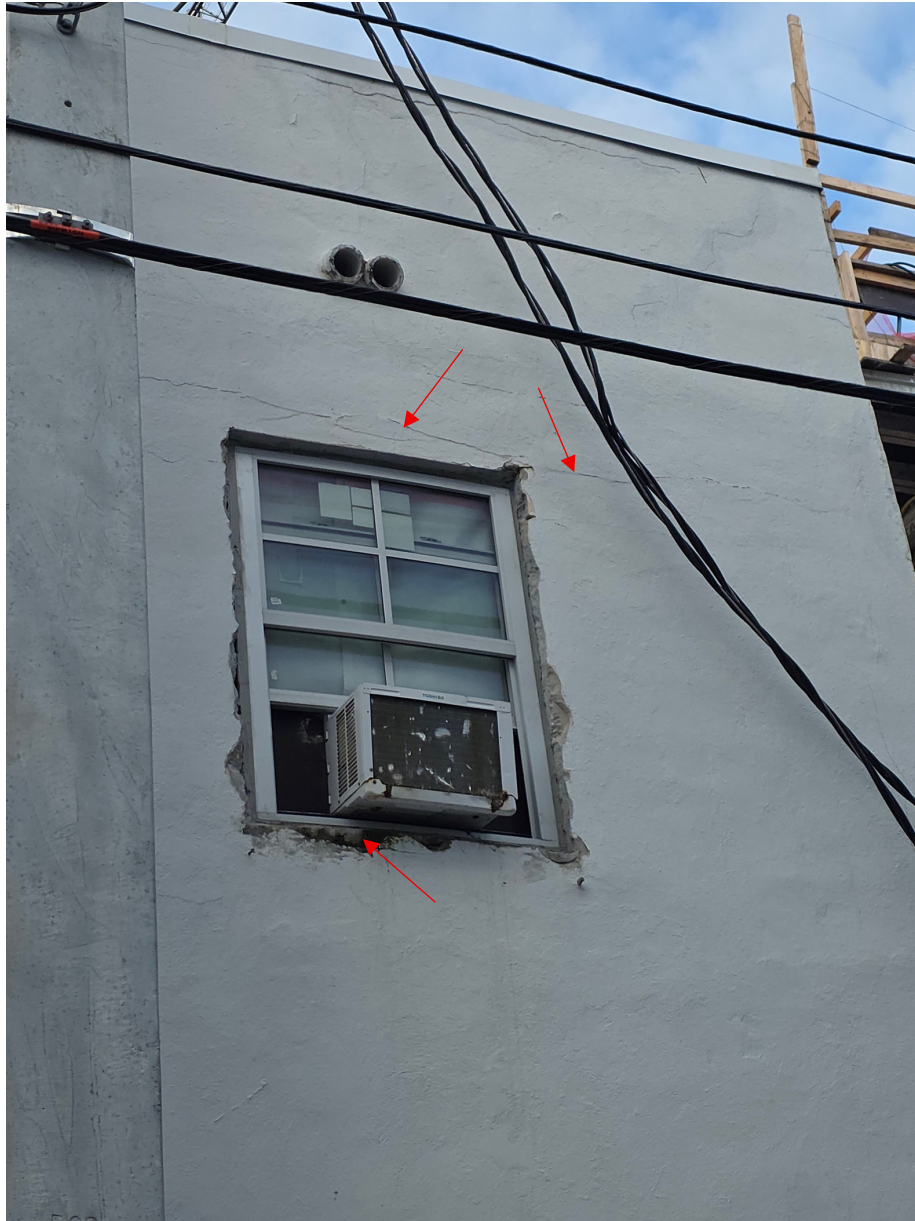
Spall and delaminated stucco and concrete present

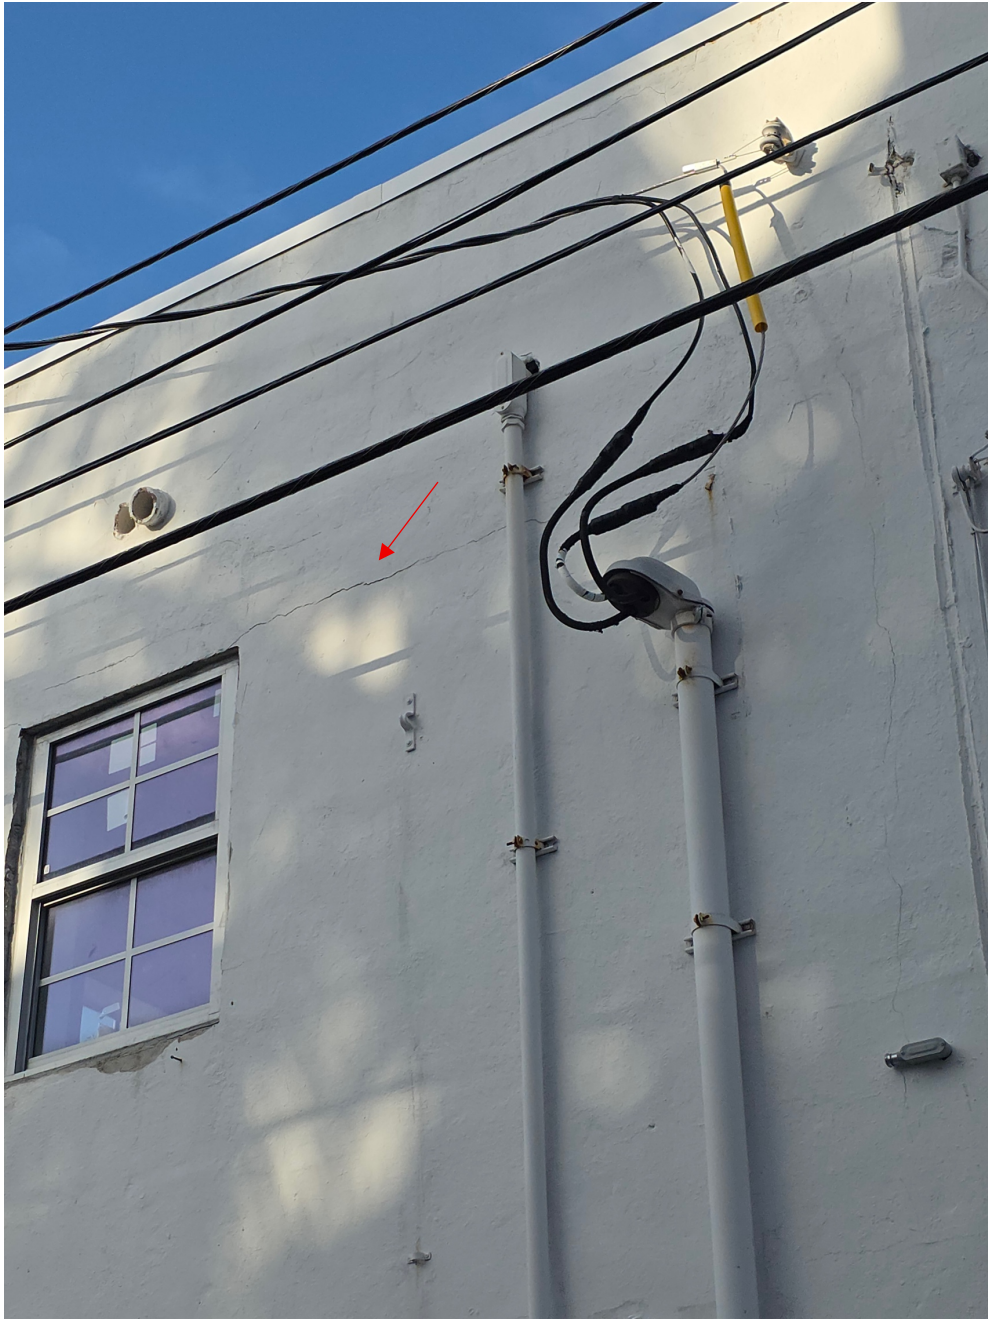
Spall and delaminated stucco and concrete present

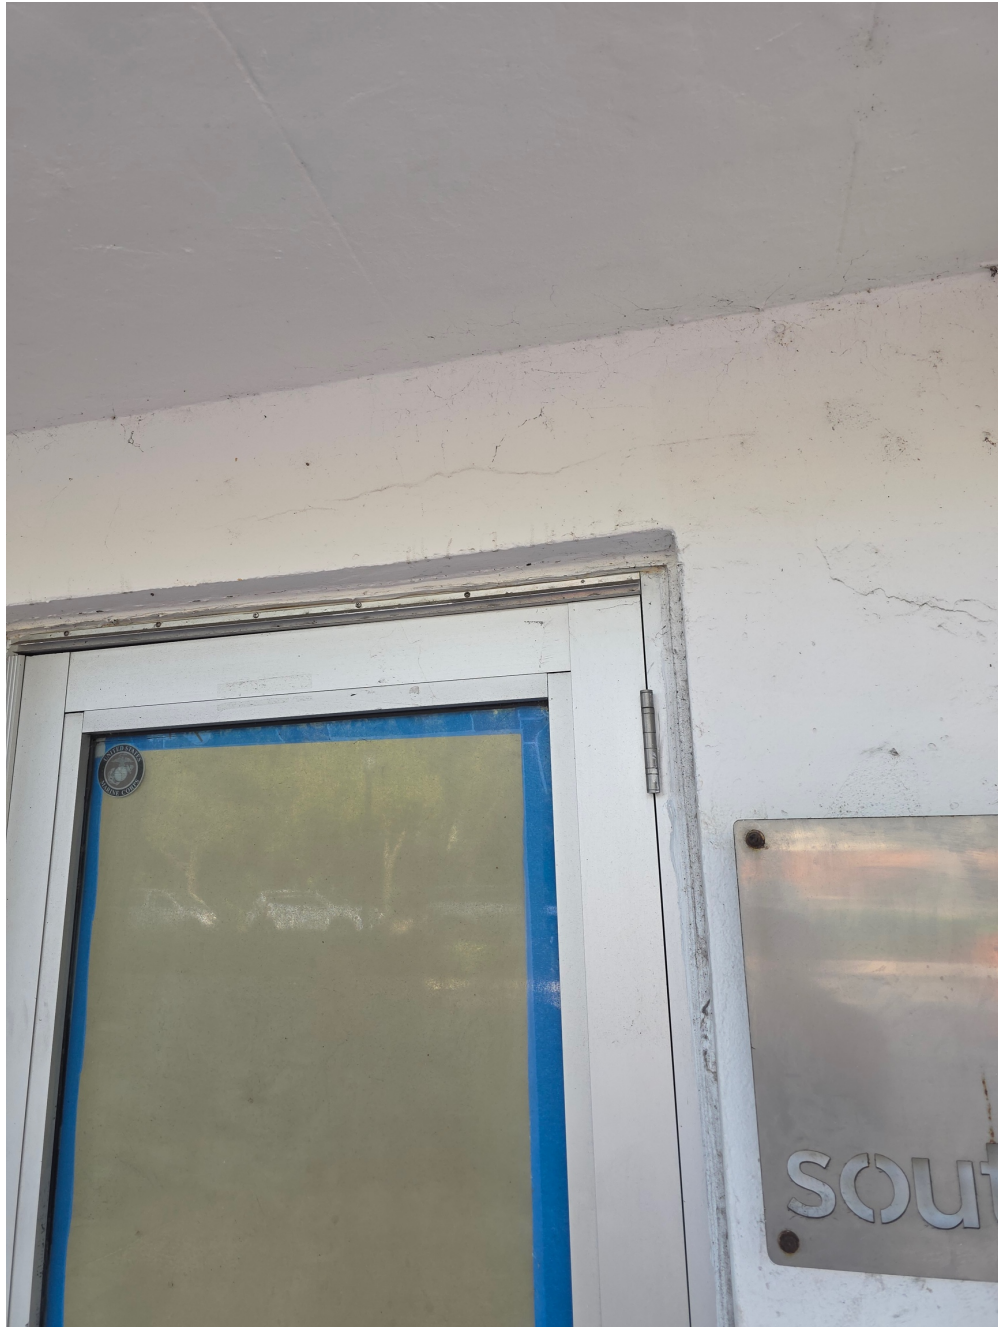
Spall and delaminated stucco and concrete present

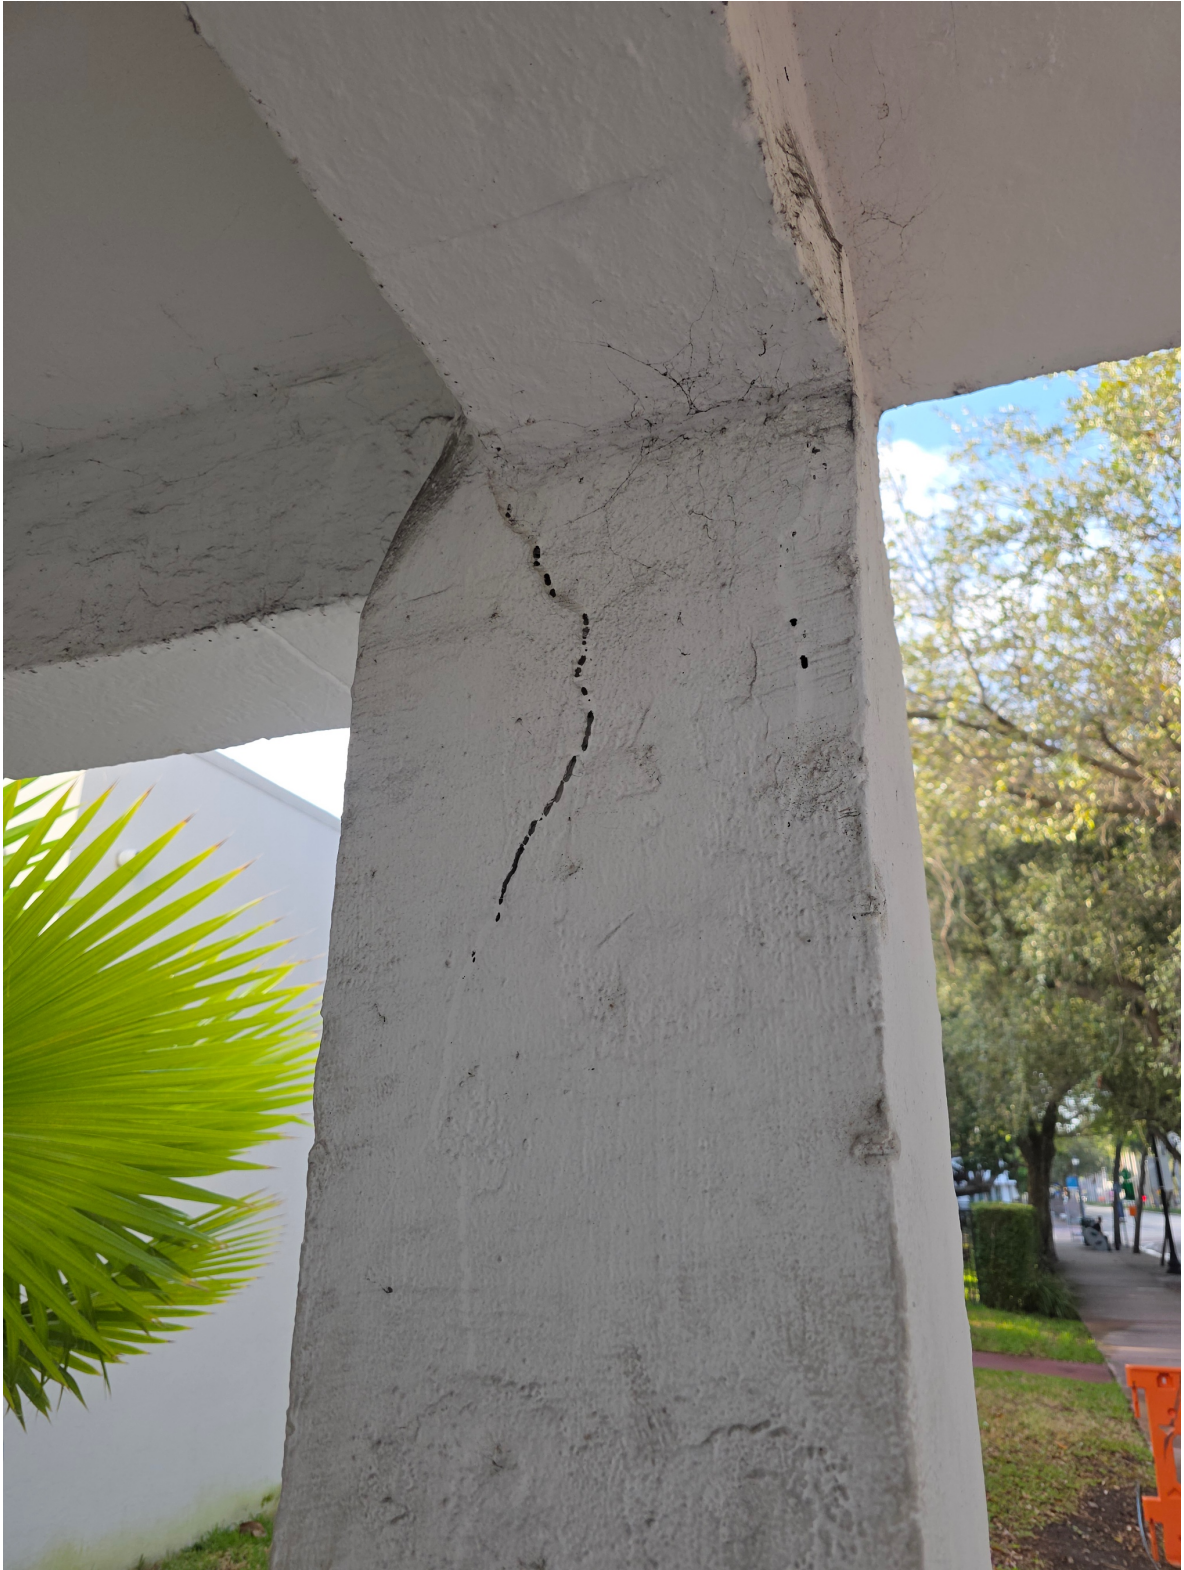
Spall and delaminated stucco and concrete present

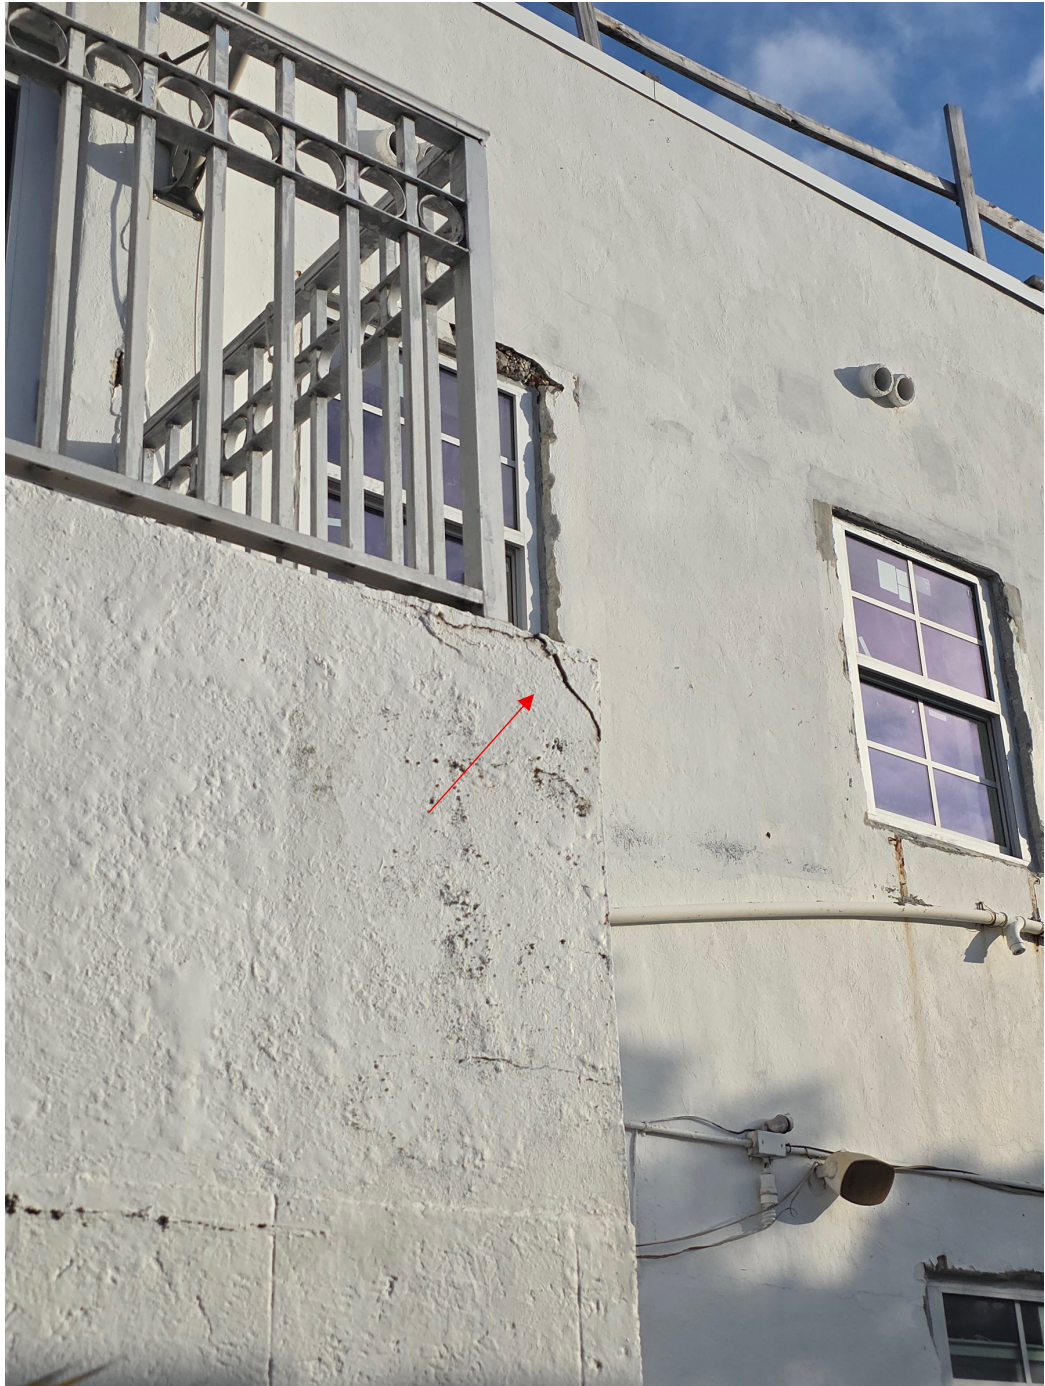
Spall and delaminated stucco and concrete present

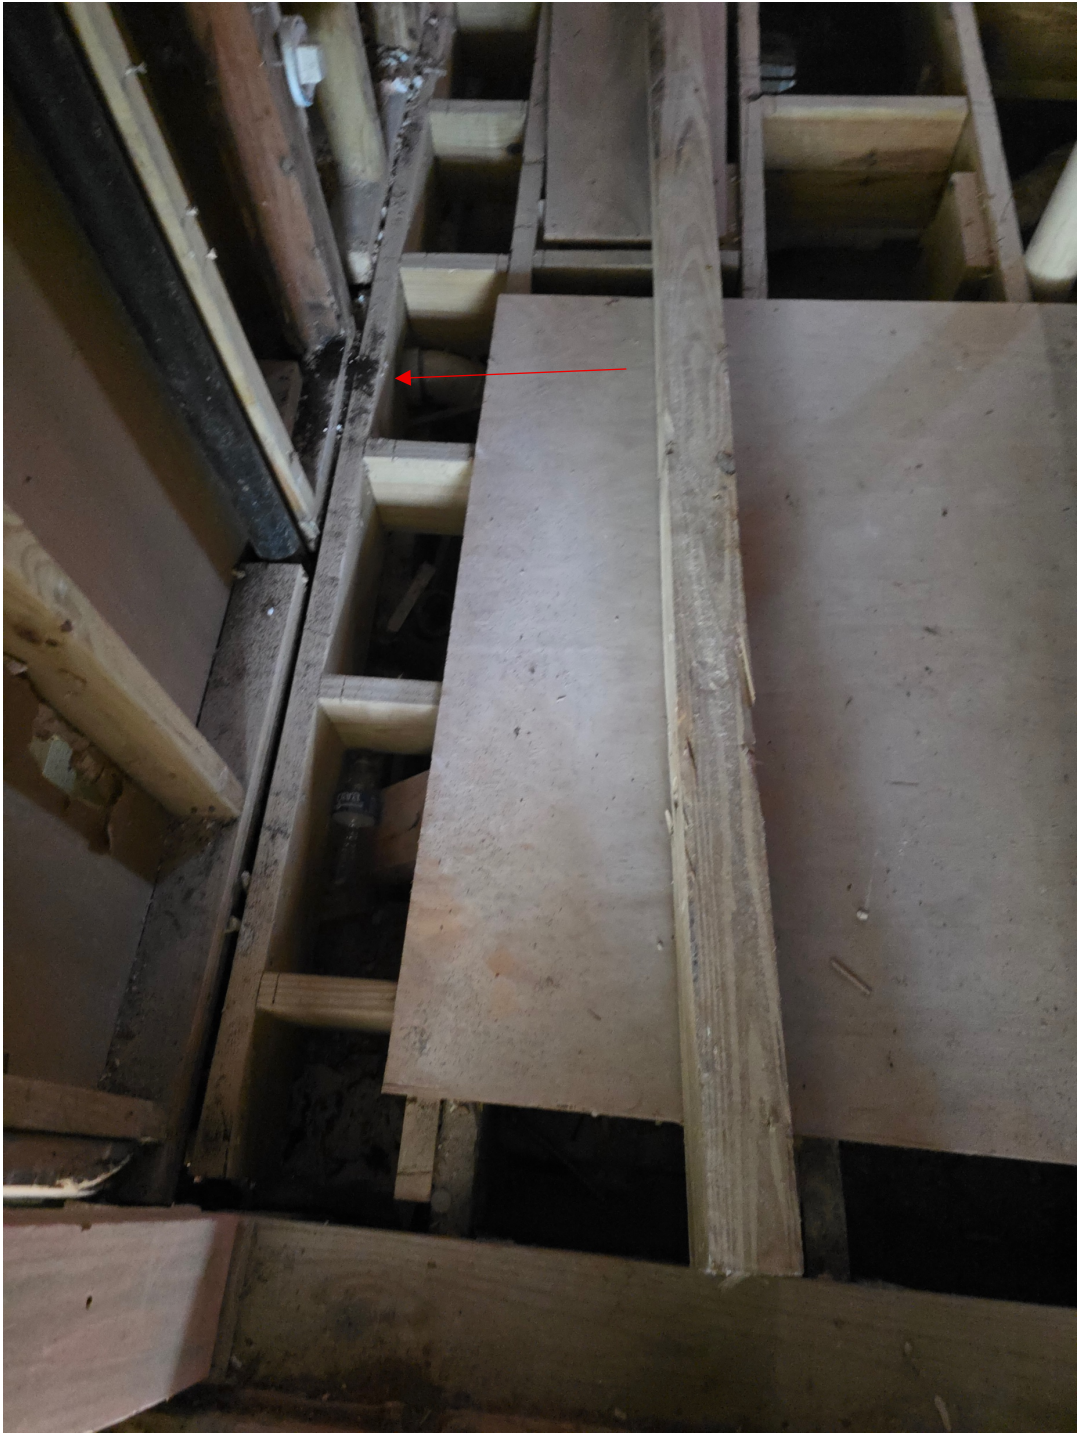
Termite dropping and stud damage
