STRUCTURAL CONDITION ASSESSMENT  
235 Washington Ave  
Miami Beach, Florida

December 19, 2025

STRUCTURAL CONDITION ASSESSMENT for  
235 Washington Ave  
Miami Beach, Florida

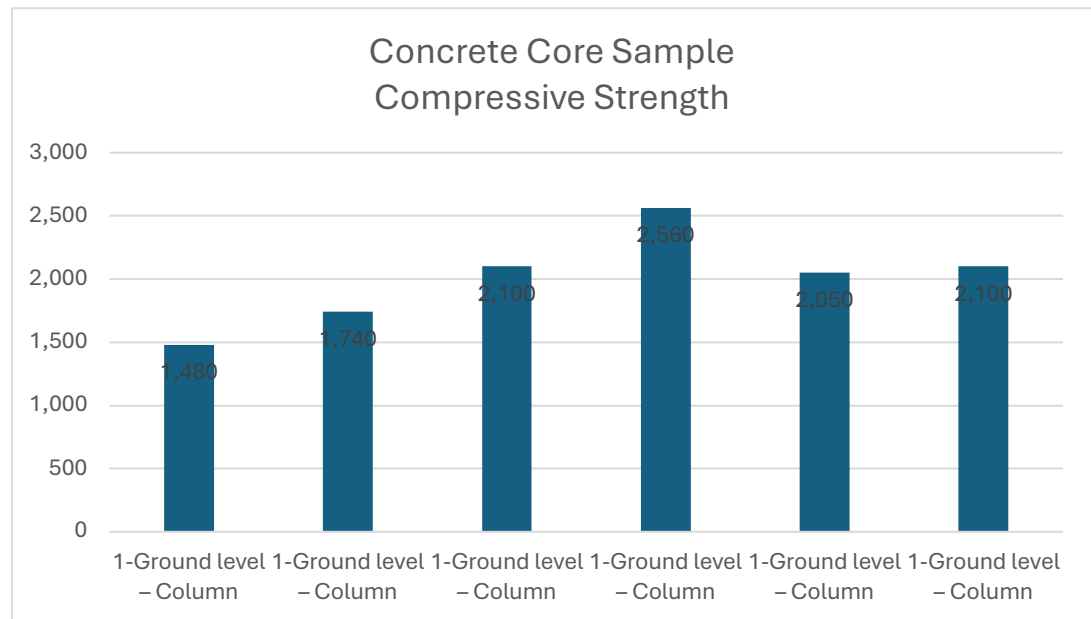
The Concrete compressive strength ranged from 1,480 to 2,560 PSI. Per Florida Building Code the concrete strength should be 5,000 PSI.

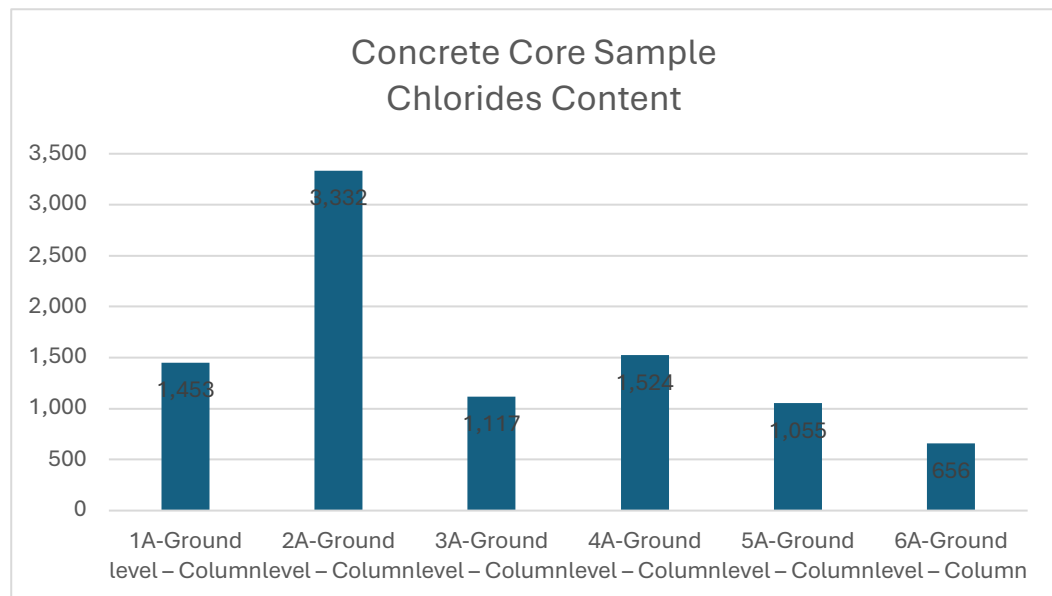
- Chloride Content: Due to the exposure to the salty environment in Miami Beach, the concrete structural frame of the building will get contaminated with chlorides by wind and rain. The chlorides will the ph of the concrete mix and lowers the alkaline protection of the steel reinforcing rebars. This leads to corrosion of the reinforcing rebars, then concrete spalling and cracking due to the increased volume of the corroded rebars.

Per American Concrete Institute (ACI 222R), and American Standards for Testing and Materials (ASTM 1152), the acid soluble chloride ion content threshold value typically used in the U.S. is 1.0 to 1.5 pounds of chloride ion per cubic yard of concrete, which translates to a threshold value of 263 ppm to 395 ppm, this is based on weight of concrete of 140 pounds per cubic foot.

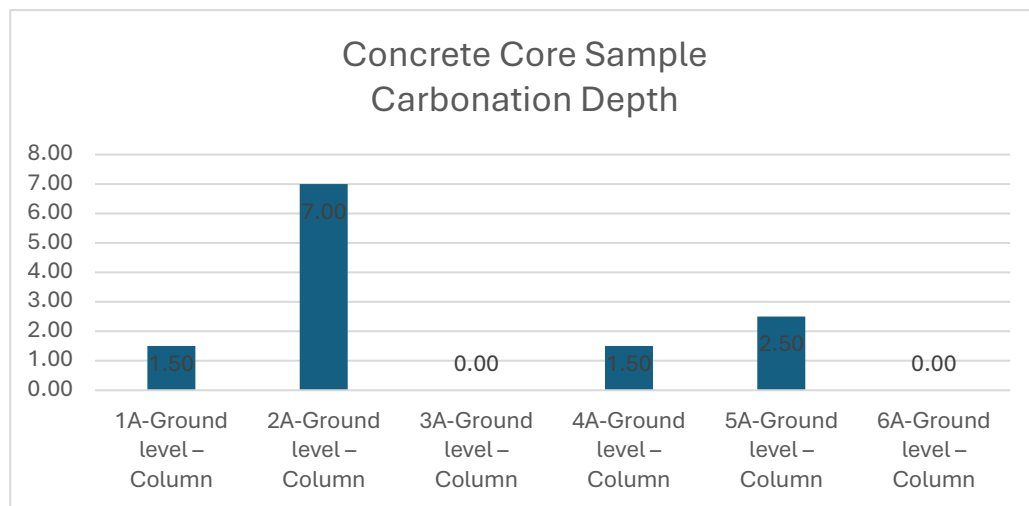
The carbonation found in the samples ranged between 0" – 7"

The carbonation is extensive and exposes the reinforcing rebars to corrosion

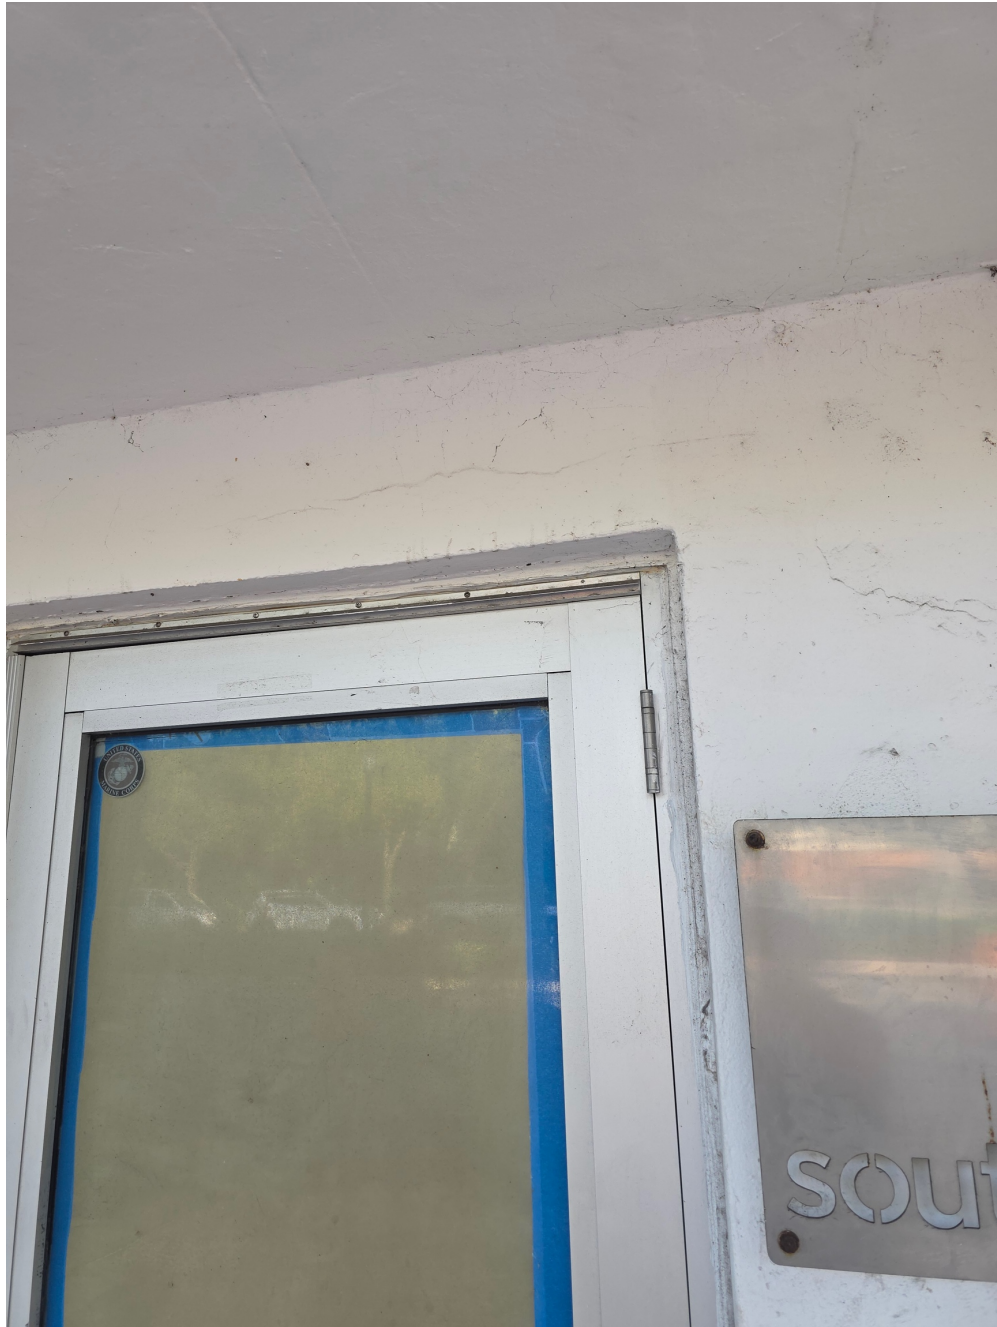
Spall and delaminated stucco and concrete present

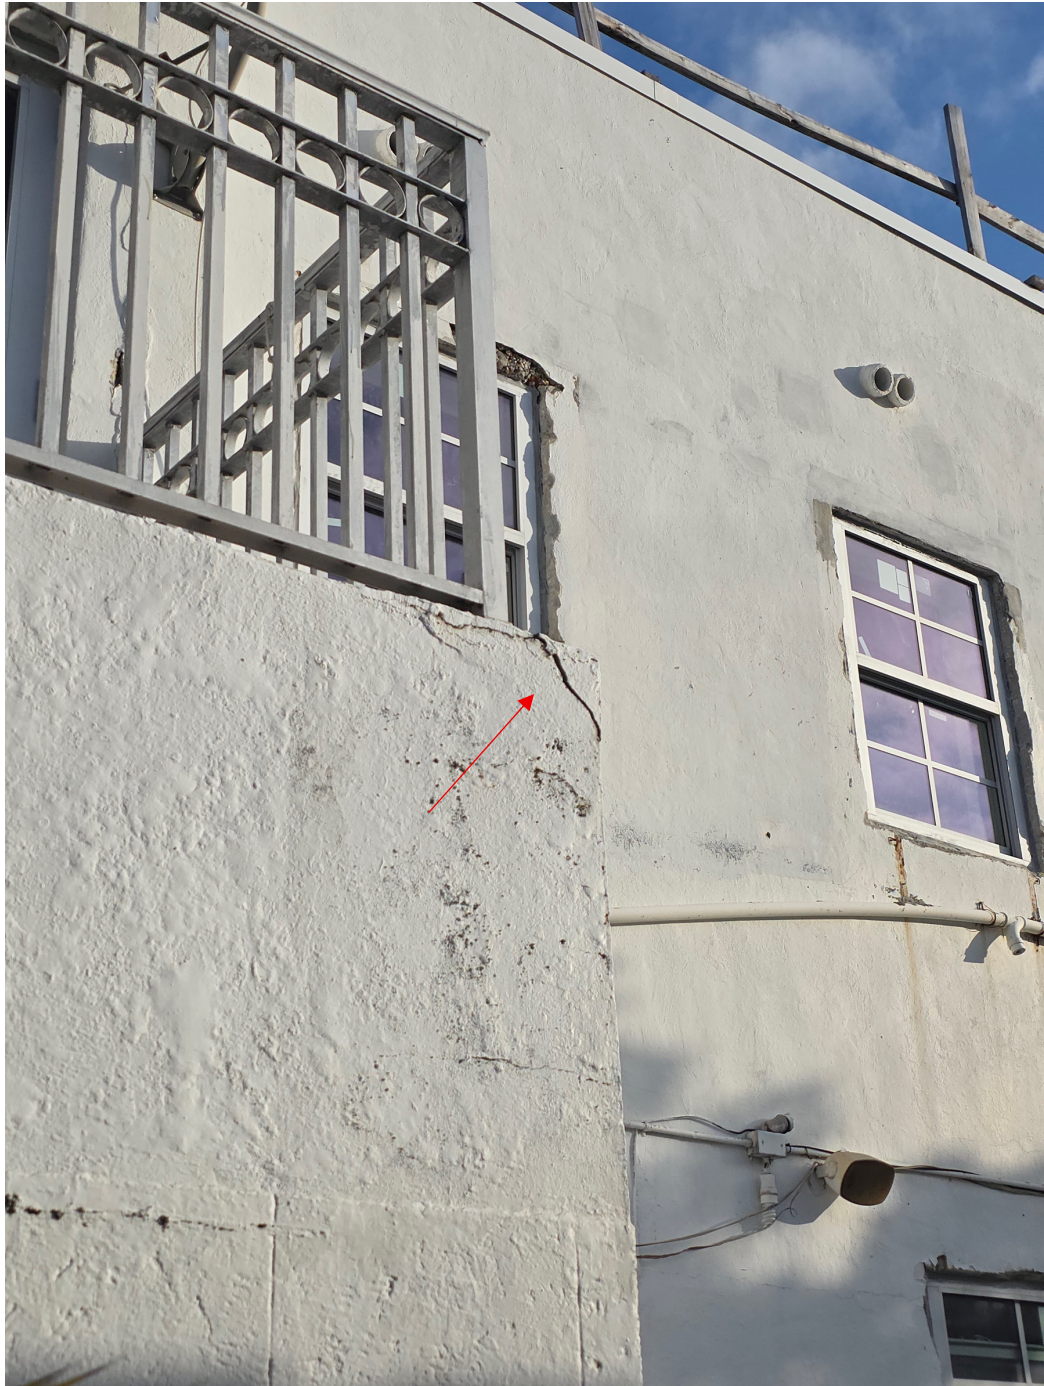
Spall and delaminated stucco and concrete present
