# 235 Washington Avenue

HPB25-0645

Historic Preservation Board

March 17, 2026

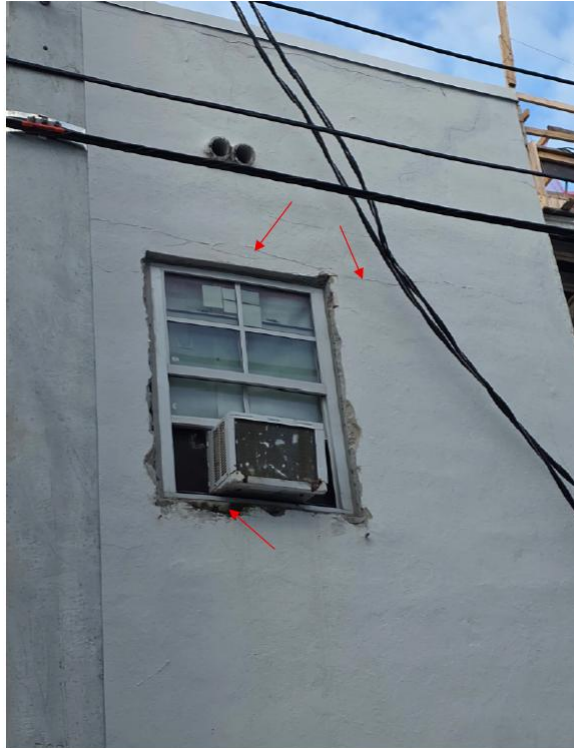
Spall and delaminated stucco and concrete present

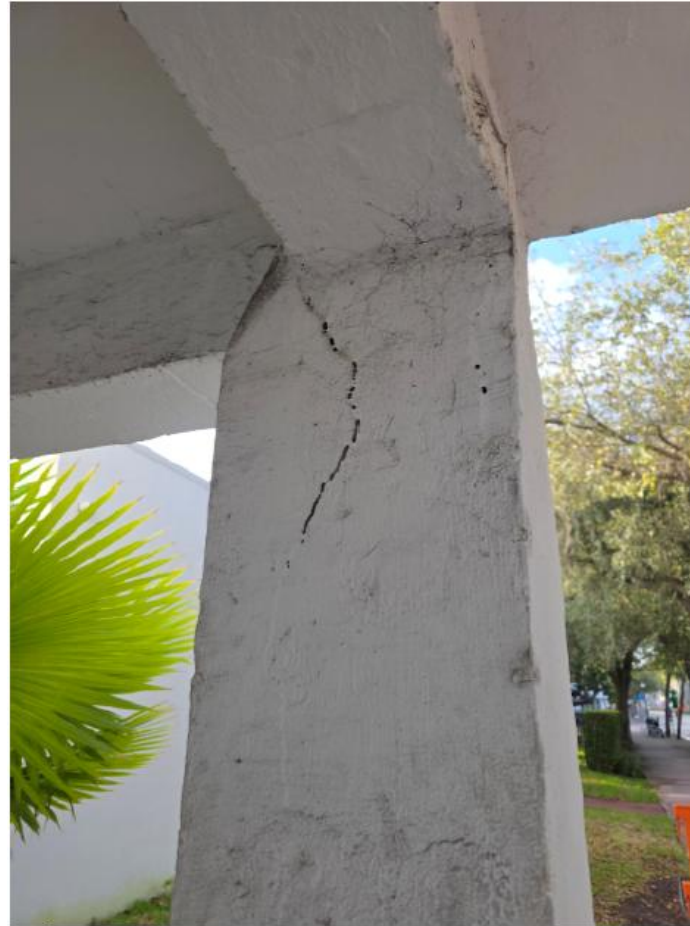
Spall and delaminated stucco and concrete present

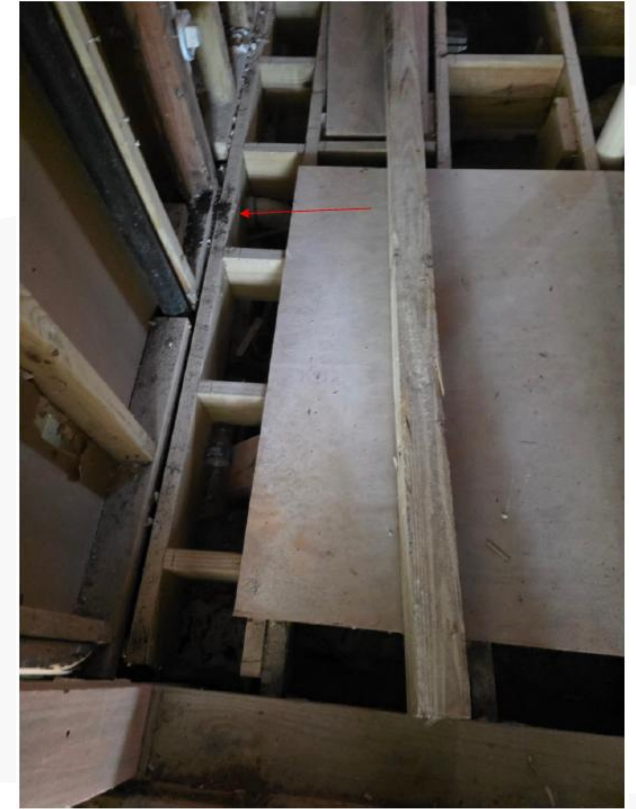
Termite dropping and stud damage

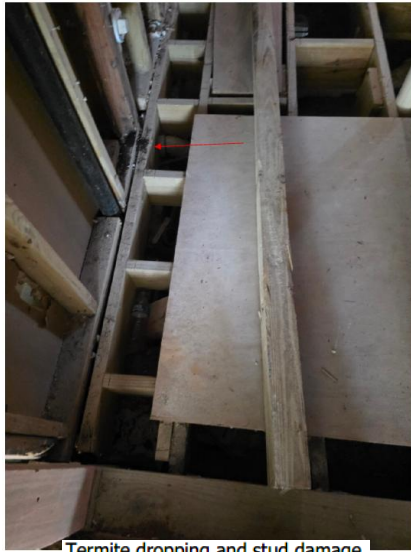
1. Roof structure failures leading to water intrusion and wood members sagging, rotting, failing, and total collapse in multiple areas
2. Concrete columns and beams exhibit spalling affecting approximately 40% of their surface area, with cracking evident throughout the building
3. Evidence of prior repair areas re-cracking
4. Presence of mold and water intrusion on interior walls and ceilings exhibit varying levels of failure

Termite dropping and stud damage

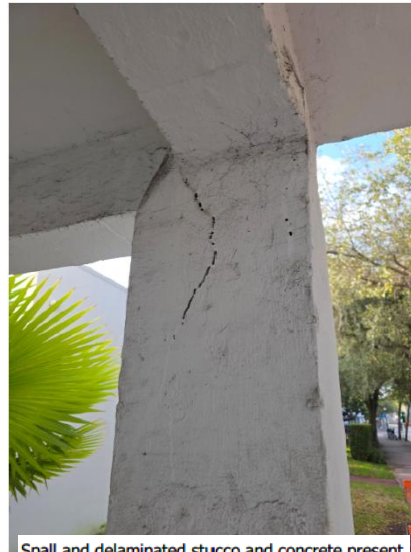
Spall and delaminated stucco and concrete present

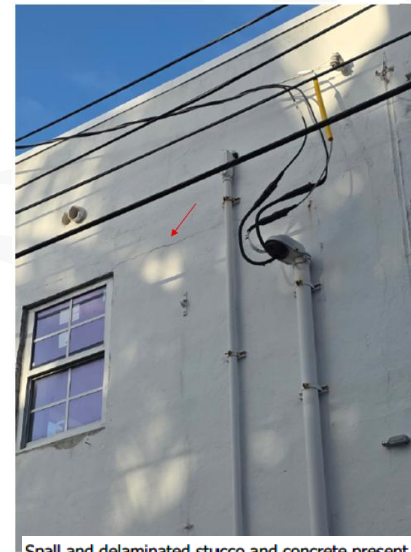
Spall and delaminated stucco and concrete present

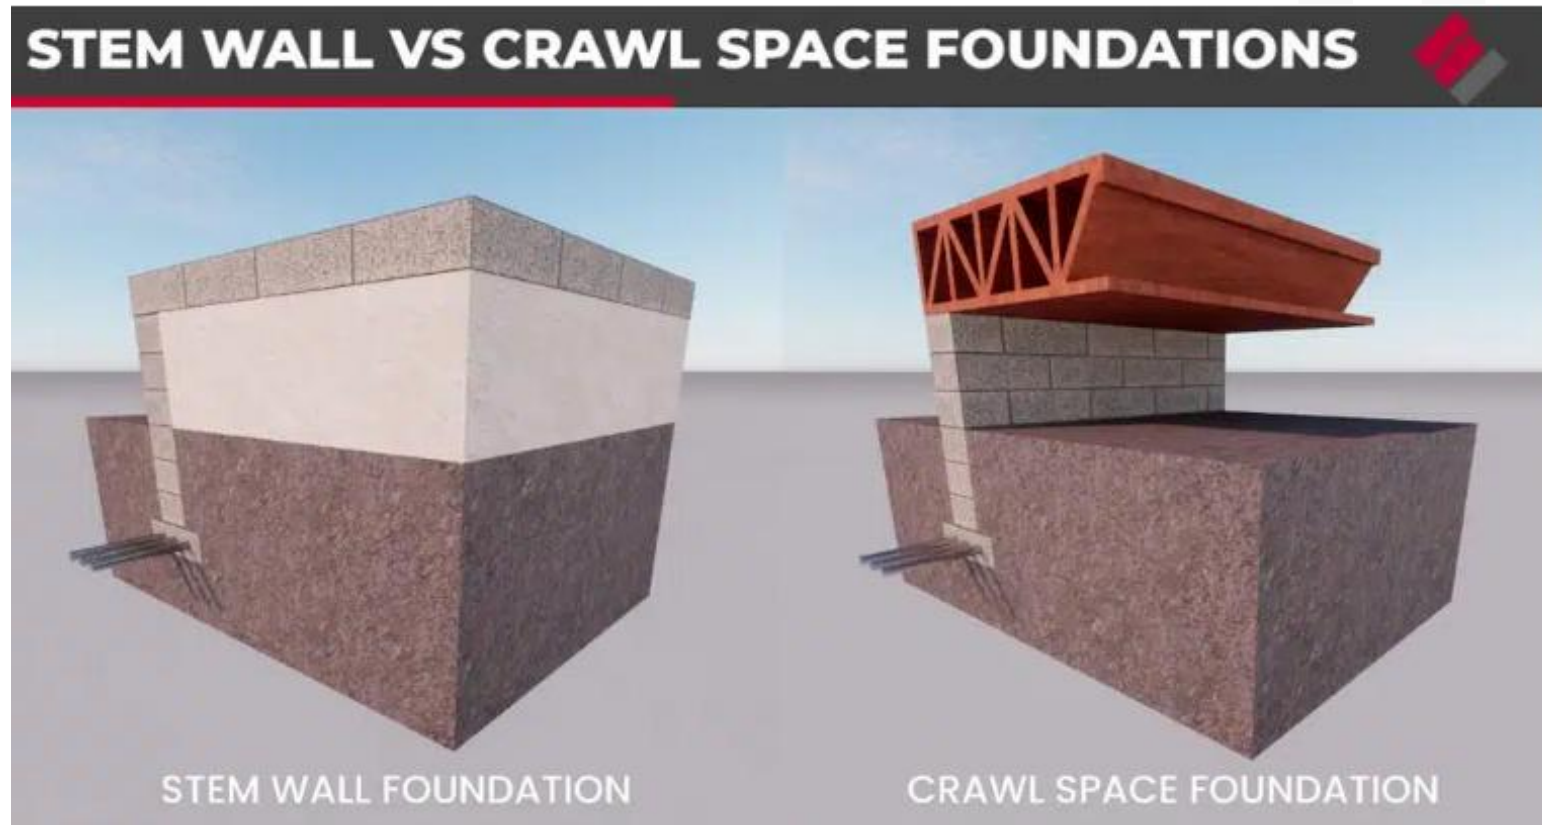
- Slab on grade
- Shallow foundation supporting concrete stem walls
- Foundation has to be strengthened to resist lateral loads

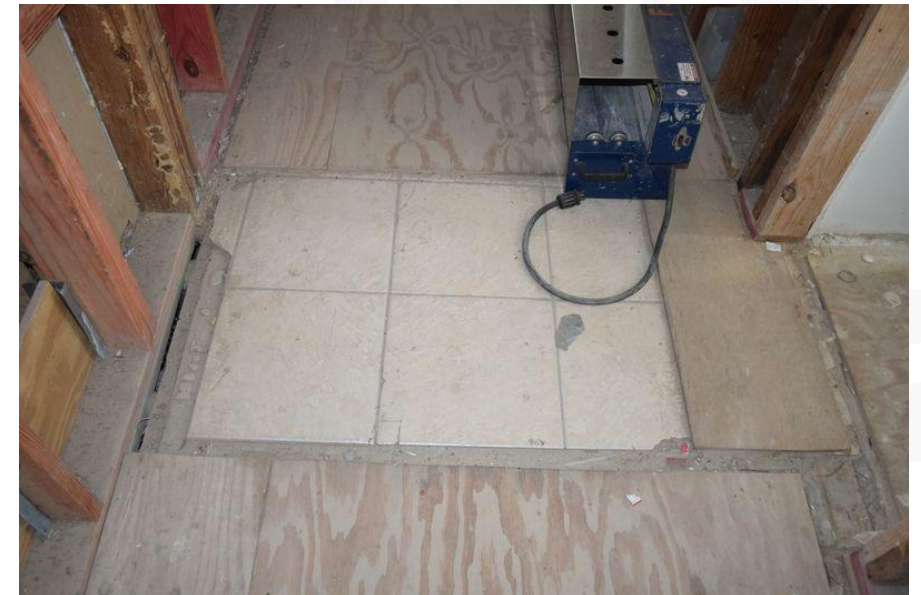
- All wood joists are “fire cut” into the wood wall, not connected to walls via strapping or any other mechanism

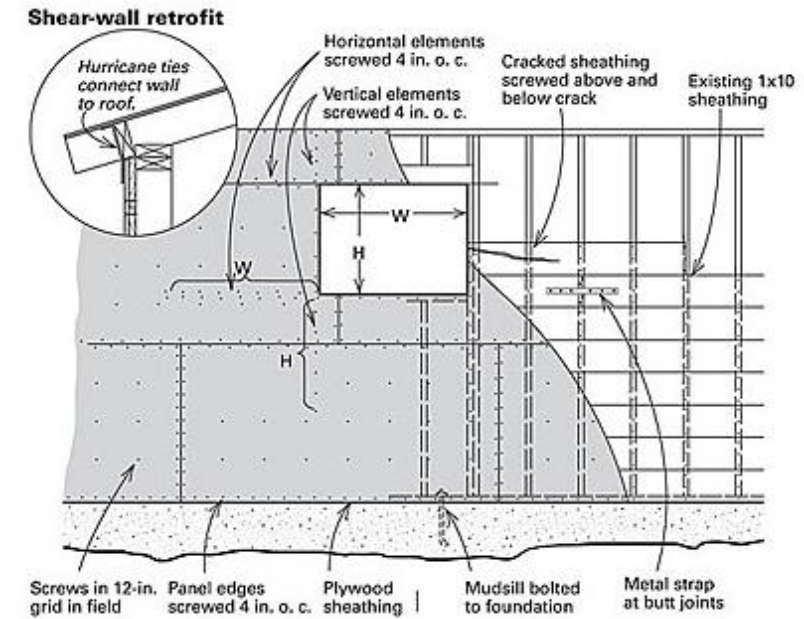
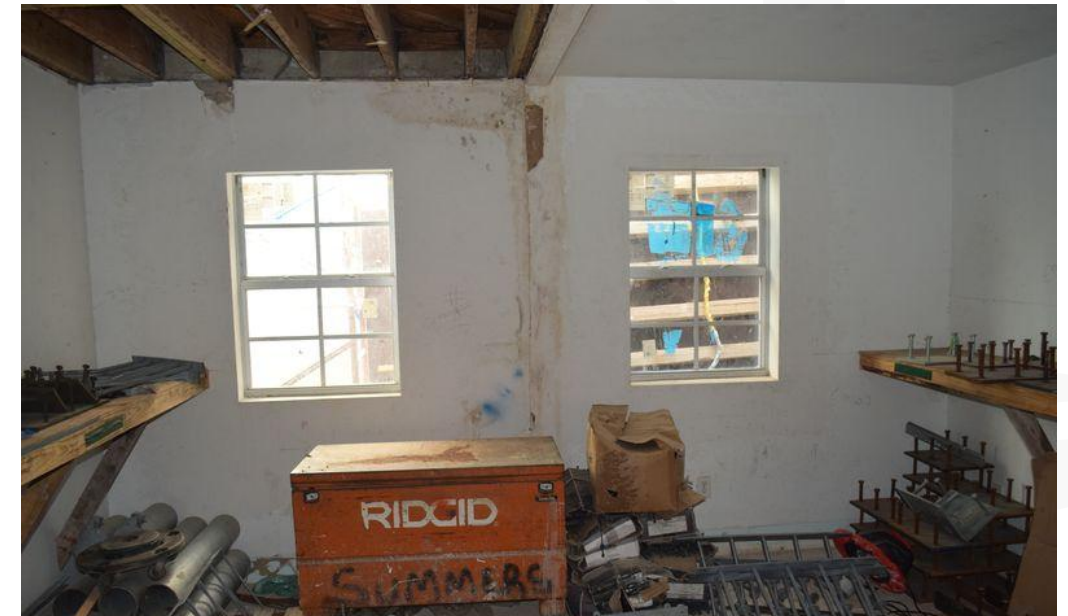
- Opening protection and wood reinforcing is non-existent
- Requires shearwalls to be installed in order for the building to be Florida Building Code compliant

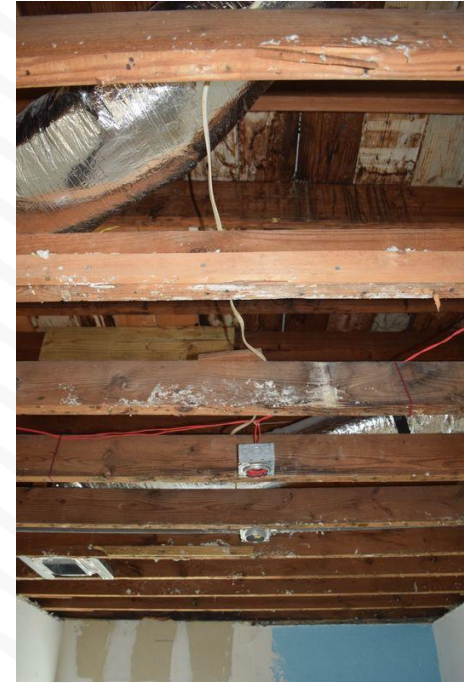
- Roof waterproofing has failed in multiple locations
- Connections for wind uplift forces and wind lateral resistance are non-existent
- Requires roof connection tie-downs be installed to strengthen the roof for Florida Building Code compliance

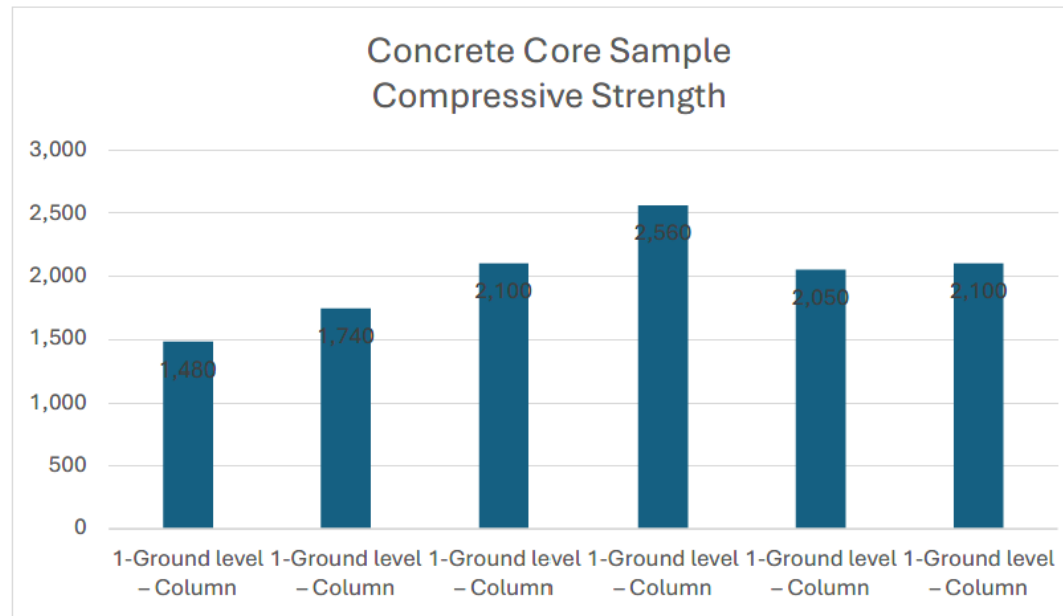
- Ability to withstand pressure before breaks or fails
- Low compressive strength concrete is more prone to cracking and spalling
- Can lead to structural failure and compromised stability

The Concrete compressive strength ranged from 1,480 to 2,560 PSI. Per Florida Building Code the concrete strength should be 5,000 PSI.

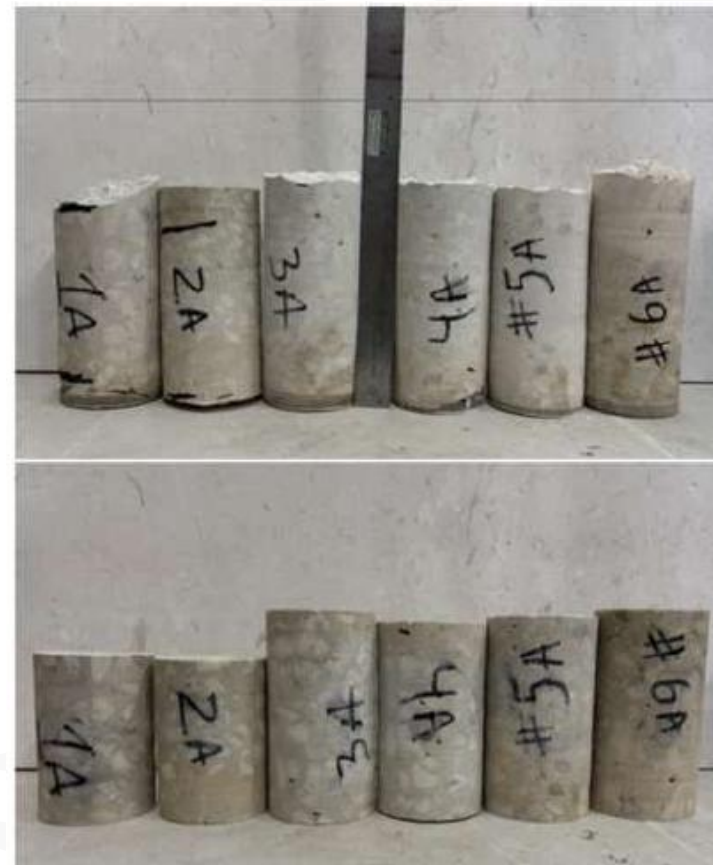
- Extracted core samples confirm a low-density, deteriorated concrete matrix, consistent with **compressive strengths well below** the Florida Building Code–required 5,000 PSI.

The Concrete compressive strength ranged from 1,480 to 2,560 PSI. Per Florida Building Code the concrete strength should be 5,000 PSI.

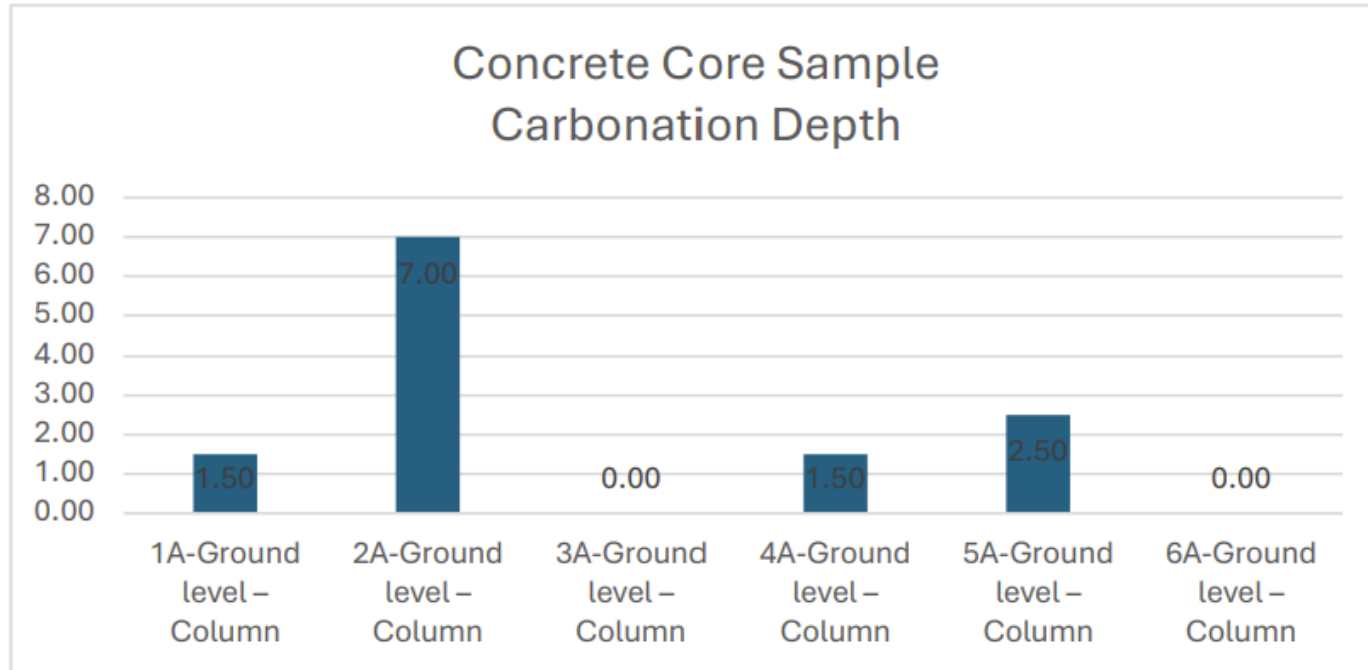
- Depth of carbonation is measured from the surface of the concrete
- Carbonation exposes the rebars to corrosion
- Carbonation is extensive and is as high as 7.00"

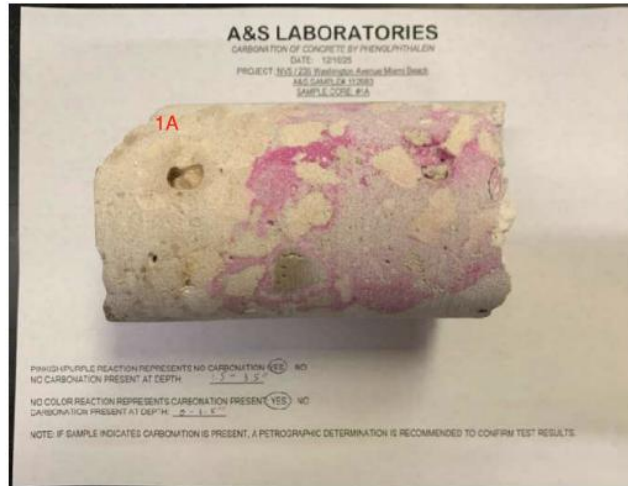
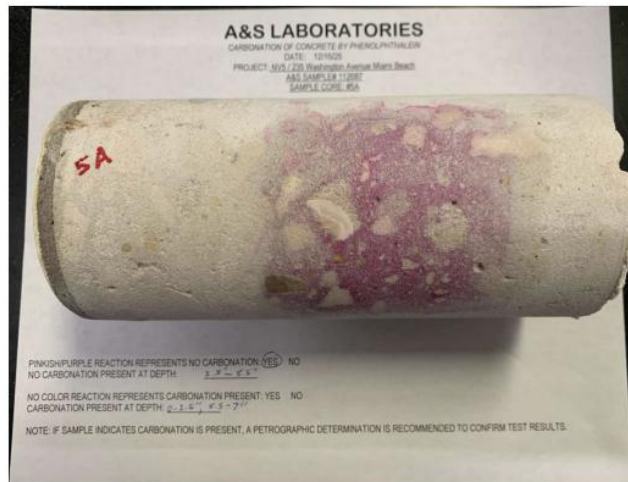
- One-third of samples show carbonation extending beyond the typical depth of reinforcing steel in concrete (>2 inches)
- Another one-third of samples are at or approaching the depth where reinforcing steel is located ( $\approx 1.5$  inches)
- This indicates that much of the structure has lost or is losing protection against steel corrosion, as **carbonation has reached or passed the reinforcing steel**

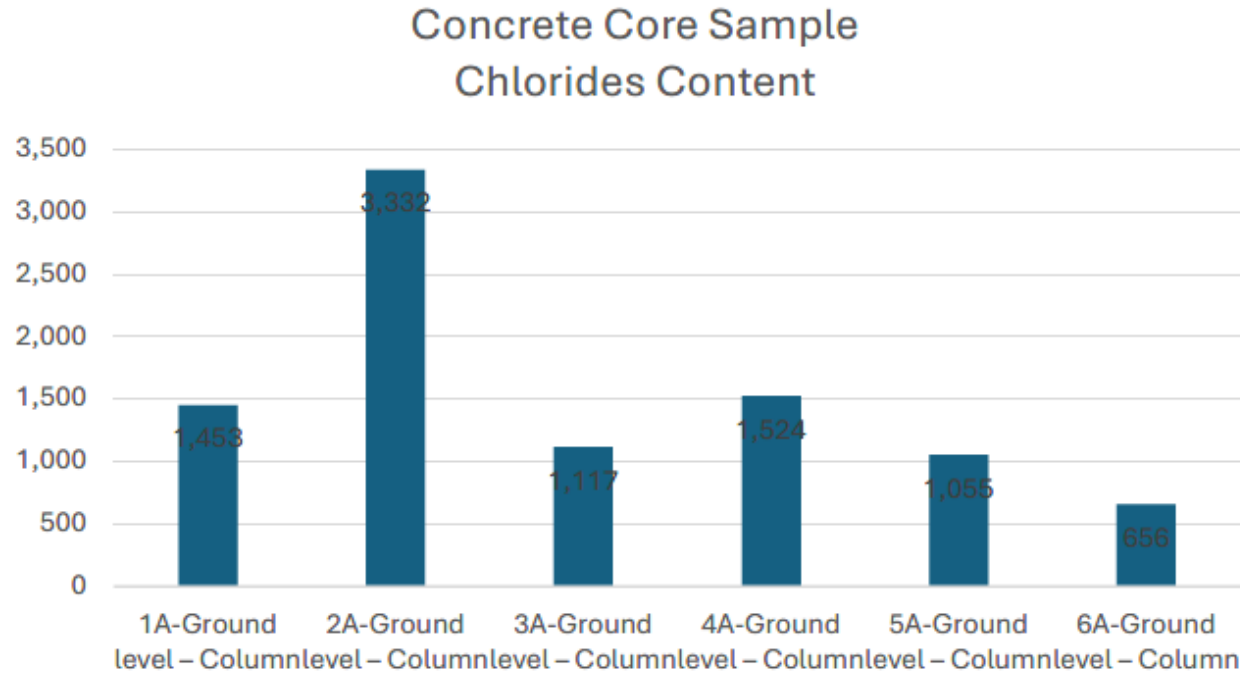
- Chloride exposure reduces alkaline protection of reinforcing steel
- Chloride-ion concentrations ranged from 656 to 3,332 ppm
- Values **exceed** the typical U.S. threshold range of approximately 263–395 ppm (American Concrete Institute)
