STRUCTURAL CONDITION ASSESSMENT  
235 Washington Ave  
Miami Beach, Florida

December 19, 2025

STRUCTURAL CONDITION ASSESSMENT for  
235 Washington Ave  
Miami Beach, Florida

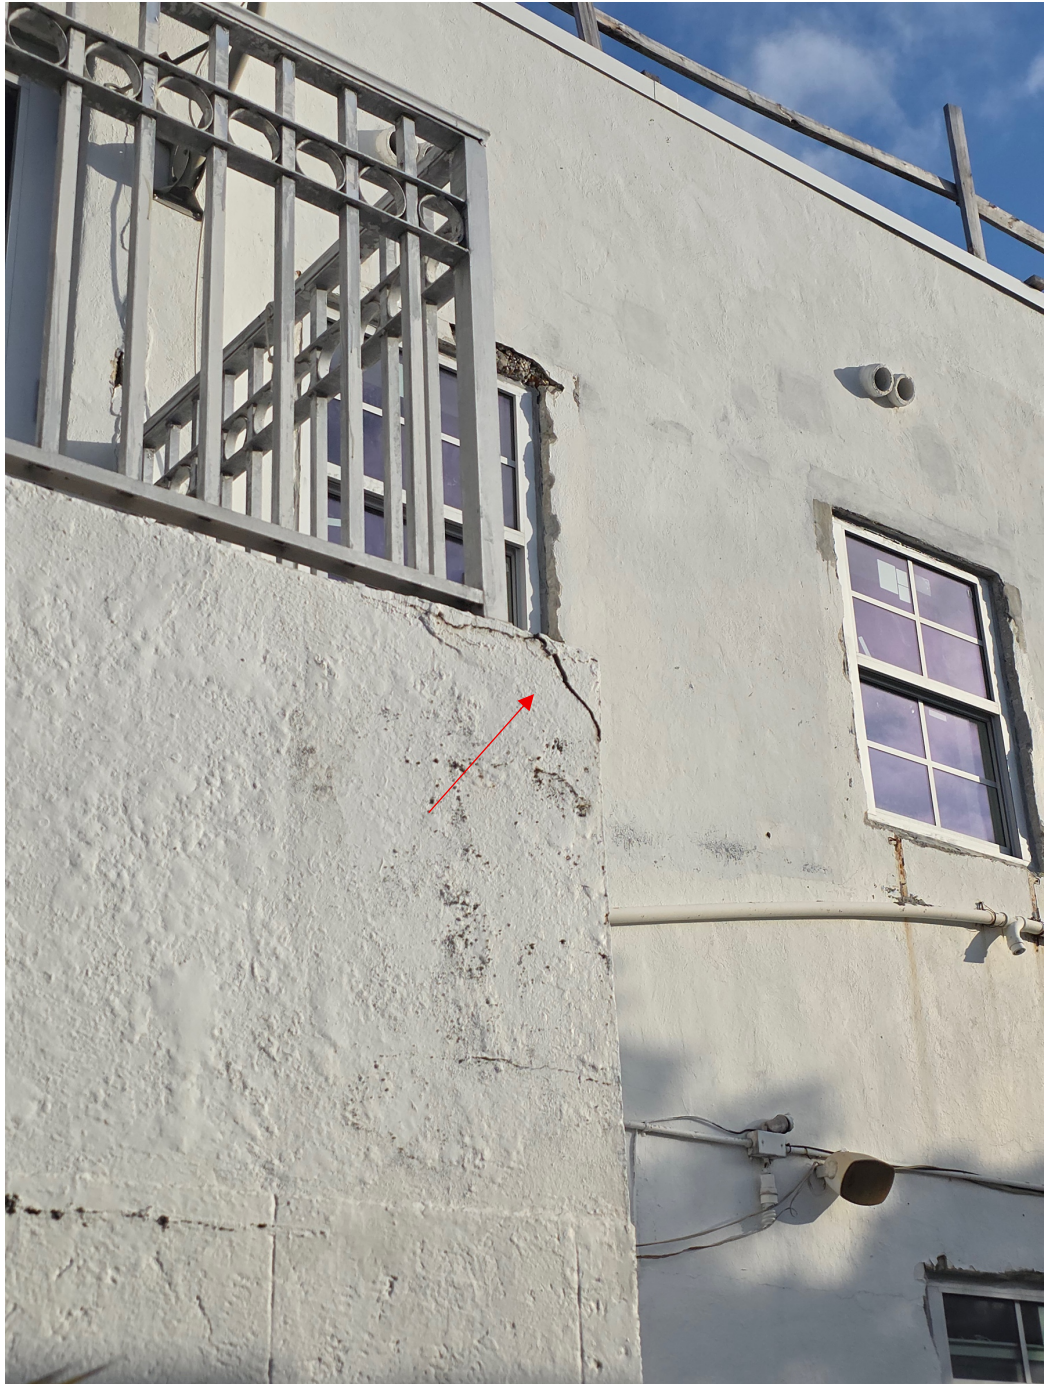
Spall and delaminated stucco and concrete present

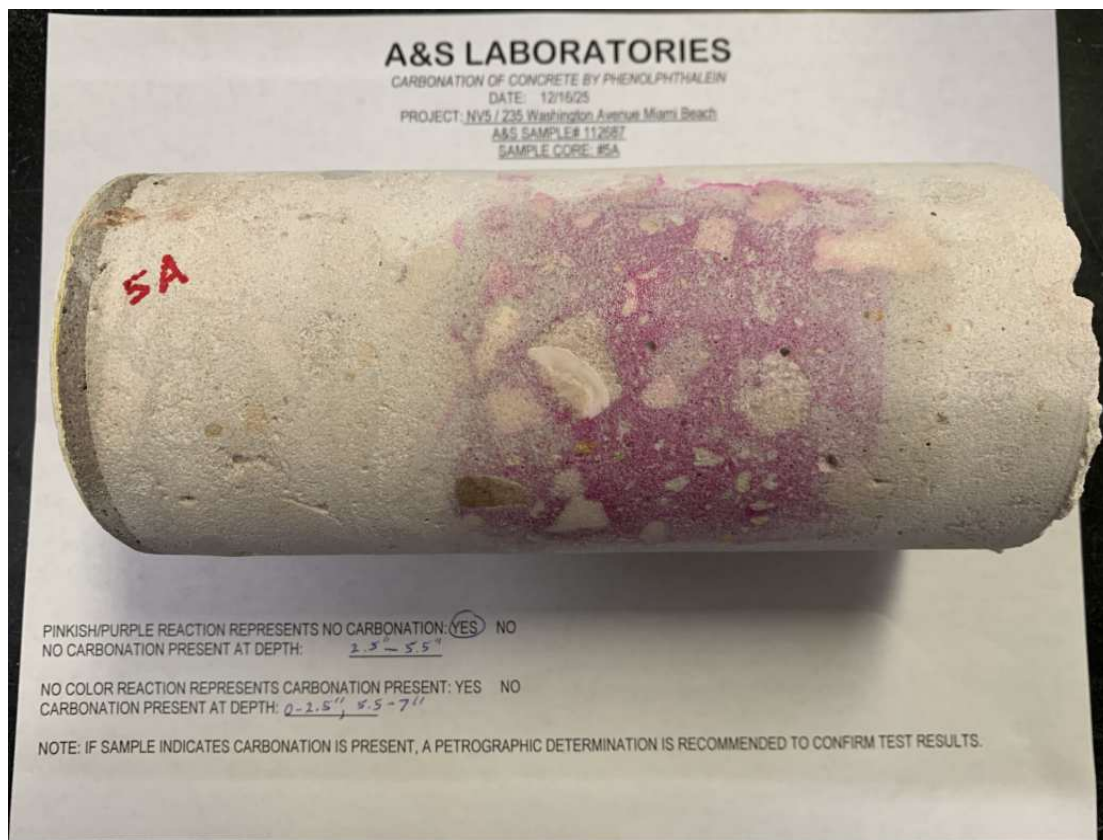
Photograph #7: Concrete Cores #5A Depth of Carbonation Testing

| Core Number | Carbonation Depth [in] |
|---|---|
| 5A-Ground level – Column | 2.50 |
