# 235 Washington Avenue

HPB25-0645

Historic Preservation Board

March 17, 2026

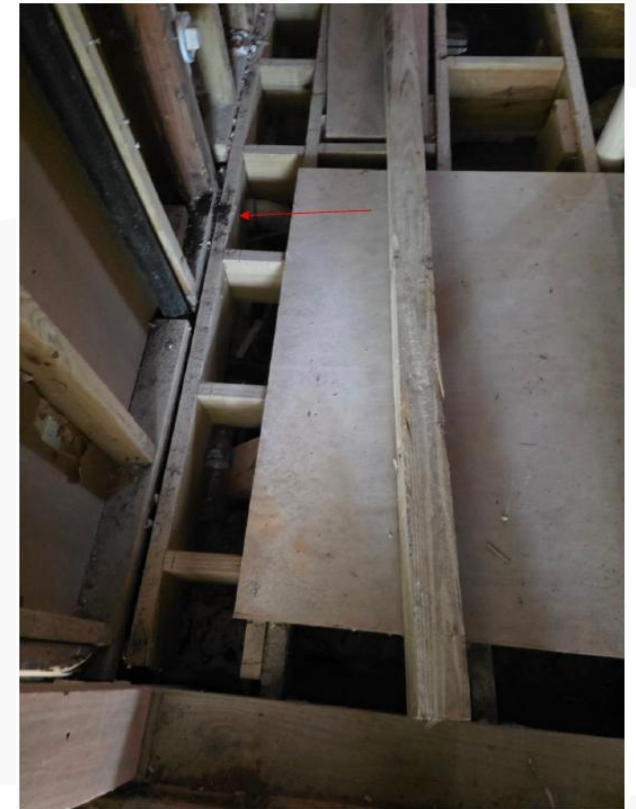
Termite dropping and stud damage

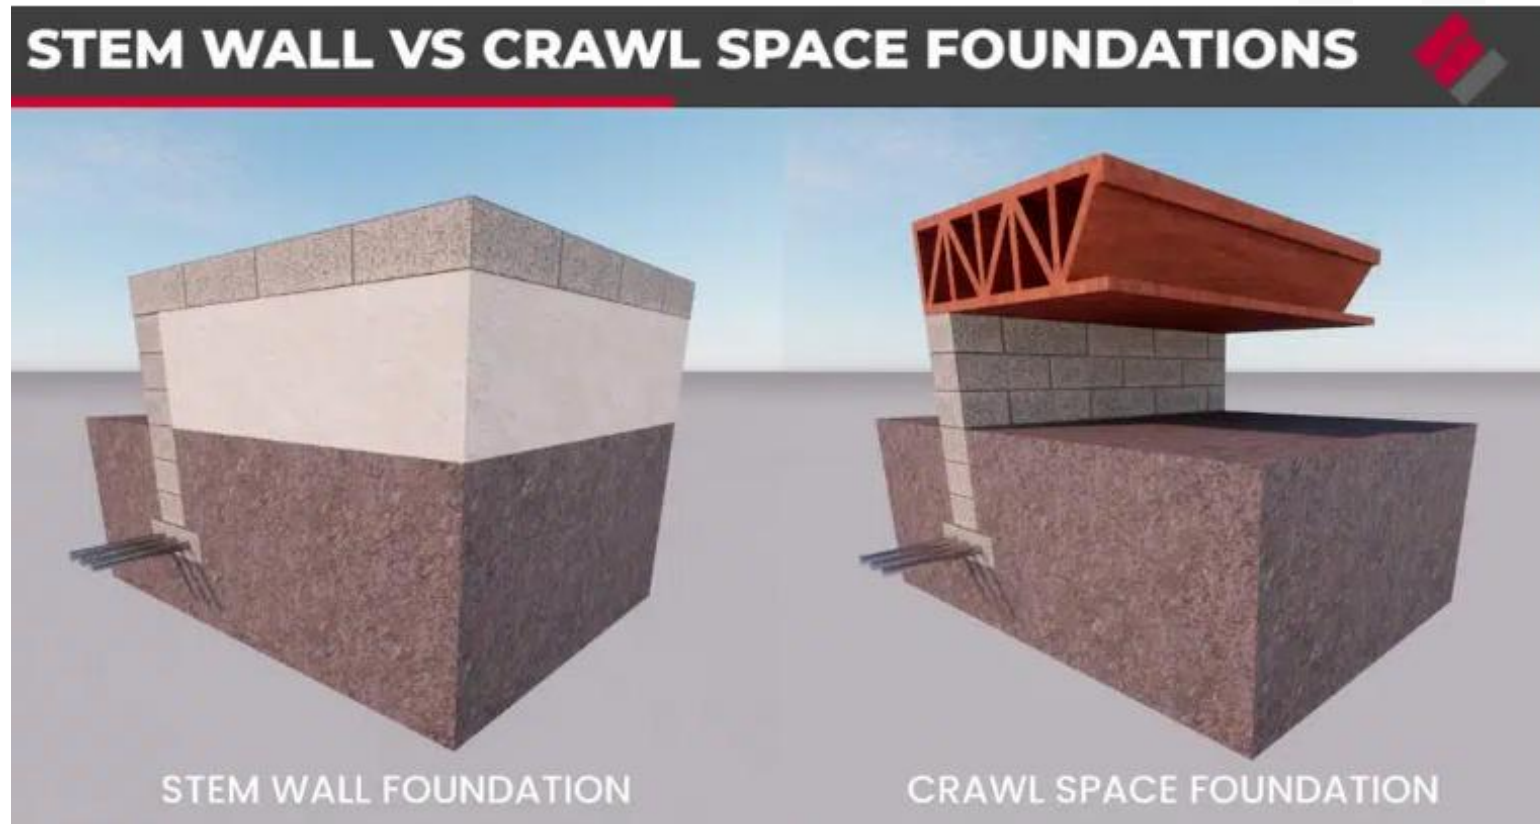
- Slab on grade
- Shallow foundation supporting concrete stem walls
- Foundation has to be strengthened to resist lateral loads

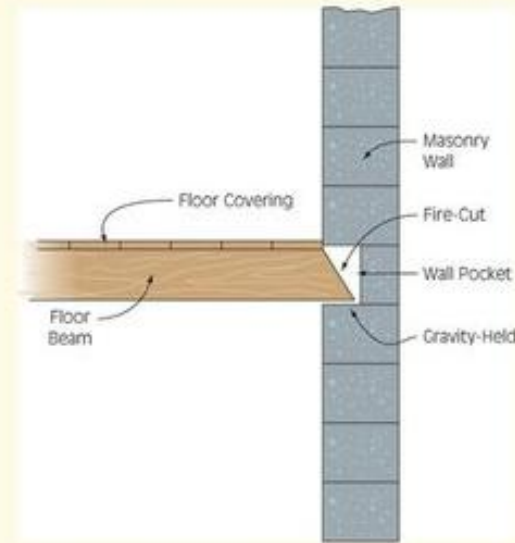
- All wood joists are “fire cut” into the wood wall, not connected to walls via strapping or any other mechanism

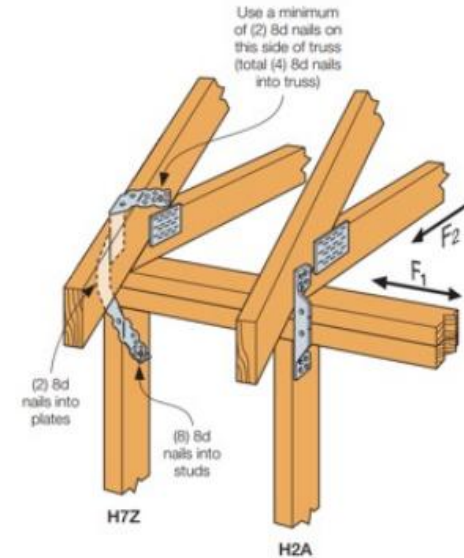
- Roof waterproofing has failed in multiple locations
- Connections for wind uplift forces and wind lateral resistance are non-existent
- Requires roof connection tie-downs be installed to strengthen the roof for Florida Building Code compliance

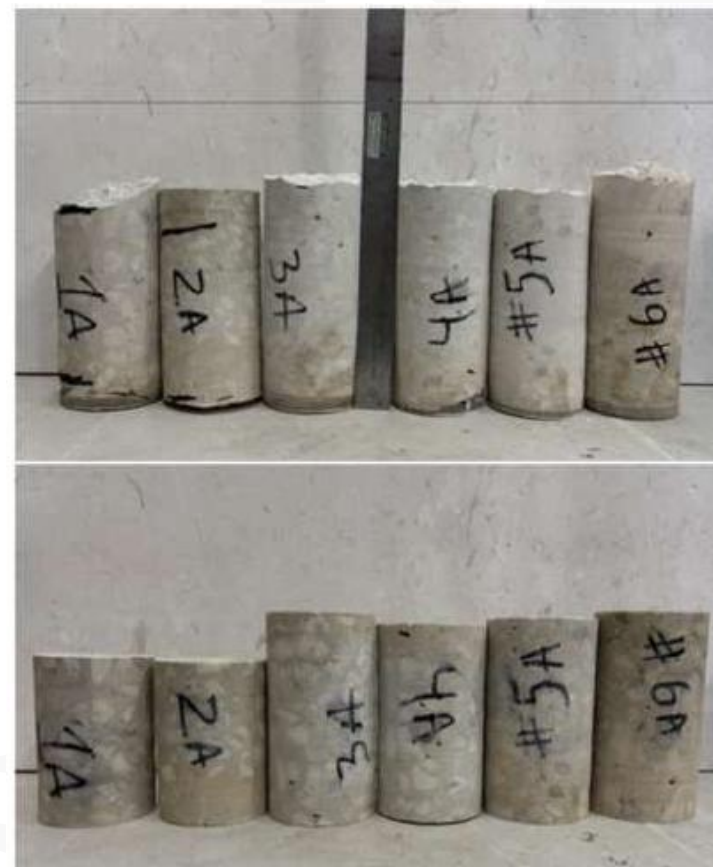
- Extracted core samples confirm a low-density, deteriorated concrete matrix, consistent with **compressive strengths well below** the Florida Building Code–required 5,000 PSI.

The Concrete compressive strength ranged from 1,480 to 2,560 PSI. Per Florida Building Code the concrete strength should be 5,000 PSI.

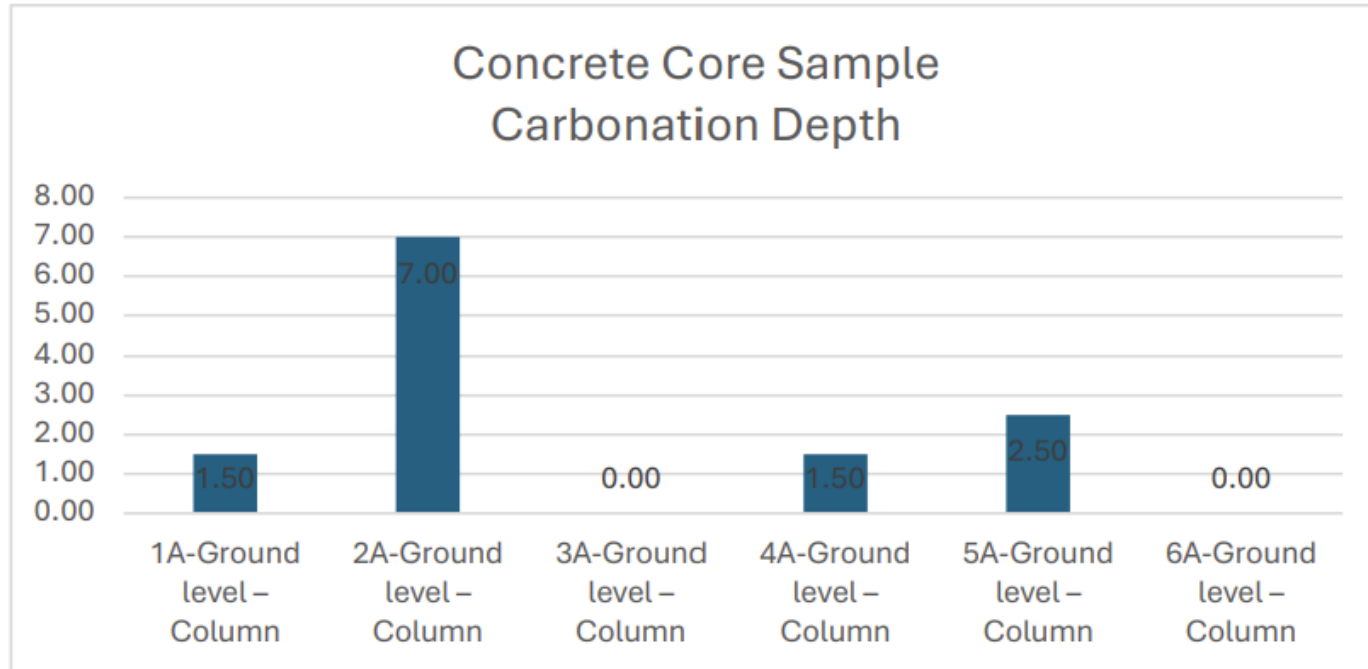
- Depth of carbonation is measured from the surface of the concrete
- Carbonation exposes the rebars to corrosion
- Carbonation is extensive and is as high as 7.00"

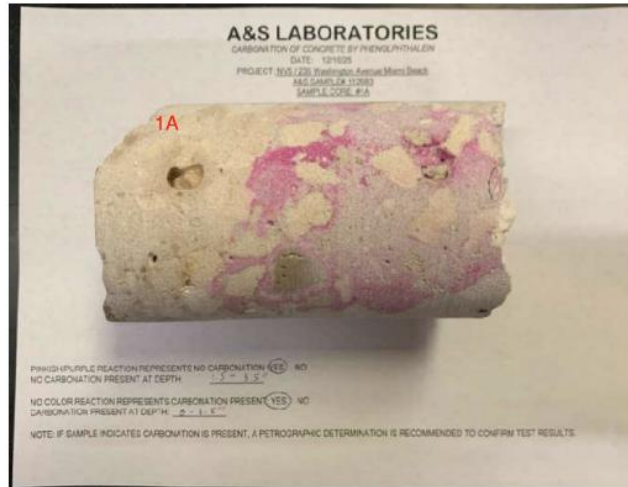
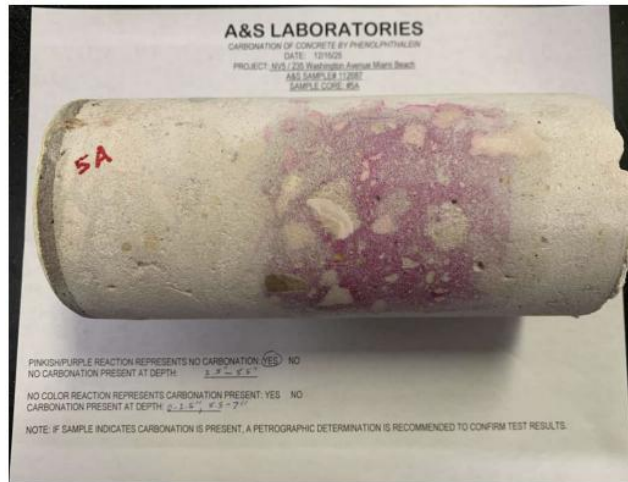
- One-third of samples show carbonation extending beyond the typical depth of reinforcing steel in concrete (>2 inches)
- Another one-third of samples are at or approaching the depth where reinforcing steel is located ( $\approx 1.5$  inches)
- This indicates that much of the structure has lost or is losing protection against steel corrosion, as **carbonation has reached or passed the reinforcing steel**
