## STRUCTURAL CONDITION ASSESSMENT

235 Washington Ave  
Miami Beach, Florida

December 19, 2025

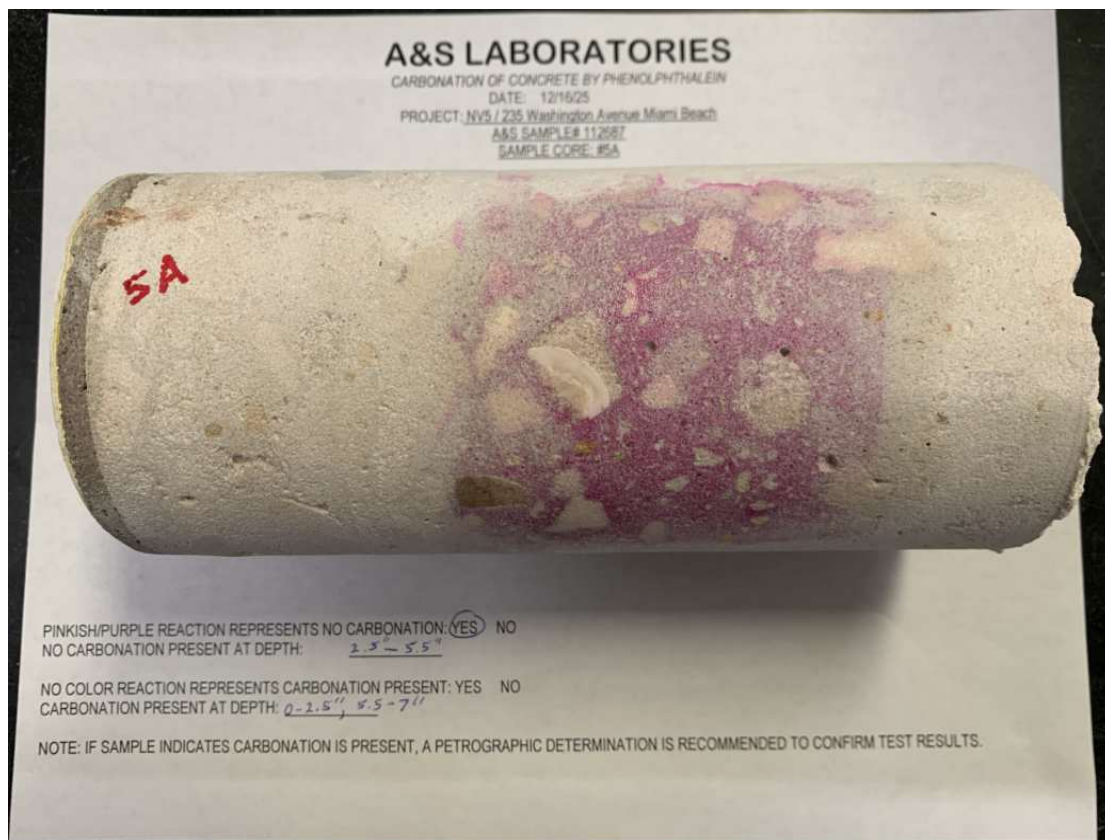
Photograph #7: Concrete Cores #5A Depth of Carbonation Testing

| Core Number | Carbonation Depth [in] |
|---|---|
| 5A-Ground level – Column | 2.50 |
