Wexler Associates

May 5, 2026

Reference: 141 & 145 South Shore Drive, Miami Beach, FL 33141

On Monday, March 30, 2026, the writer visited the existing buildings at 141 and 145 South Shore Drive (Normandy Shores) in Miami, FL at the Owner's request to assess the structural conditions.

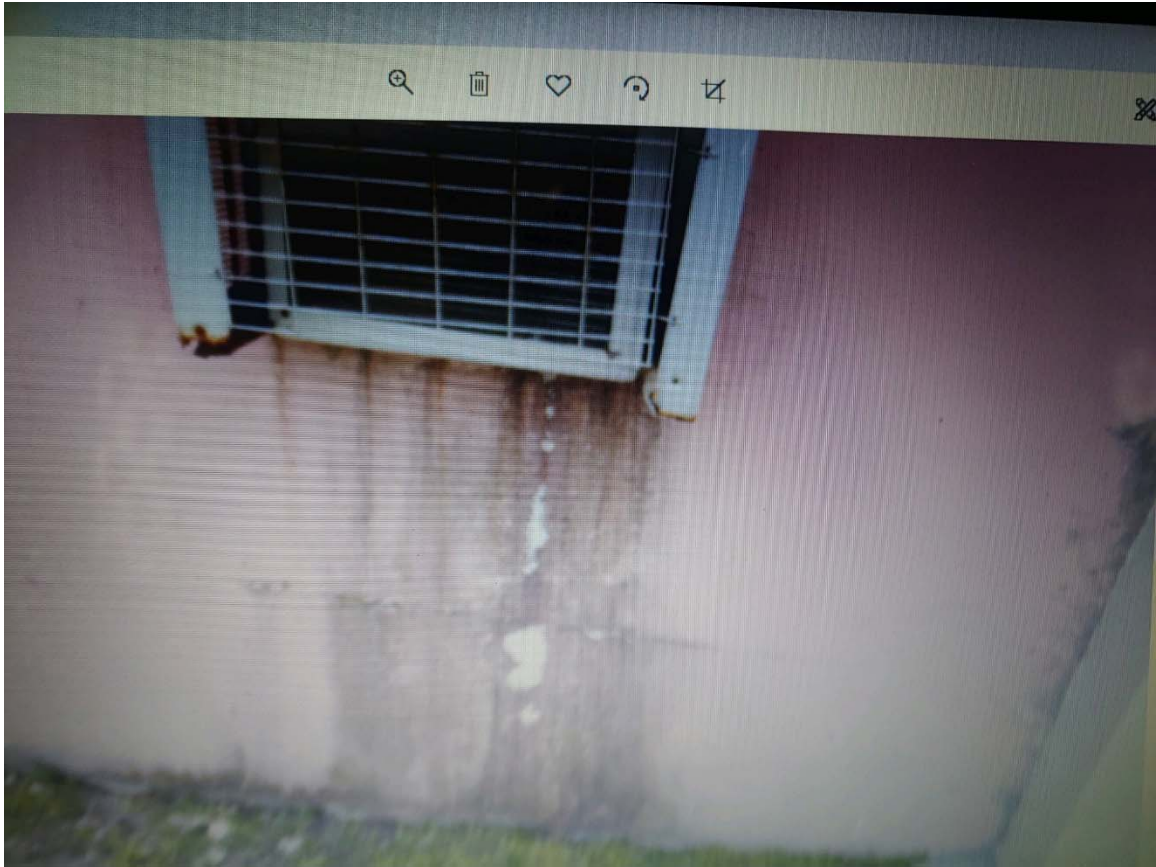
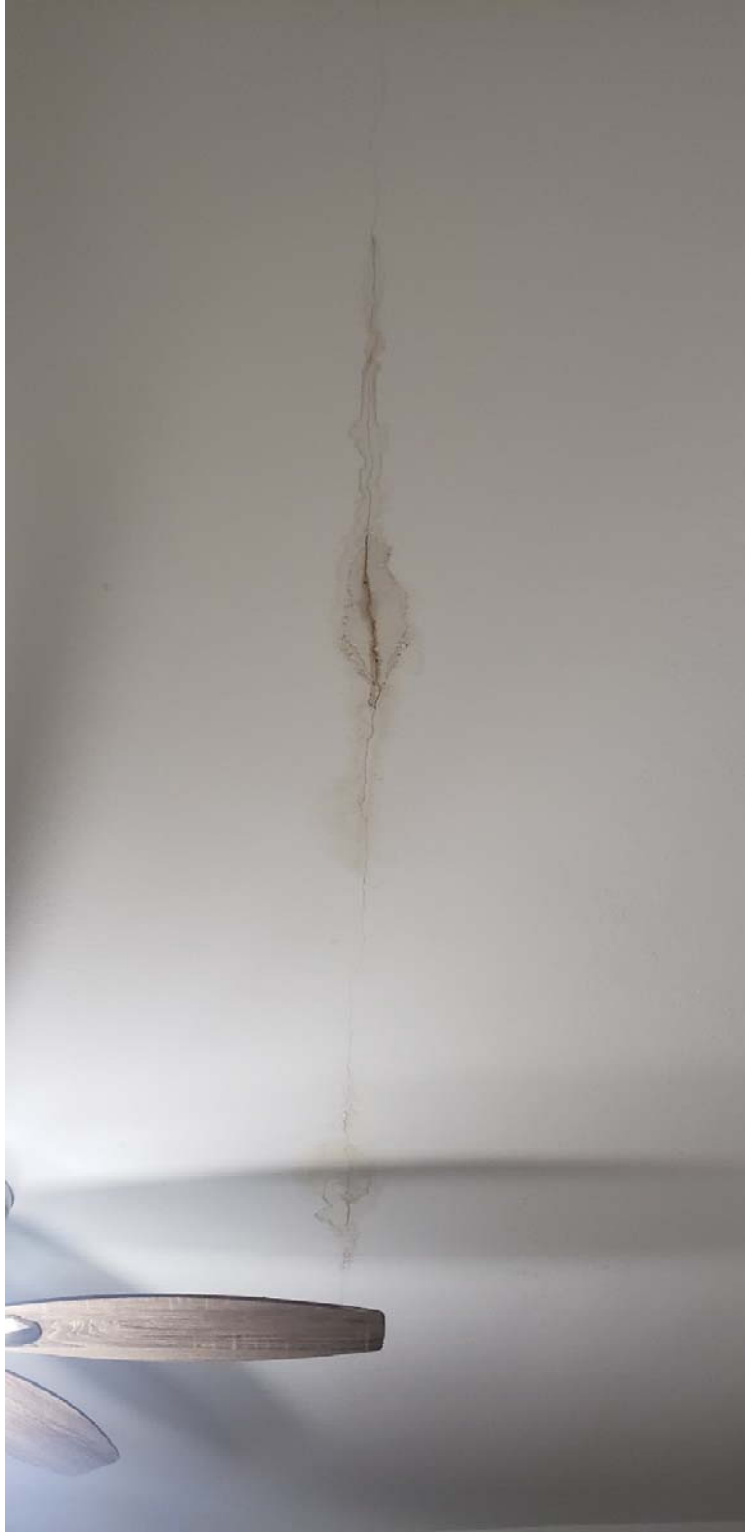
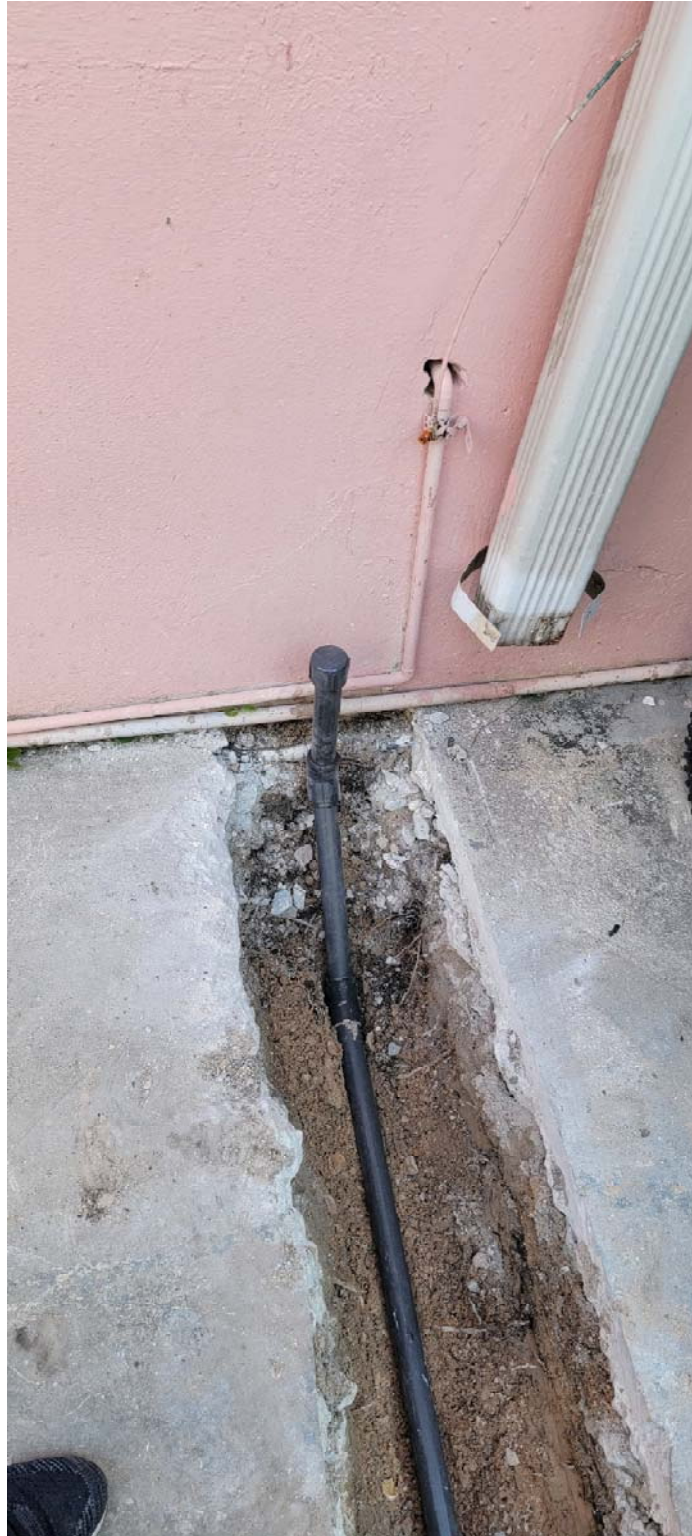
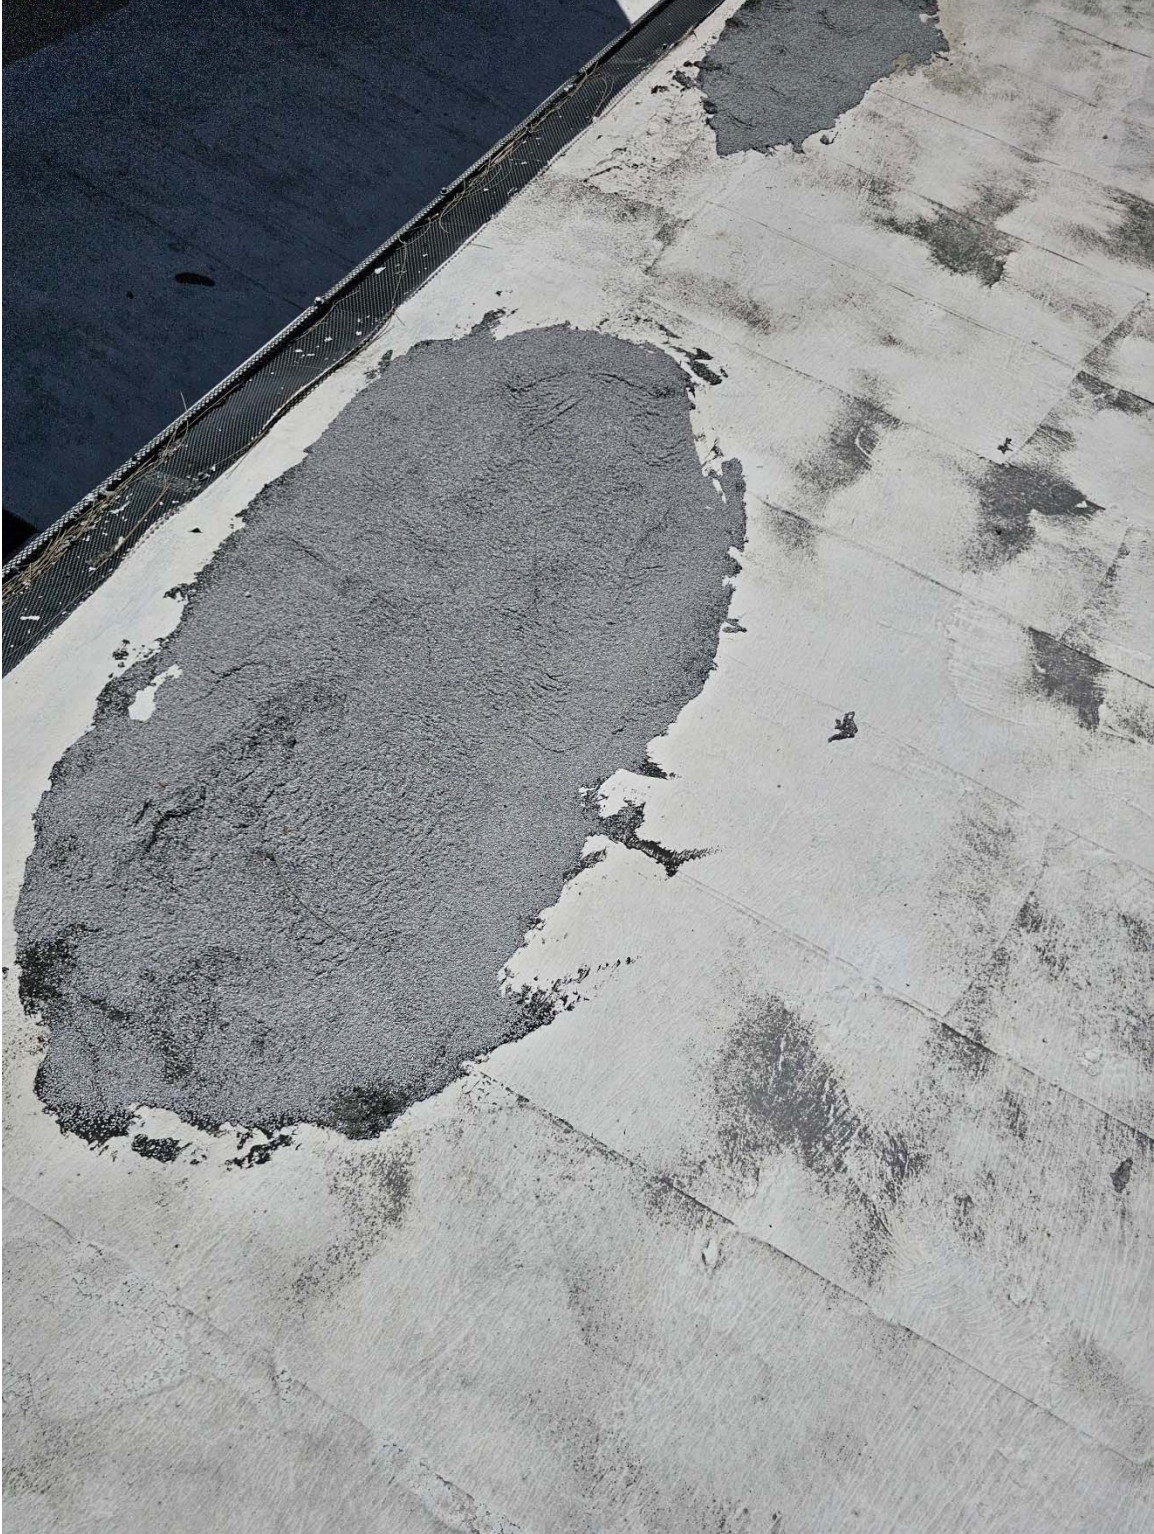
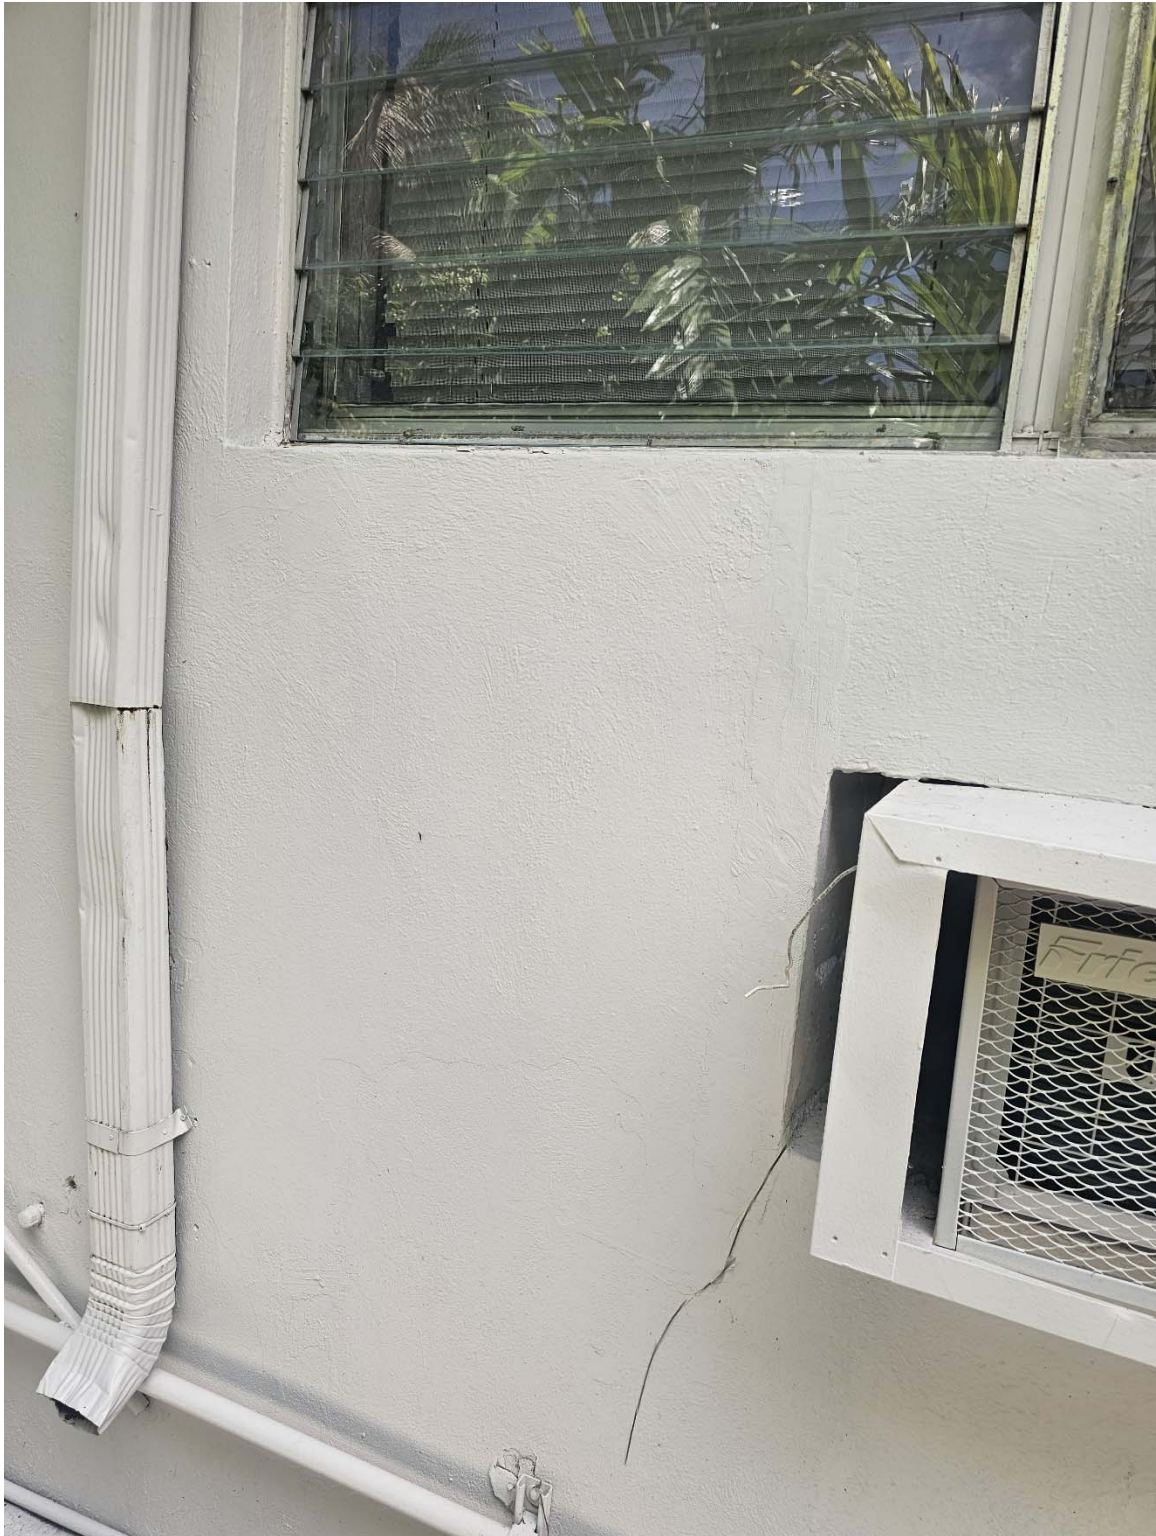
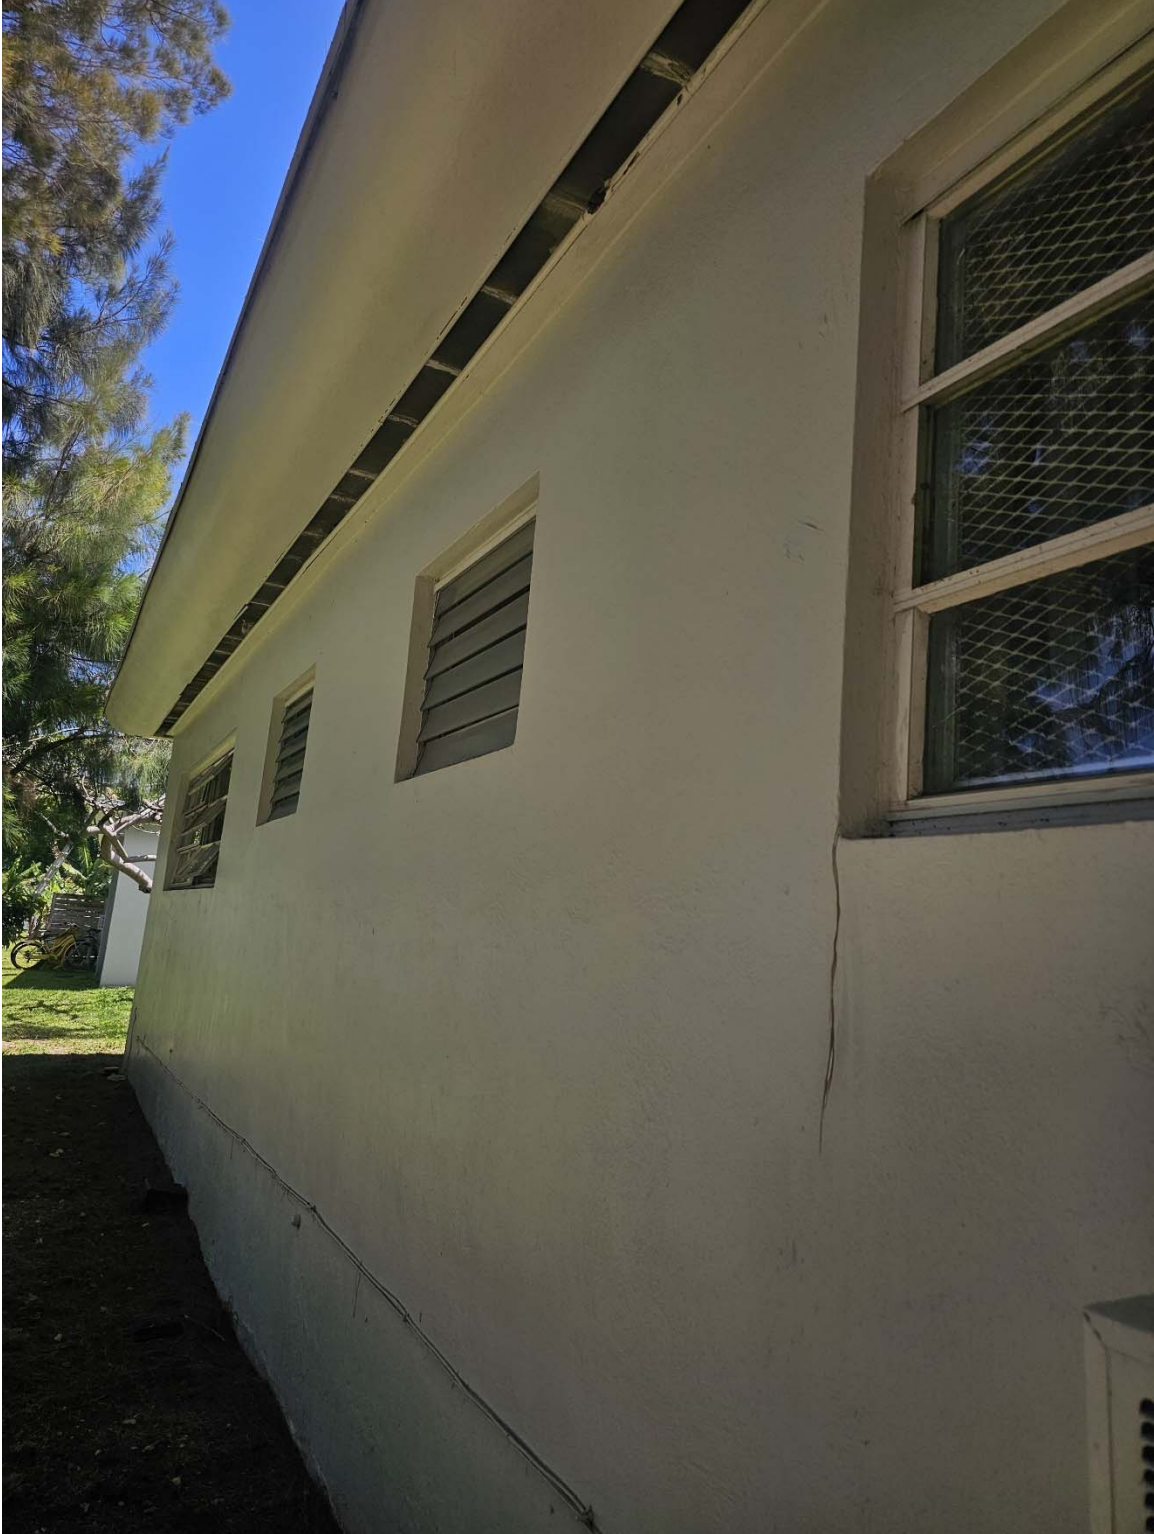
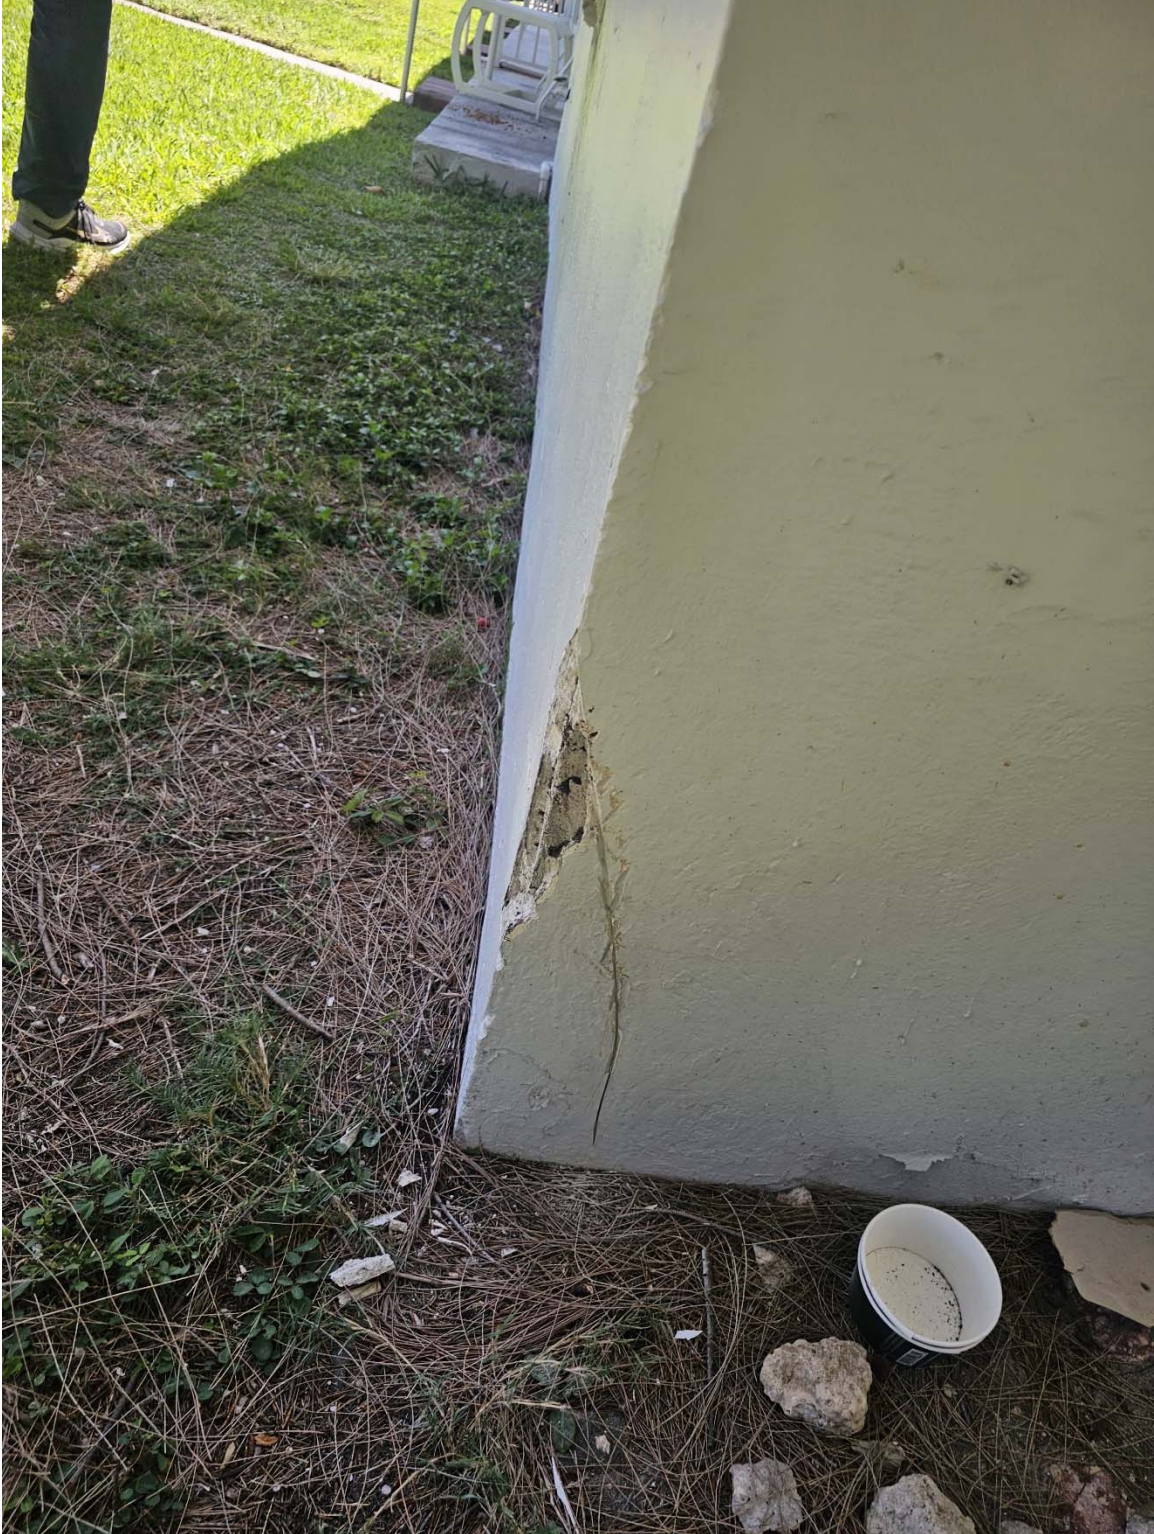
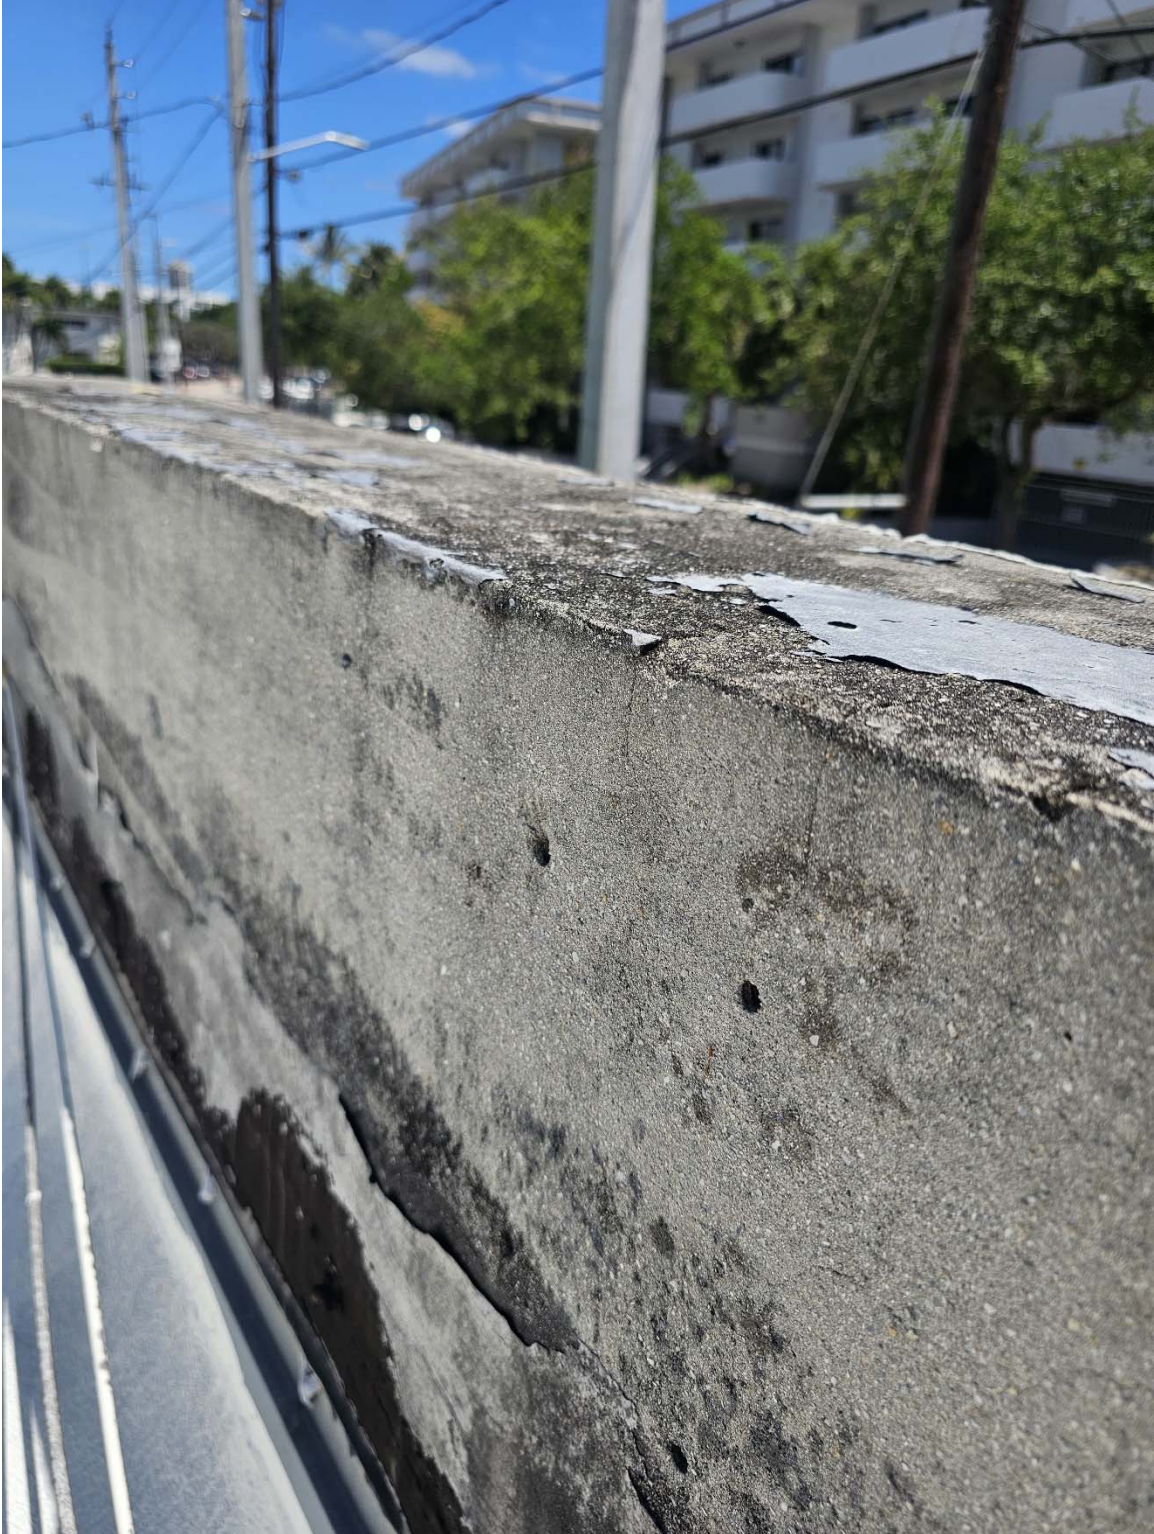
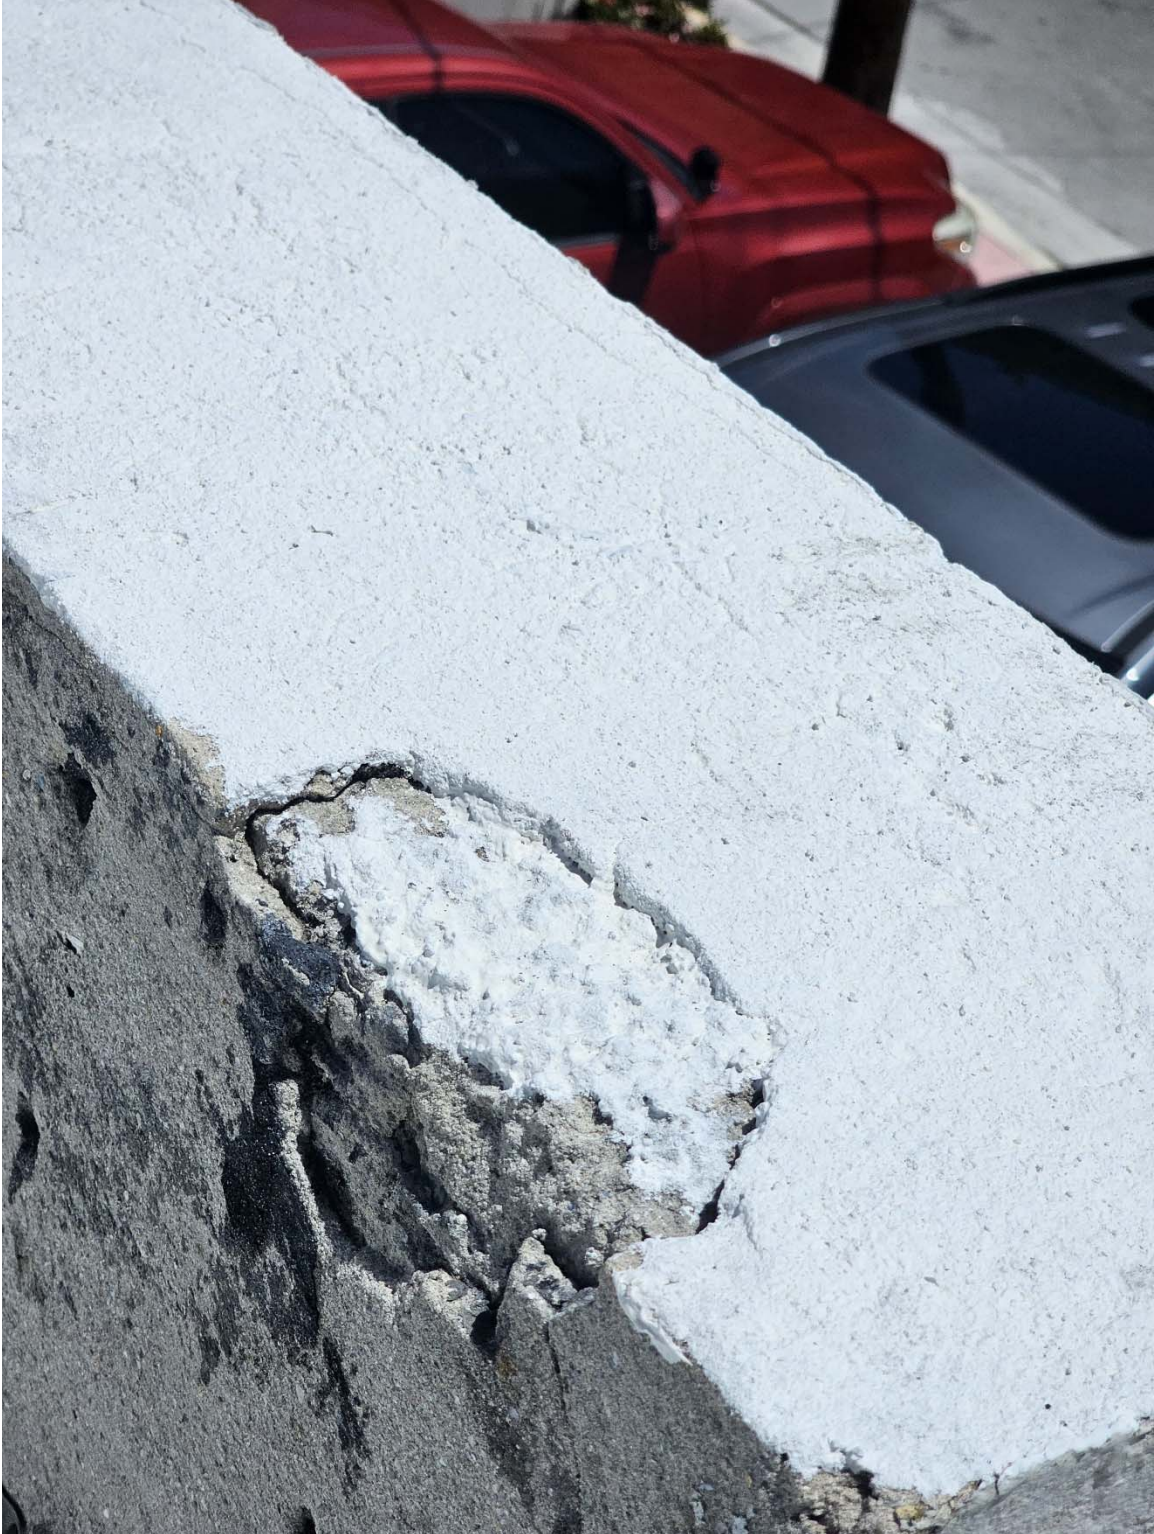
Repair Photos:

During the site visit, the owner mentioned that extensive repair work had been undertaken at both buildings, some to comply with 40 year recertification and some due to various damage that had occurred over the years. These include complete replacement of the plumbing systems to use PVC pipes in lieu of the existing cast iron pipes, spot repair of the roofs due to water infiltration, repair of cracking in exterior walls due to water damage...etc. see photos at end of this report. This maintenance has imposed significant financial burdens on the owner.
